Hurricane Kate

November 15-23, 1985

Department of Natural Resources
Division of Beaches and Shores
Post Storm Report No. 86-1
September, 1986
By Ralph Clark

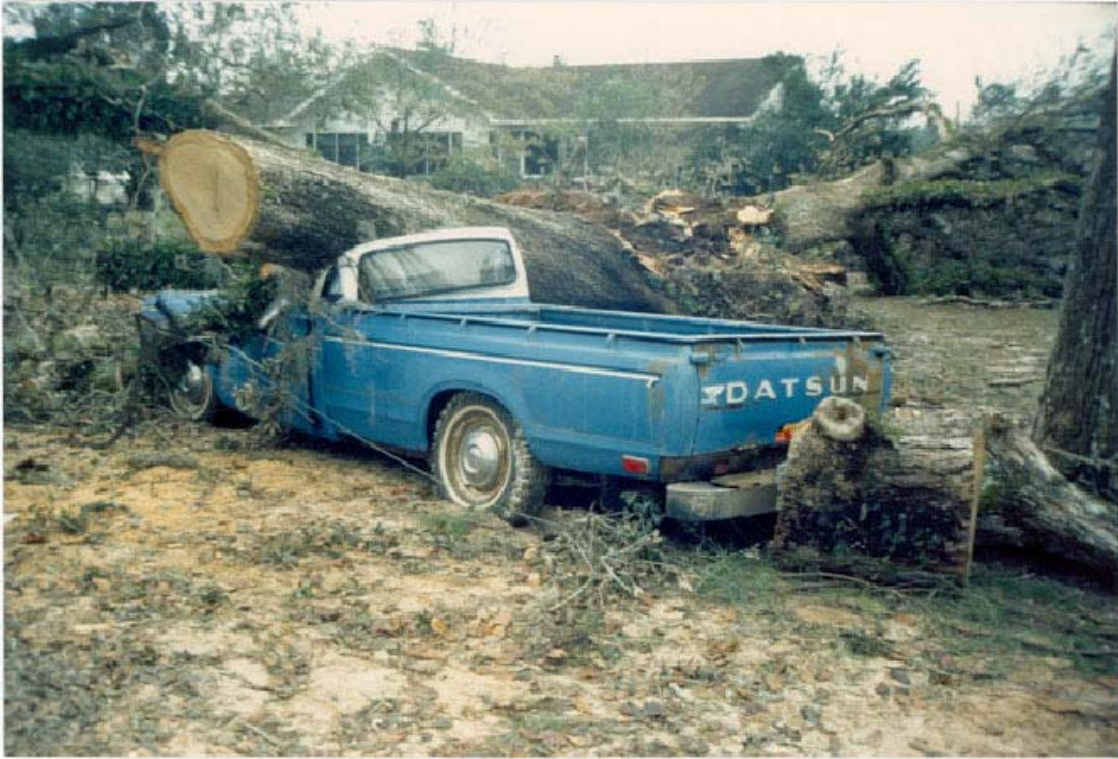
Kate brought rainfall totals averaging between 4 to 6 inches in the major impact areas of north Florida and southwest Georgia. Kate apparently spawned at least one small tornado on Live Oak Island, Florida, although numerous downbursts were apparent throughout Gadsden and Leon Counties in north Florida. The inland areas of north Florida and South Georgia sustained widespread wind damage to buildings and utilities and countless tree damage, many of which caused damage to adjacent structures when they fell (Figure 5).

FIGURE 5. Tree Damage on Lanier Road, Gadsden County

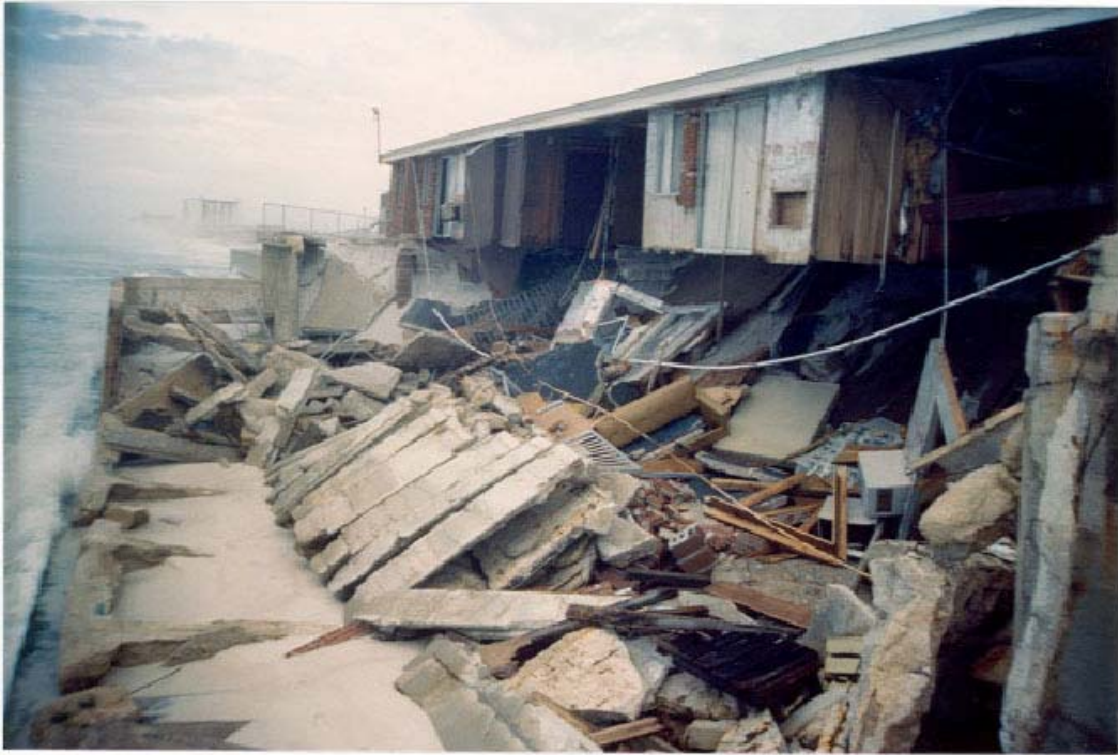
At the Treasure Island Motel, the seaward projecting concrete bulkhead at the east end of the property had been destroyed during tropical storm Juan on Halloween. The storm wave activity from Kate caused substantial damage to the motel building by undermining the foundation and destroying four of the motel units (Figure 7). Reconstruction of at least 150 feet of concrete bulkhead will be necessary to provide a reasonable level of protection to the remaining building. A landward relocation of the bulkhead will increase its chances of survival during future minor storms and will reduce the impact of the structure on the longshore transport of sediment.

FIGURE 7. Treasure Island Motel Damage, Panama City Beach.

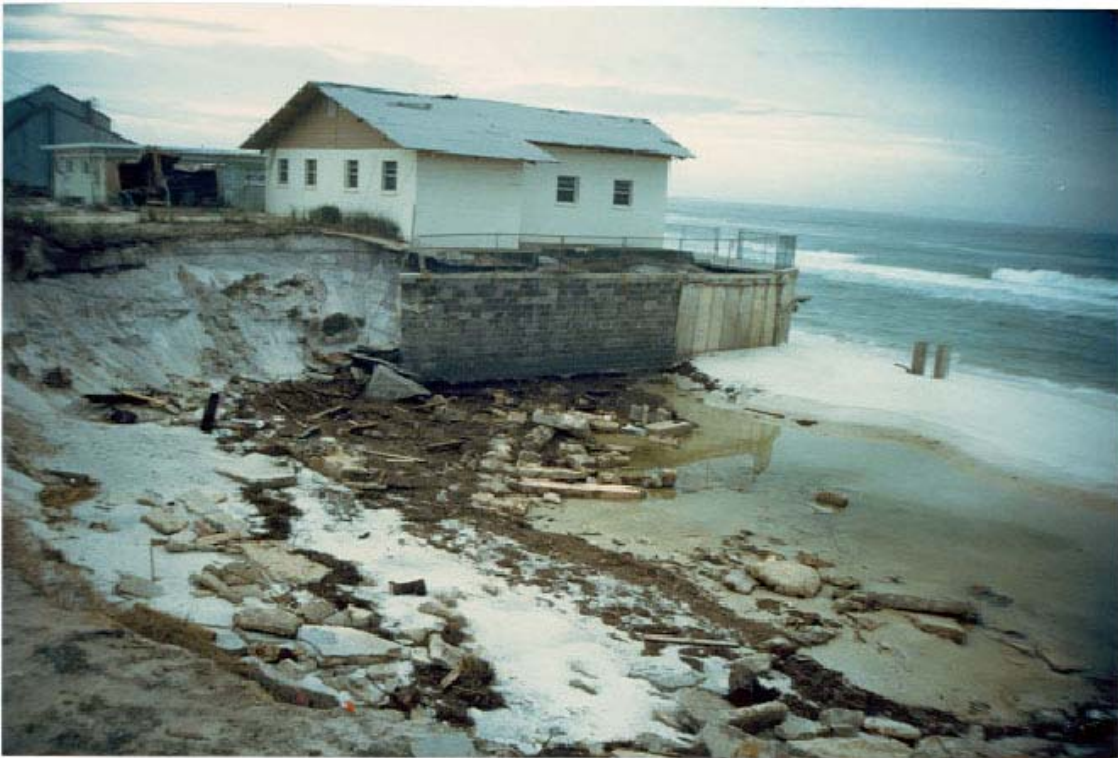
FIGURE 8. Heavy Dune Erosion adjacent Spyglass Drive has flanked a return wall and threatens a dwelling.

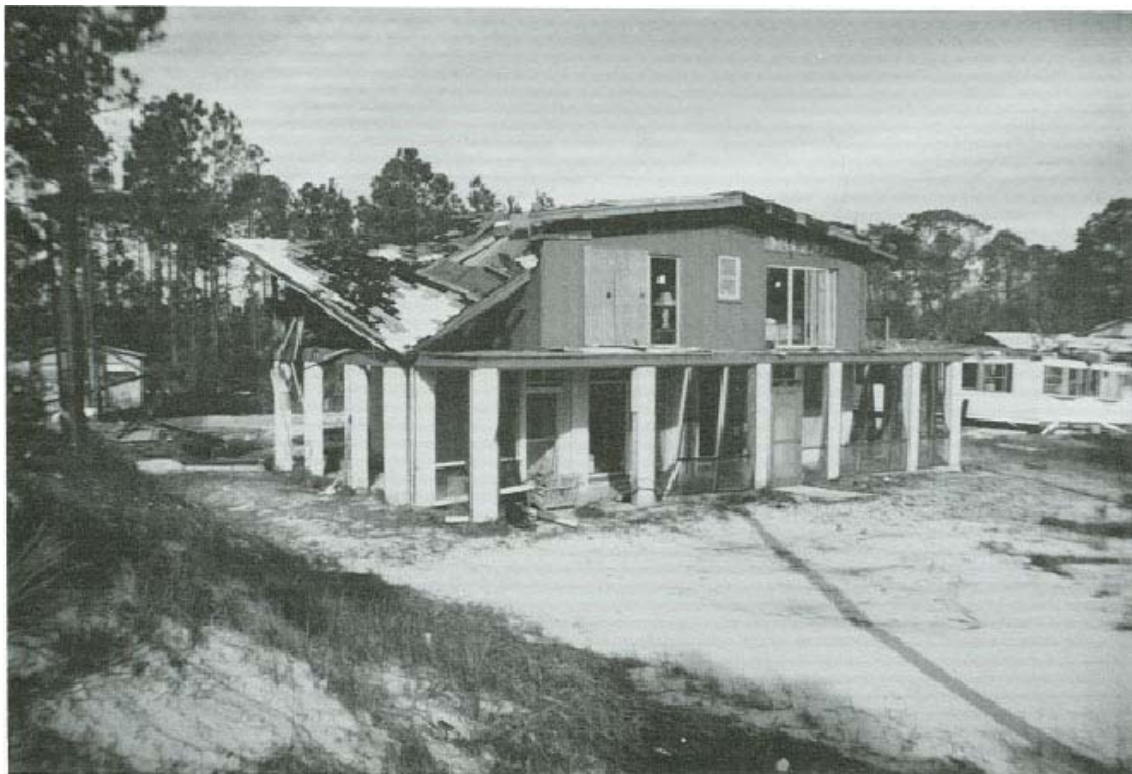
Money Bayou was opened to tidal flow by the storm surge of Kate. In this area the Coastal and Oceanographic Engineering Department, University of Florida, measured a high water mark of +8.4 feet NGVD. East of Money Bayou, extensive flooding and wind damage was sustained (Figure 22). The first dwelling east of Money Bayou, a two-story structure, sustained major flood damage to the ground floor and major roof collapse due to wind loads (Figure 23). The adjacent dwelling to the east, a manufactured

FIGURE 23. Dwelling damaged by wind and flooding.

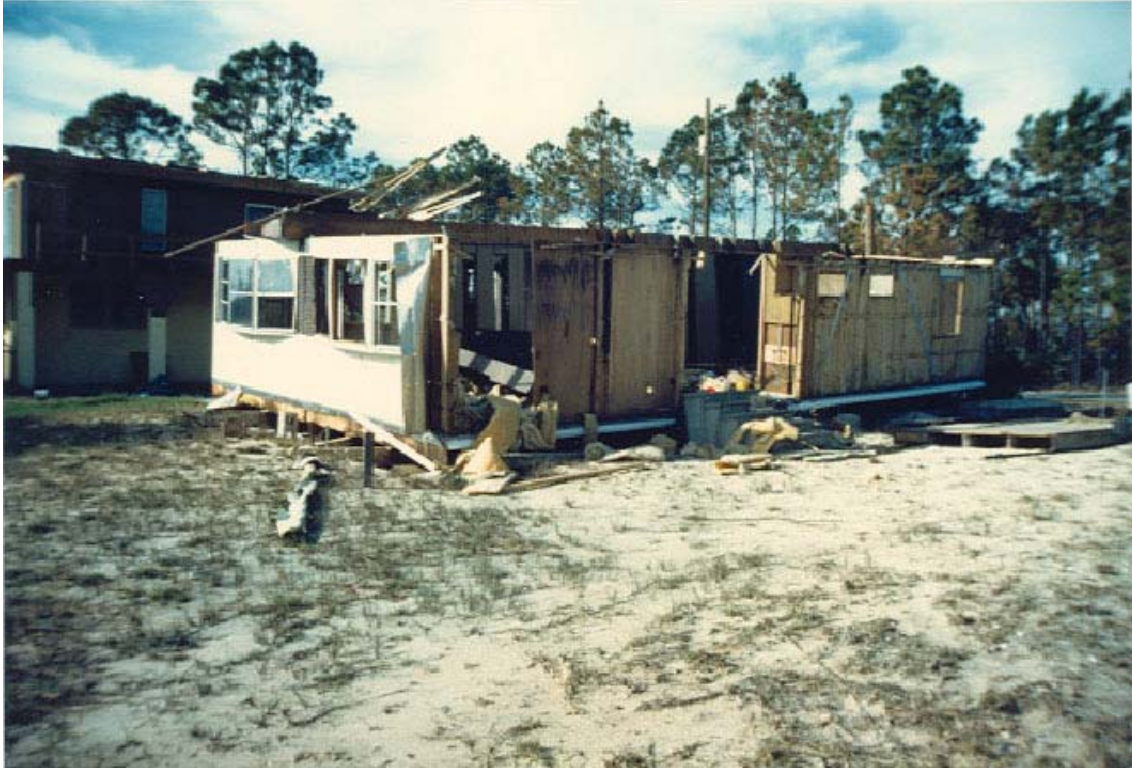
home, was destroyed by winds, waves, and flooding (Figure 24) and the next dwelling to the east was floated completely off its short pile foundation and sustained wind and flooding damage (Figure 25). The fourth dwelling east of Money Bayou sustained major roof damage and two others sustained minor roofing damage. A quarter mile east of Money Bayou a mobile home was destroyed by wind and flooding (Figure 26) and three-quarters of a mile east of Money Bayou a dwelling sustained major structural damage to the lower floor due to wave impact loads (Figure 27). Profile data of the Bureau of Coastal Data Acquisition reflected about 5 feet of vertical scour to the foredunes in this area due to Kate.

FIGURE 24. Manufactured dwelling destroyed by winds, waves, and flooding.

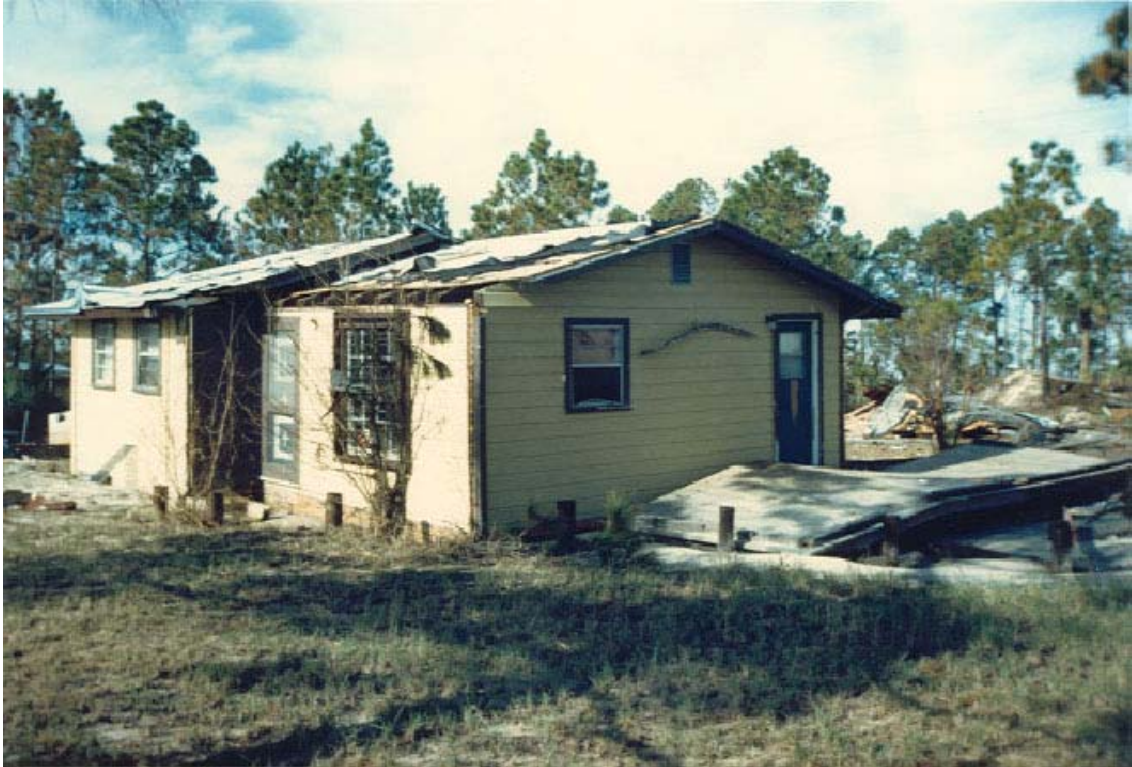
FIGURE 25. Damaged dwelling floated off its short pile foundation.

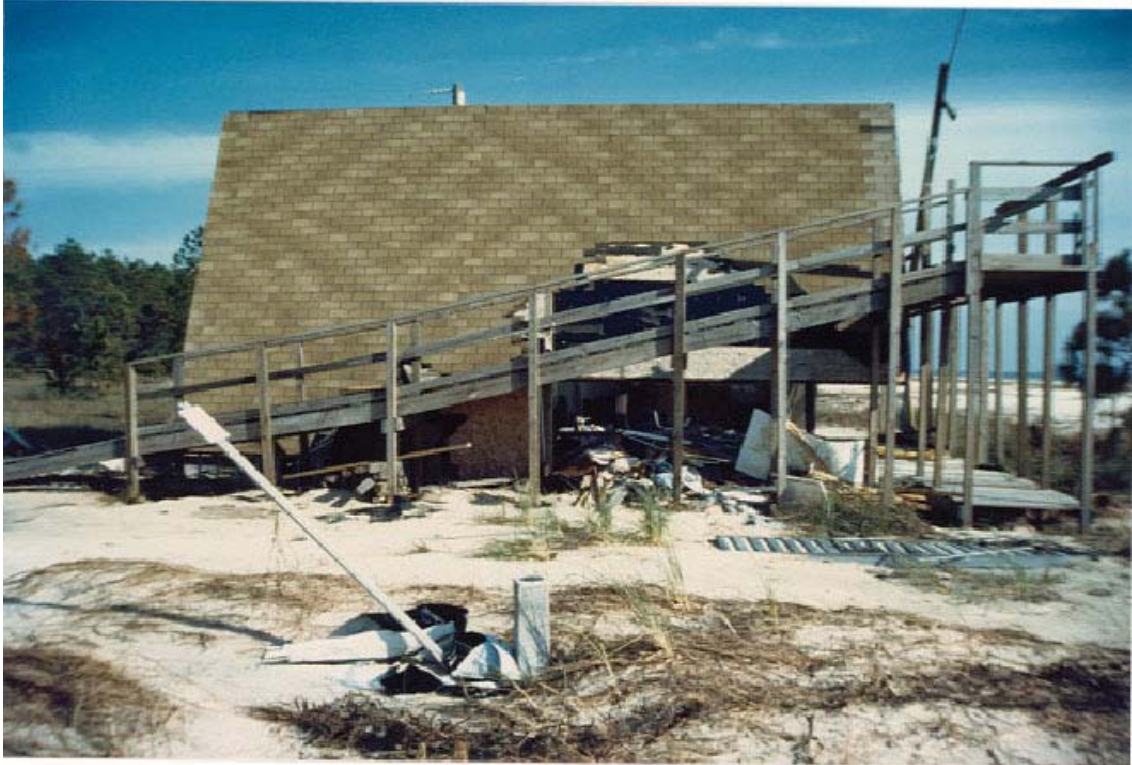
FIGURE 27. Dwelling damaged by wave impact loads.

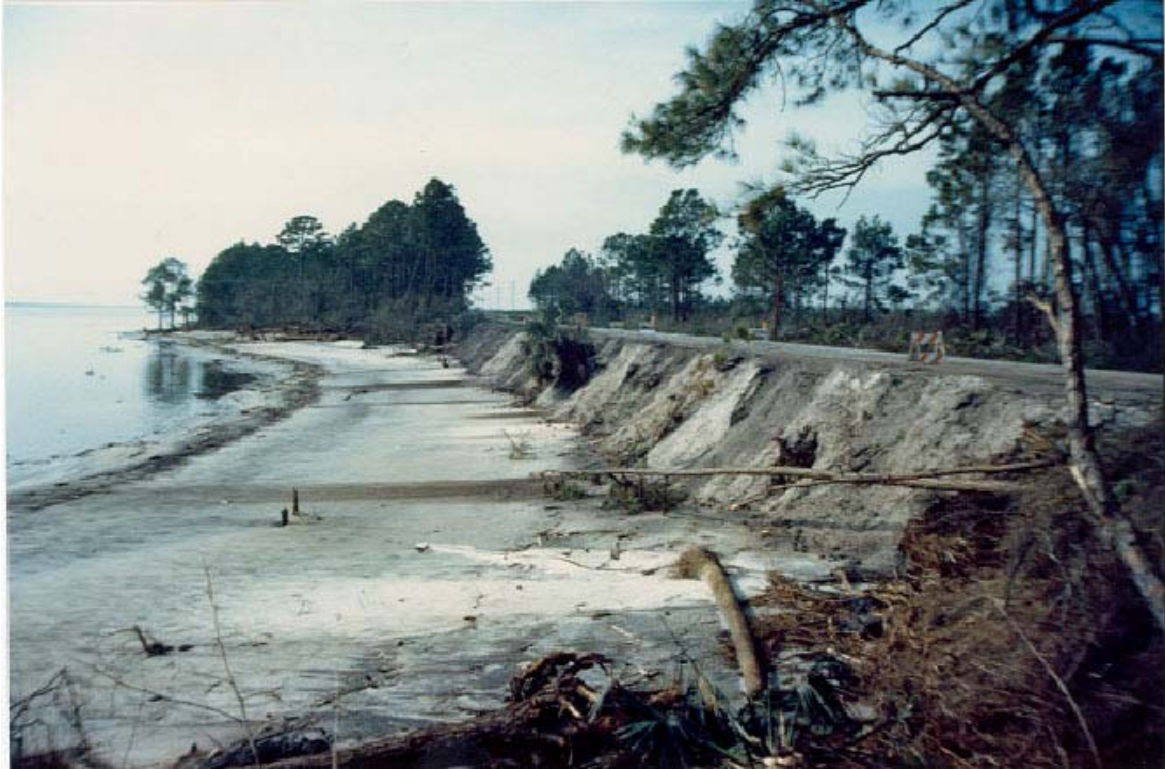
At an area known as 14 Mile, two mobile homes were destroyed by the flooding. These structures were the St. Vincent National Wildlife Refuge offices. Substantial tree damage made many of the refuge trails unpassable on St. Vincent Island. At an area known as 13 Mile, three structures were destroyed by the flooding. A concrete block slab-on-grade seafood processing plant located on the St. Vincent Sound shoreline was totally destroyed by storm waves propagating on the storm surge. About 2,000 feet inland from the sound a frame single-family dwelling and a mobile home were destroyed by the flood waters. Nearby a large steel hull boat strapped to a trailer was floated further inland about 100 feet by the flood. Just west of the junction with U.S. Highway 98, about 350 feet of Franklin County Road 3022 was substantially damaged due to erosion from St. Vincent Sound (Figure 28).

FIGURE 28. Franklin County Road 3022 damage from St. Vincent Sound shoreline erosion.

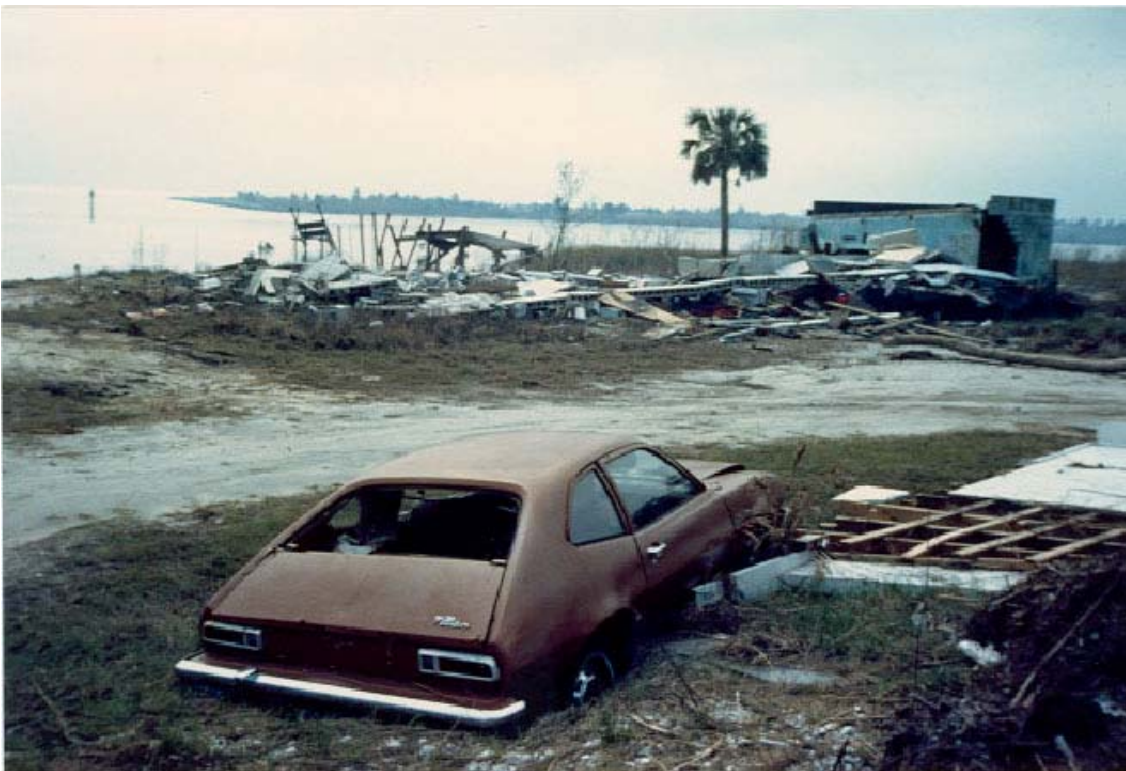
At the gap in the breakwater for the navigation channel, evidence existed indicating how substantial the damage would have been without the breakwater (Figure 29). A large concrete block

FIGURE 29. Heavy damage at the gap in the two mile breakwater, Apalachicola.

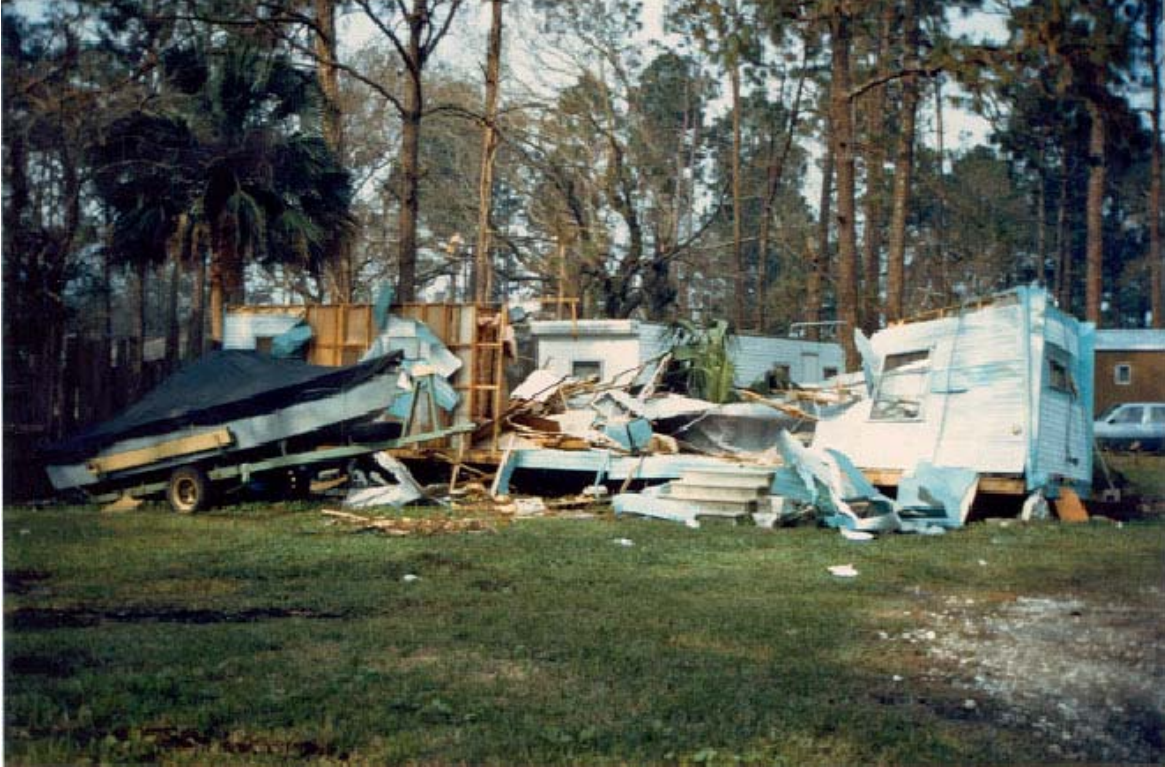
FIGURE 32. Mobile home destroyed by wind.

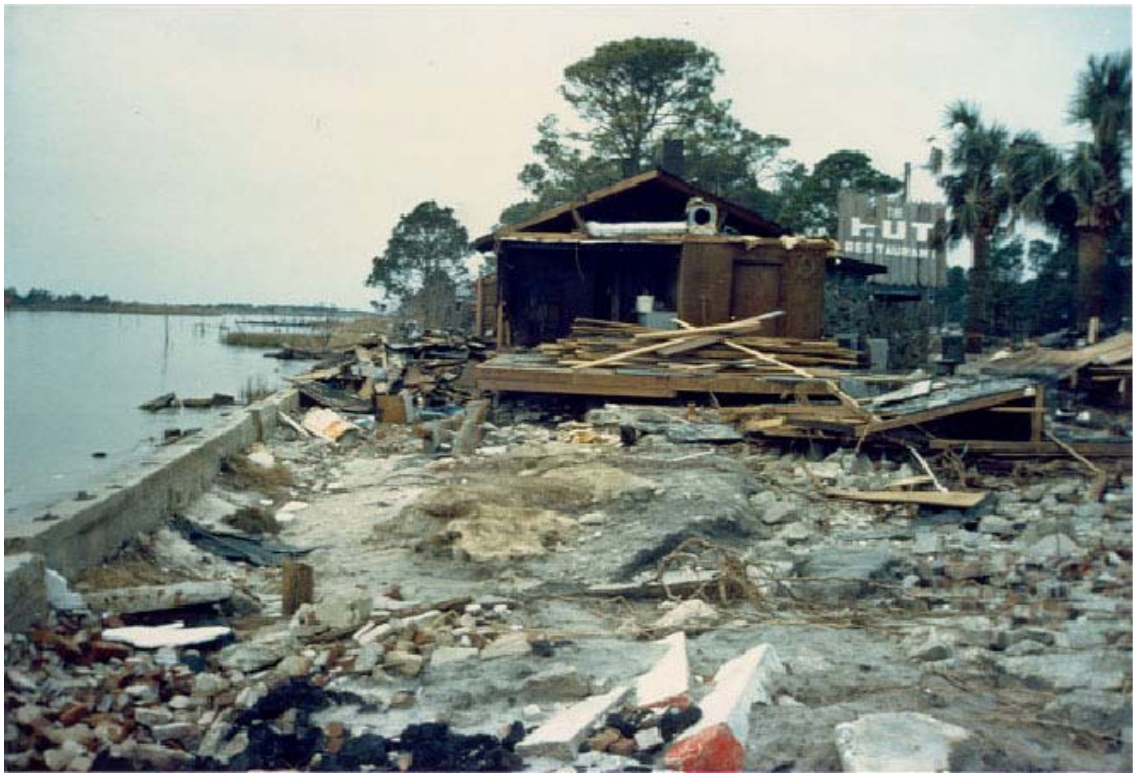
FIGURE 33. Wave damage to the Hut Restaurant on Apalachicola Bay shoreline.

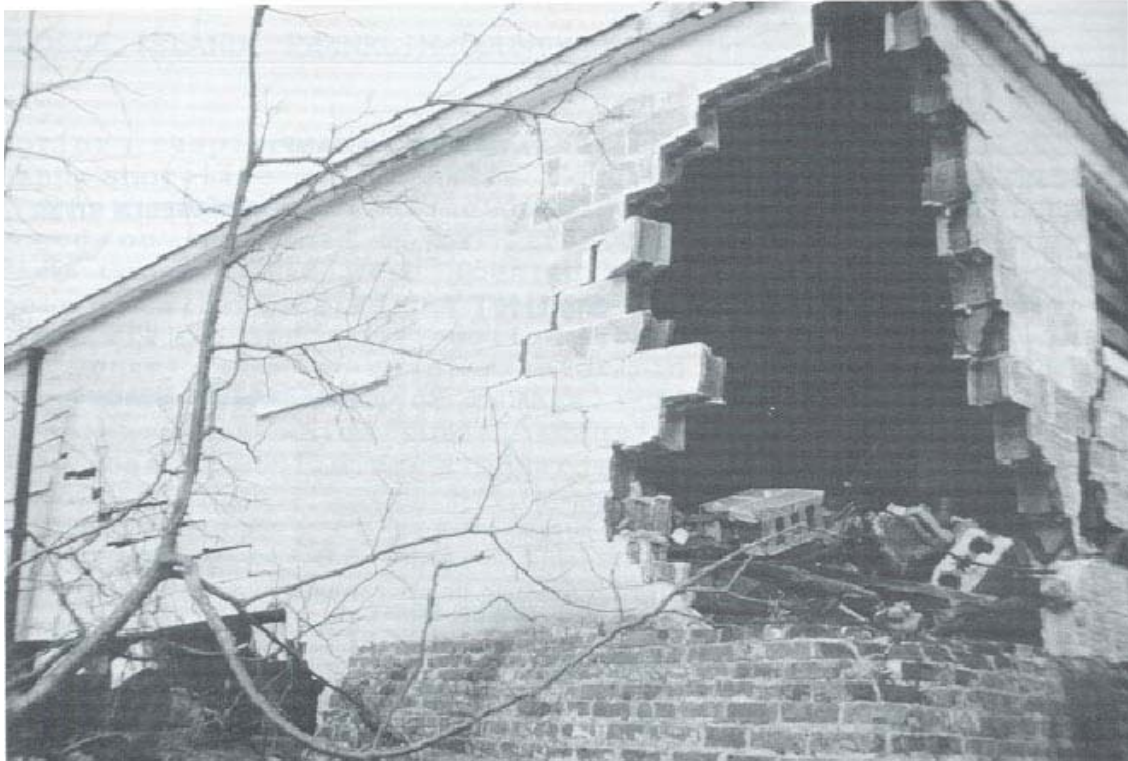
FIGURE 36. Building damaged by waves at the mouth of the Apalachicola River.

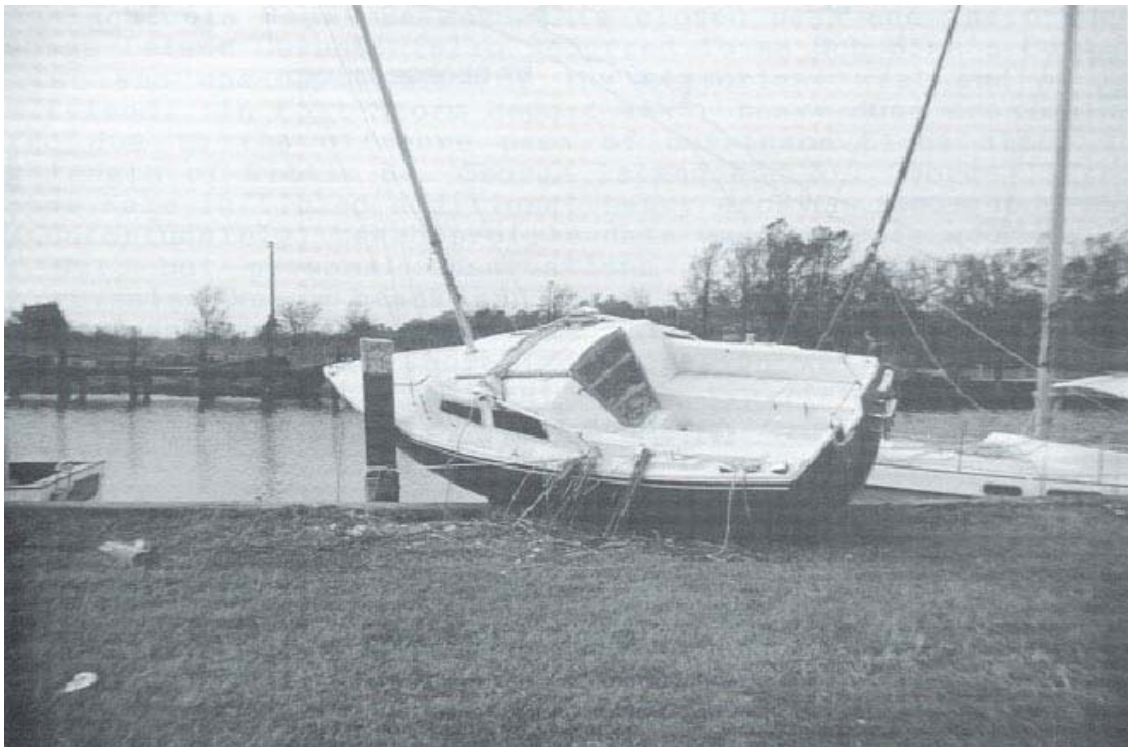
FIGURE 37. Marina Damage at Battery Park, Apalachicola.

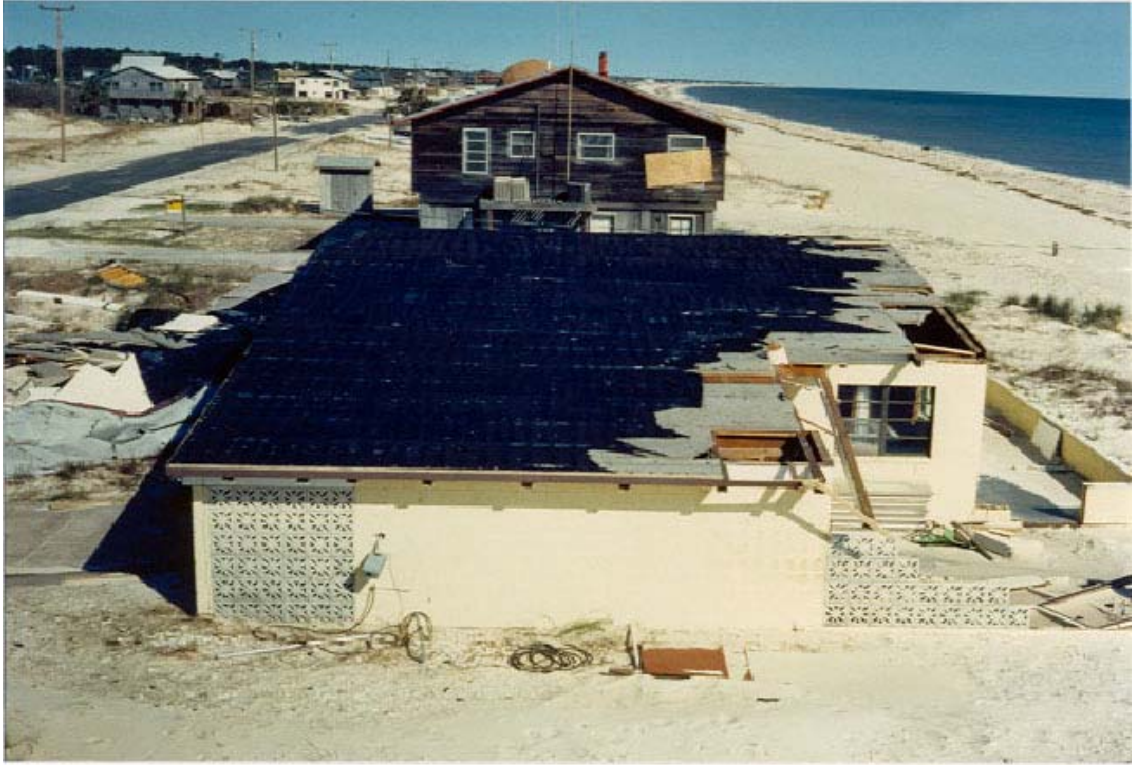
FIGURE 43. Major roof damage due to wind.

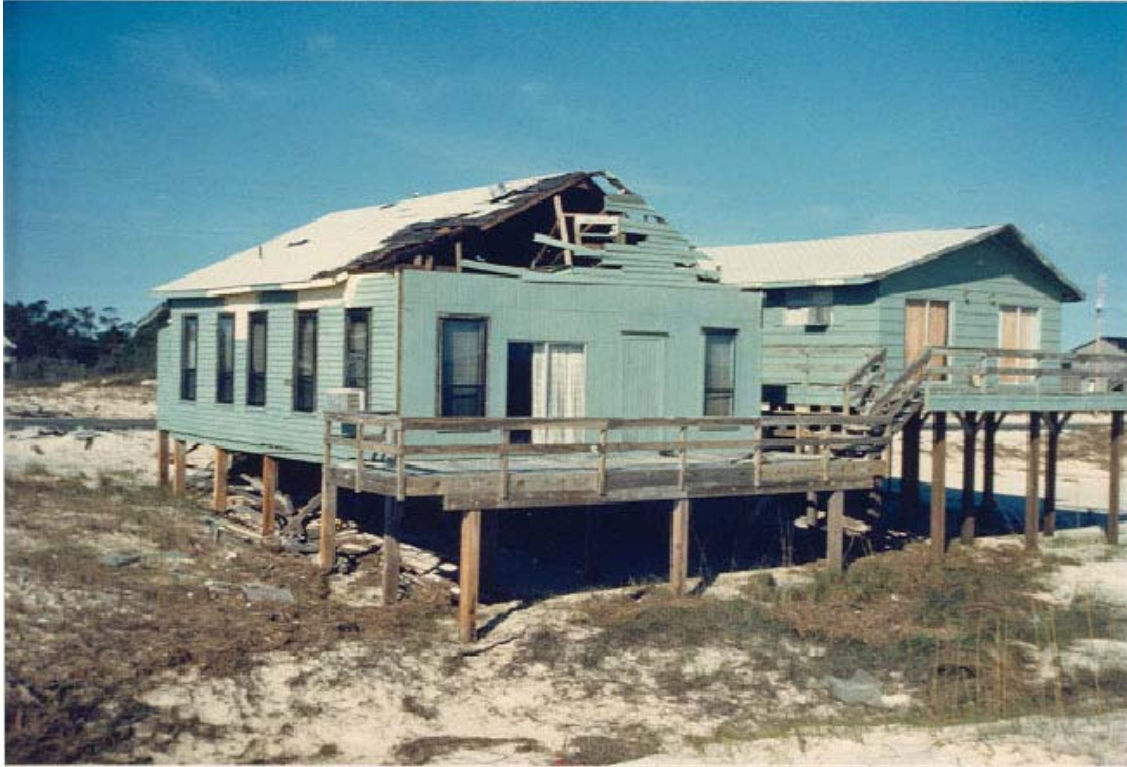
Adjacent to the beach to the east of the end of 8th Street West, the older of two adjoining wood frame dwellings sustained major structural roof damage due to wind (Figure 45). The roof damage seen in Figures 44 and 45 reflect the need for stronger roof to wall connections particularly where large roof overhangs are

FIGURE 45. Severe Structural roof damage due to wind.

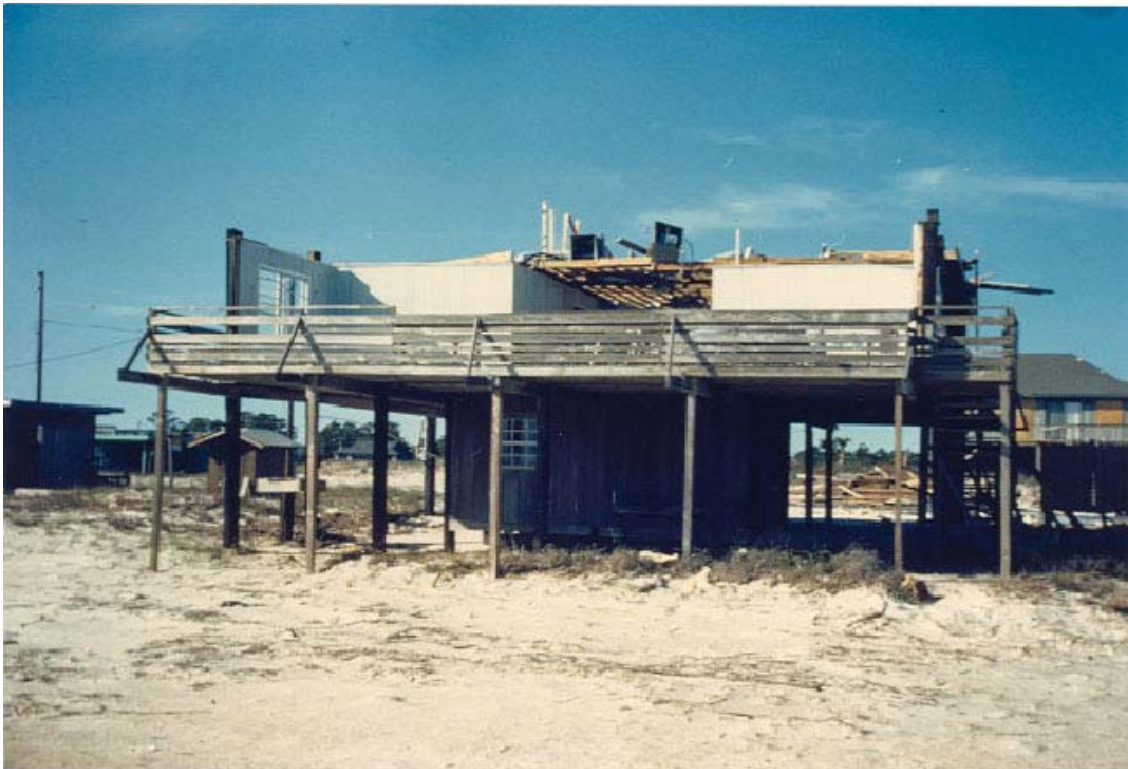
FIGURE 46. St. George Island beach Dwelling destroyed by wind.

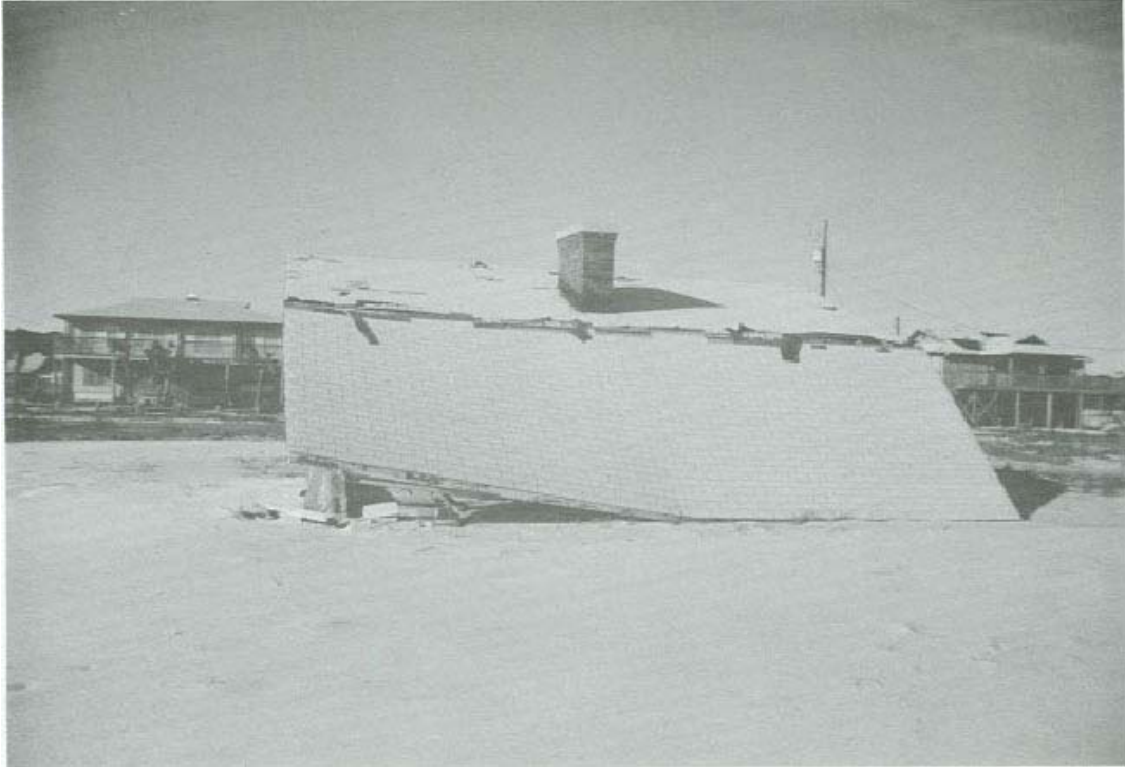
was destroyed and its roof collapsed causing major structural roof damage to the main portion of the structure (Figure 49). Immediately adjacent and to the east, a pile-supported wood frame dwelling sustained major foundation damage due to wind in combination with the scour of sediment around the piles (Figure 50). The structure's inadequate pile to beam connections were damaged and pile penetration was insufficient causing the structure to lean towards the north in danger of collapse from another strong onshore wind.

FIGURE 49. Porch destroyed and roof collapsed.

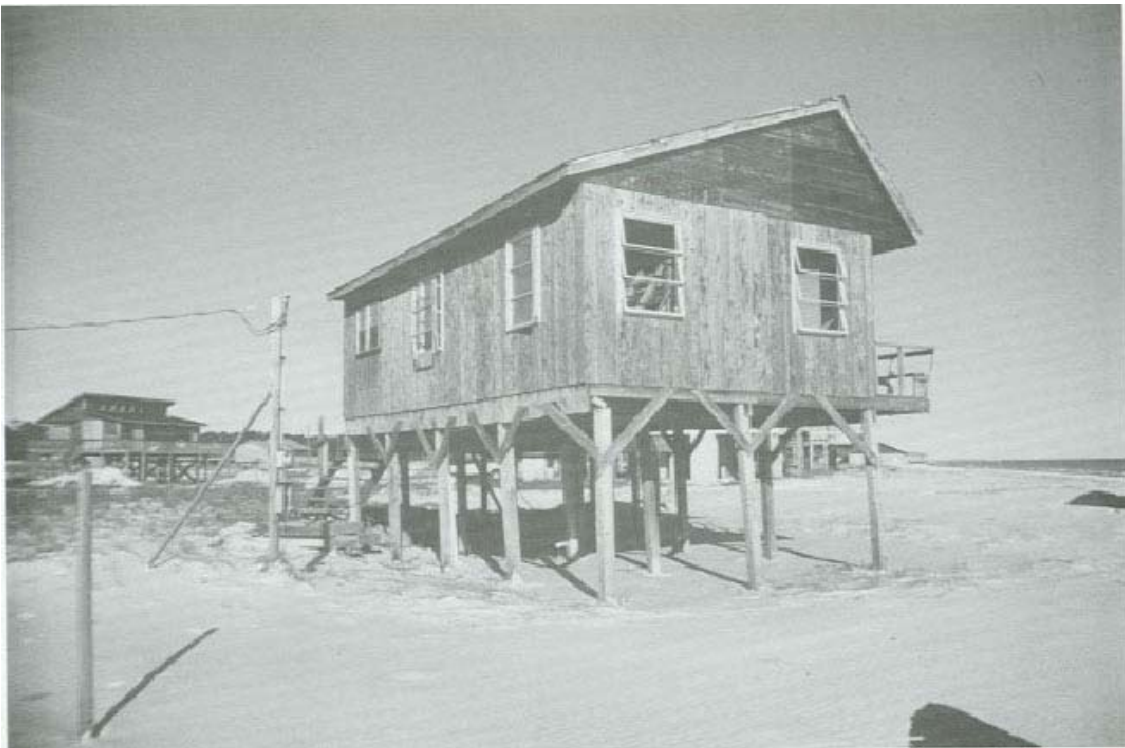
FIGURE 50. Pile-supported dwelling with inadequate pile to beam connections and insufficient pile penetration leans following wind loads and scour.

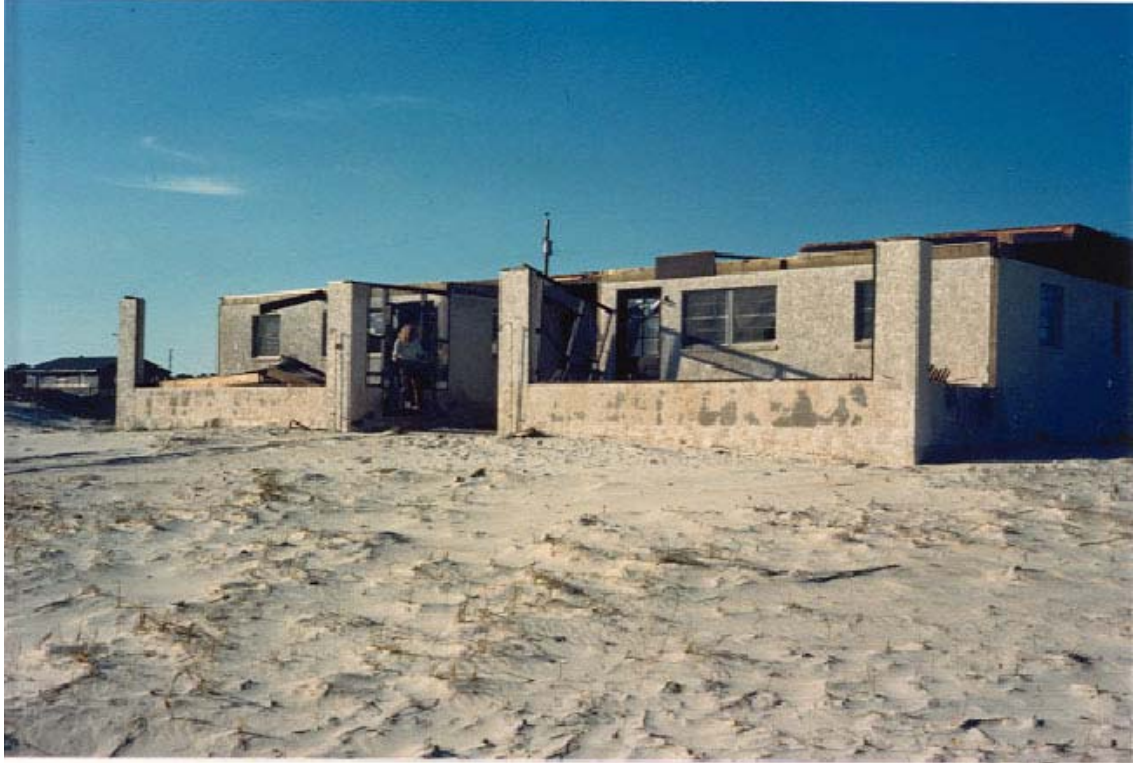
FIGURE 51. Duplex sustained major structural roof damage.

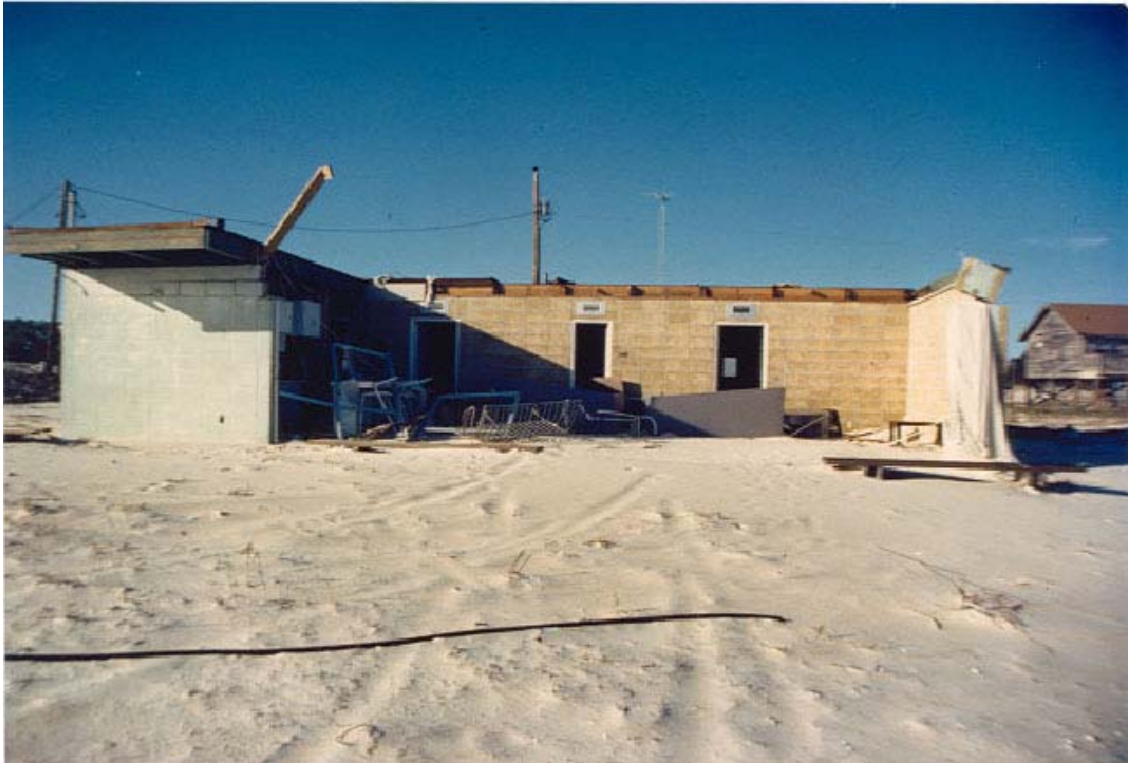
FIGURE 52. Dwelling with roof blown off and seaward wall destroyed by waves.

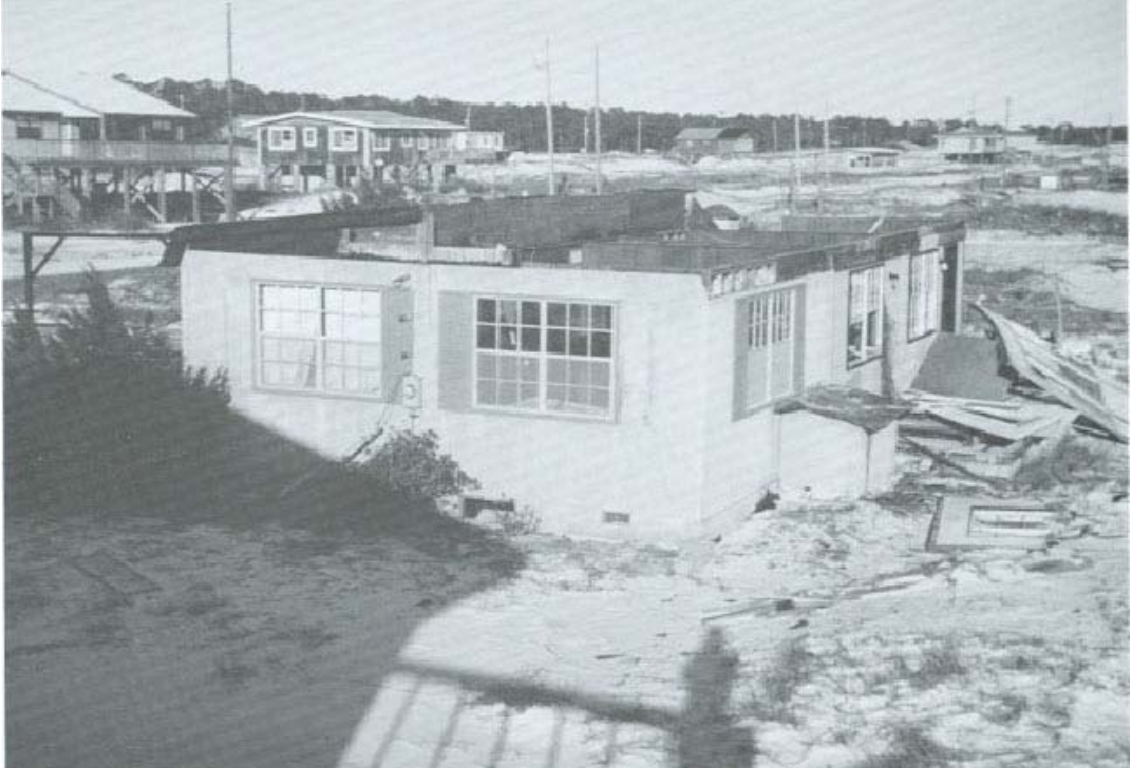
FIGURE 53. Frame dwelling damaged beyond repair by wind and wave loads.

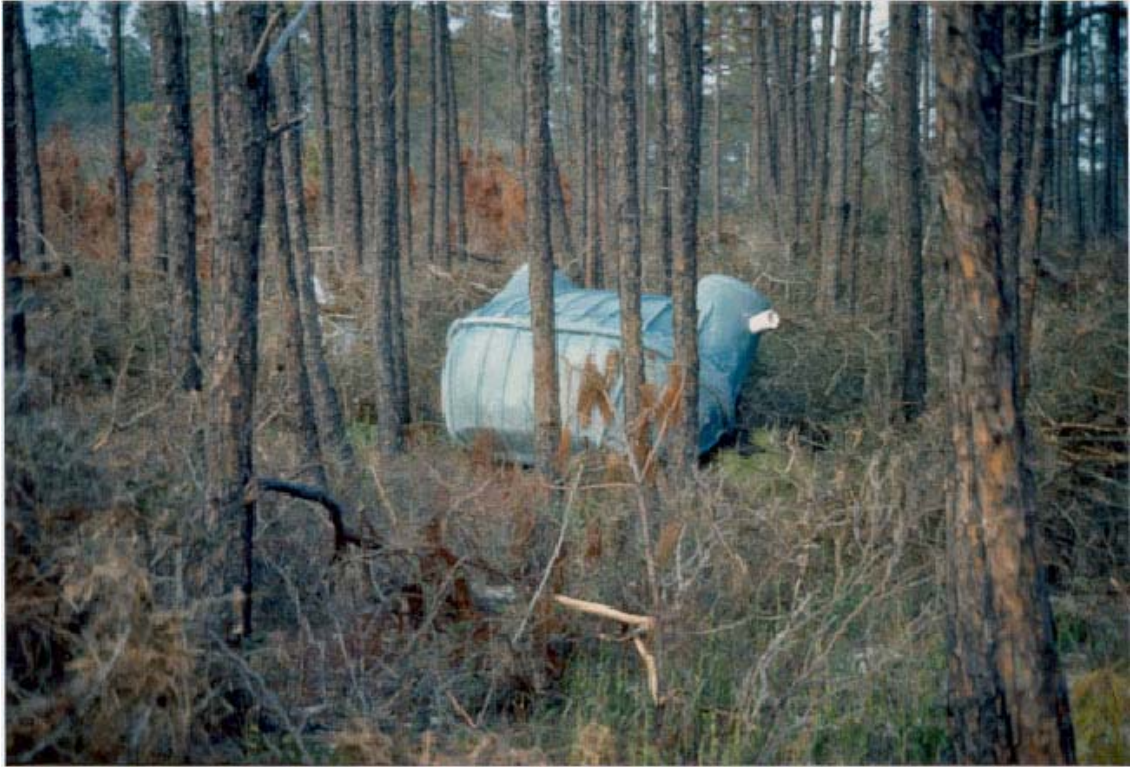
FIGURE 59. Dog Island septic tank carried inland by the flood.

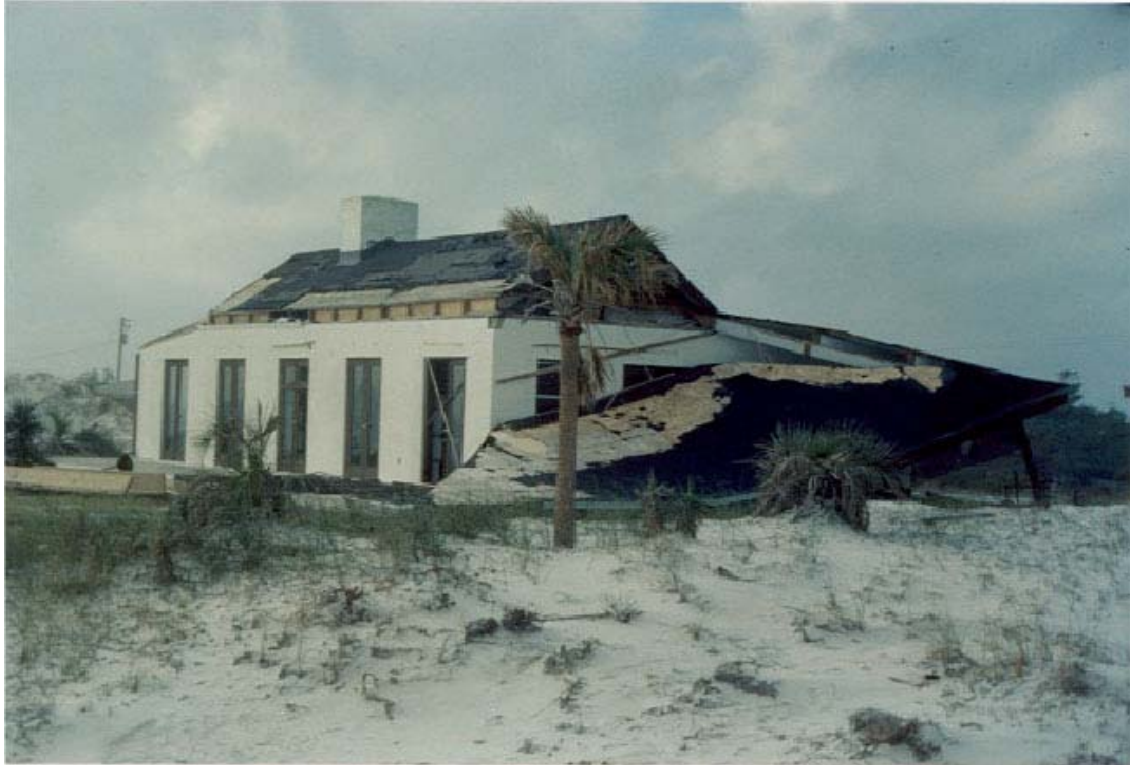
Figure 62 shows one dwelling, located just east of the Mountains, which sustained additional major structural roof damage due to Kate's winds after tropical storm Juan caused the initial damage. At another dwelling nearby, a seaward section of roof with the roof trusses was blown over the house and inland nearly 100 feet. At the slab-on-grade dwelling next door, the wind undermined the slab, sandblasted the paint off the trim, and filled the screen windows with sand (Figure 63). Figure 64 shows one of two Dog Island dwellings which not only had structural roof damage but also had the seaward wall blown inward by Kate's winds. Near the east end of Dog Island one slab-on-grade concrete block dwelling is threatened by dune erosion which reached to within a foot of the foundation. This structure will probably not survive another major erosion event.

FIGURE 62. Dwelling sustained major structural roof damage due to wind.

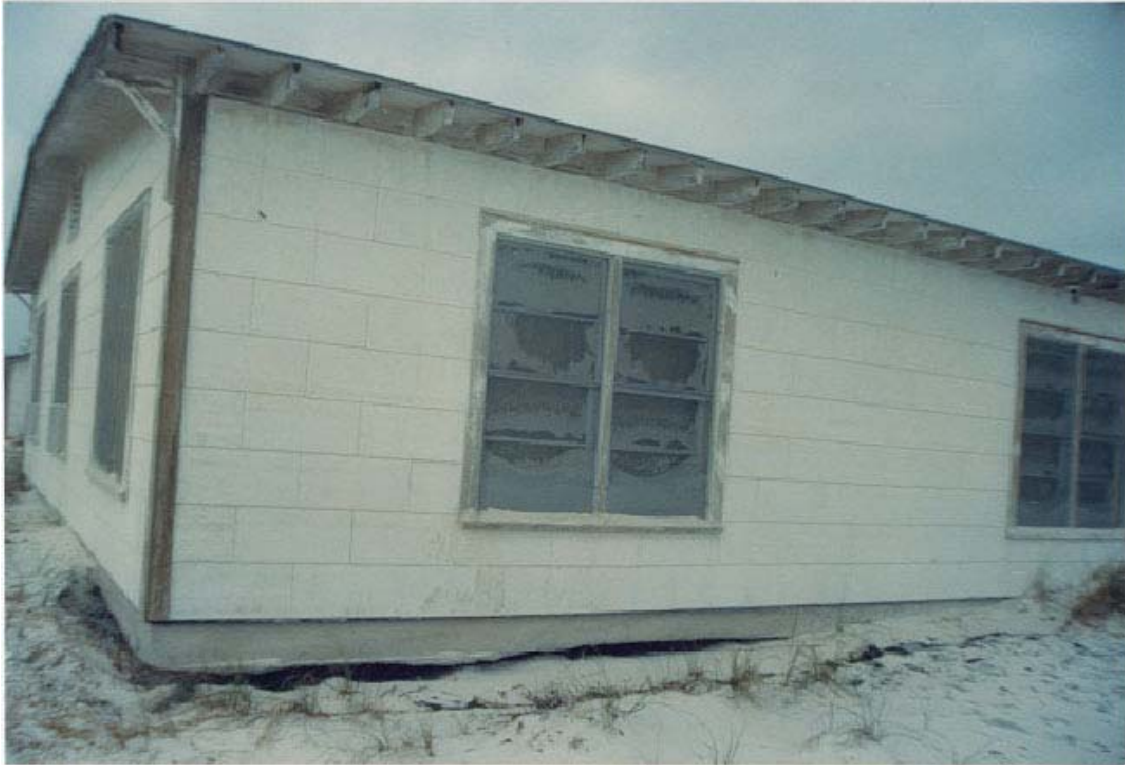
FIGURE 63. Wind undermined the slab, sandblasted the paint off the trim, and filled the screen windows with sand.
