Hurricane Kate

November 15-23, 1985

Department of Natural Resources
Division of Beaches and Shores
Post Storm Report No. 86-1
September, 1986
By Ralph Clark

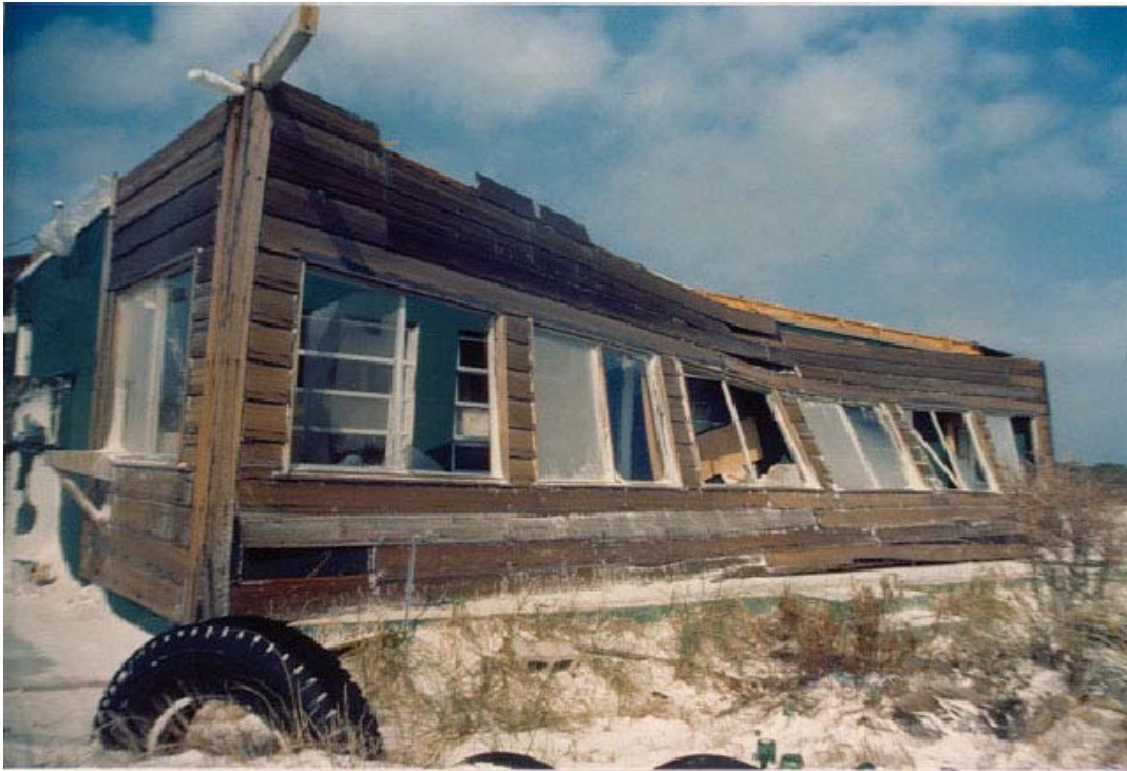
FIGURE 64. Island dwelling with heavy wind damage.

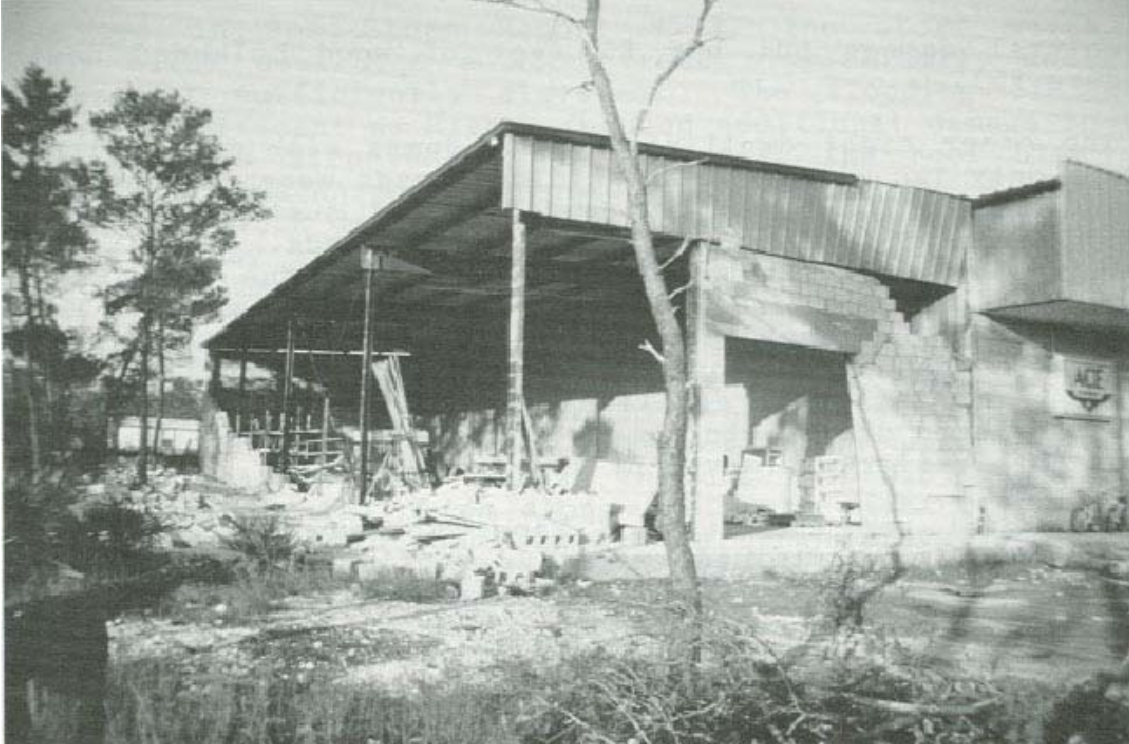
FIGURE 65. Ace Hardware store damage by wind, Eastpoint.

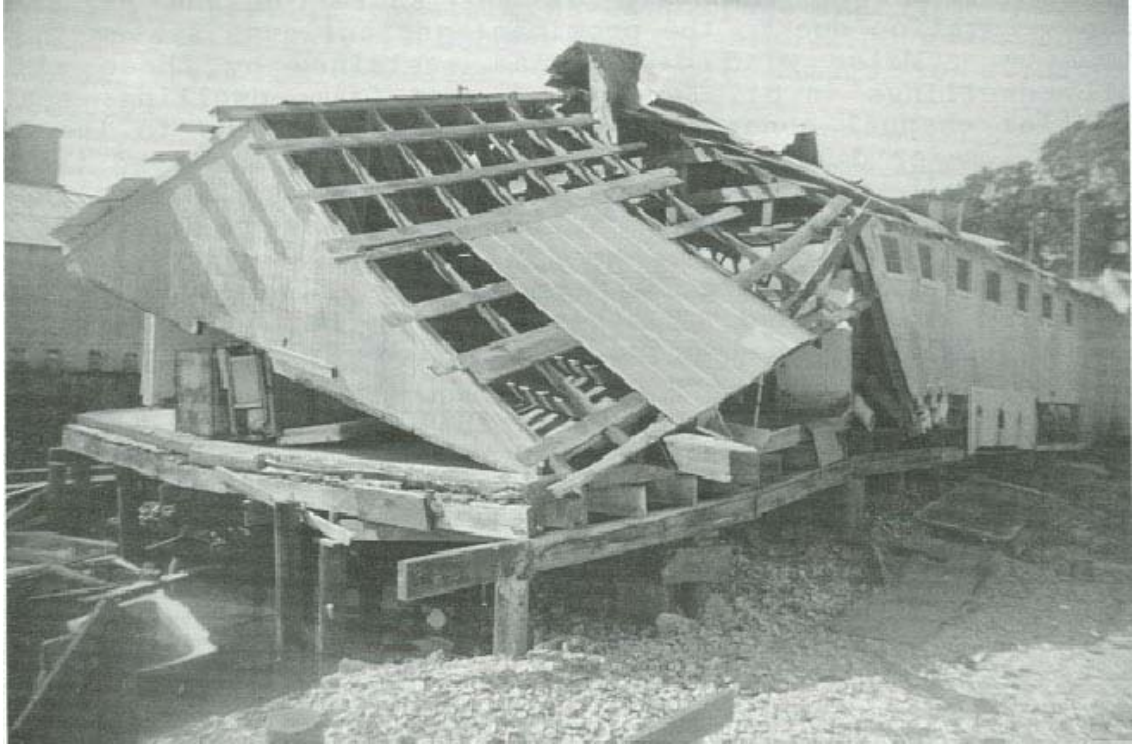
FIGURE 66. Oyster house damaged by flooding and waves, Eastpoint.

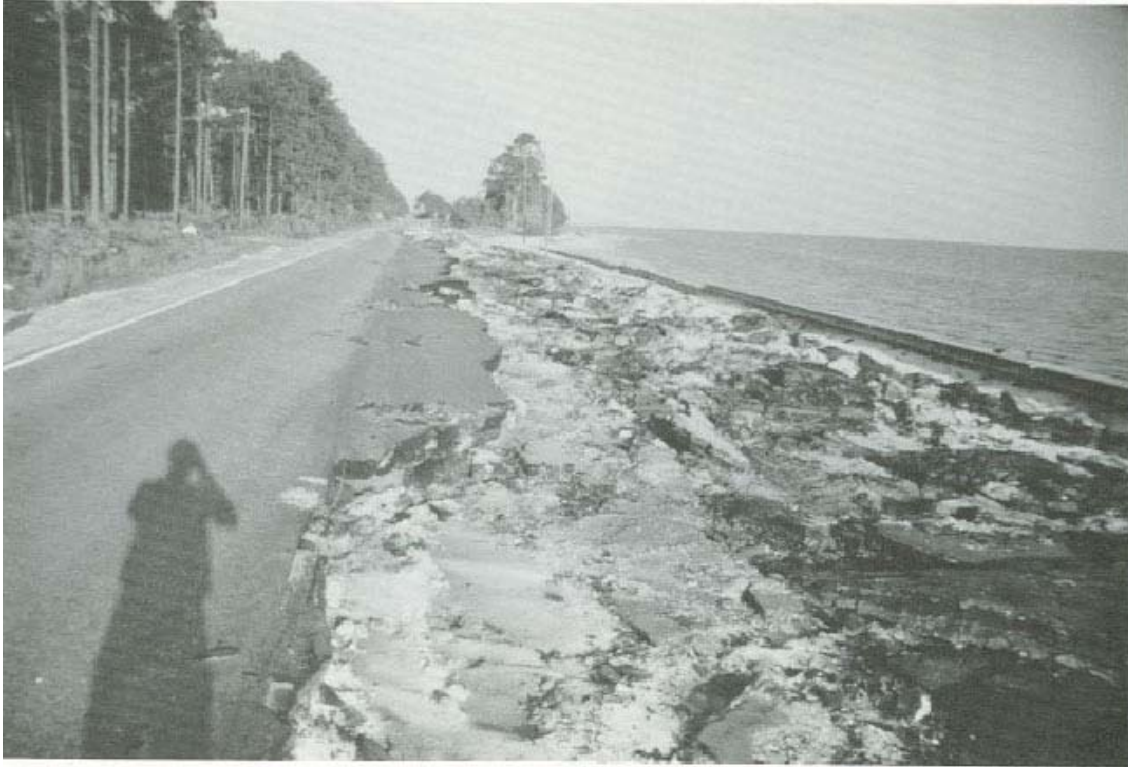
FIGURE 67. U.S. Highway 98 destroyed near Green Point.

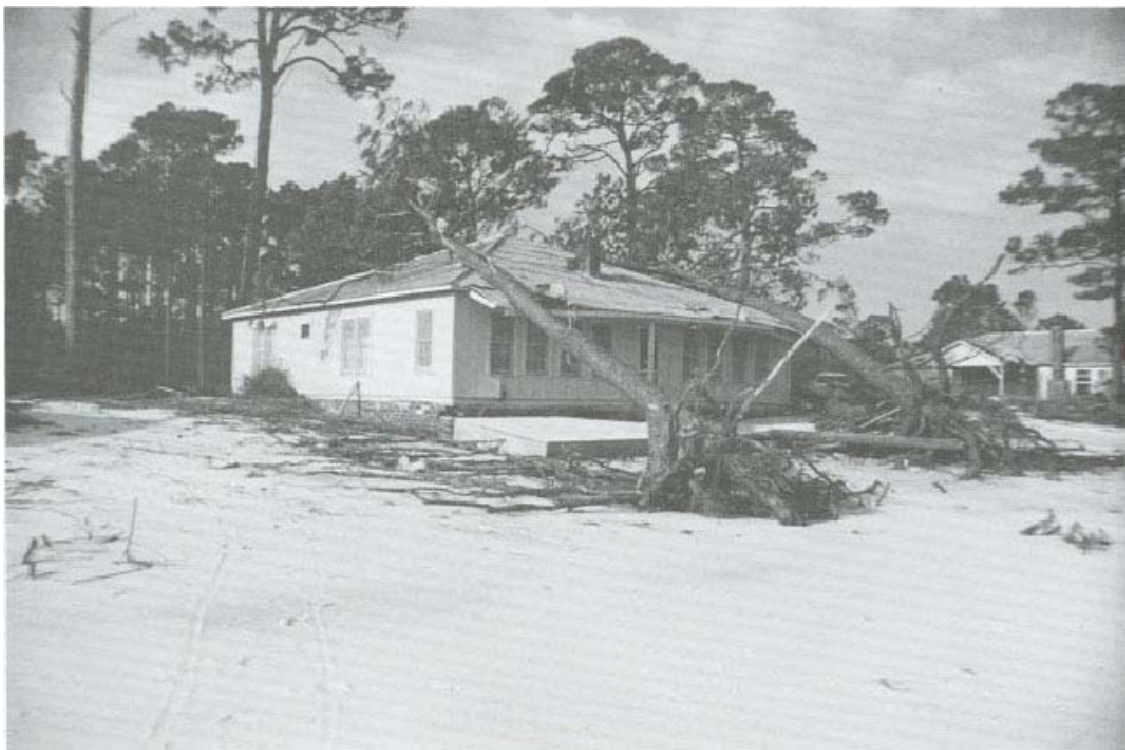
FIGURE 72. Dwelling damaged by two toppled pines.

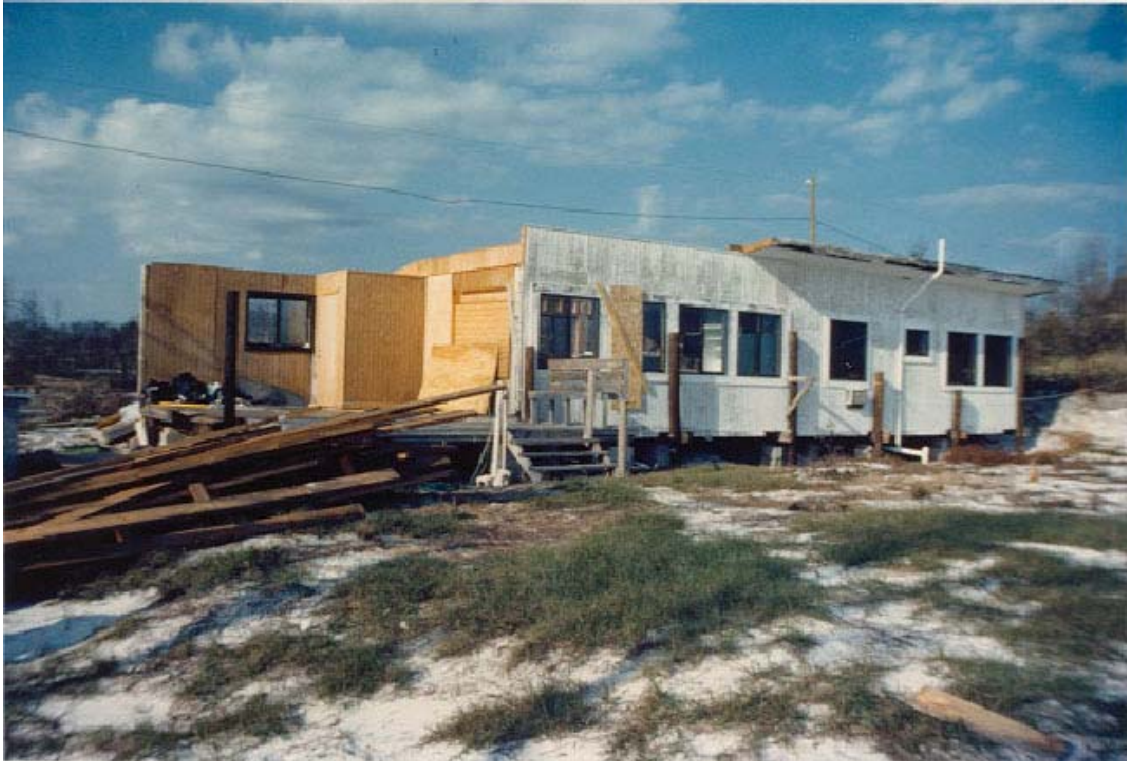
FIGURE 74. Manufactured dwelling destroyed by wind, with the roof blown across U.S. Highway 98.

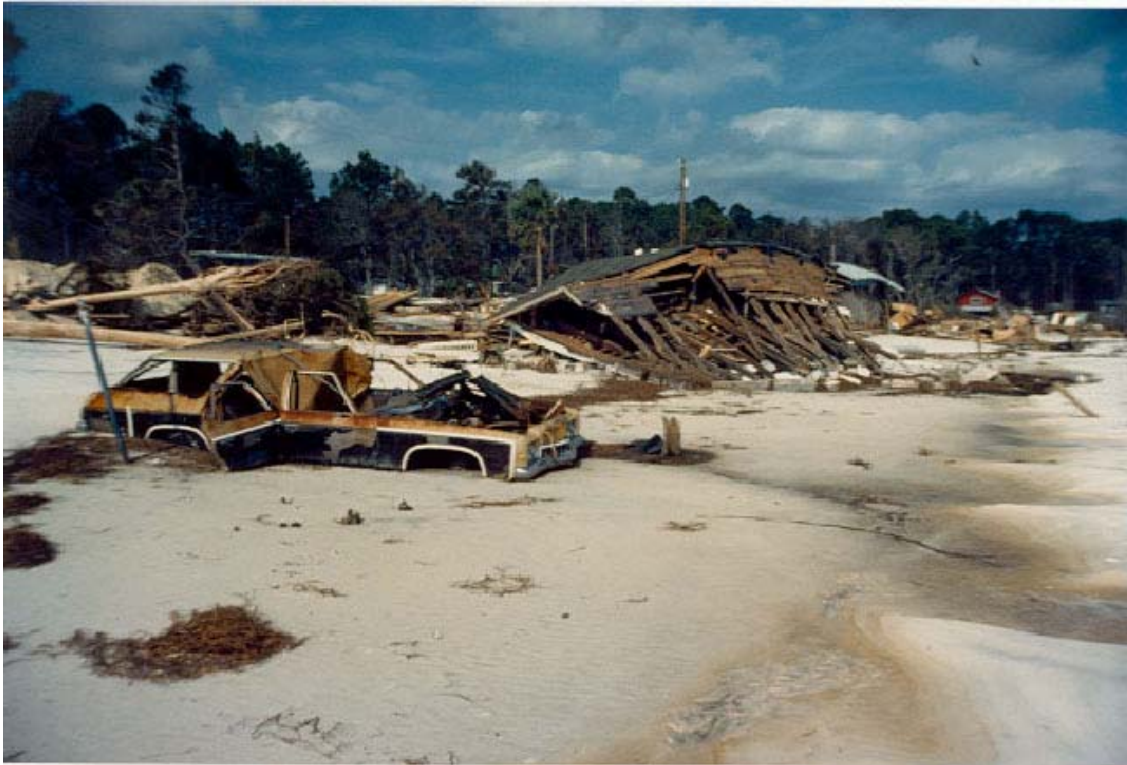
FIGURE 76. Severe damage west of Carrabelle Beach.

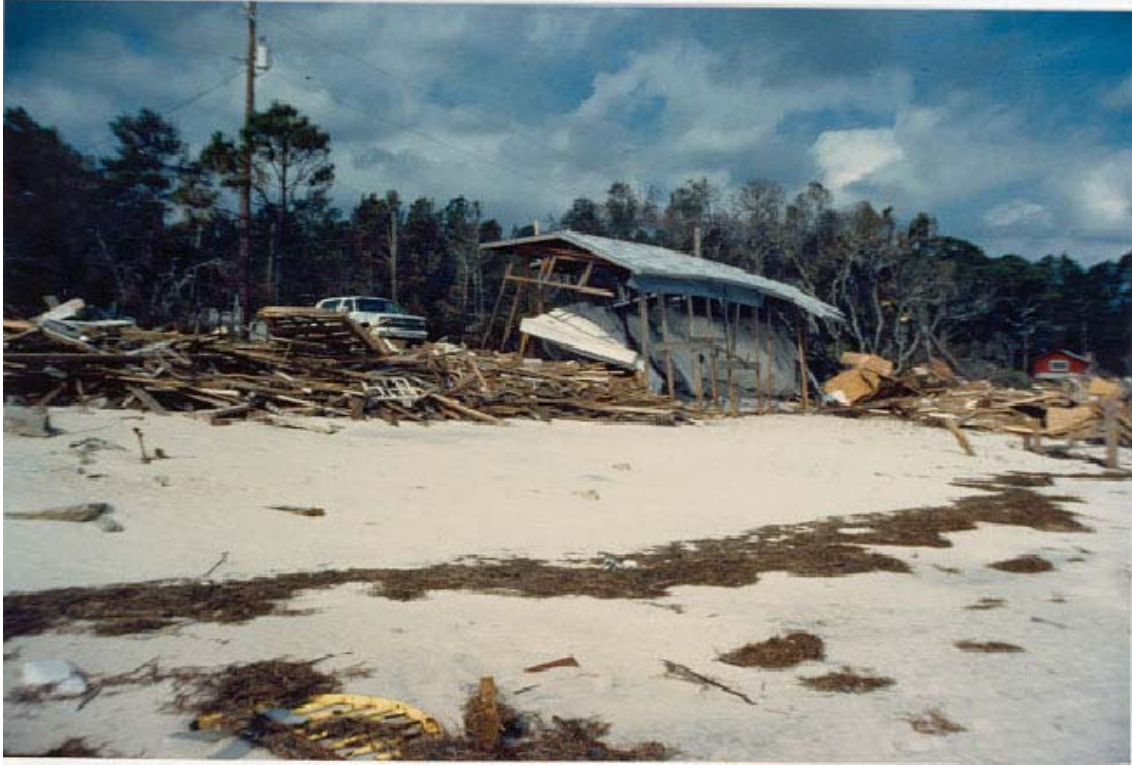
FIGURE 77. Pile-supported mobile home which survived Elena was destroyed by Kate..

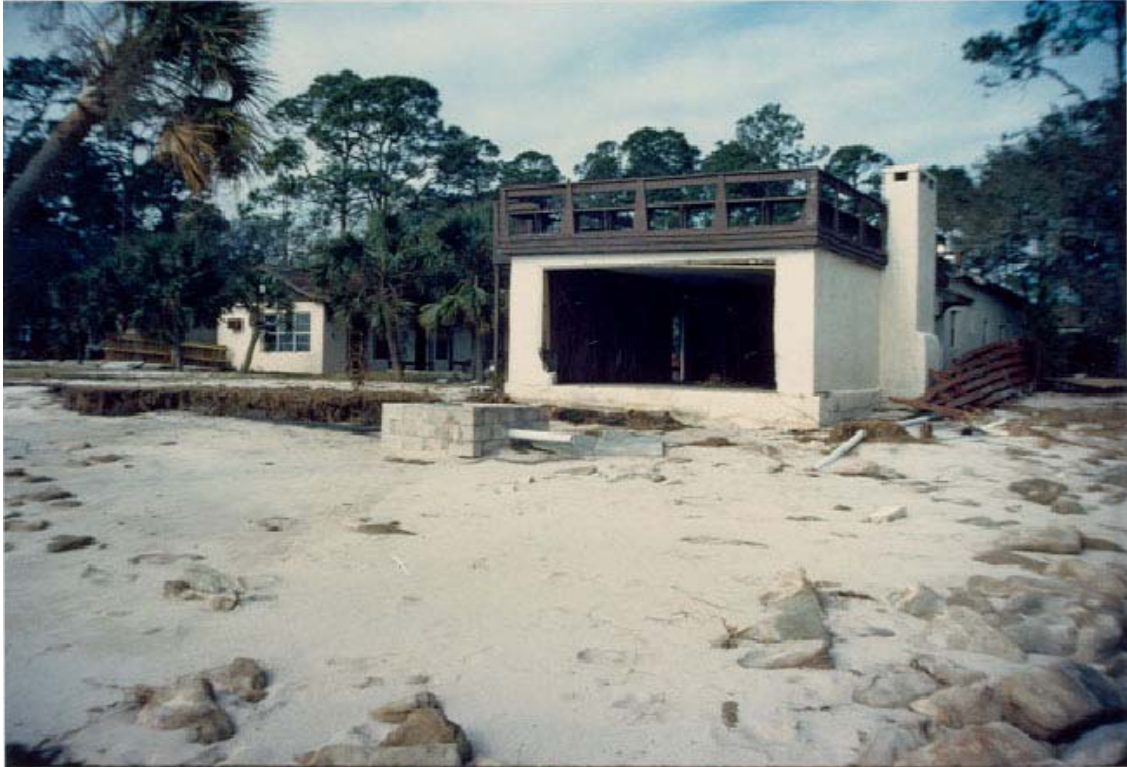
FIGURE 83. Wave loads damaged seaward unit of motel St. James.

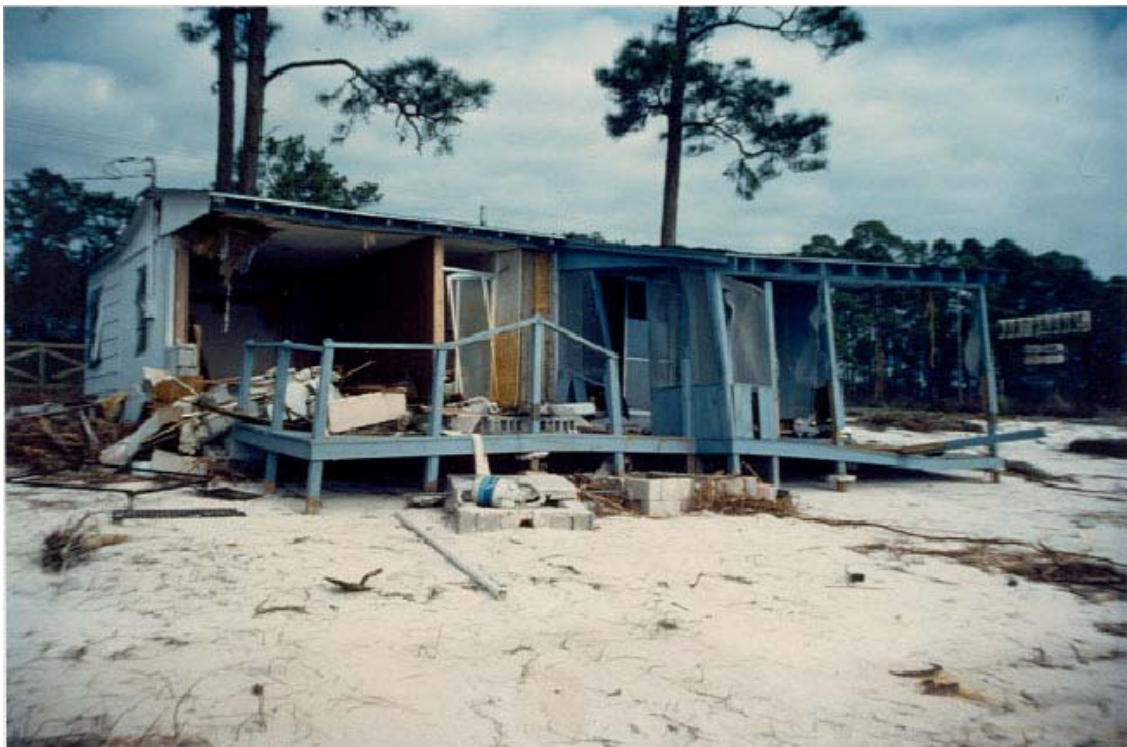
FIGURE 84. Dwelling destroyed by waves west of Martha Anns Motel.

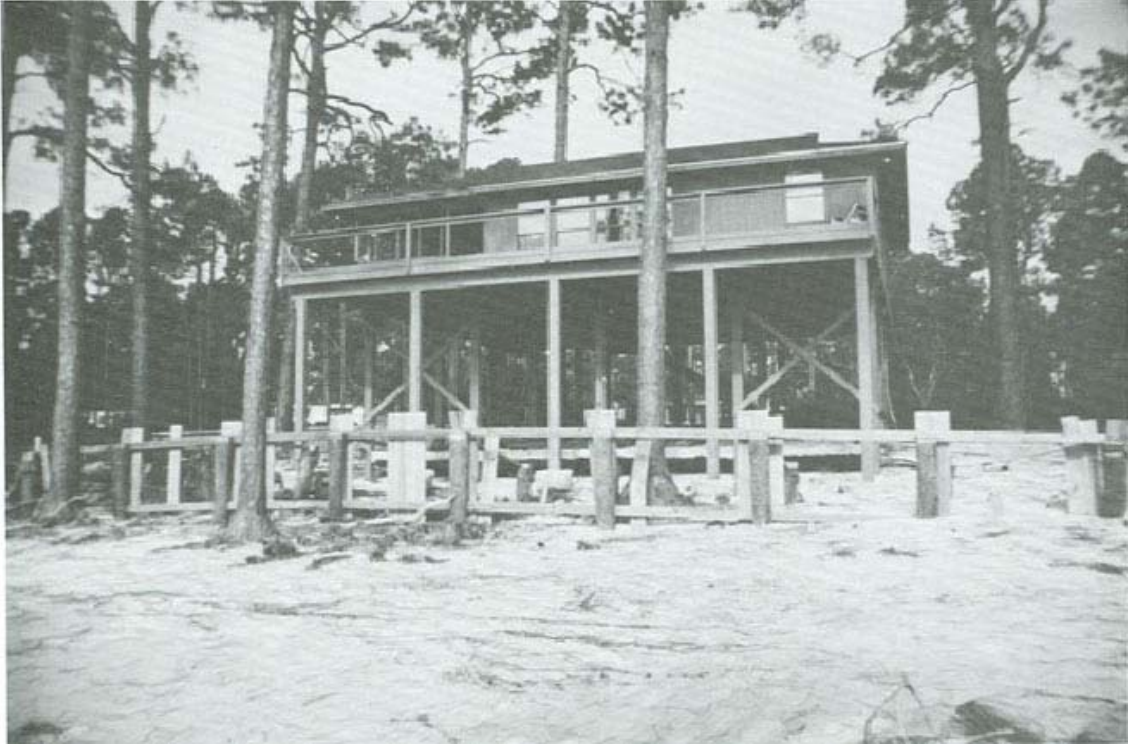
FIGURE 85. Sufficiently elevated dwelling with no damage although wood bulkhead was destroyed.

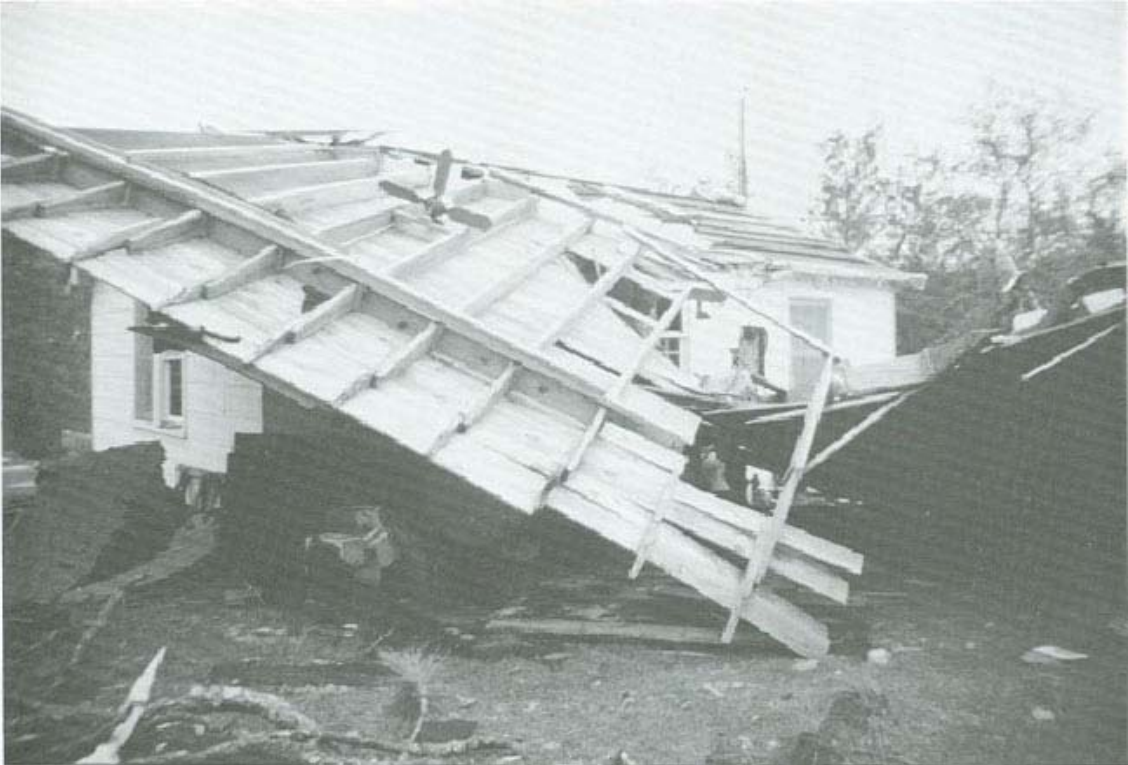
FIGURE 86. St. Teresa dwelling damaged by the impact of an airborne roof off another dwelling.

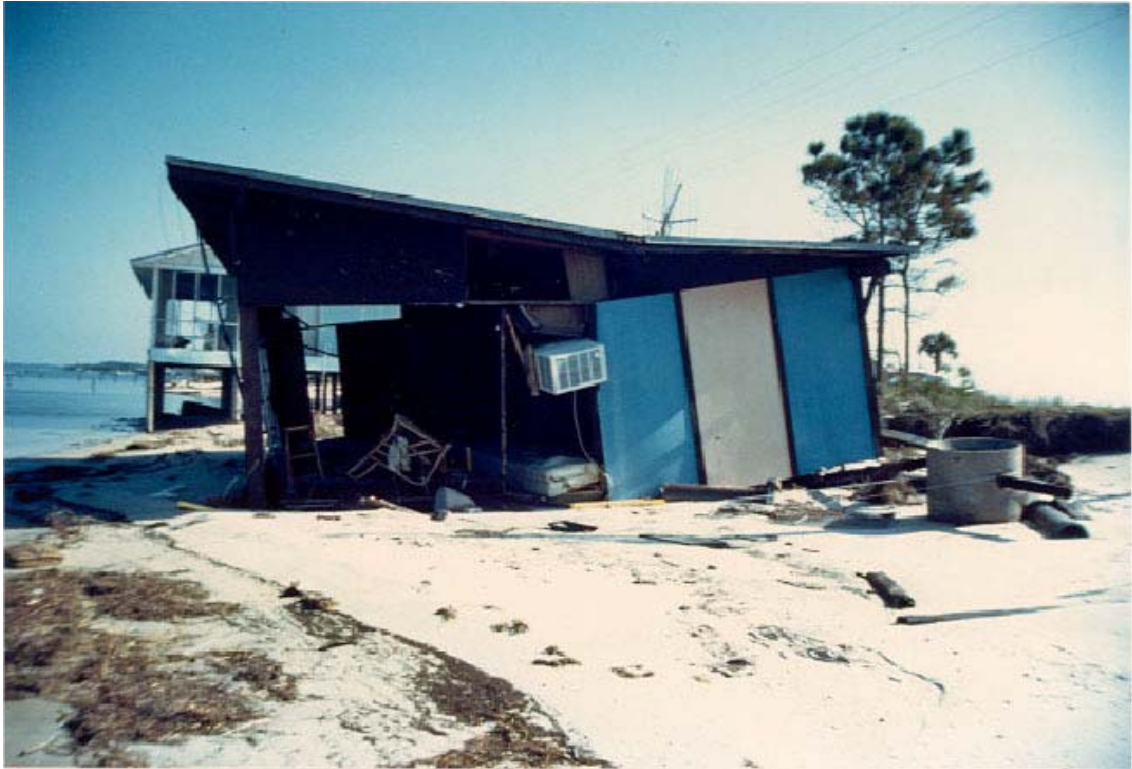
FIGURE 87. Alligator Harbor shoreline dwelling destroyed.

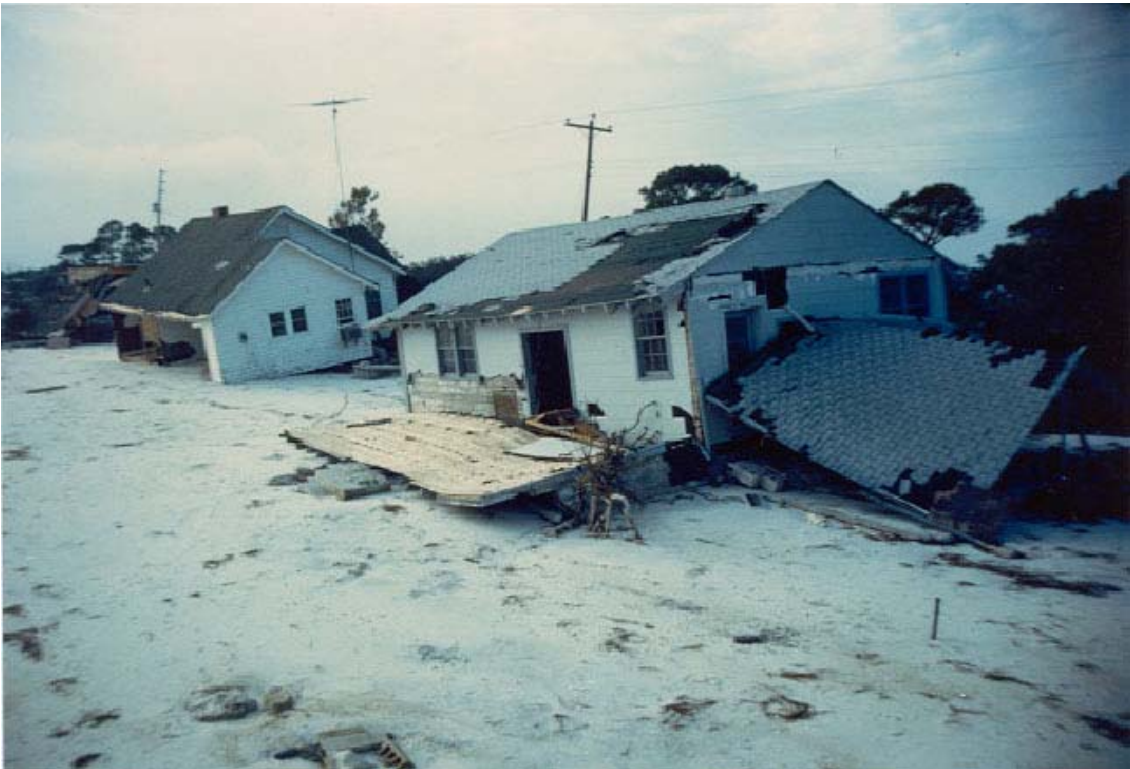
FIGURE 90. Dwellings damage by Elena were additionally damaged by Kate.

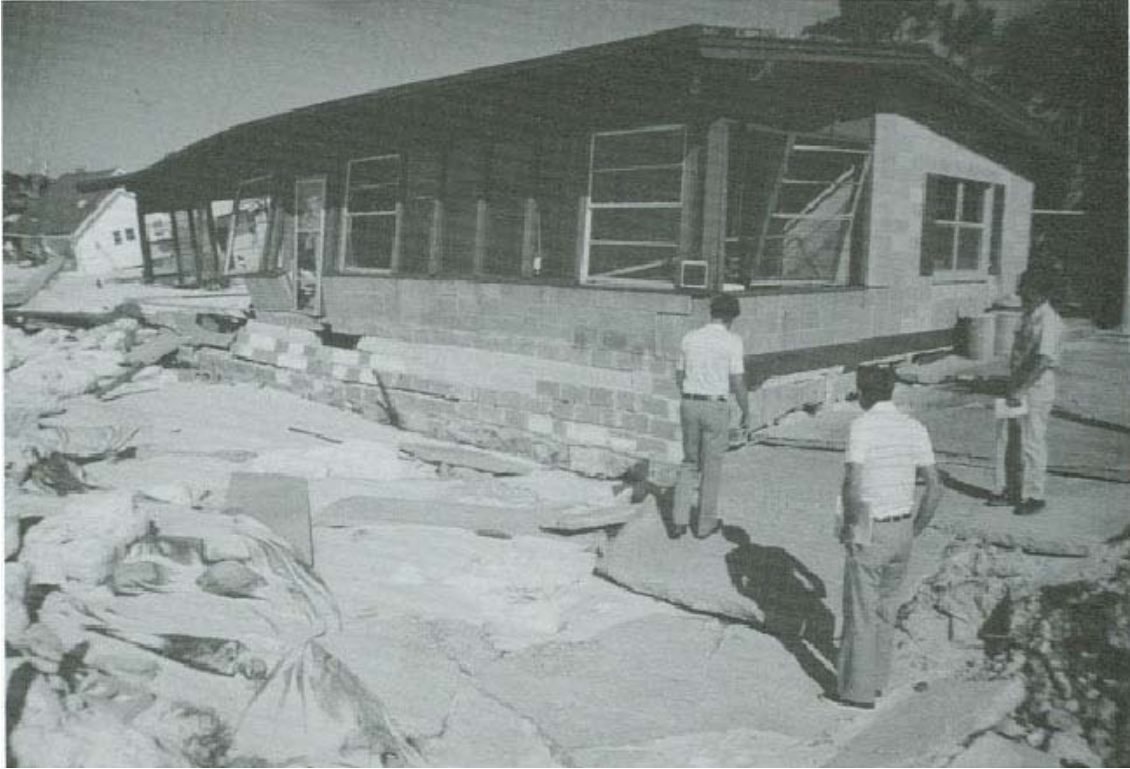
FIGURE 91. Concrete block dwelling damaged by Elena.

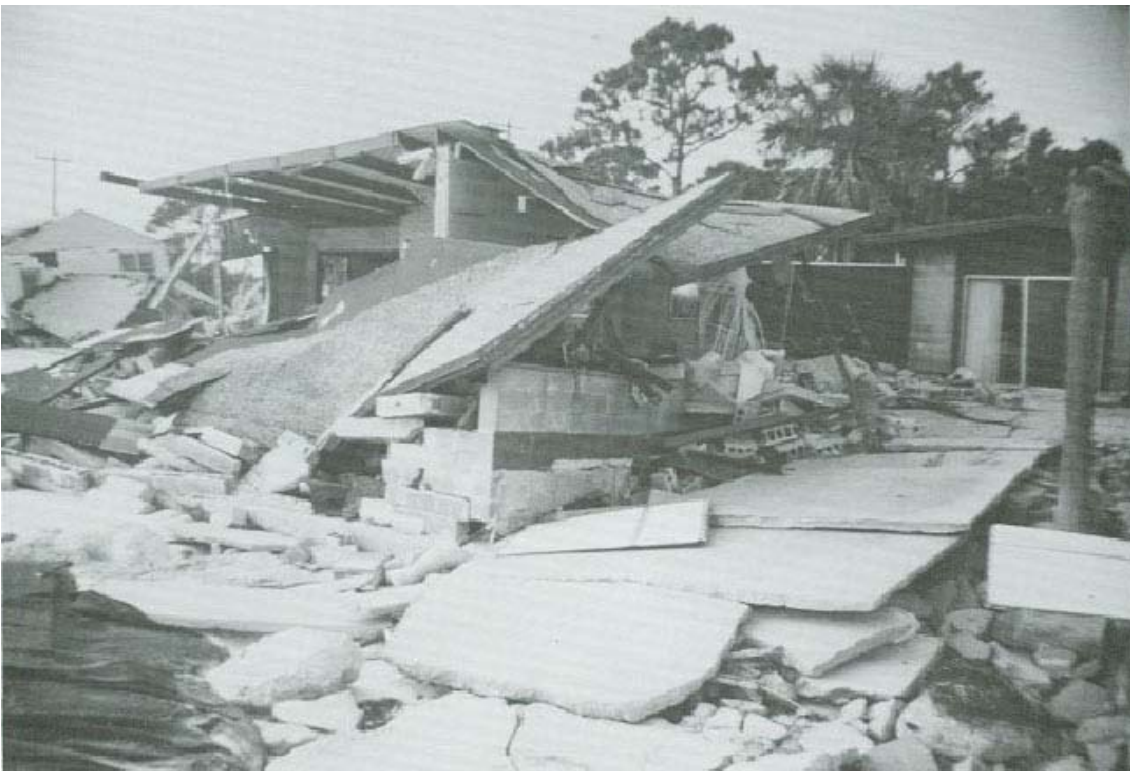
FIGURE 92. Same dwelling destroyed by Kate.

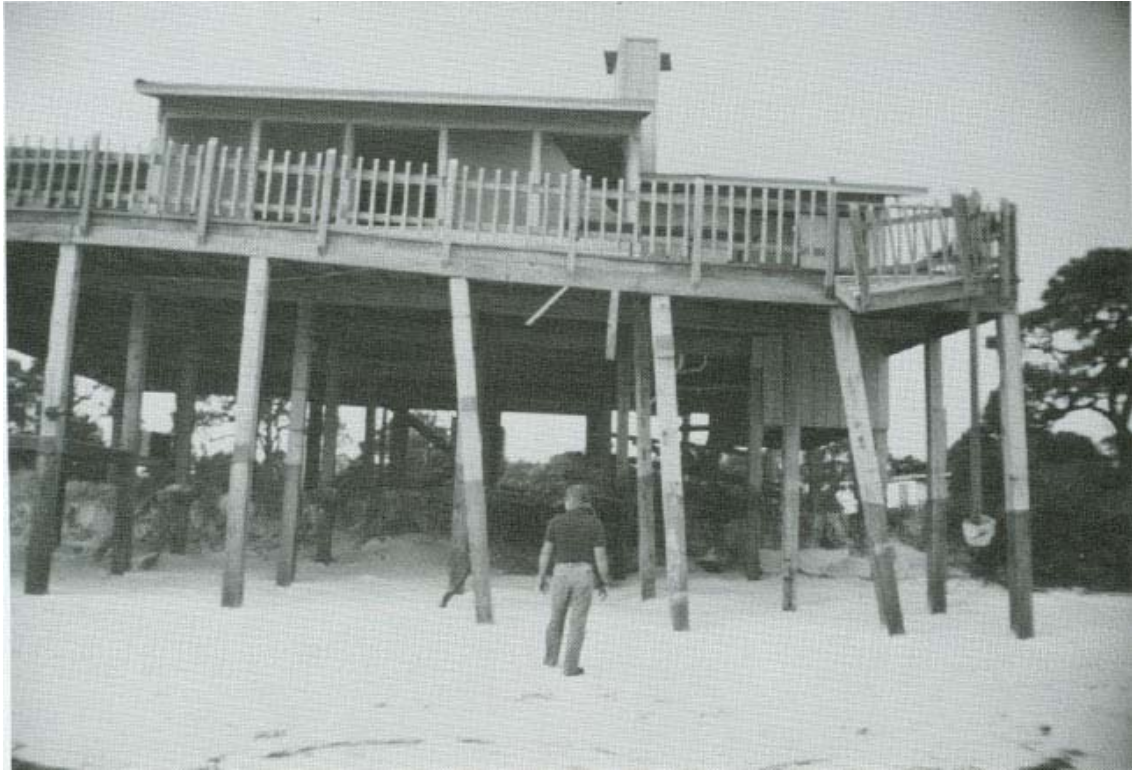
FIGURE 95. Pile-supported dwelling with insufficient pile penetration was damaged by scour.

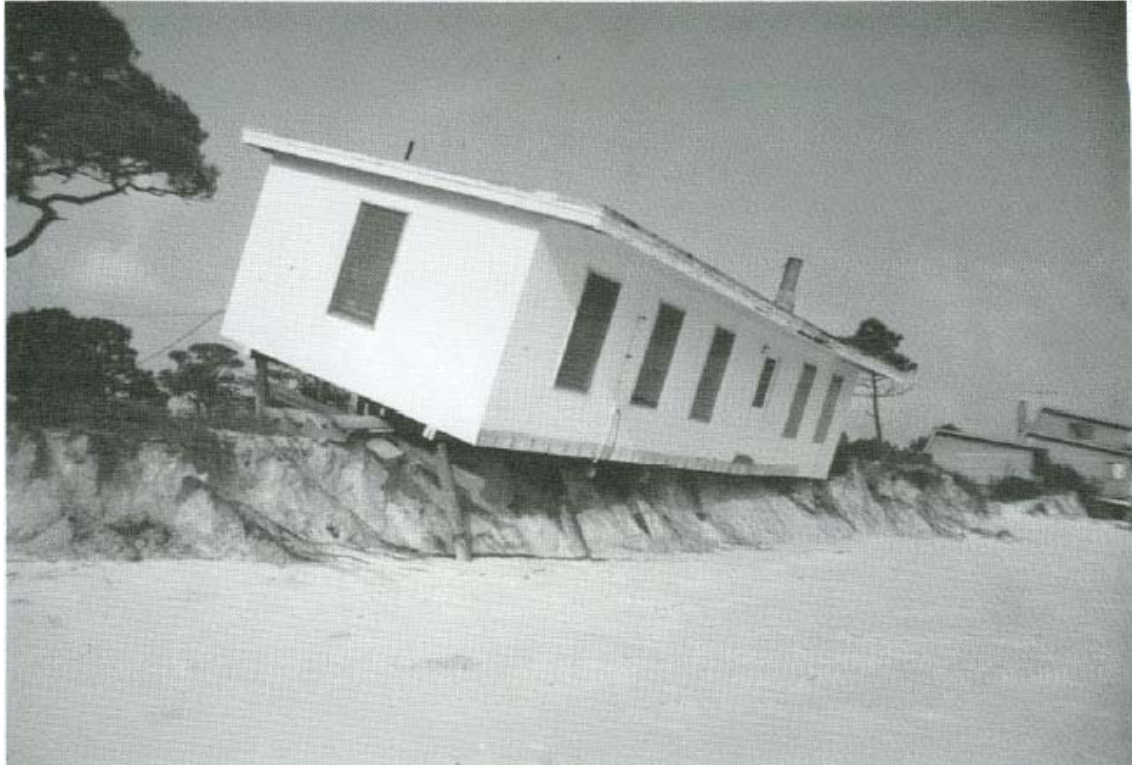
FIGURE 96. Lighthouse Point dwelling damaged by Kate's erosion.

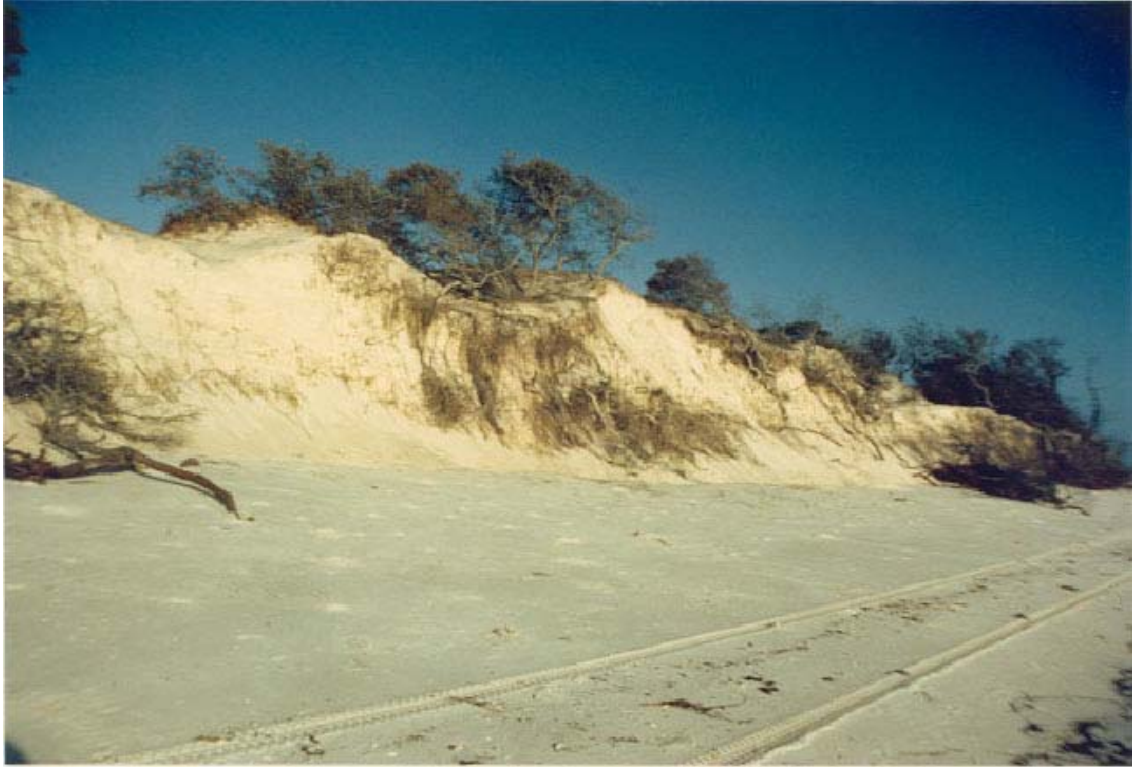
FIGURE 97. Heavy dune erosion between Lighthouse Point and Bald Point.

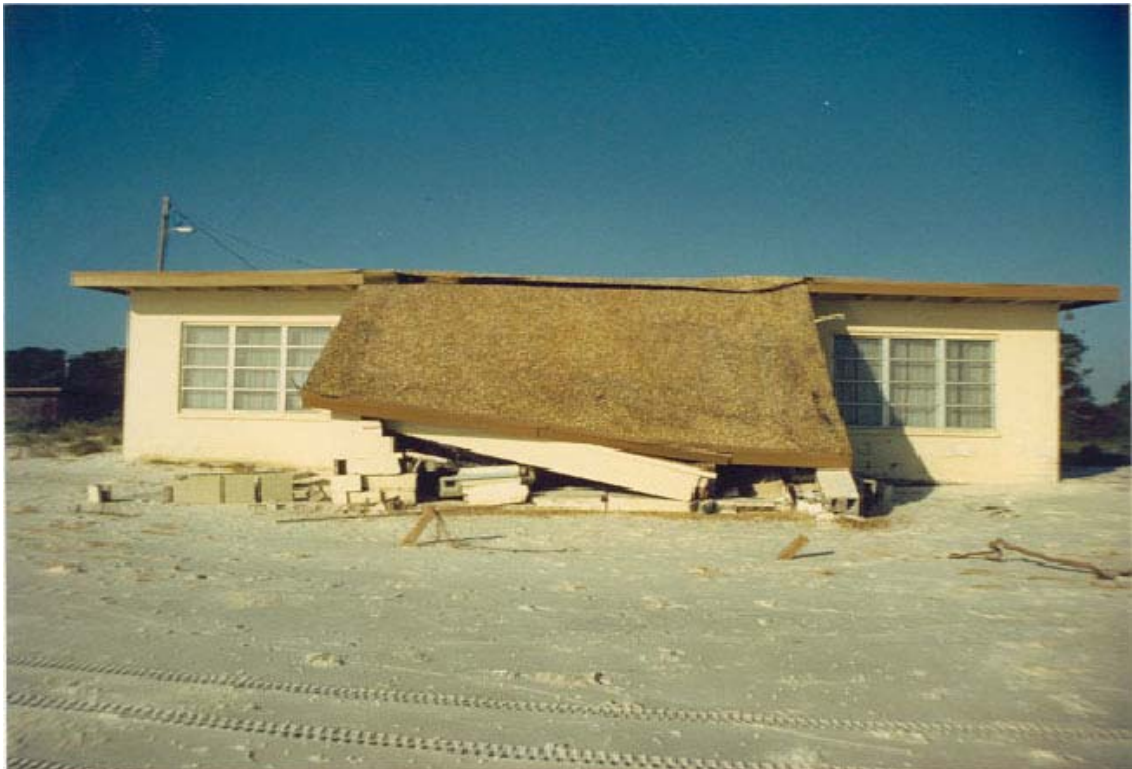
FIGURE 98. Wave damage to dwelling near Bald Point.

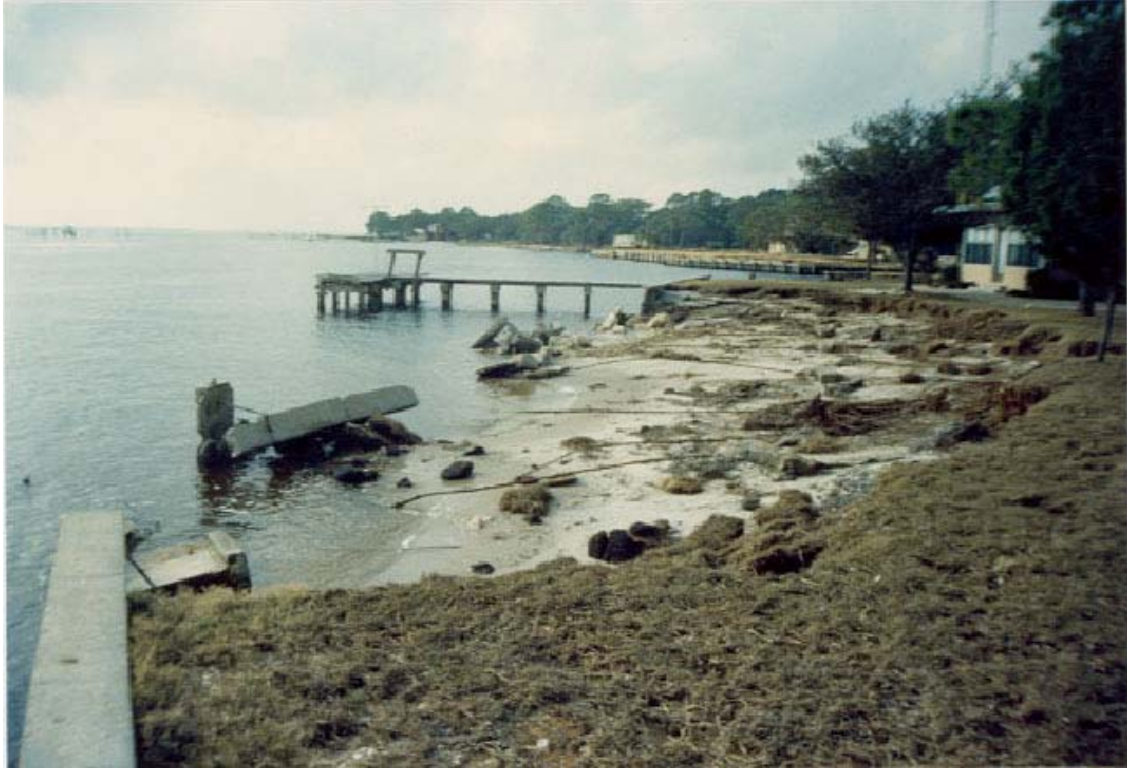
FIGURE 100. Ochlockonee Bay shoreline bulkheads destroyed at Blue Heron Way.

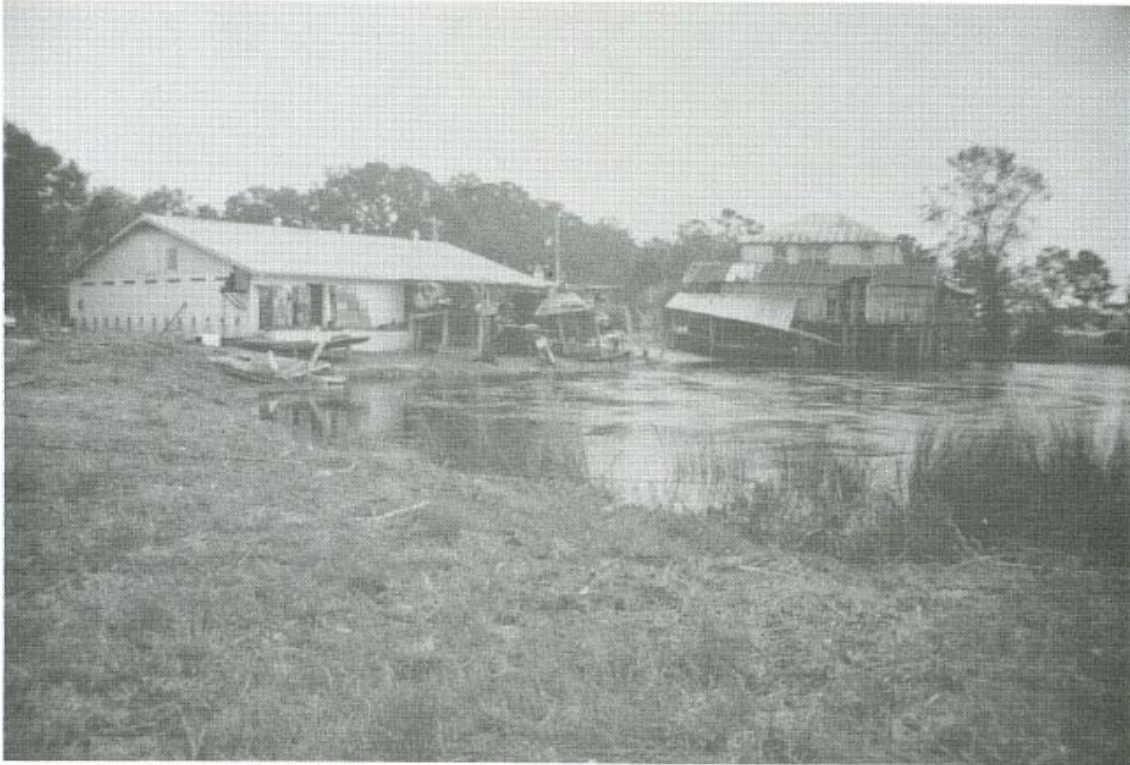
FIGURE 102. Damage to Spring Creek seafood processing plants.

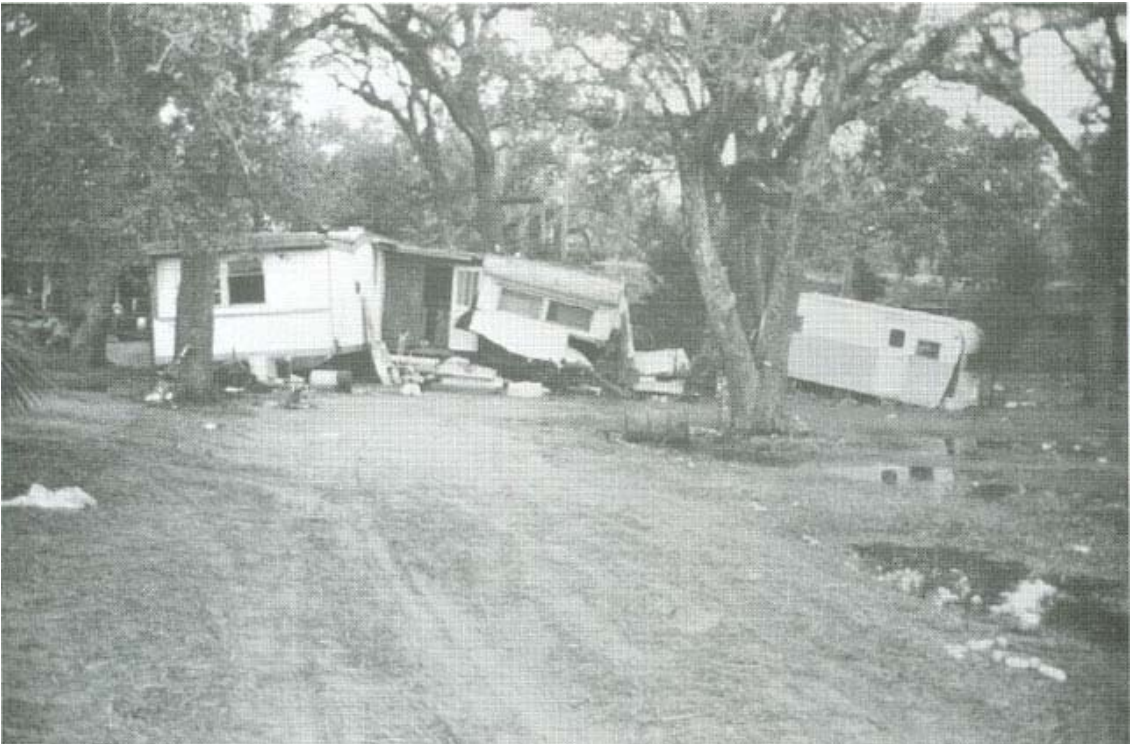
FIGURE 103. Mobile home damaged by flooding, Spring Creek.

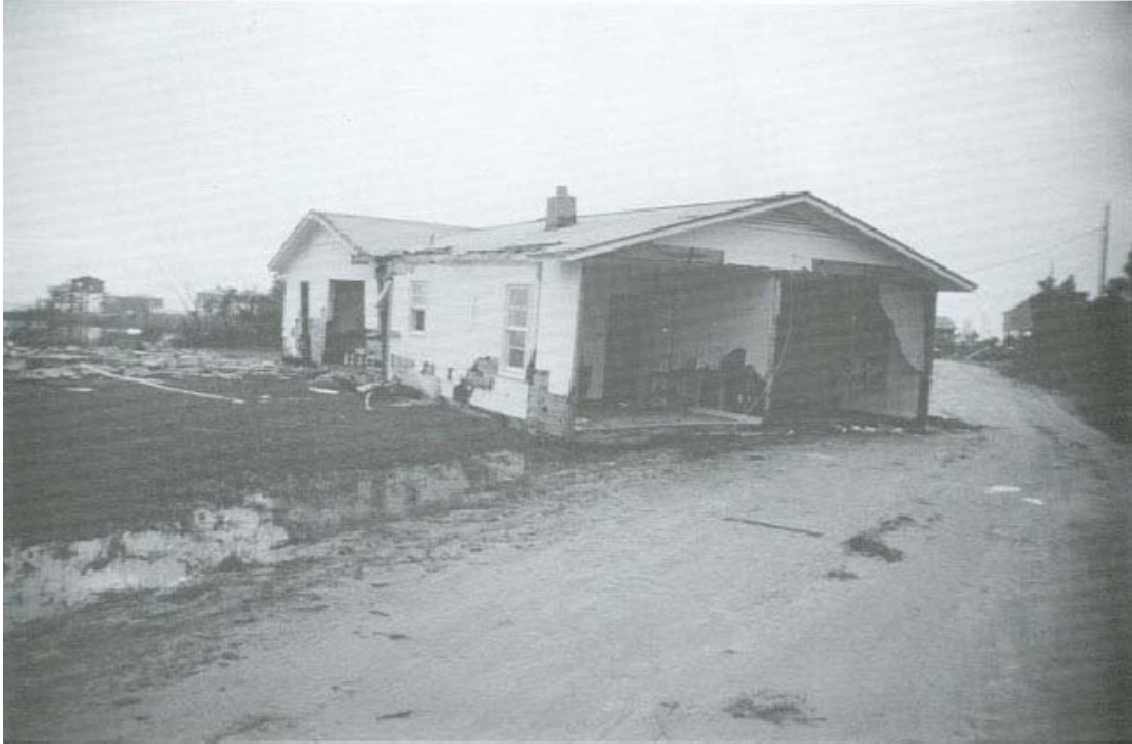
FIGURE 104. Oyster Bay dwelling damaged by waves, floated inland by flood waters, and deposited on road.

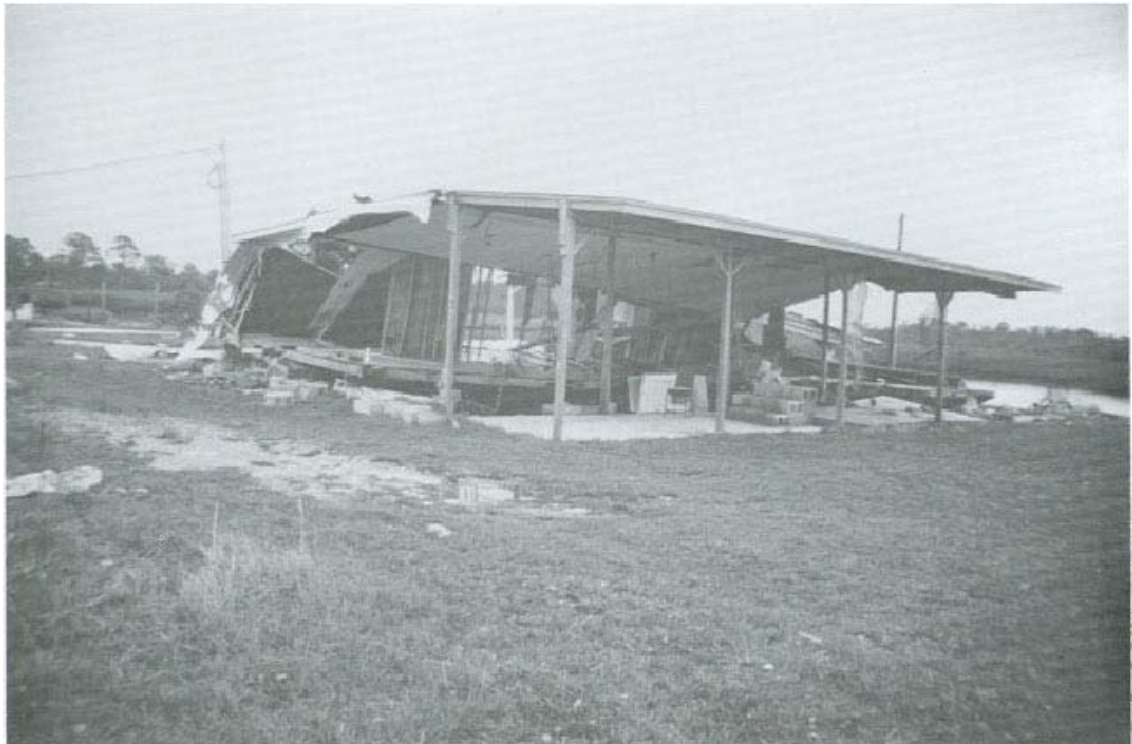
FIGURE 105. Oyster Bay dwelling was destroyed yet screened porch was still standing.

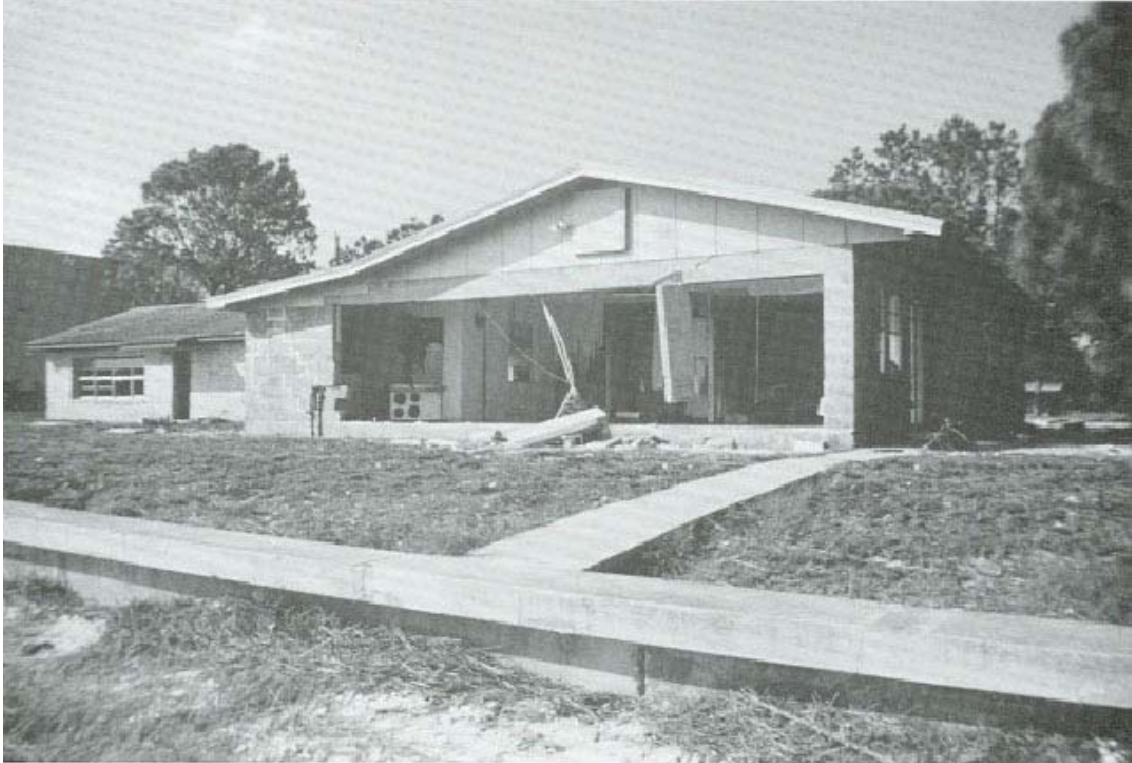
FIGURE 107. Shell Point beach dwelling damaged by waves and flooding.
