Hurricane Kate

November 15-23, 1985

Department of Natural Resources
Division of Beaches and Shores
Post Storm Report No. 86-1
September, 1986
By Ralph Clark

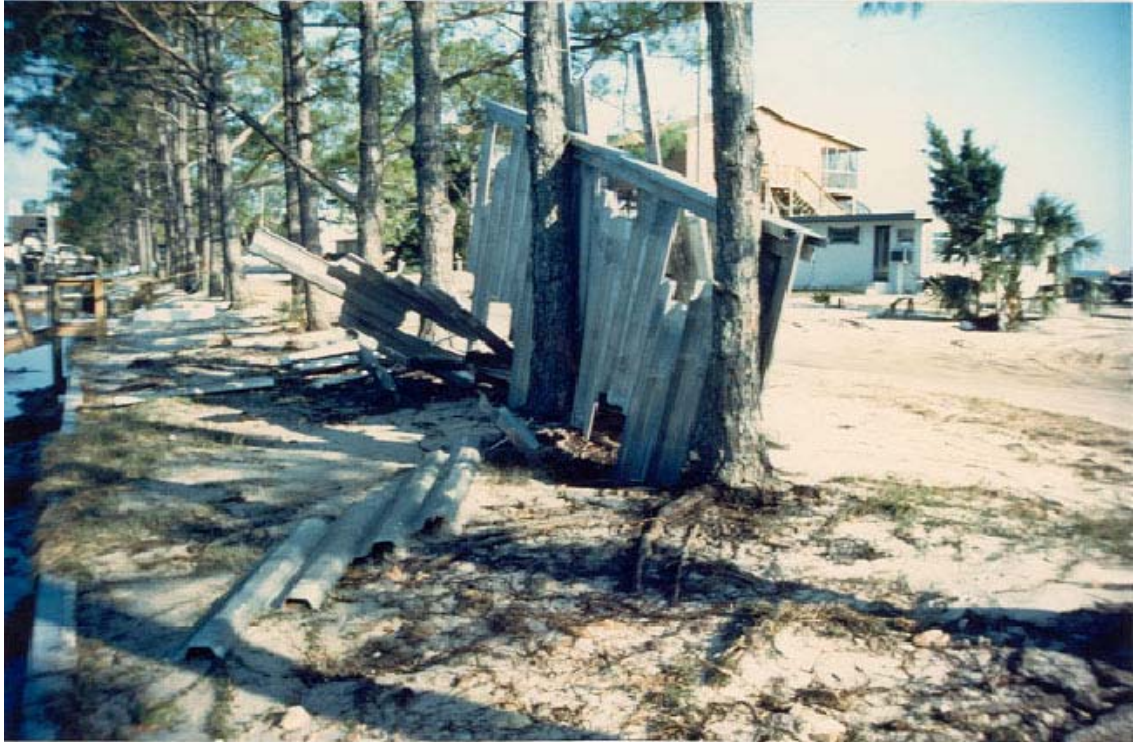
FIGURE 108. Aluminum bulkhead debris transported inland on Shell Point.

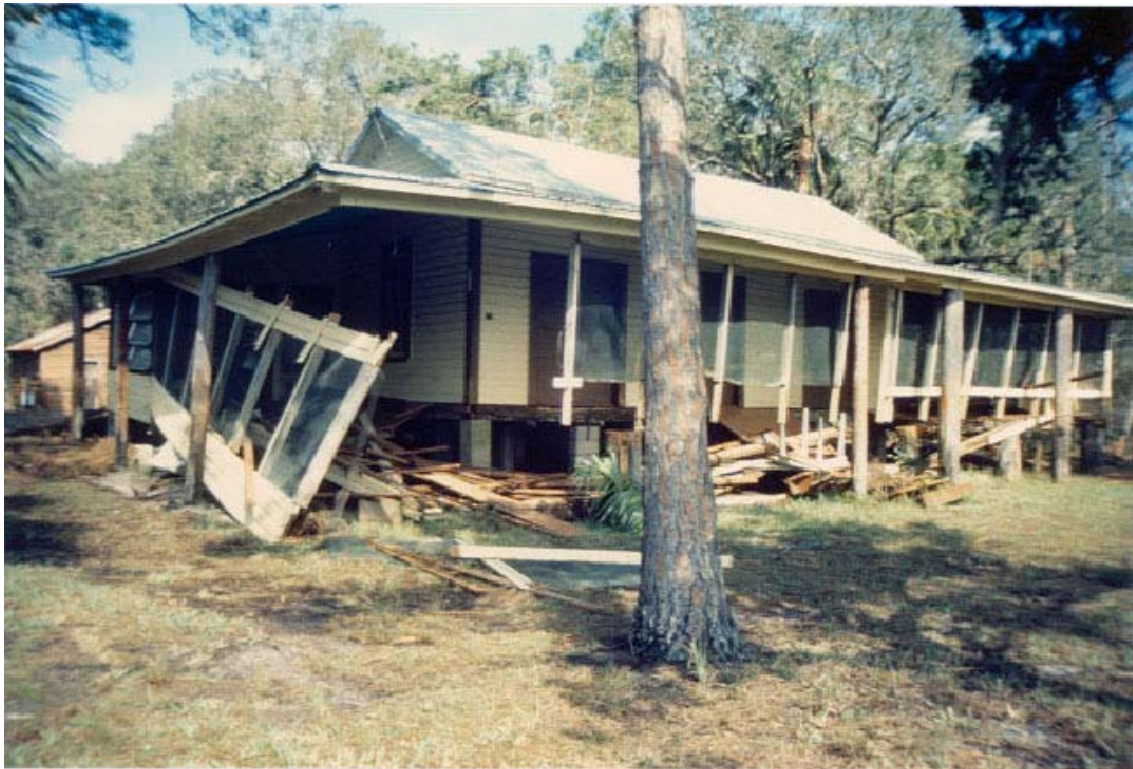
FIGURE 109. Beach dwelling damaged by waves and flooding.

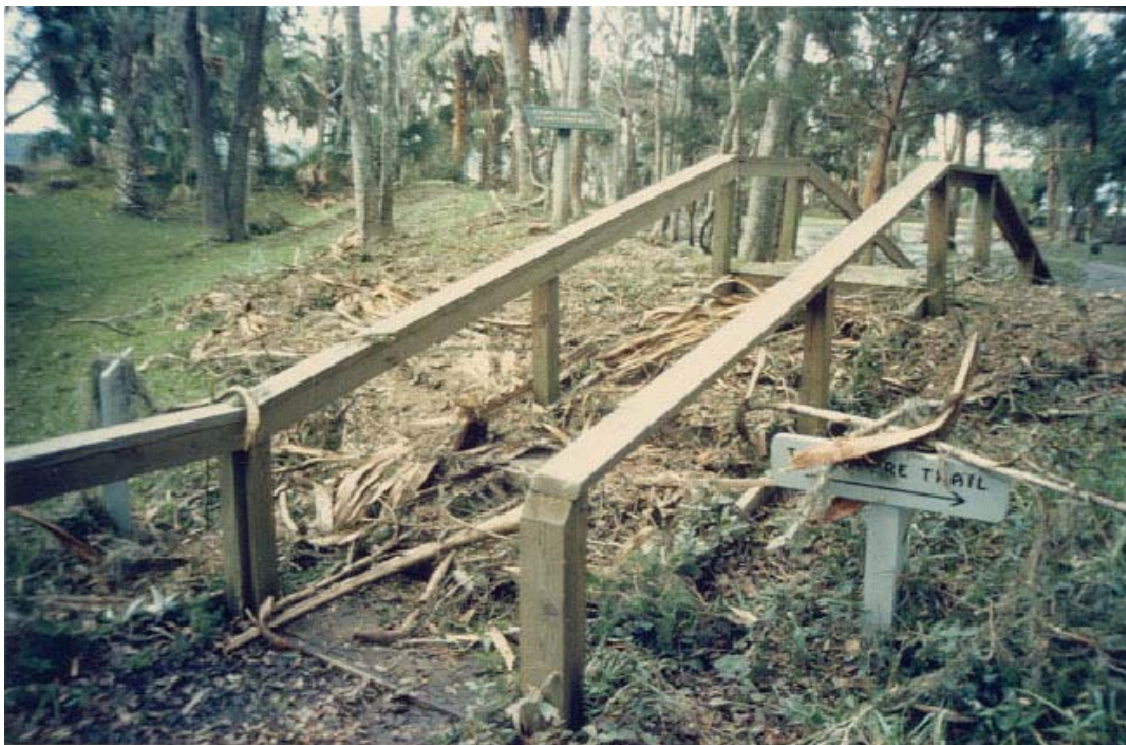
FIGURE 110. Confederate earthworks at Fort San Marcos de Apalachee on the St. Marks River were breached by flooding.

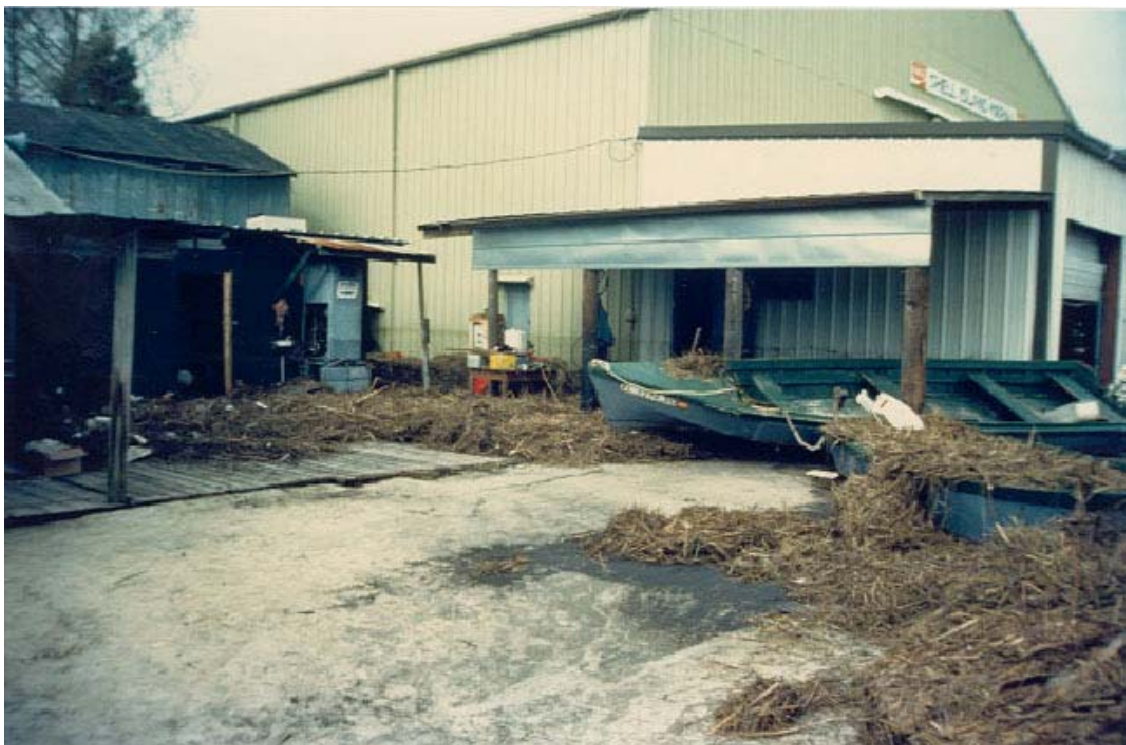
FIGURE 111. Shell Island Marina on the Wakulla River was damaged by flooding.

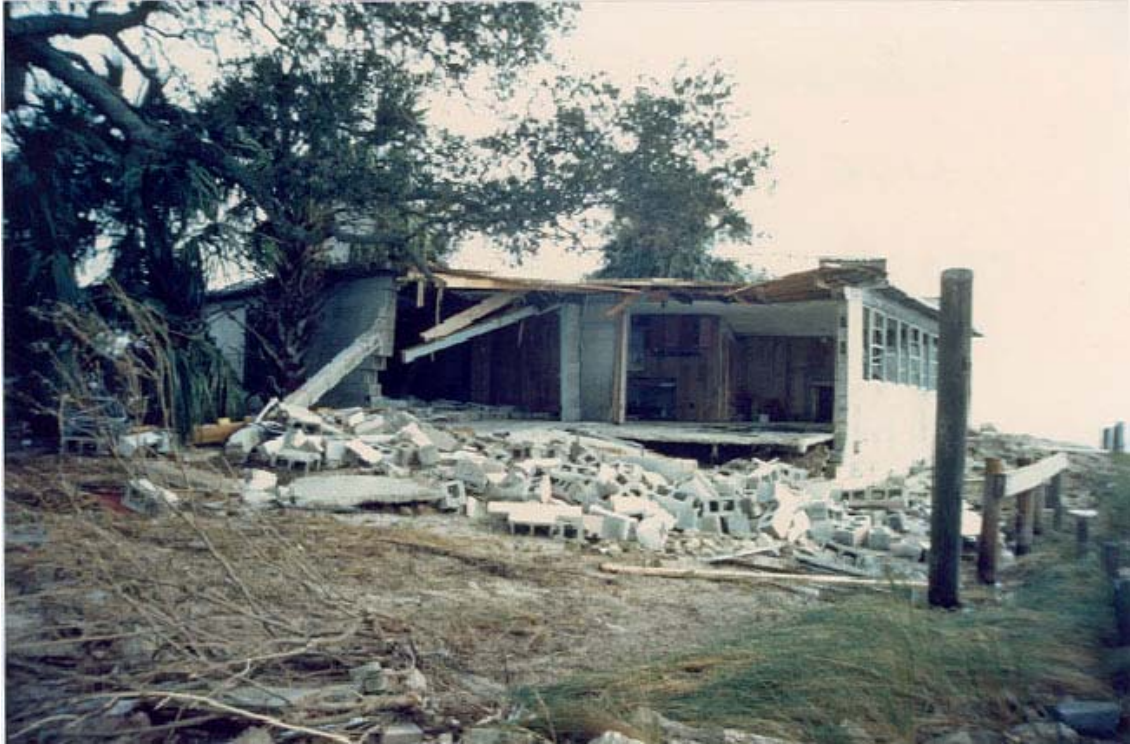
FIGURE 113. Dwelling destroyed at west point of Live Oak Island.

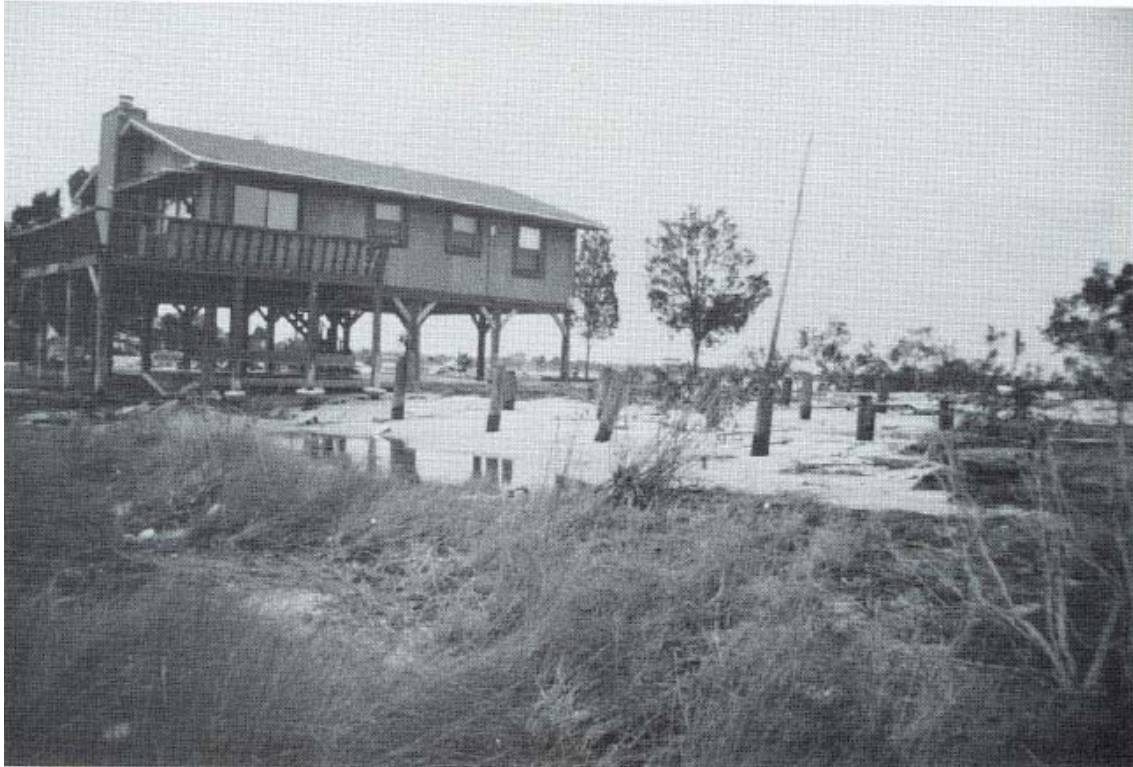
FIGURE 119. Foundation piles are sole remains of dwelling which "disappeared" during Kate.

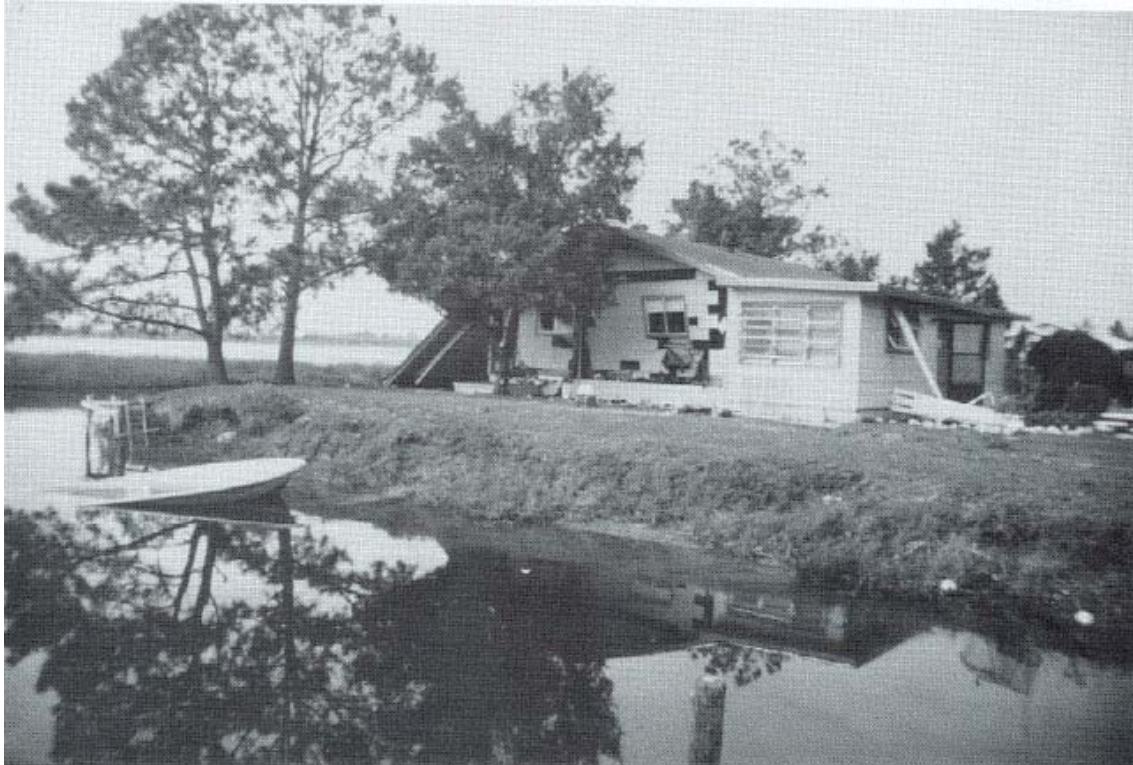
FIGURE 120. Dwelling damaged by waves which propagated across the island and the canal.

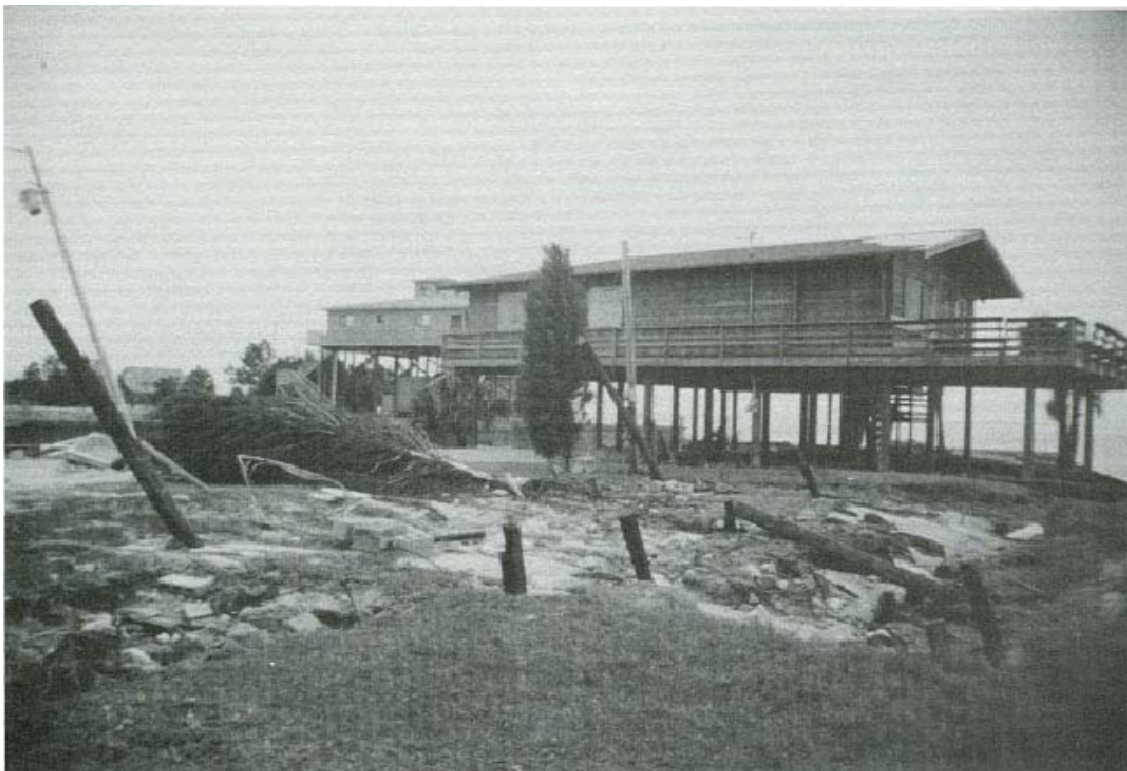
FIGURE 122. Site of the dwelling which was probably hit by a tornado.
