HURRICANE OPAL

BEACH AND DUNE EROSION AND STRUCTURAL DAMAGE ALONG THE PANHANDLE COAST OF FLORIDA

REPORT NO. BCS-98-01
BUREAU OF BEACHES AND COASTAL SYSTEMS
DEPARTMENT OF ENVIRONMENTAL PROTECTION
STATE OF FLORIDA

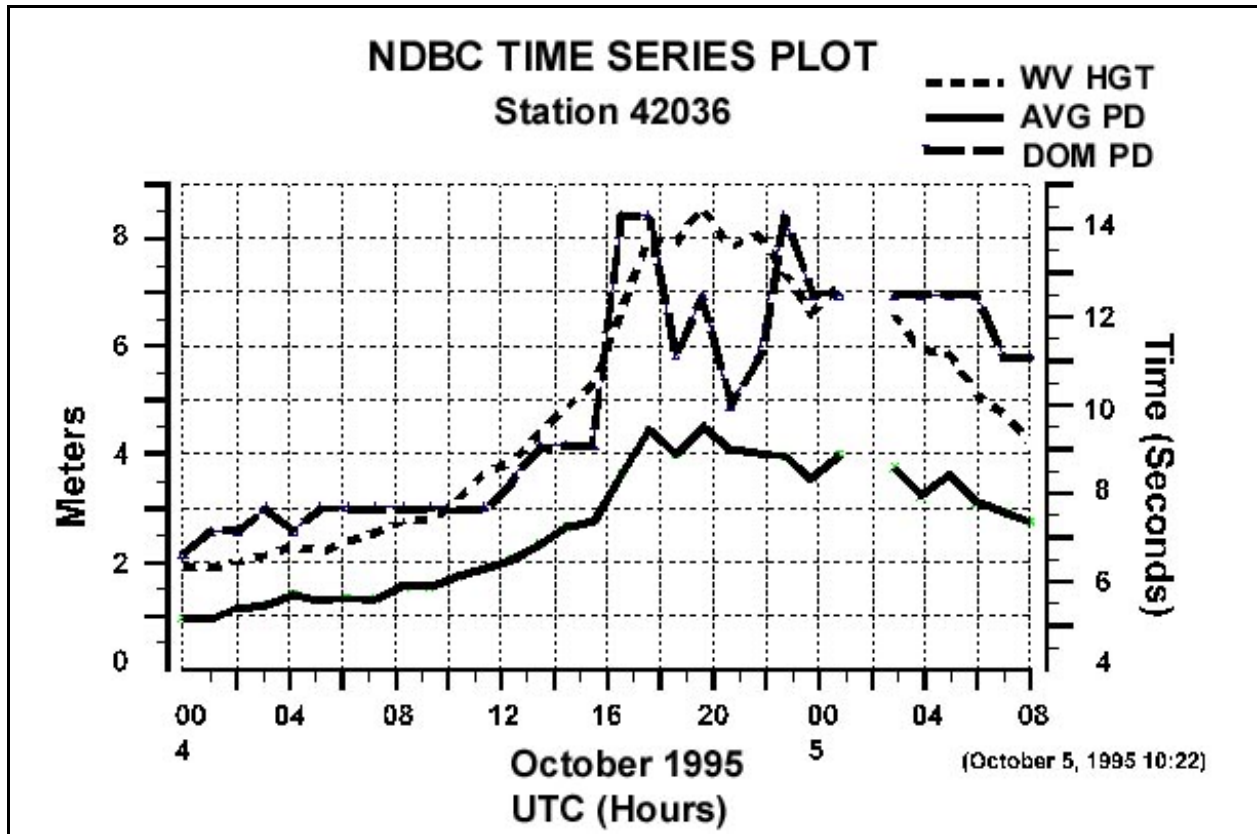
Figure 4. Wave data at NDBC buoy 42036 during passage of Opal.

Wave data collected at station 42036 which is nearest to the Florida coast is shown below in Figure 4. The illustration of the NOAA data at this station shows the dramatic increase in wave height and in average and dominant wave period at this particular buoy station as Opal traveled across the Gulf, even though Opal's track was quite a significant distance westward of this station. Graphs of other NOAA data are given in Appendix A.

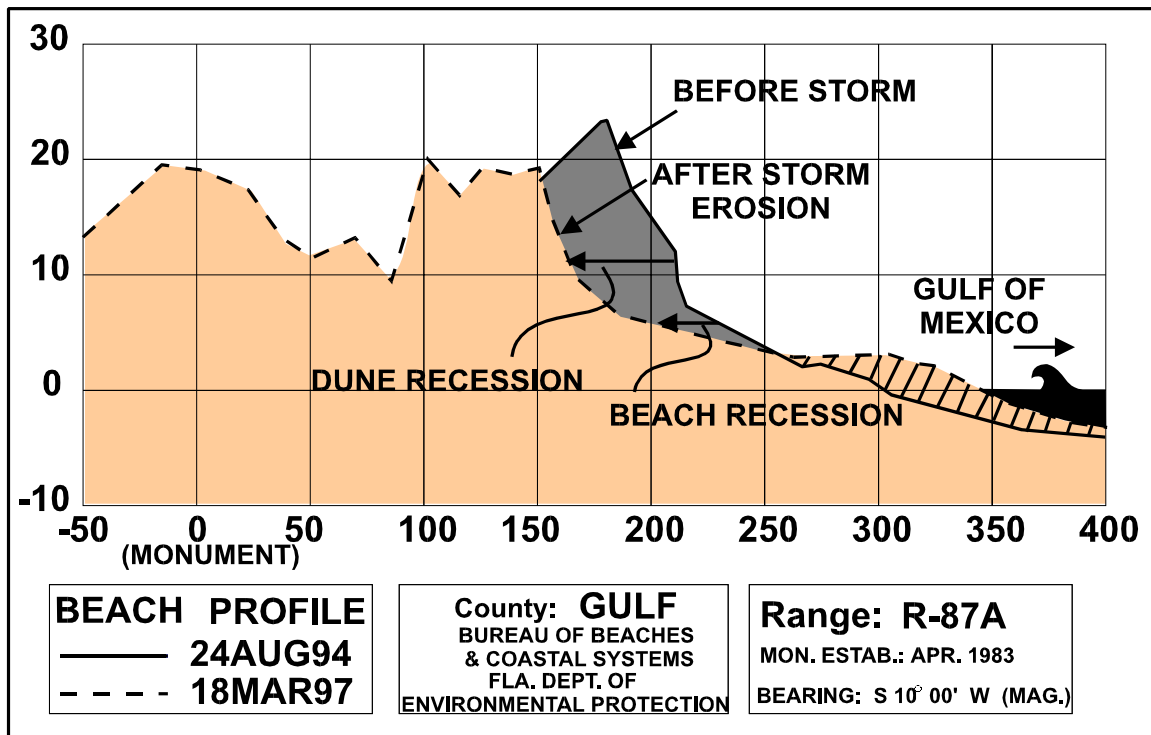
Figure 34. Beach and dune erosion from at R-87A Opal in Gulf County.

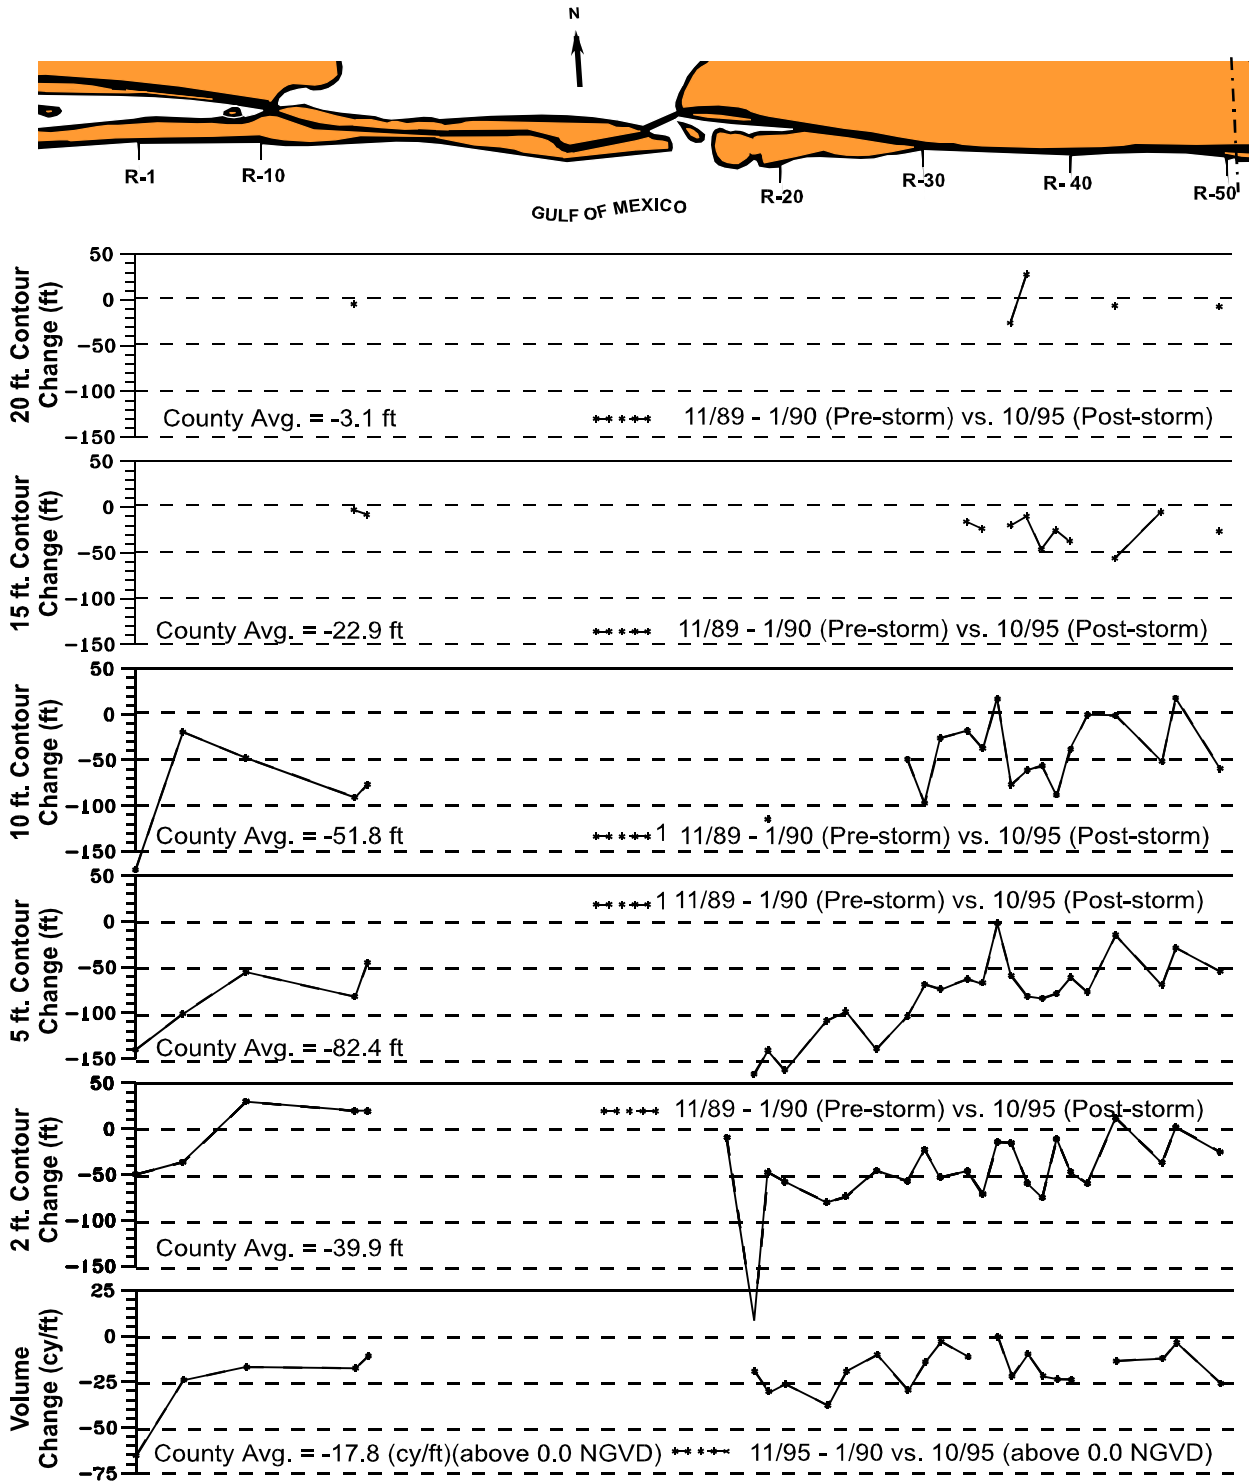
Figure 42. Alongshore distribution of 2, 5, 10, 15, and 20 foot contour recession and volumetric loss across Okaloosa County.

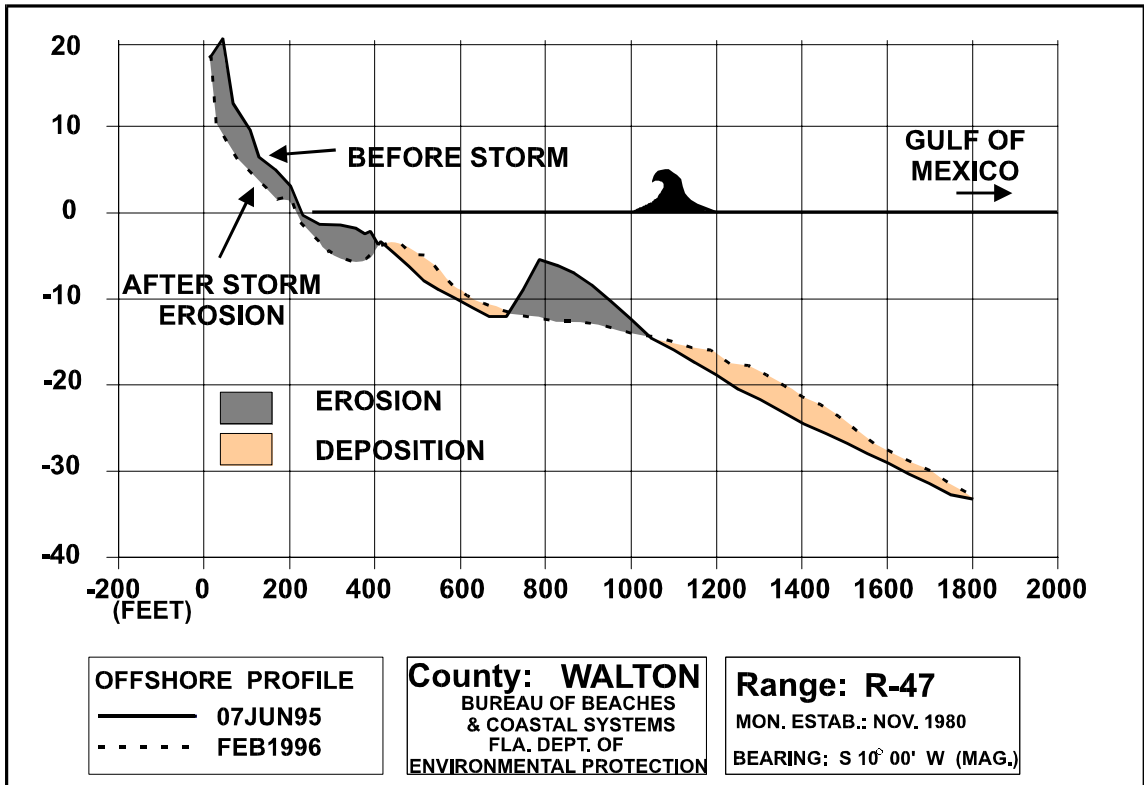
Figure 45. Dune erosion and offshore sand deposition at R-47 in Walton Co.

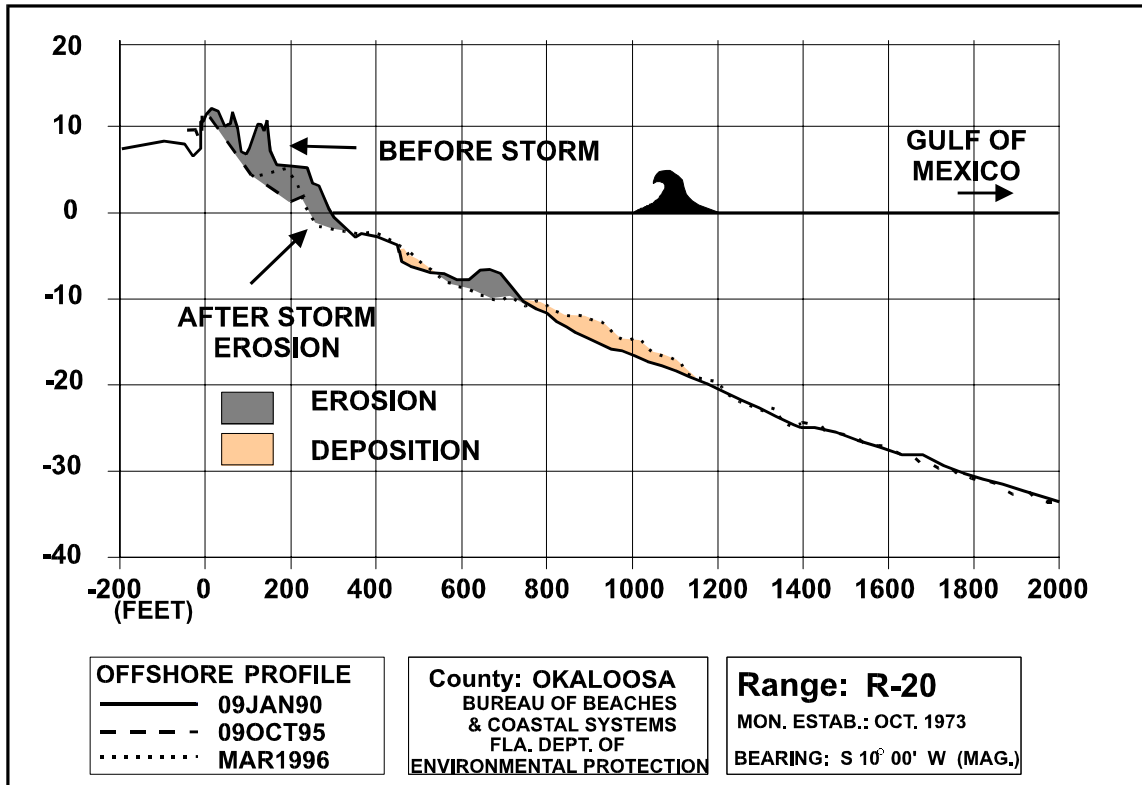
Figure 47. Dune erosion and offshore sand deposition at R-20 in Okaloosa Co.

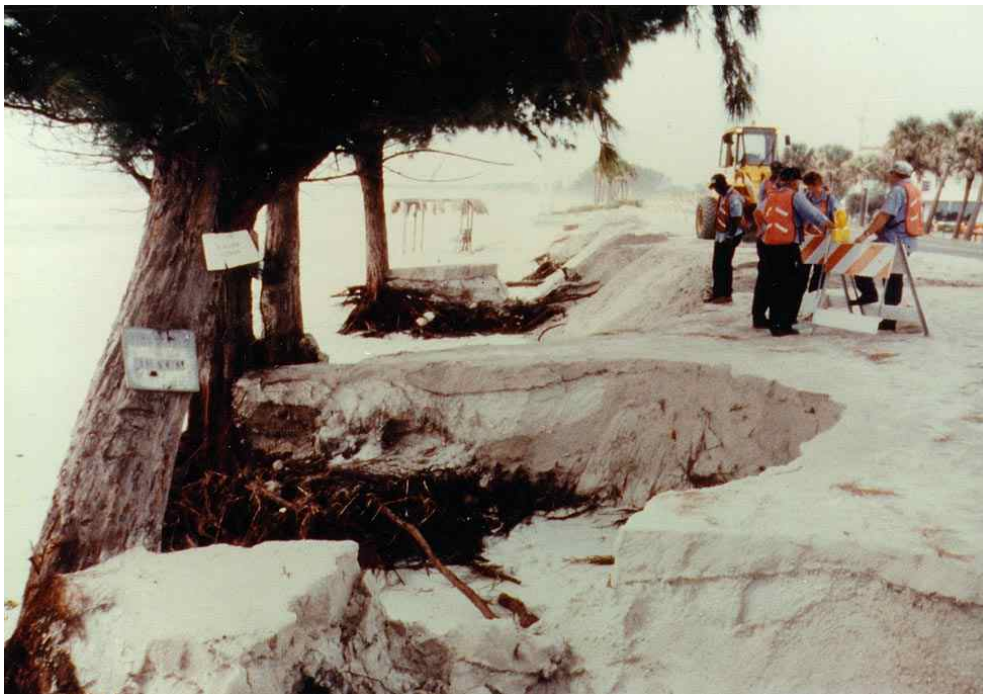
A view of erosion resulting from Opal along a critical segment of coastal roadway protected by beach restoration on Longboat Key in Sarasota County is shown in Figure 50 (Spadoni, 1995). Clearly, the restoration project provided valuable protection to this vital coastal road.

Figure 50. Erosion of beach restoration project on Longboat Key from Opal.

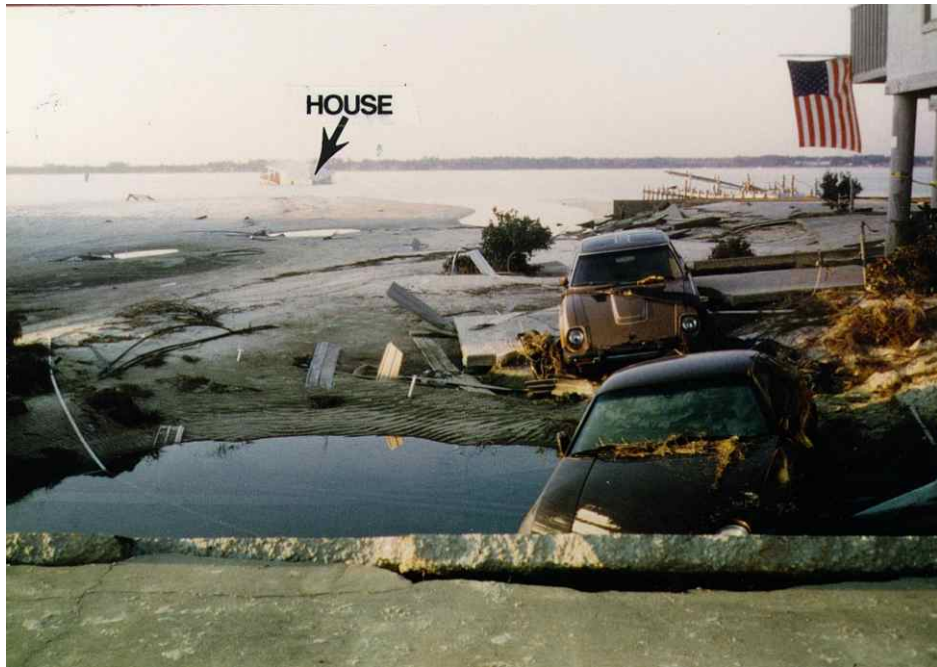
Figure 51. Overwash deposition near Navarre Beach, Santa Rosa County. Note house transported by Opal and deposited into Santa Rosa Sound in the background.

The recovery plan outlines recommended recovery measures and cost estimates for those measures. The major recovery projects identified include post-Opal debris removal and dune restoration work, as well as, beach restoration for Panama City Beach and improved inlet management, among others. Extensive dune restoration has been performed in the months following the storm through county-by-county implementation with FDEP assistance and oversight. Debris removal from submerged lands in the Gulf and inland waters has been performed by the State to augment upland debris removal by local governments. Photos on the following page depict dune restoration and debris removal projects performed under the plan. The house removal shown is the same house shown in Figure 51 deposited in Santa Rosa Sound.

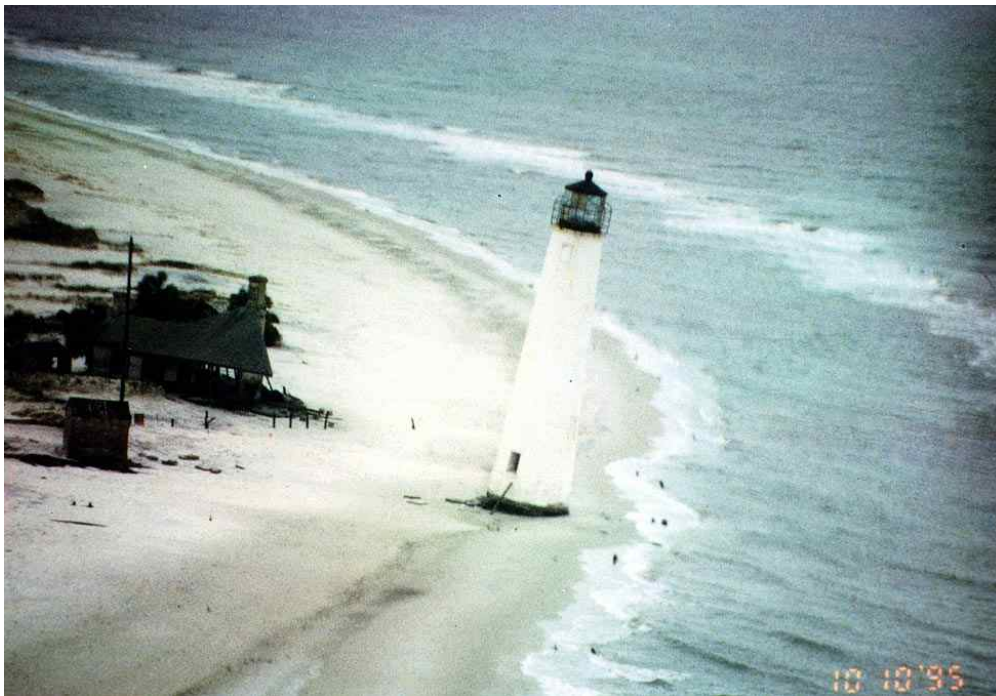
Figure 56. Cape St. George Lighthouse on Little St. George Island (already severe erosion area significantly worsened by Hurricane Opal).

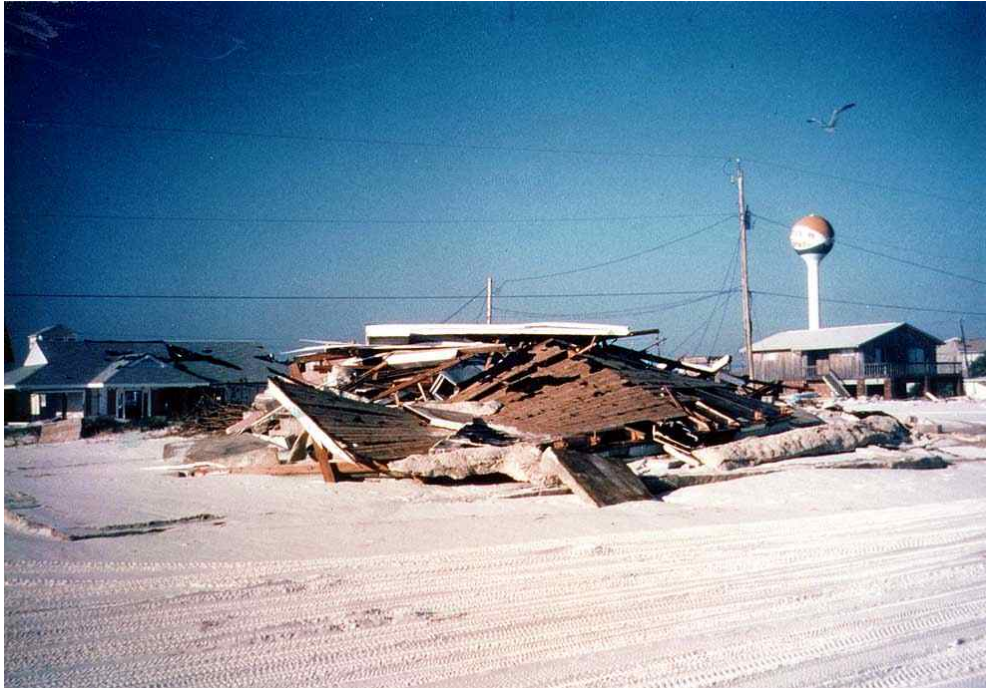
Figure 57. Escambia County - Example of destroyed major habitable structure in Pensacola Beach.

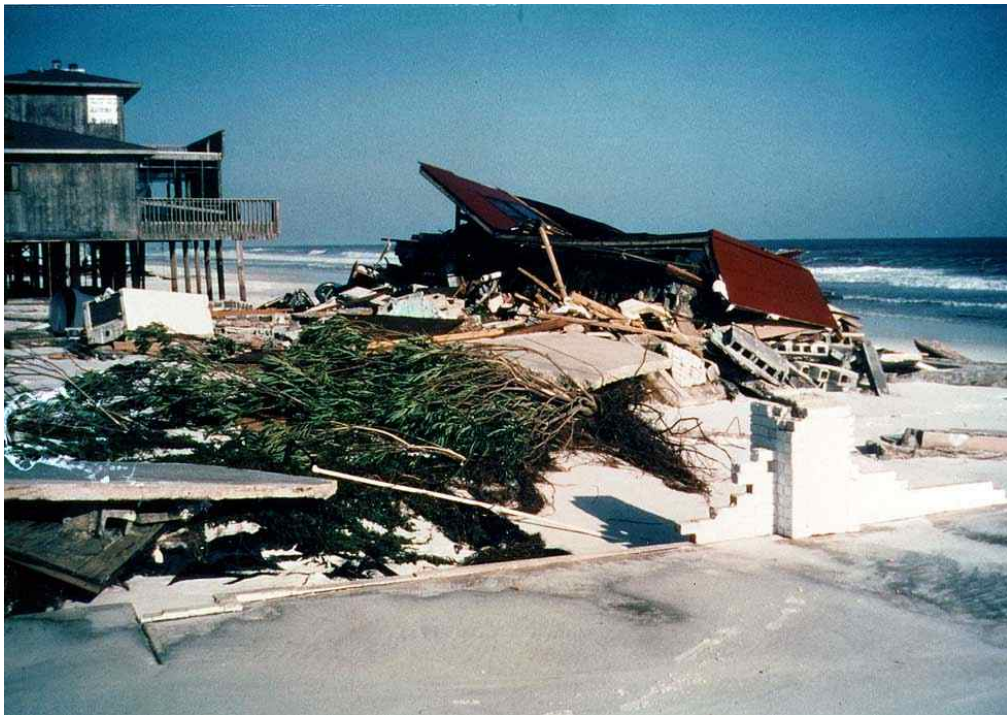
Pile-supported dwelling structures were able to survive the loss of soil support beneath habitable floors where structures on soil-bearing foundations could not survive erosional losses. Despite pile foundations, some habitable structures were still destroyed as a result of low, inadequate floor elevations which allowed storm surge and wave penetration into the habitable portions of the structures or as a result of inadequate pile penetration.

Figure 58. Escambia County - Pensacola Beach. This shows the contrast between a pile-supported structure which survived Opal and a poorly-designed one which did not.

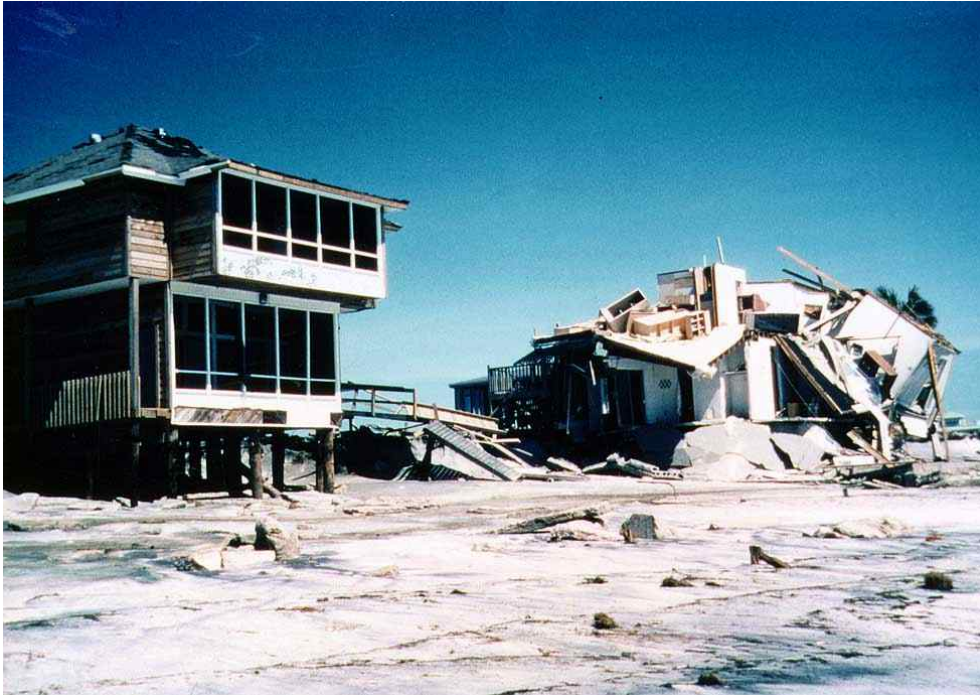
Figure 59. Walton County - Dune Allen. Contrast between a pile-supported structure which survived Opal and a poorly-designed one which did not.

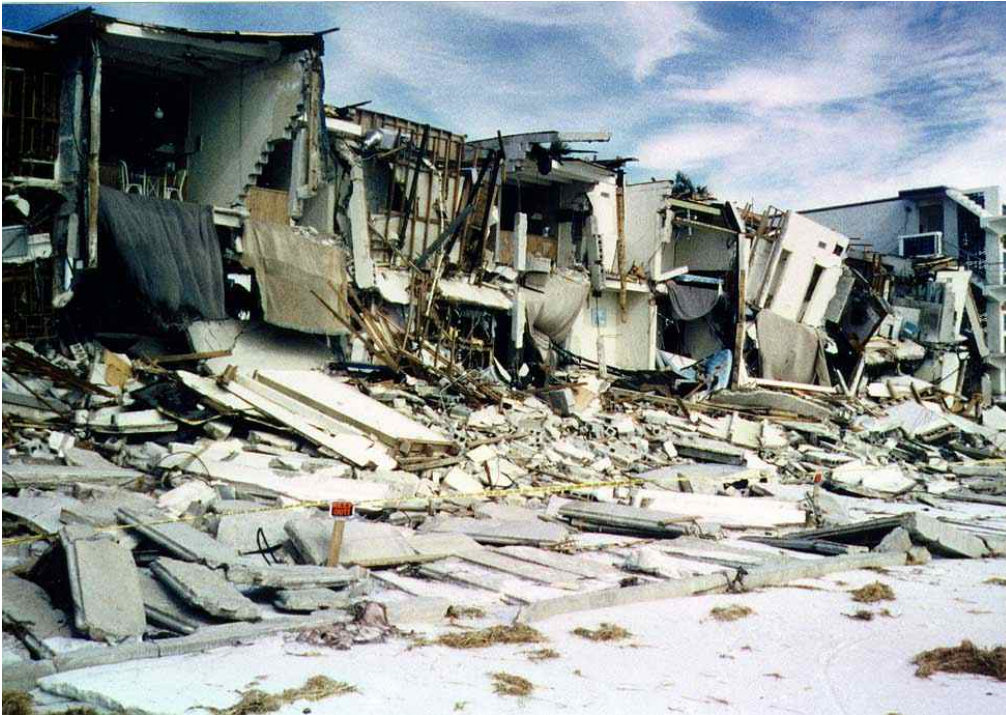
Figure 60. Bay County - Panama City Beach. This shows a seawall which was destroyed and did not protect the severely damaged multi-family dwelling from Opal.

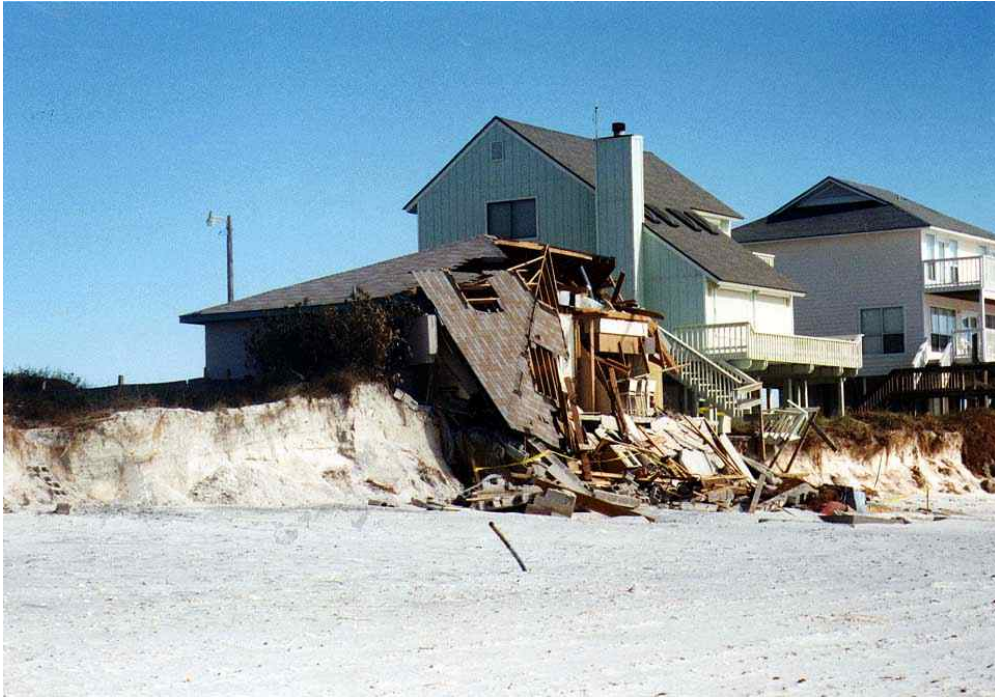
Habitable structures which were sited sufficiently landward of eroding dune blufflines survived any significant damage, as can be seen in the photos of structural damage in Gulf and Franklin counties on the following pages. In contrast, structures located in areas of eroding dune blufflines were undermined and sustained significant damage or destruction when not designed on adequate foundations to withstand the erosion, as seen in the photos.

Figure 61. Gulf County - St. Joseph Peninsula. Poorly-sited and poorly-designed structure destroyed compared to permitted structures with better siting and design.

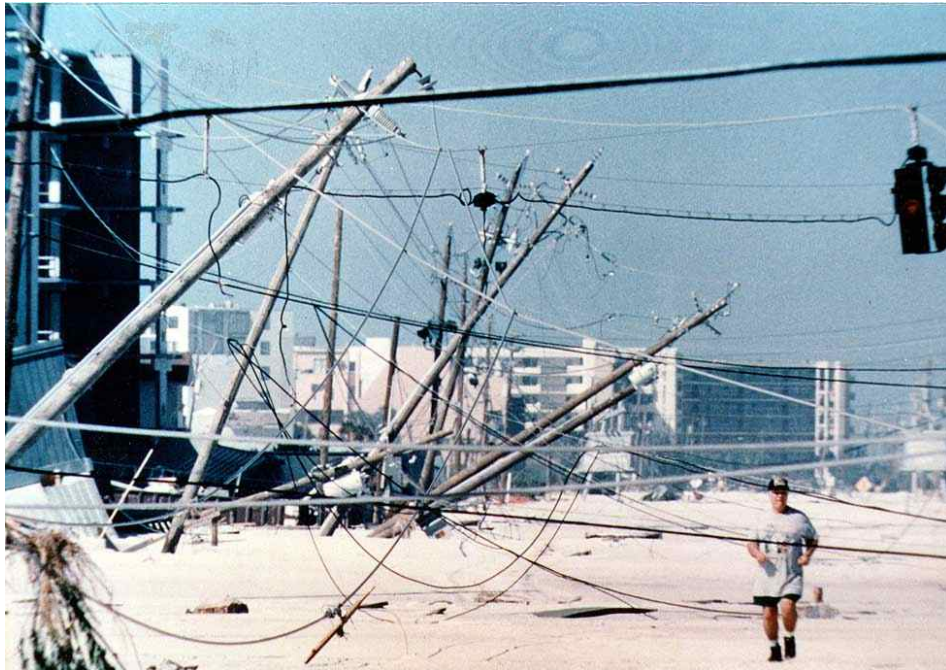
One particularly problematic recovery issue has involved overwash sand removal and debris removal. The photo below (Northwest Florida Daily News, 1995) depicts a typical scene in the western Panhandle (Destin) where a roadway and other upland properties have been completely inundated by overwash sand. In some of the western Panhandle areas, such as Pensacola Beach and Ft. Walton Beach, extensive volumes of overwash sand were retrieved and placed back in pre-storm dune areas to assist in dune recovery efforts.

Figure 63. Typical Post-Opal aftermath depicting excessive overwash sand covering roads and upland properties (Gulf of Mexico is to the left beyond the gulf-front buildings).

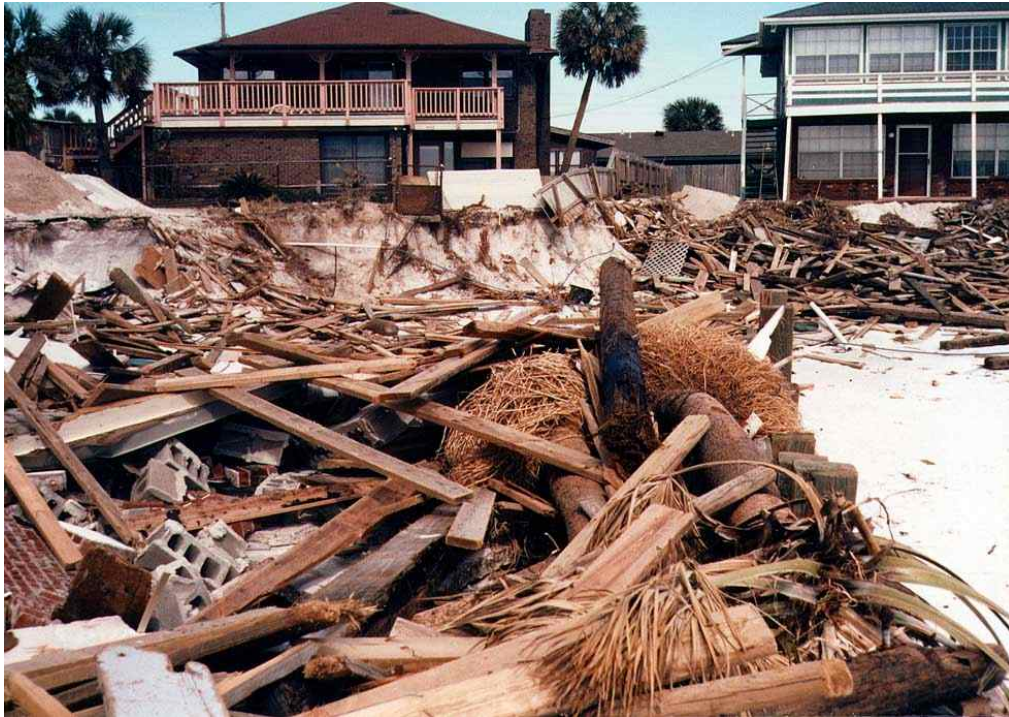
A major concern has involved the potential of hazardous debris which may be buried beneath the sand or in nearshore areas. The photo shown in Figure 64 on the following page illustrates typical extensive debris which littered coastal areas following the storm.

Figure 64. Typical Storm Debris in Panhandle Areas Following Hurricane Opal (Spyglass Drive area of Panama City Beach)

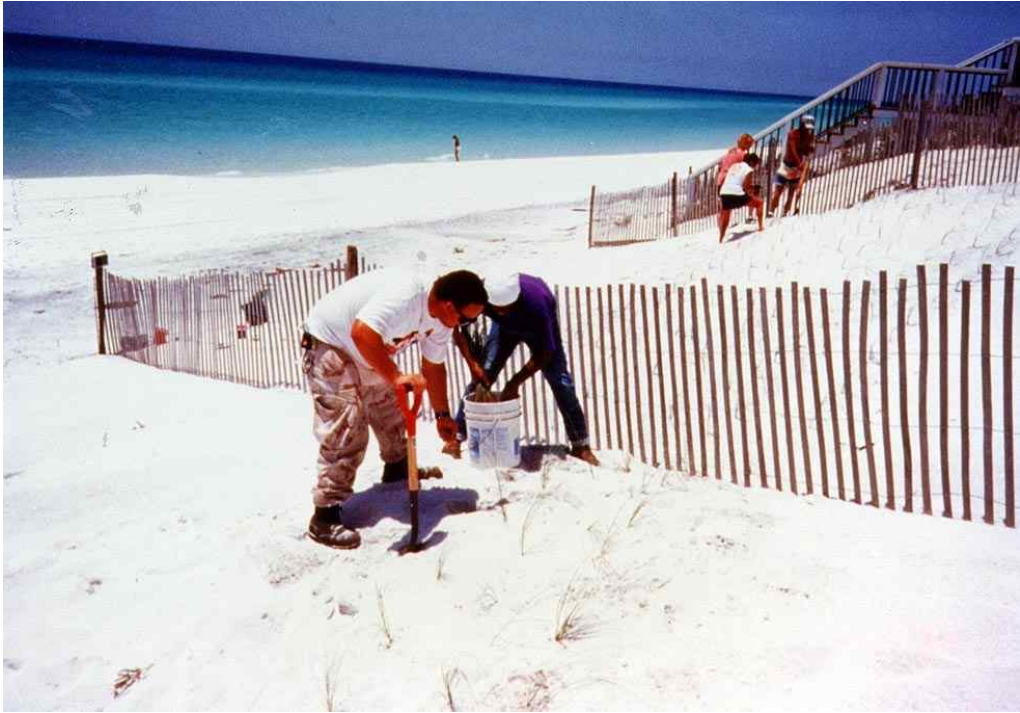
Figure 67. Dune restoration work; sea oat planting and sand fencing; Panhandle Coast.

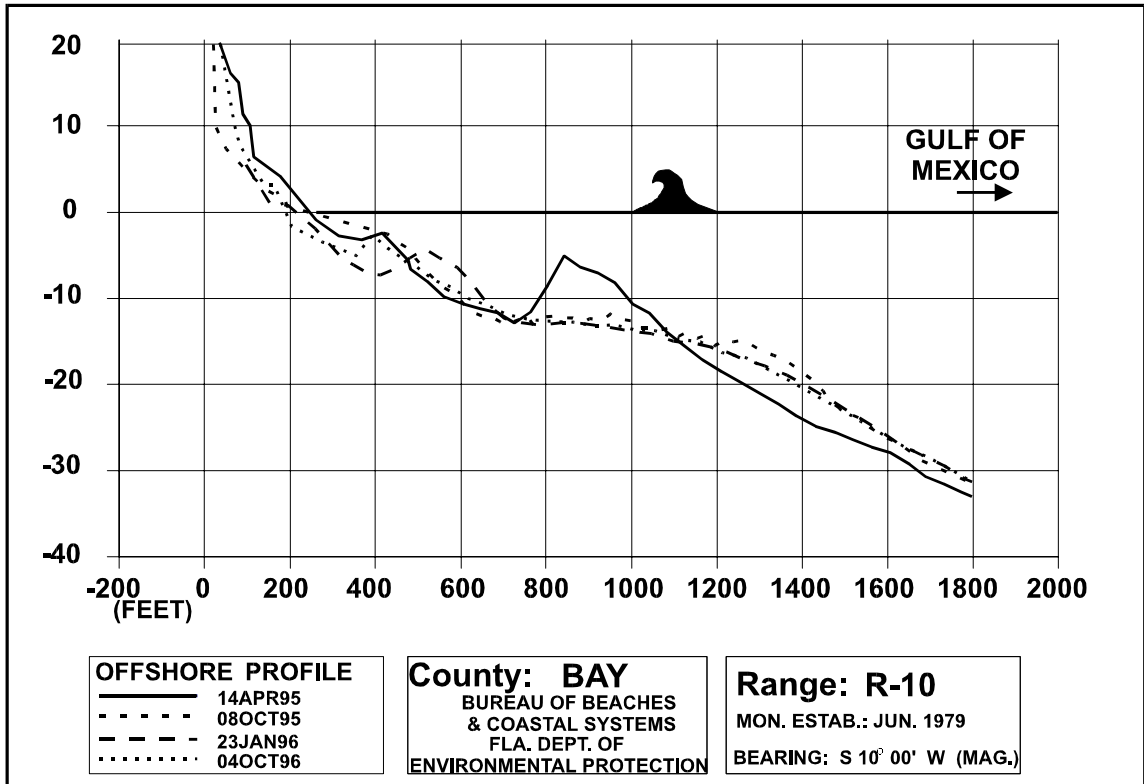
Figure 69. Pre-Opal through one-year post-Opal profile response in Bay Co.

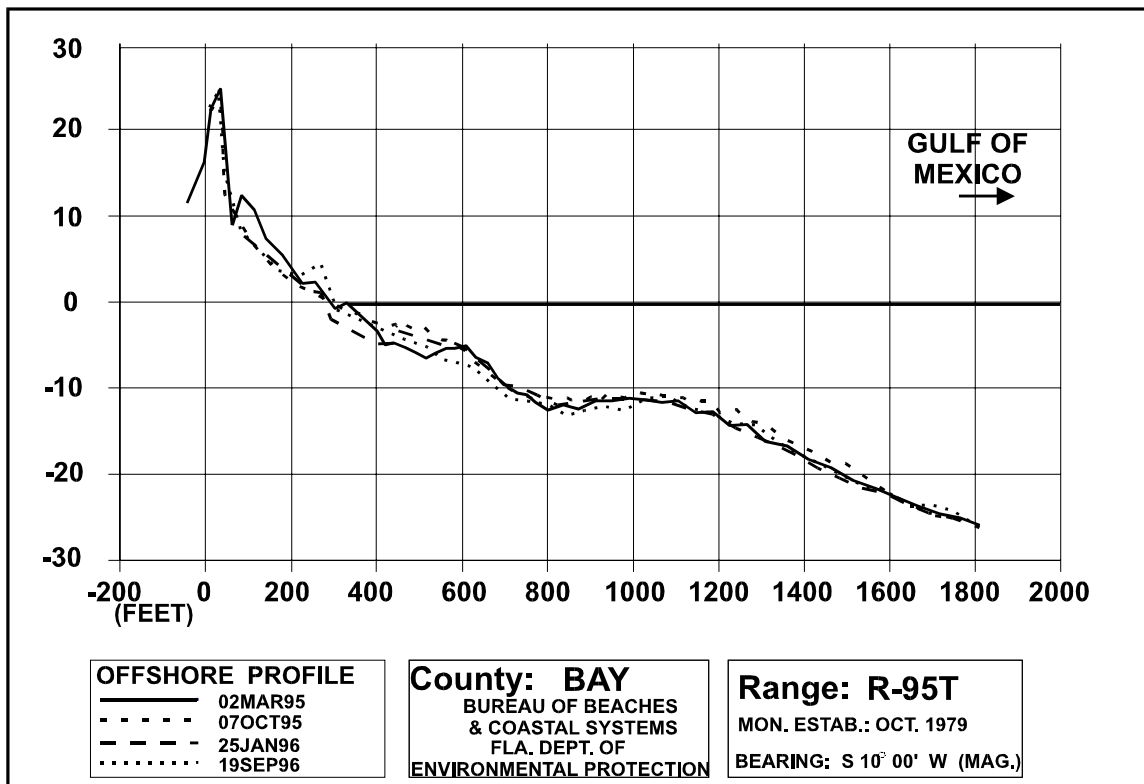
Figure 72. Pre-Opal through one-year post-Opal profile response in Bay Co.

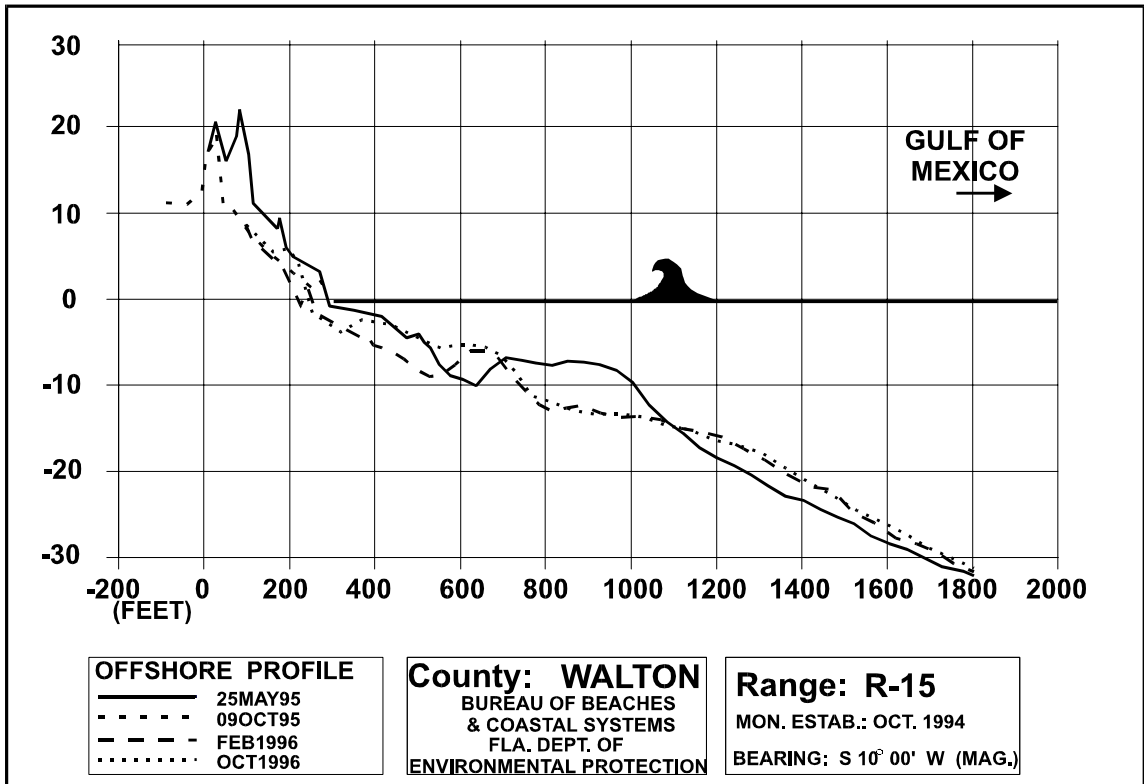
Figure 73. Pre-Opal through one-year post-Opal profile response in Walton Co.

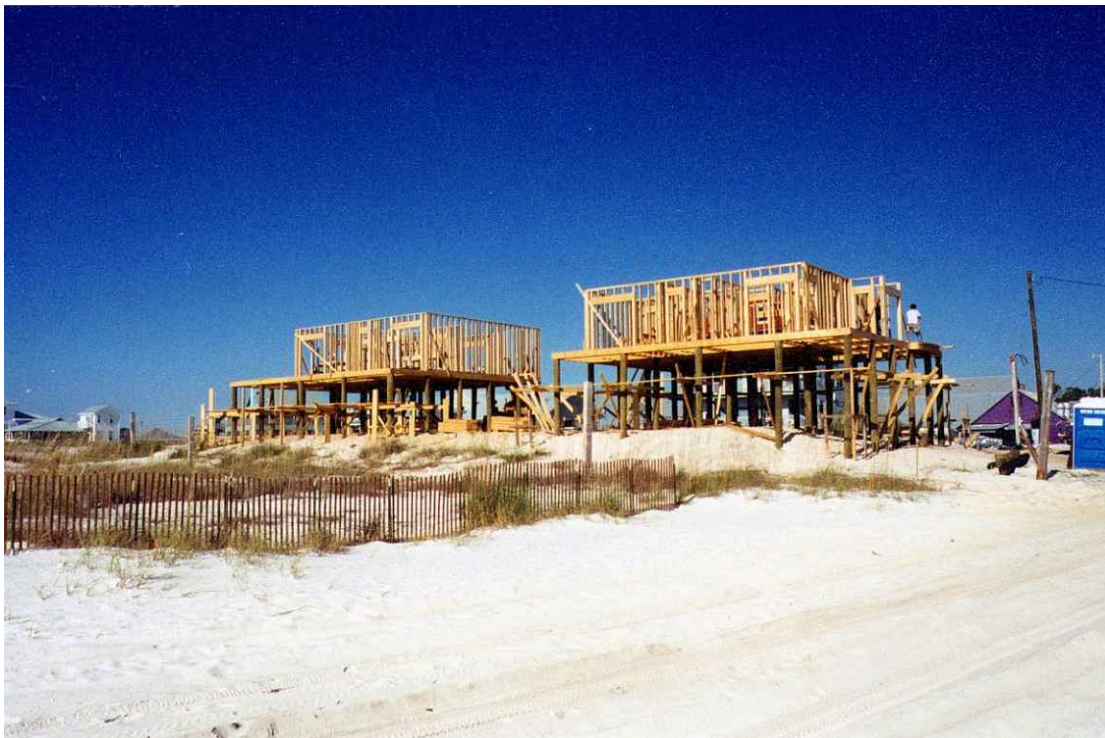
Figure 81. FDEP-permitted habitable structures under construction following Opal.

Another measure adopted by the FDEP to improve survivability of habitable structures was to adopt a general elevation of +17 feet (NGVD) as a minimum for underside elevations for first level habitable, pile-supported floors for the entire Panhandle coast. These types of measures will help to ensure that, if all substantially damaged or destroyed major habitable structures across the Panhandle are rebuilt, over half of these structures will be FDEP-permitted structures and will significantly reduce the potential for the type of devastating damage from Opal in the future.

Structural damage photos shown in Section III of this report illustrate survivability of elevated, pile-supported habitable structures in comparison to poorly-designed structures which were destroyed by Hurricane Opal. The photo shown below illustrates two permitted, pile-supported, habitable structures under construction which are typical of structures being constructed to FDEP design and siting standards. These structures are located in Walton County just west of Grayton Beach State Park and are designed to withstand potential hurricanes of the intensity of Hurricane Opal.
