Hurricane Kate

November 15-23, 1985

Department of Natural Resources
Division of Beaches and Shores
Post Storm Report No. 86-1
September, 1986
By Ralph Clark

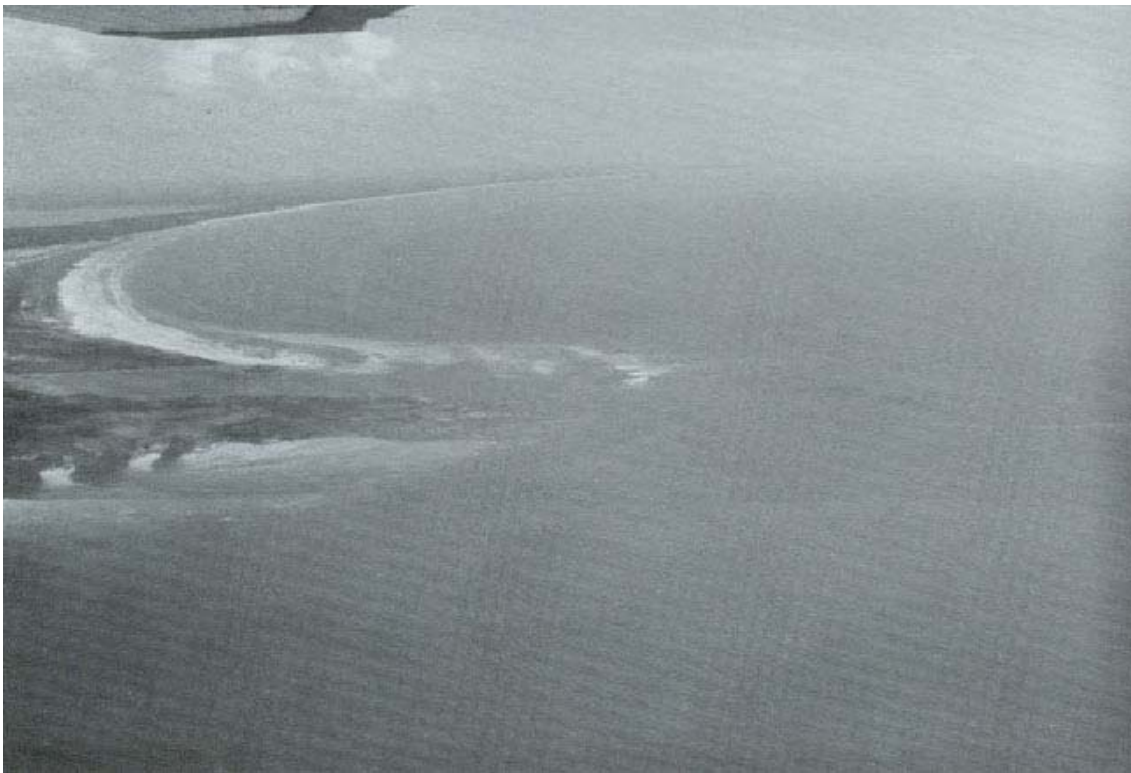
Cape disappeared after Elena passed by approximately 30 miles offshore on the evening of September 1. Another approximately 1,000 feet of the Cape was removed by hurricane Kate on November 21. Figure 18 shows Cape San Blas from the air in November, 1984 and Figure 19 taken on November 24, 1985, shows the remains of the Cape, three days after Kate 's impact and after nearly one half mile of the Cape was lost to the two hurricanes. The exposed southwest shore of Cape San Blas sustained heavy beach and dune erosion. About 200 feet of the end of the beach access road was destroyed (Figure 20). Profile data obtained by the Bureau of Coastal Data Acquisition adjacent to this beach access road revealed the barrier dune which had had a peak elevation of about +13.5 feet NGVD had been completely destroyed. An elevation of +3 feet NGVD remained at the site of this barrier dune after Kate. The entire barrier dune along the southern one mile of Gulf front beach south of the beach access road to the south tip of the Cape was totally destroyed. Most of the Cape is federally owned and extensive roofing damage was sustained by the several government buildings. In addition numerous equipment structures were damaged and a tall radio antennae was destroyed.

FIGURE 19. Cape San Blas, November, 1984 (Photograph provided by Kevin R. Bodge, University of Florida)

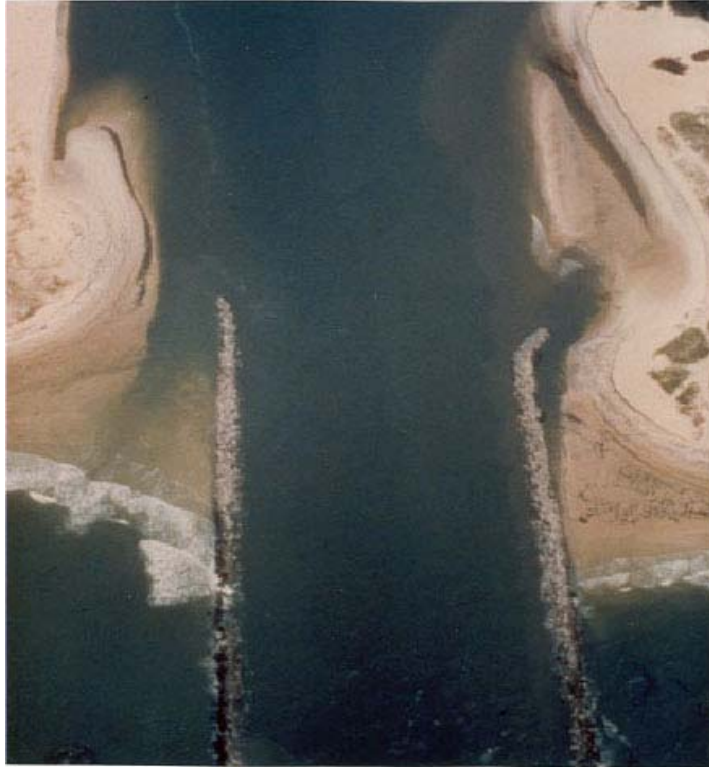
As reported in Post-Storm Report 85-3, the inlet's rock jetties at Sike's Cut were breached by the substantial shoreline recession caused by Elena on September 1. Figure 39 is an aerial photograph of the inlet prior to Kate. The Mobile District Corps of Engineers conducted an emergency dredging operation in the channel after Elena, removing shoals and placing the material in the breach between the east jetty and the shoreline. Although some erosion did occur in this filled area immediately east of

FIGURE 39. Sike's cut (St. George Island Channel) in November, 1985 prior to Kate (photograph by Kevin R. Bodge).

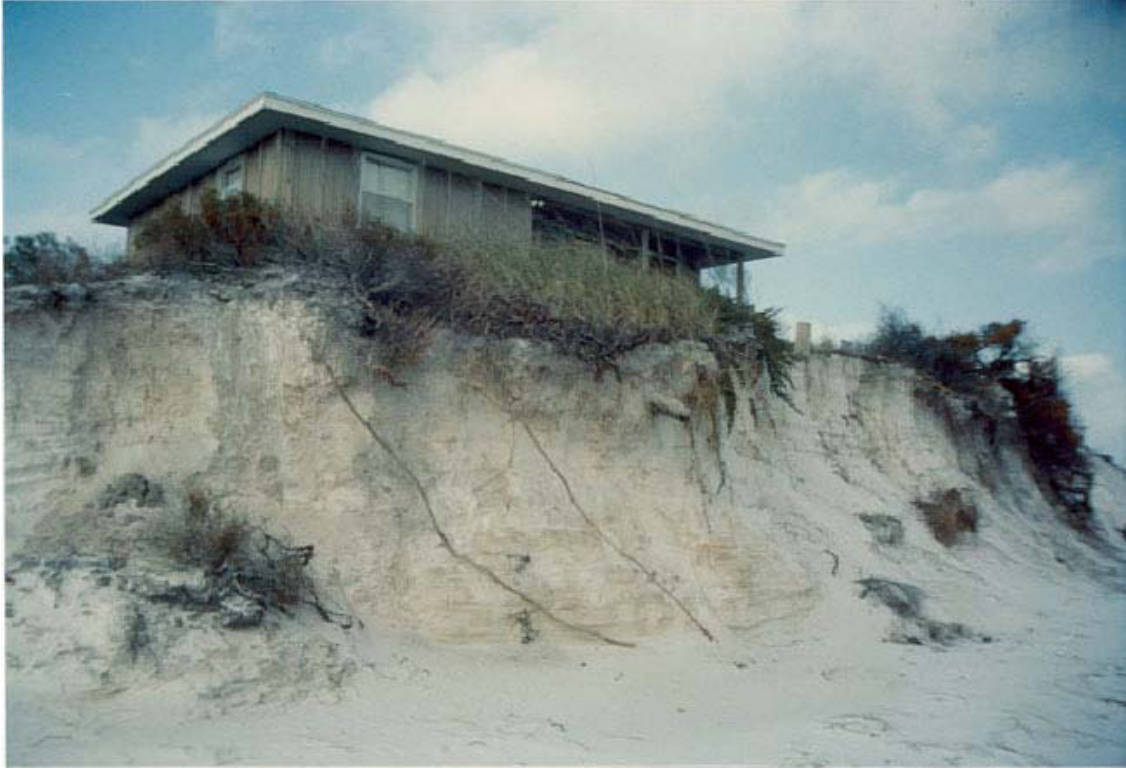
FIGURE 61. Severe erosion threatens dwelling, Dog Island.

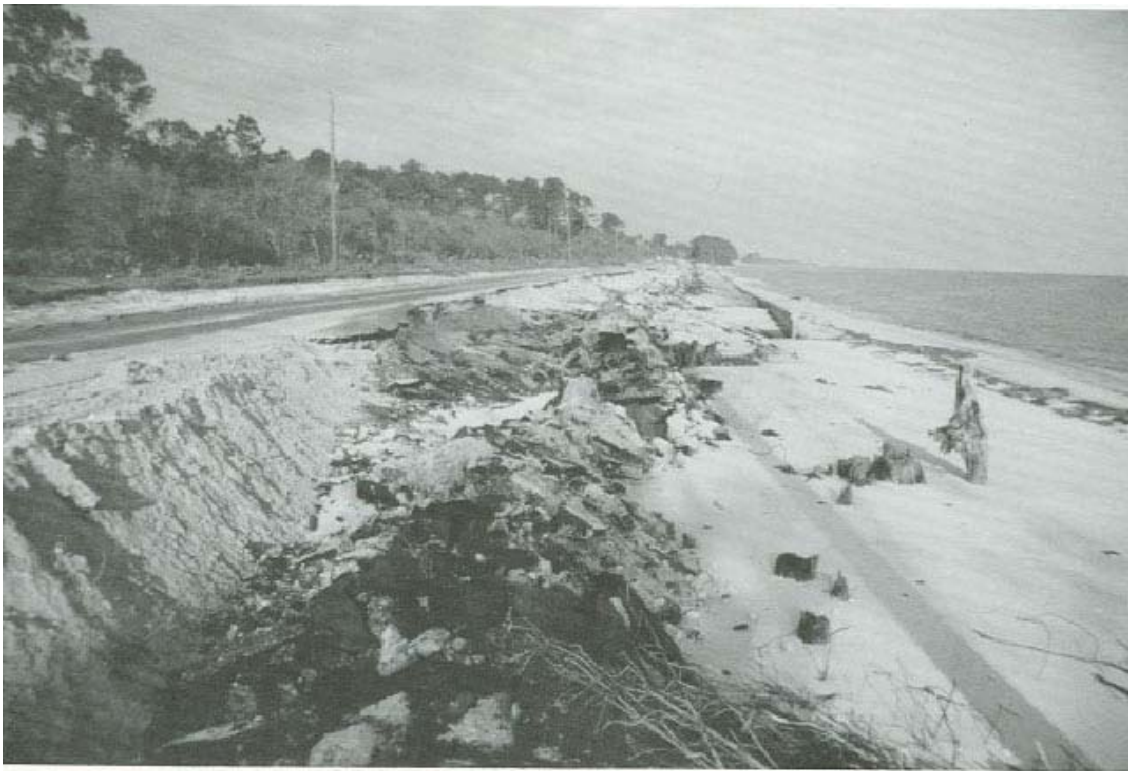
FIGURE 68. U.S. Highway 98 destroyed between Green Point and Yent Bayou.

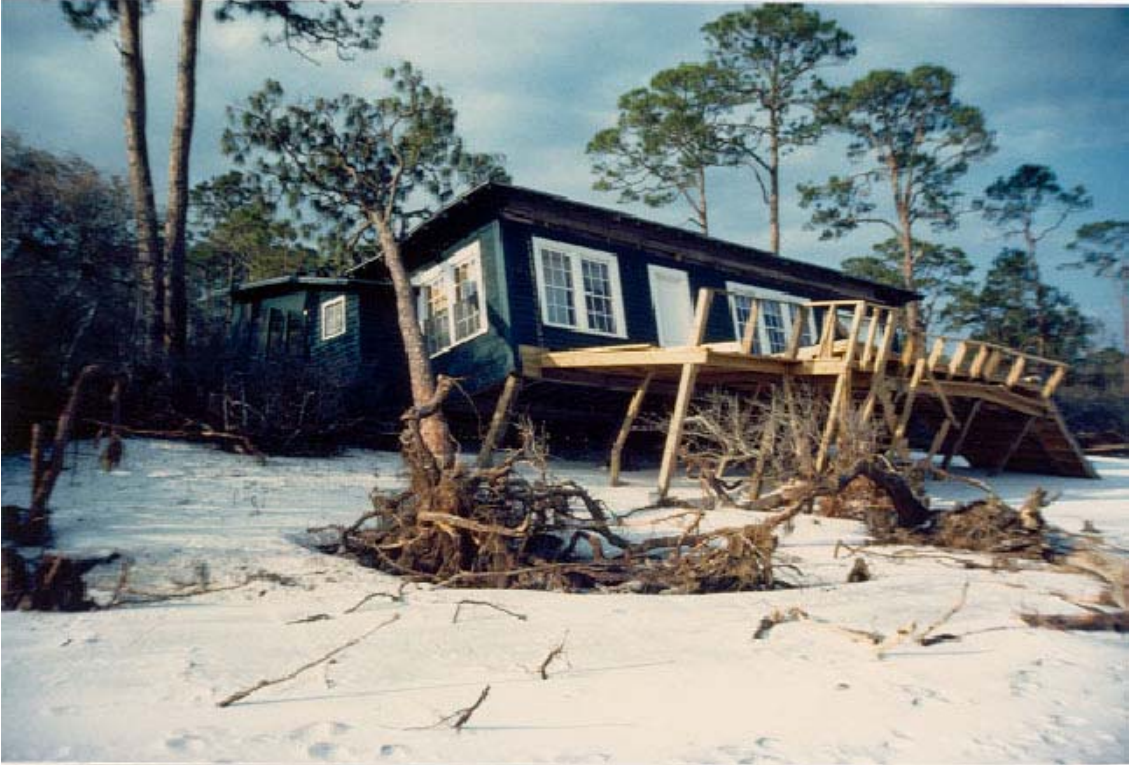
FIGURE 69. Dwelling with one front row of piles collapsed when undermined by erosion.

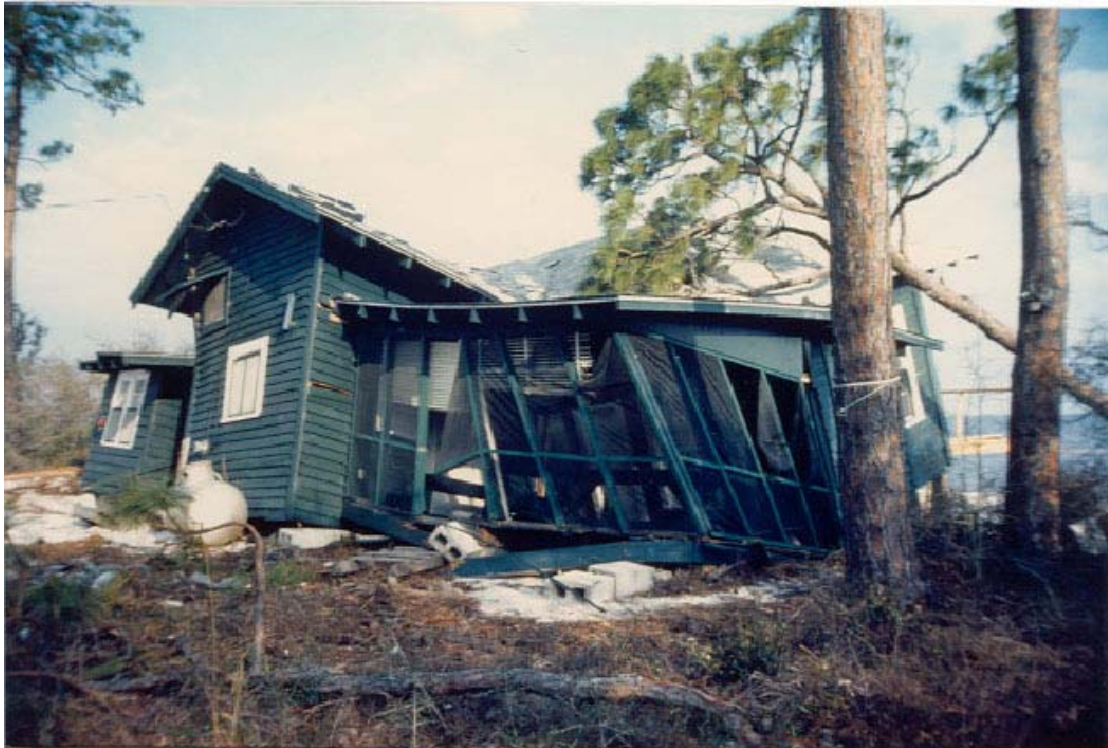
FIGURE 70. Landward side of same dwelling still supported by original grade showing the collapse in the middle.

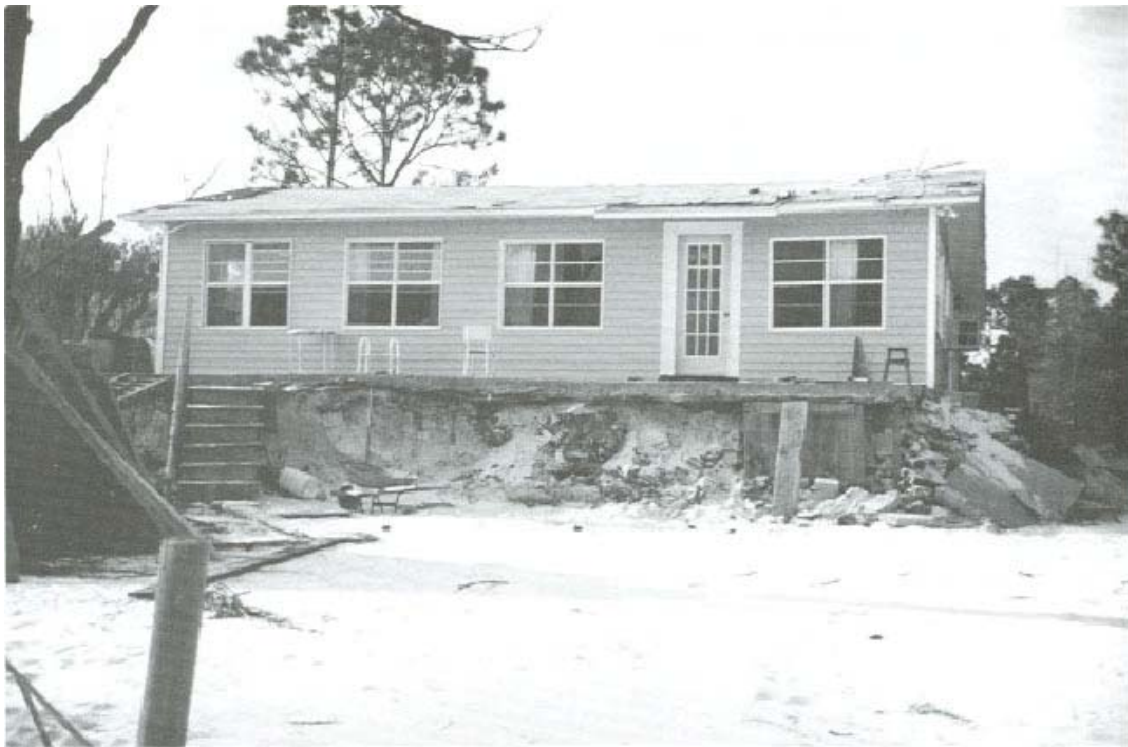
FIGURE 71. Dwelling threatened by erosion, St. George Sound shoreline.

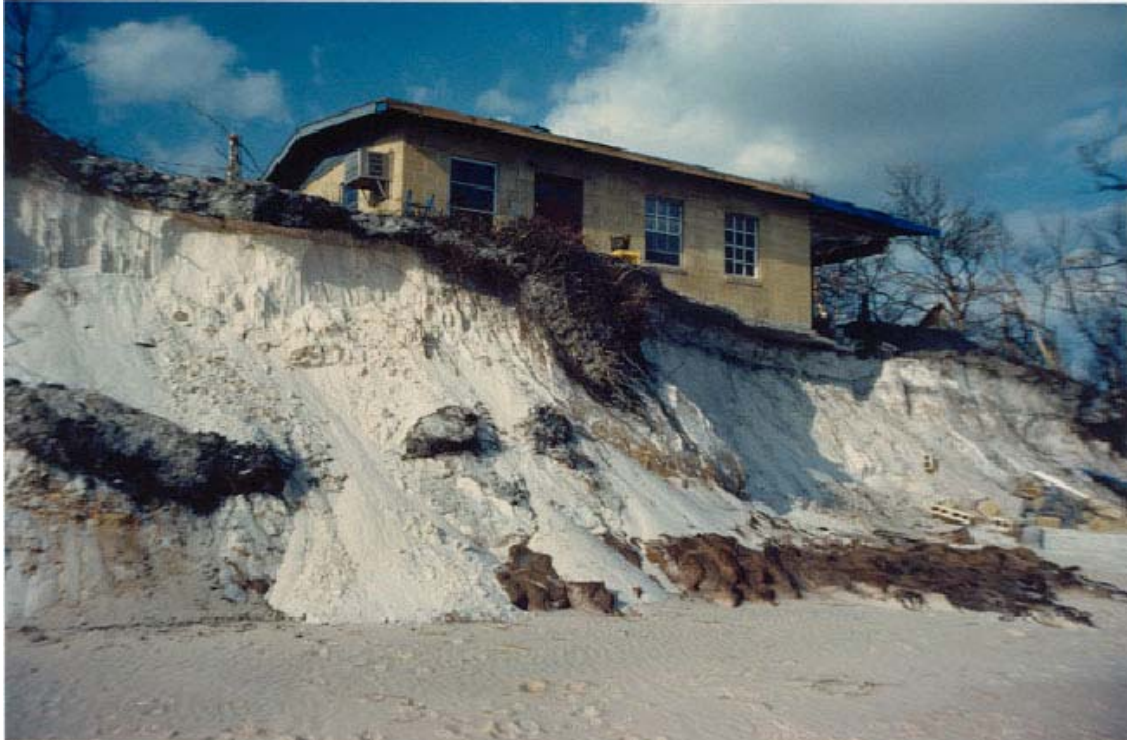
FIGURE 73. Partially undermined and damaged dwelling in imminent danger from severe dune erosion.

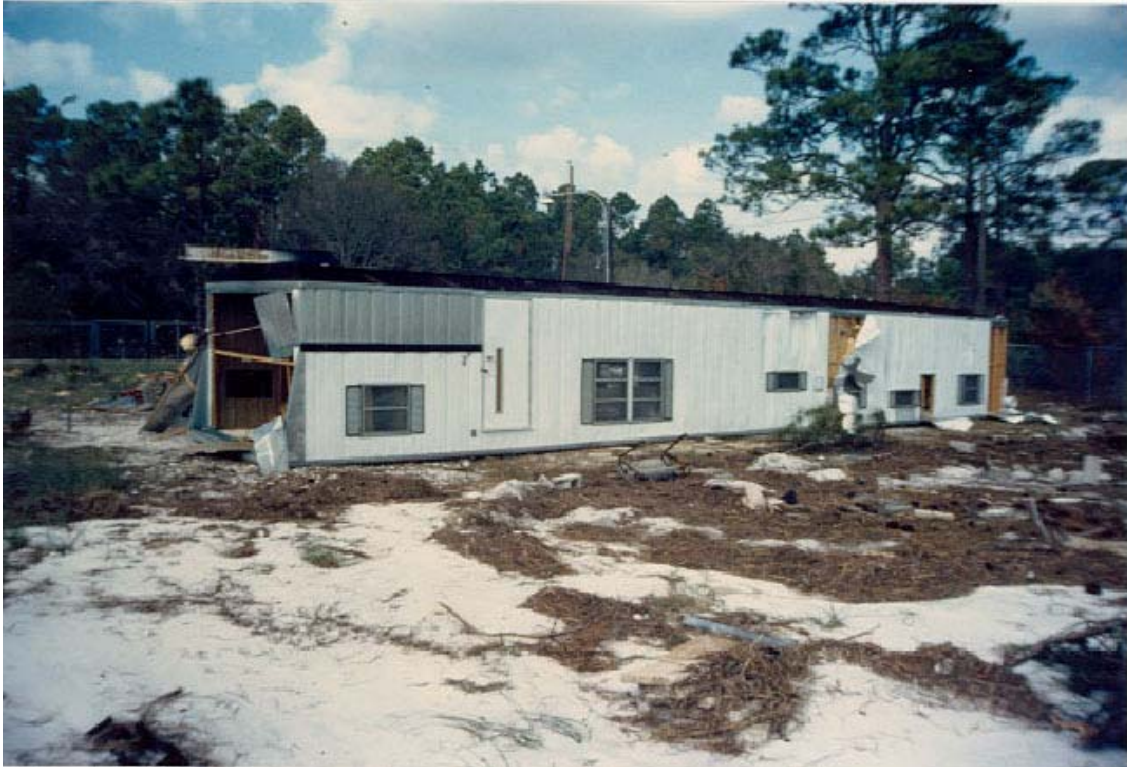
FIGURE 75. Mobile home rolled over by the wind and flooded.

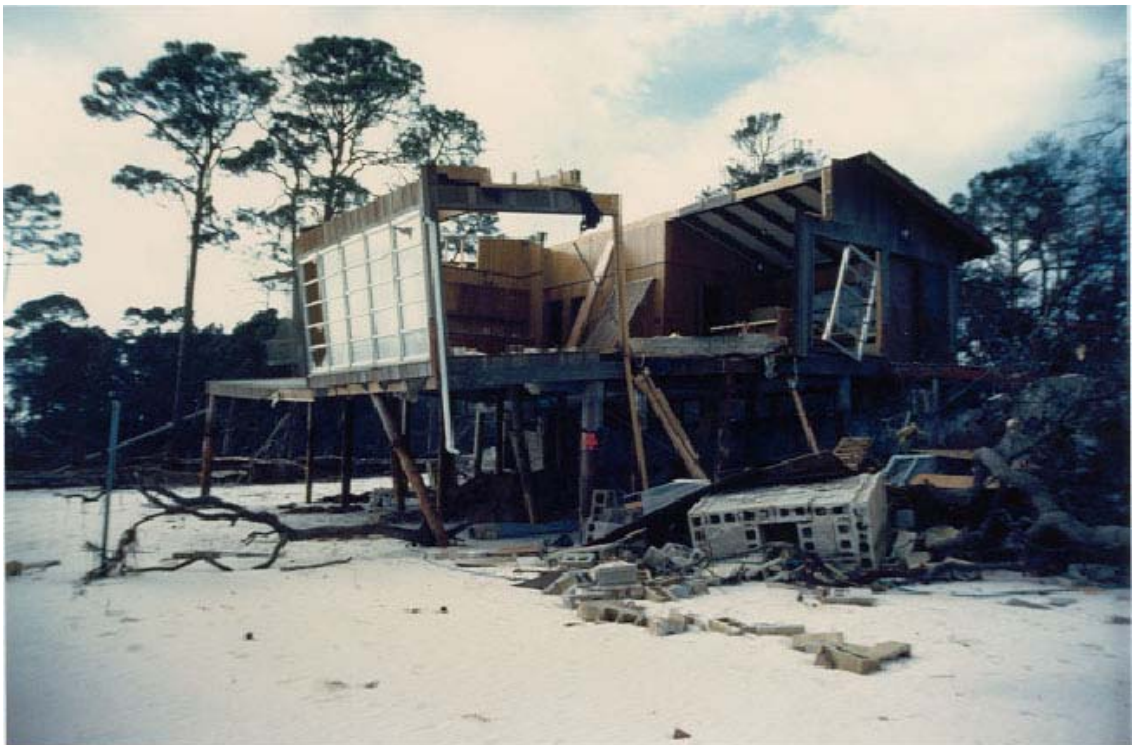
FIGURE 78. Pile-supported dwelling destroyed by wind, waves, and erosion of Kate.

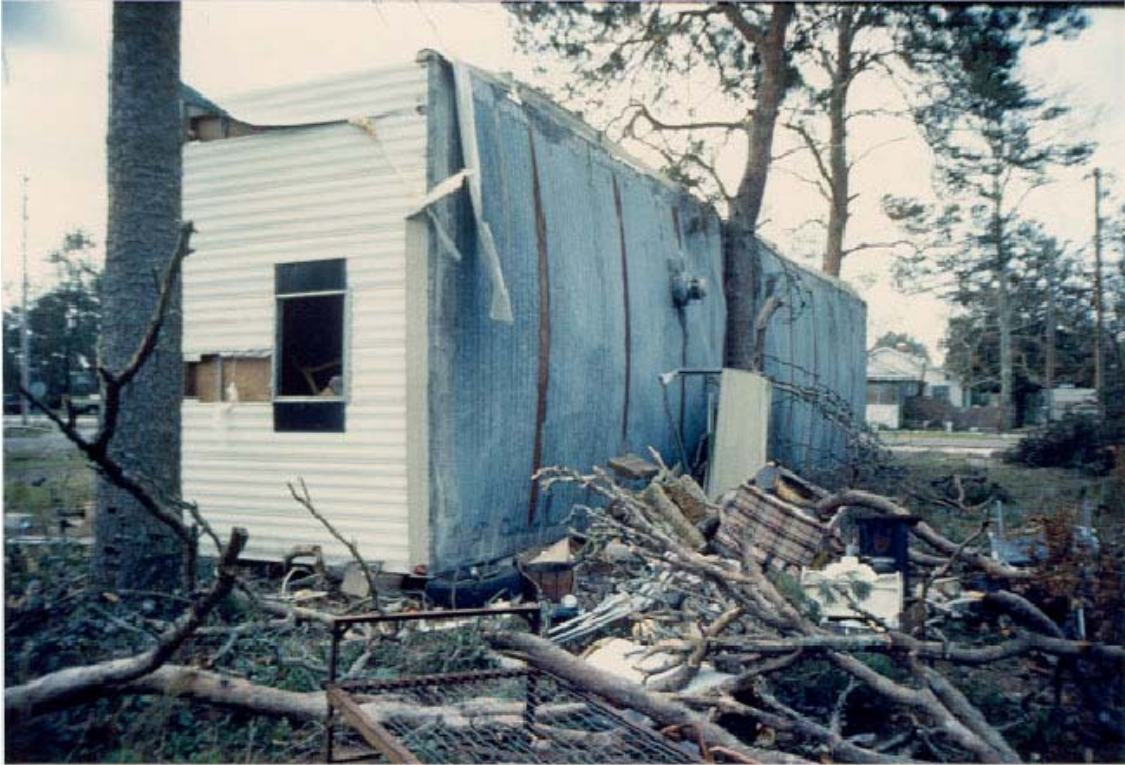
FIGURE 79. Mobile home rolled by downburst behind the Carrabelle IGA Food Store.

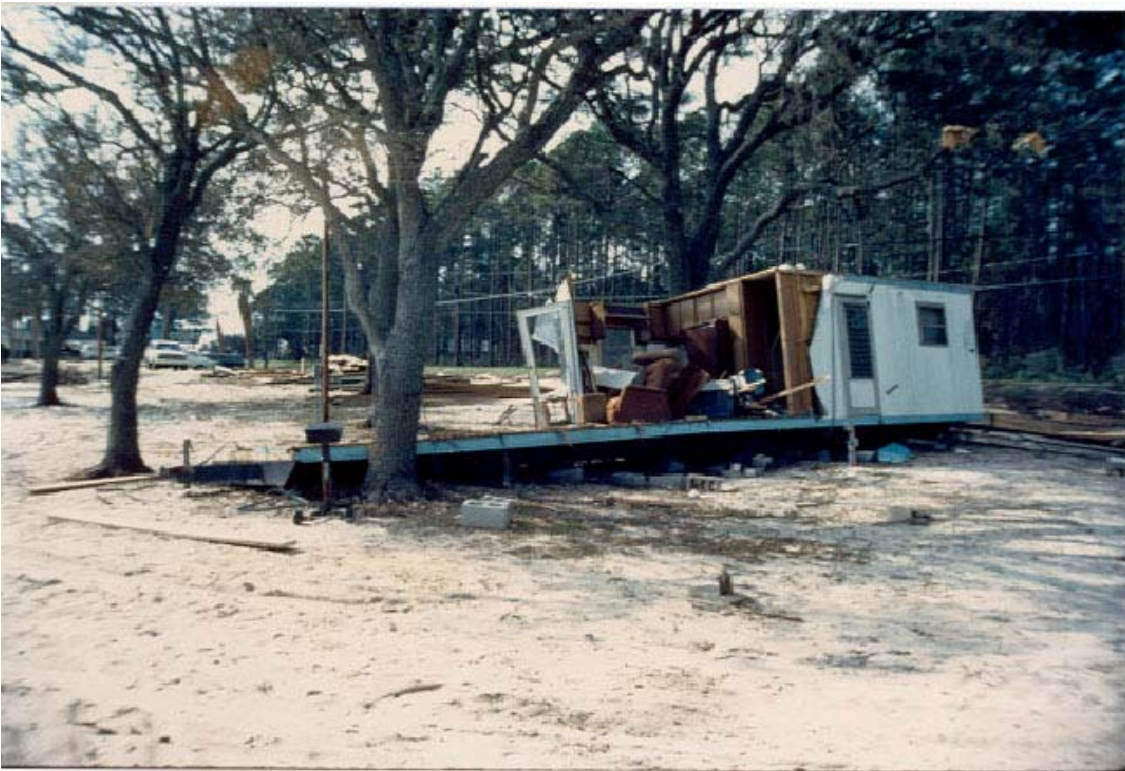
FIGURE 80. Mobile home east of Carrabelle destroyed by battering loads of waterborne debris from house destroyed on Dog Island.

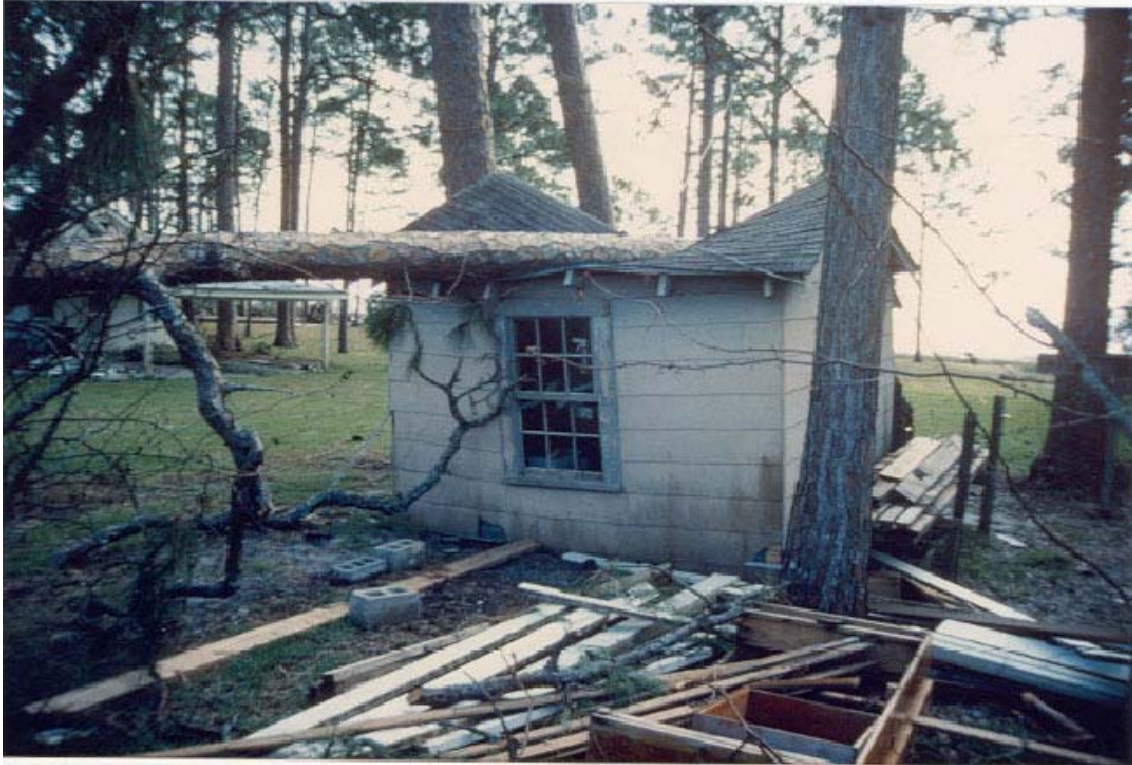
FIGURE 81. One of many fallen pines in St. James.

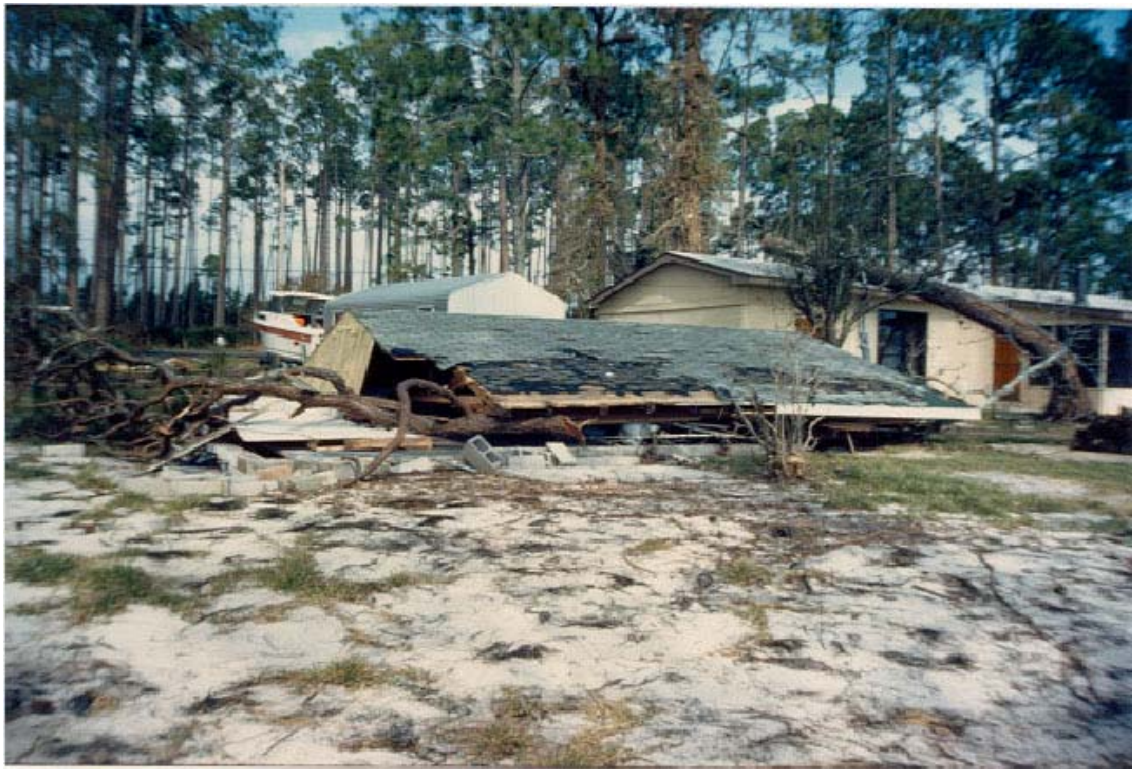
FIGURE 82. Wind and wave loads destroyed a St. James structure.

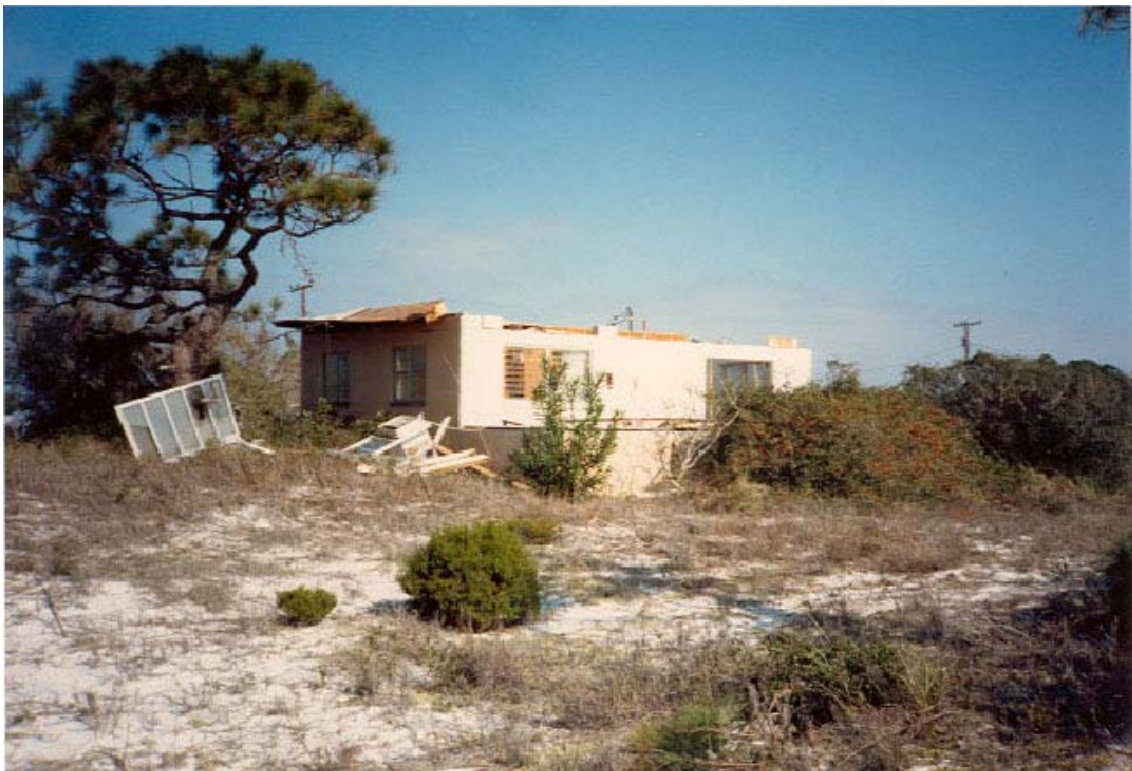
FIGURE 88. Flat roof blown off Alligator Point dwelling.

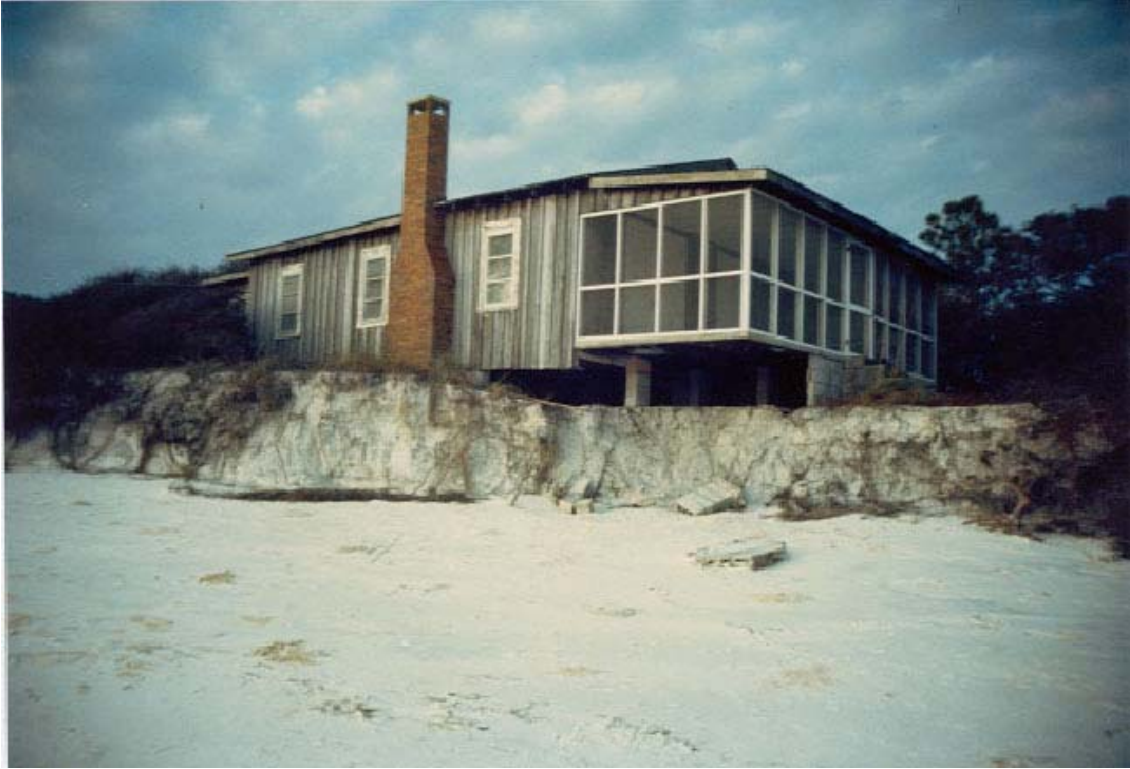
FIGURE 89. Southwest Cape dwelling partially undermined by Kate.

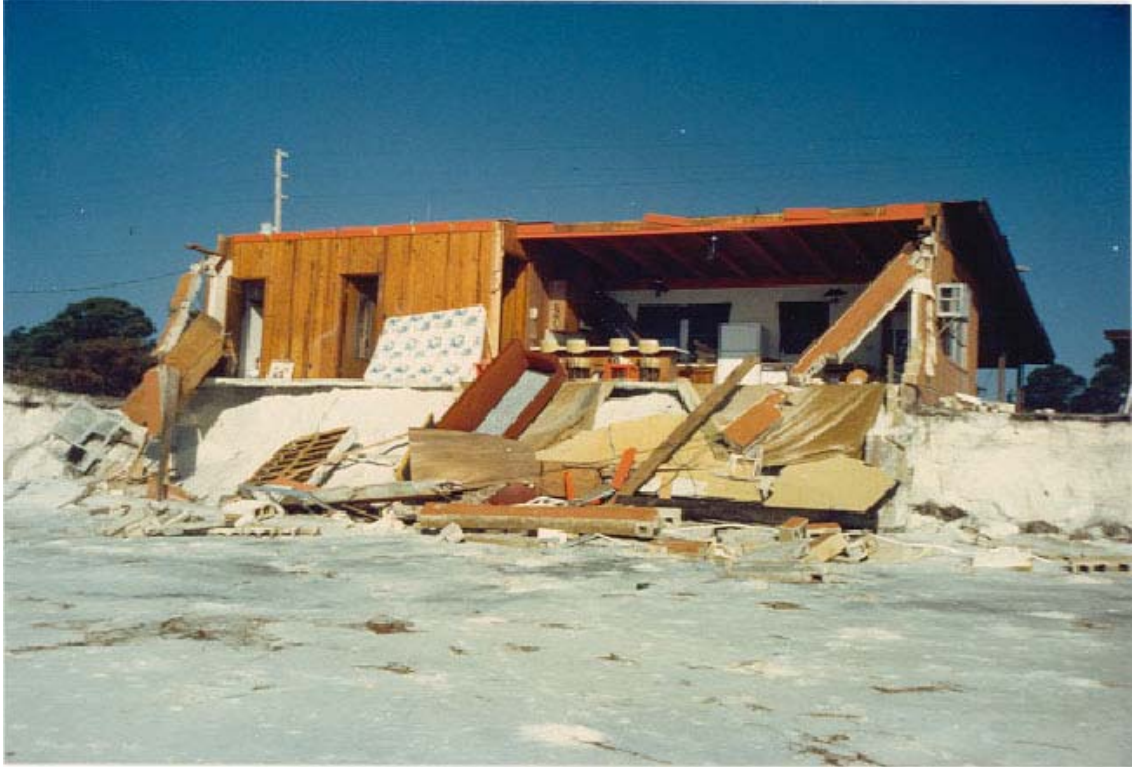
FIGURE 93. Slab-on-grade dwelling undermined and destroyed.

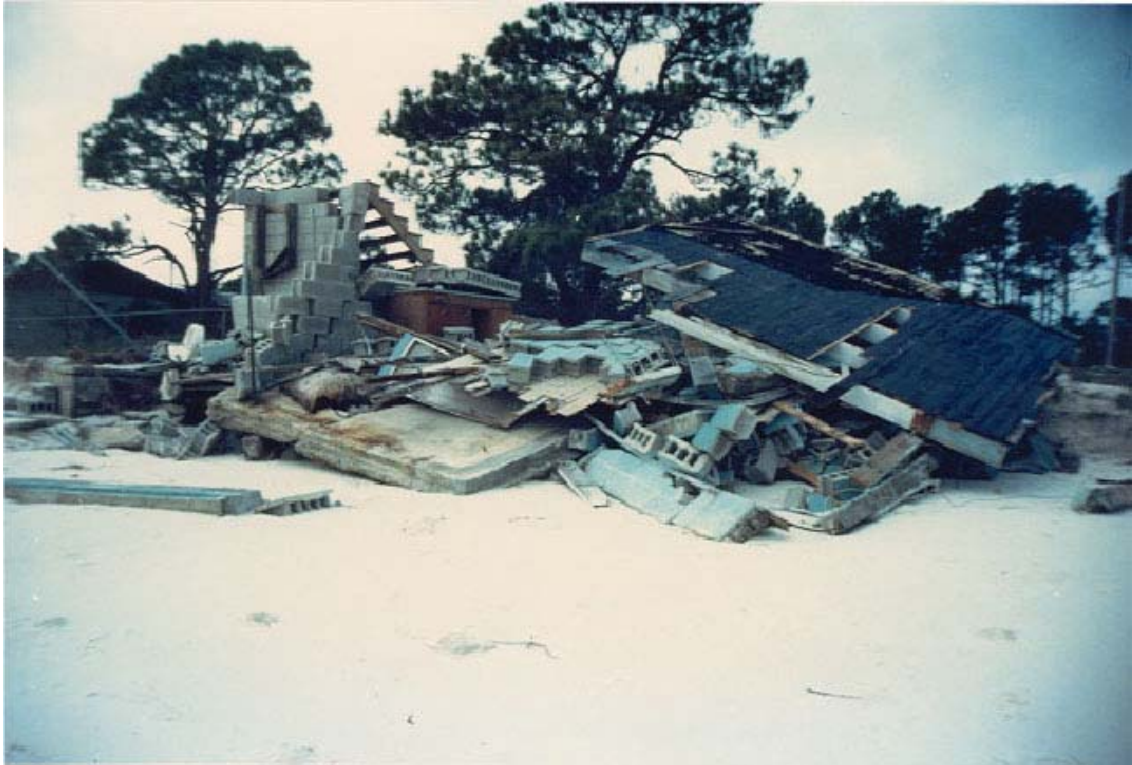
FIGURE 94. Concrete block dwelling destroyed by wave loads.

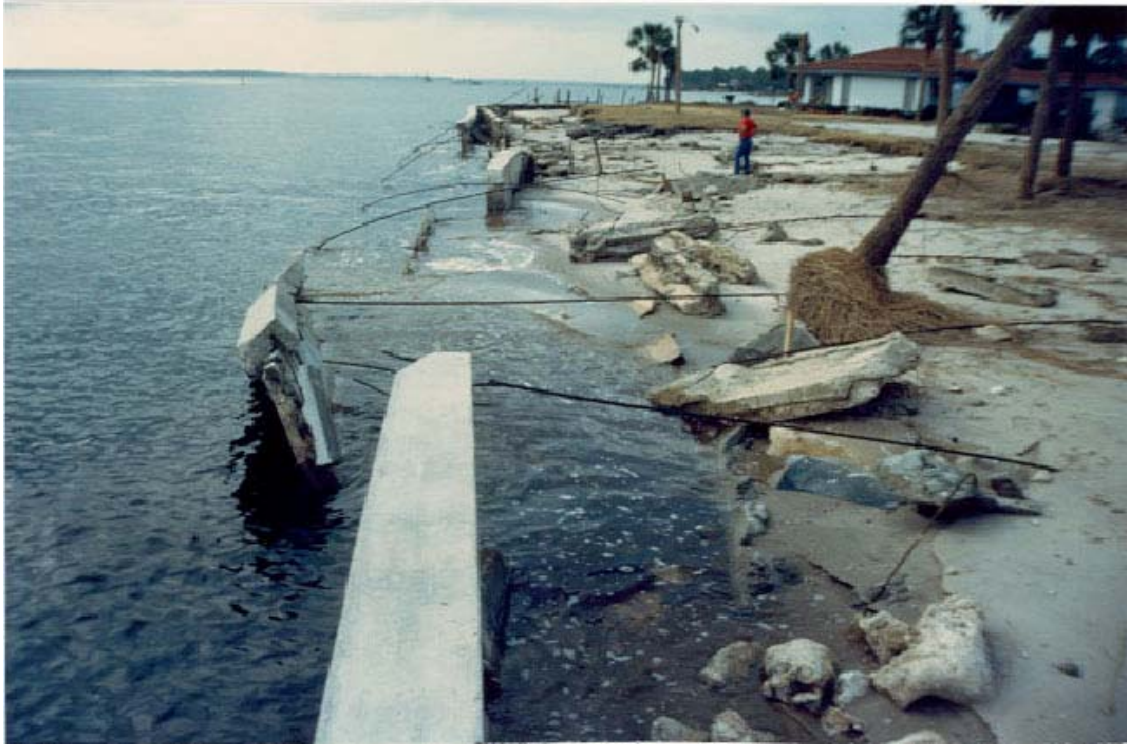
FIGURE 101. Bulkheads destroyed at Sunrise Lane on Ochlockonee Bay.

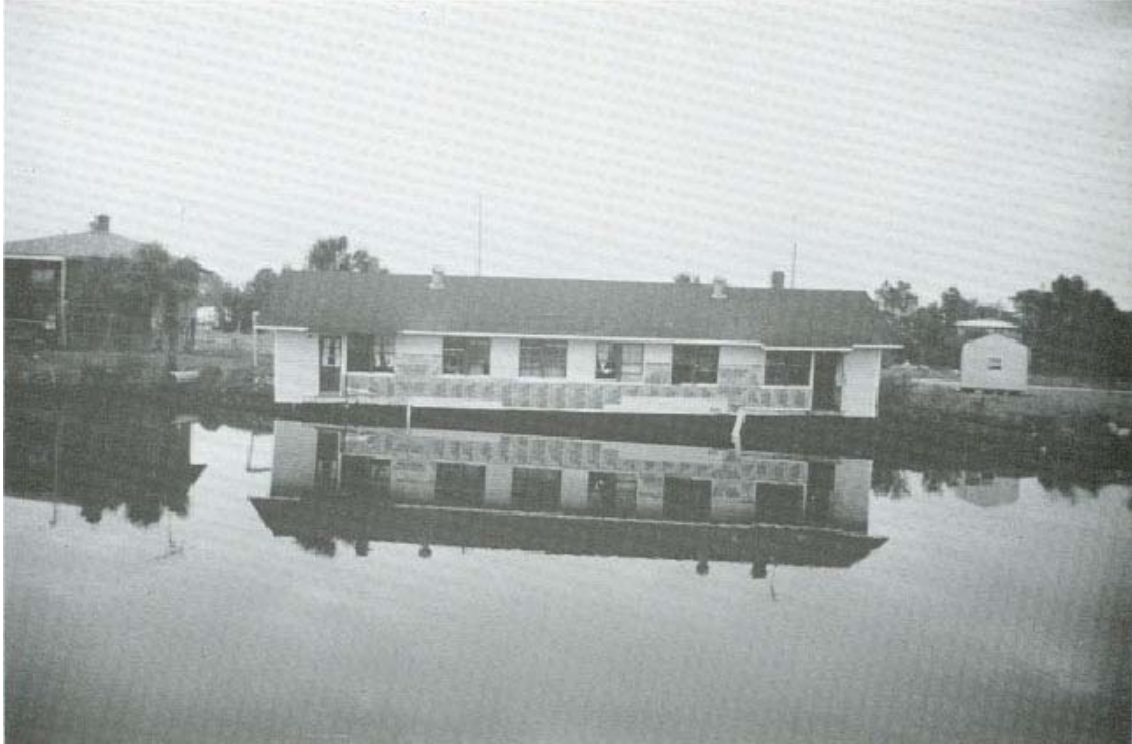
FIGURE 106. Oyster Bay dwelling was carried across the canal by flood waters and deposited on the opposite bank.

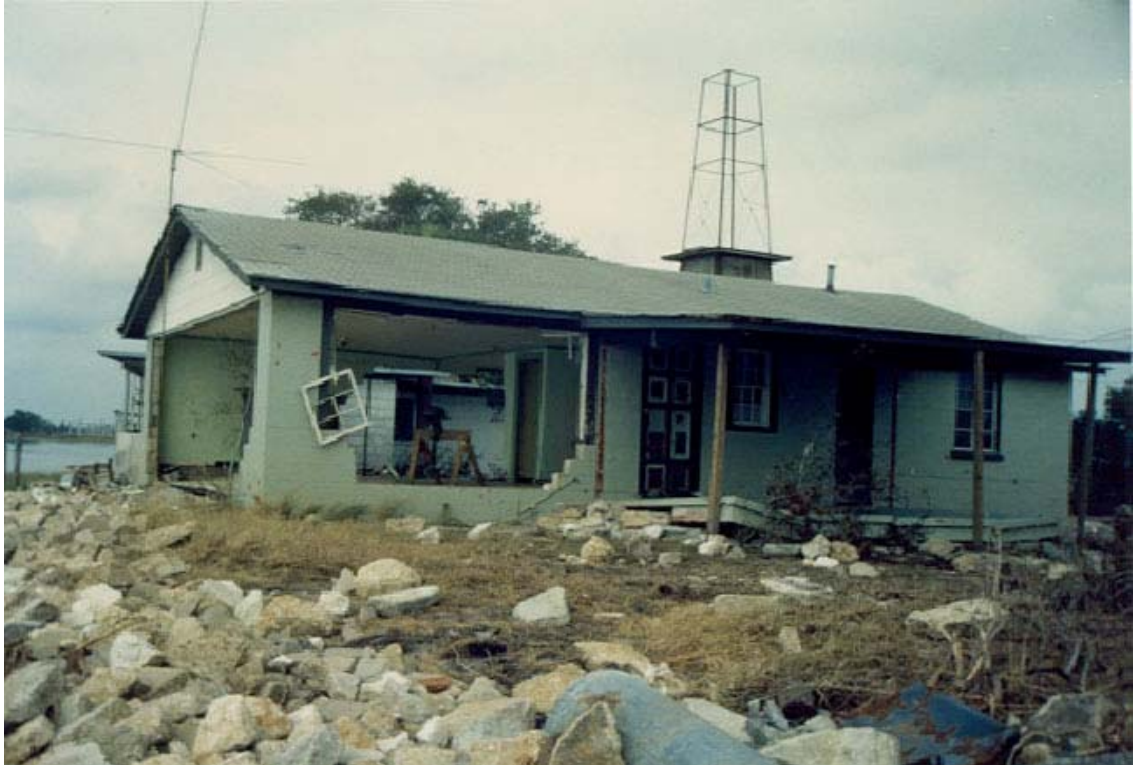
FIGURE 114. Dwelling destroyed at Walker Creek entrance.

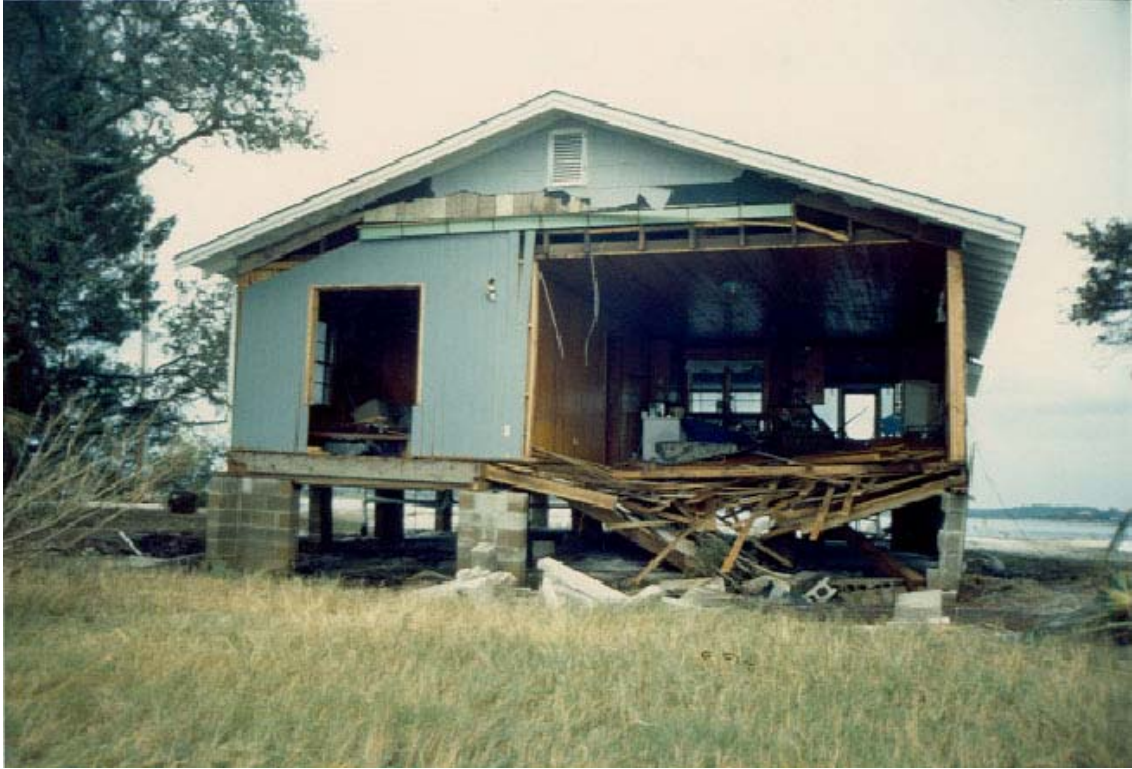
FIGURE 115. Frame dwelling on footings destroyed by wave loads.

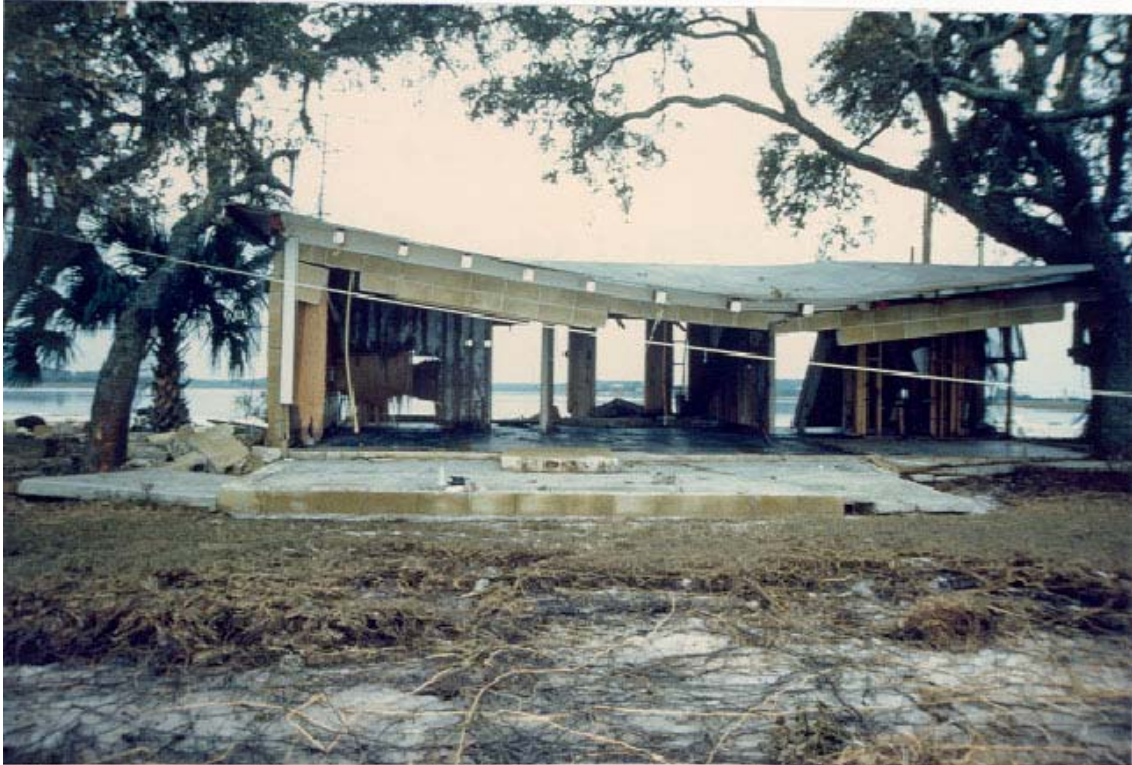
wave activity. The next three dwellings are wood frame structures on concrete block footings elevated about three feet above grade. The first two dwellings sustained heavy wave damage to their siding and footings and the third dwelling was substantially destroyed by wave impact loads to the walls, floor, and footings (Figure 115). Next door to the east, the seventh dwelling from the west end was a concrete block slab-on-grade structure which was destroyed by the storm tide and wave impact loads and was left standing as a frame skeleton with the roof miraculously hanging suspended (Figure 116).

FIGURE 116. Slab-on-grade dwelling gutted by the waves and flooding.

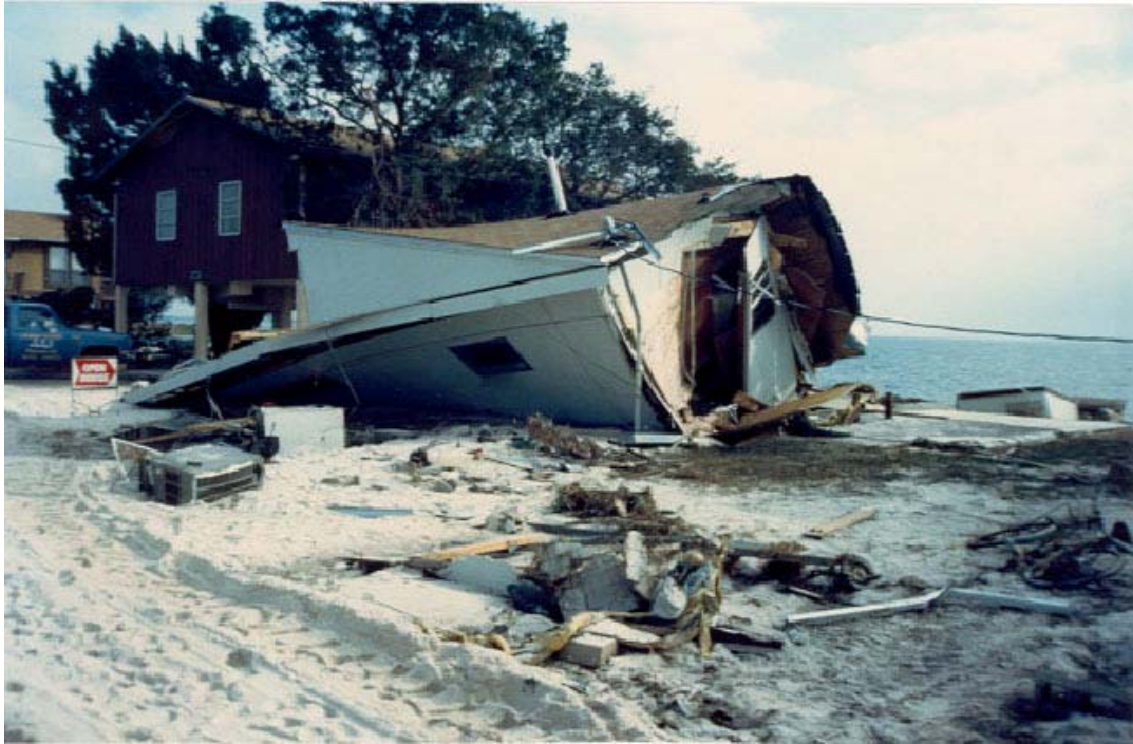
FIGURE 117. Grade level frame dwelling destroyed by waves.

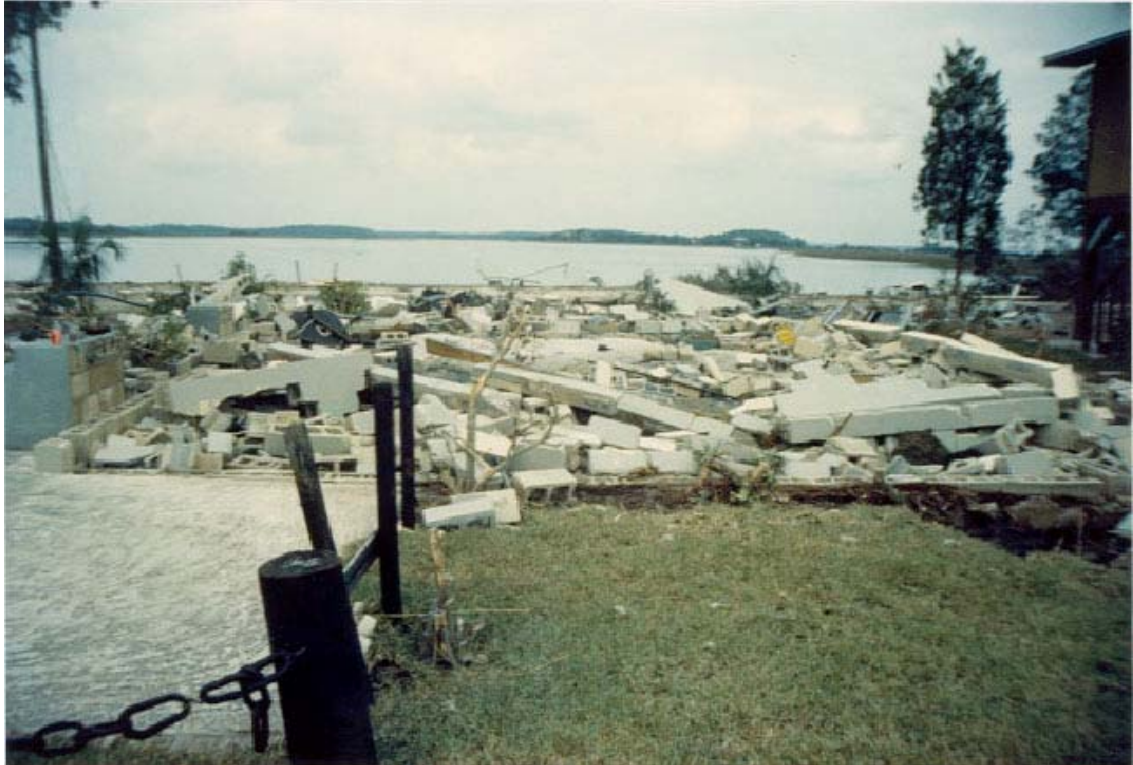
FIGURE 118. Concrete block dwelling pulverized by wave activity.
