Hurricane Kate

November 15-23, 1985

Department of Natural Resources
Division of Beaches and Shores
Post Storm Report No. 86-1
September, 1986
By Ralph Clark

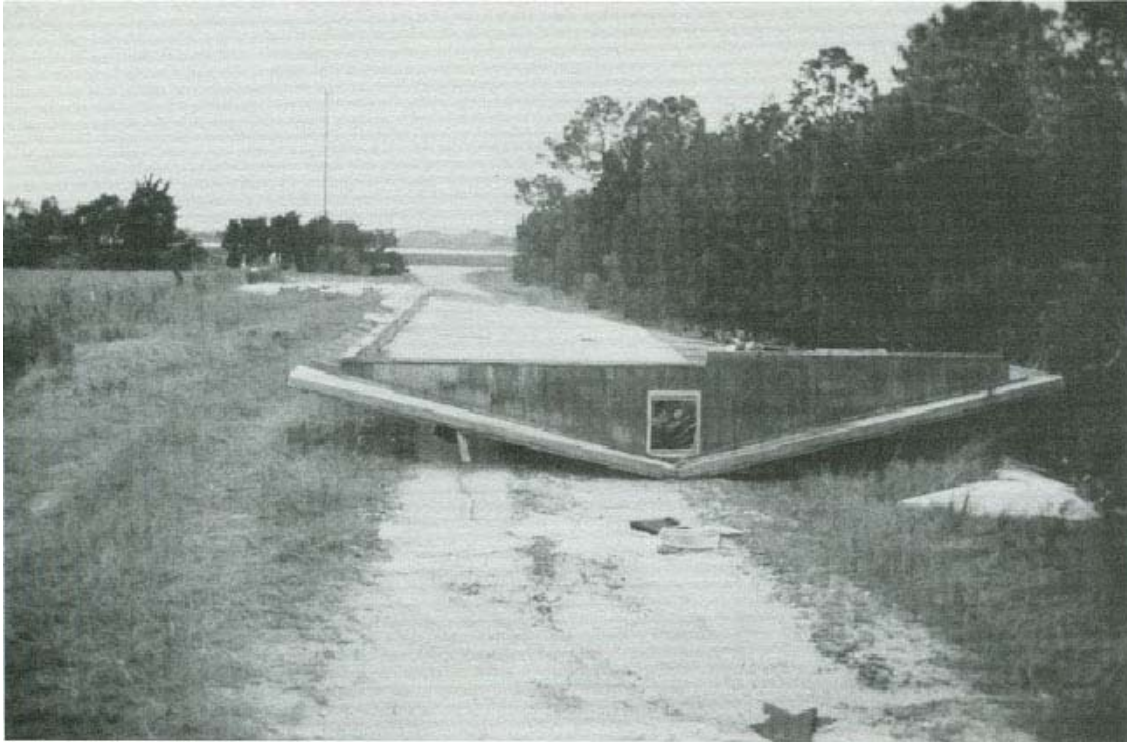
dwelling was deposited about 700 feet inland in a wetland marsh. The dwelling's roof was deposited 1,000 feet inland virtually in one piece on an access road to the east shoreline (Figure 121). In contrast to the dwelling in the West Point Subdivision which disappeared without a trace leaving upright foundation piles, this dwelling's foundation, utility pole, and shrubbery were all pushed over or completely removed (Figure 122). The dwelling to the east sustained only minor roofing damage and the pile supported mobile home with a large roofed screen porch to the west sustained no apparent damage. This lack of adjacent damage suggests the localized impact was the result of a tornado in lieu of a downburst

FIGURE 121. The roof was blown 1,000 feet inland and deposited in one piece on an access road.
