## **Appendix X**

SBEACH 15 and 25 yr. Storm Erosion Profiles

Indian River County

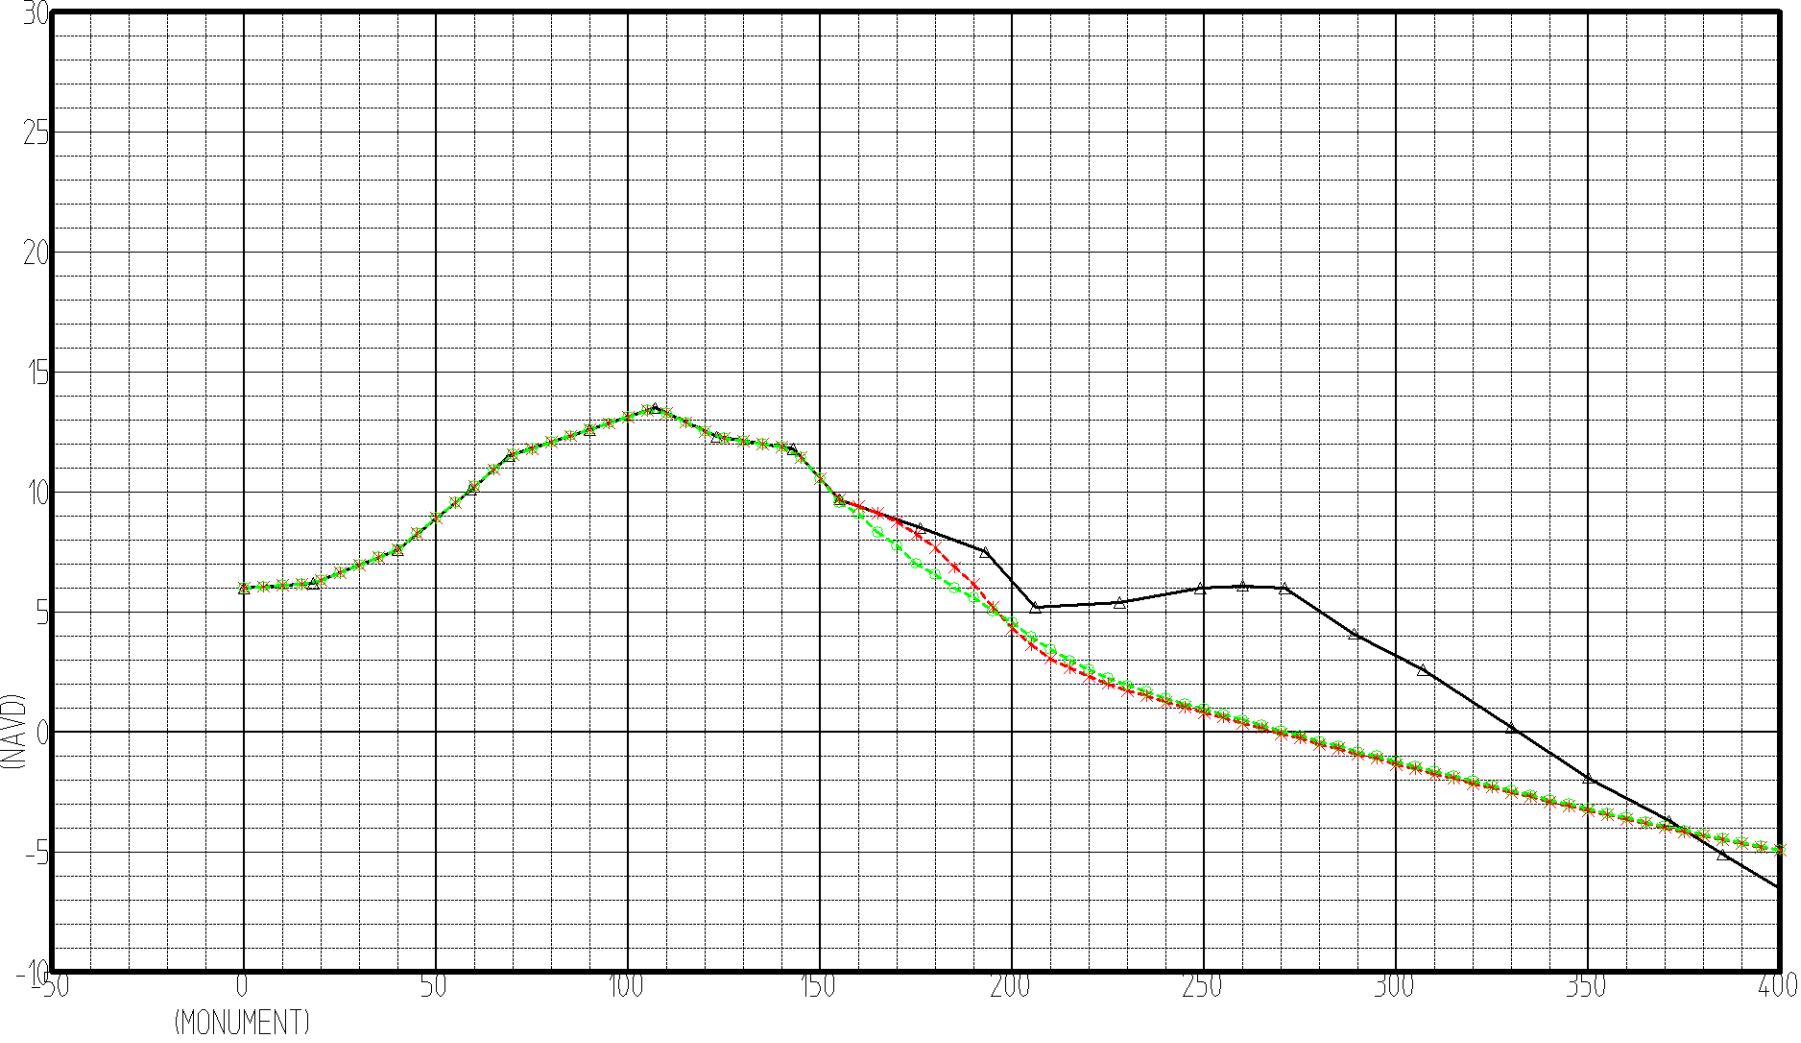
Range: R-1

BEACH PROFILE

—△—△— 2008-08 Indian River

- - - \* - - - 15YR SBEACH ERODED

- - - o - - - 25YR SBEACH ERODED

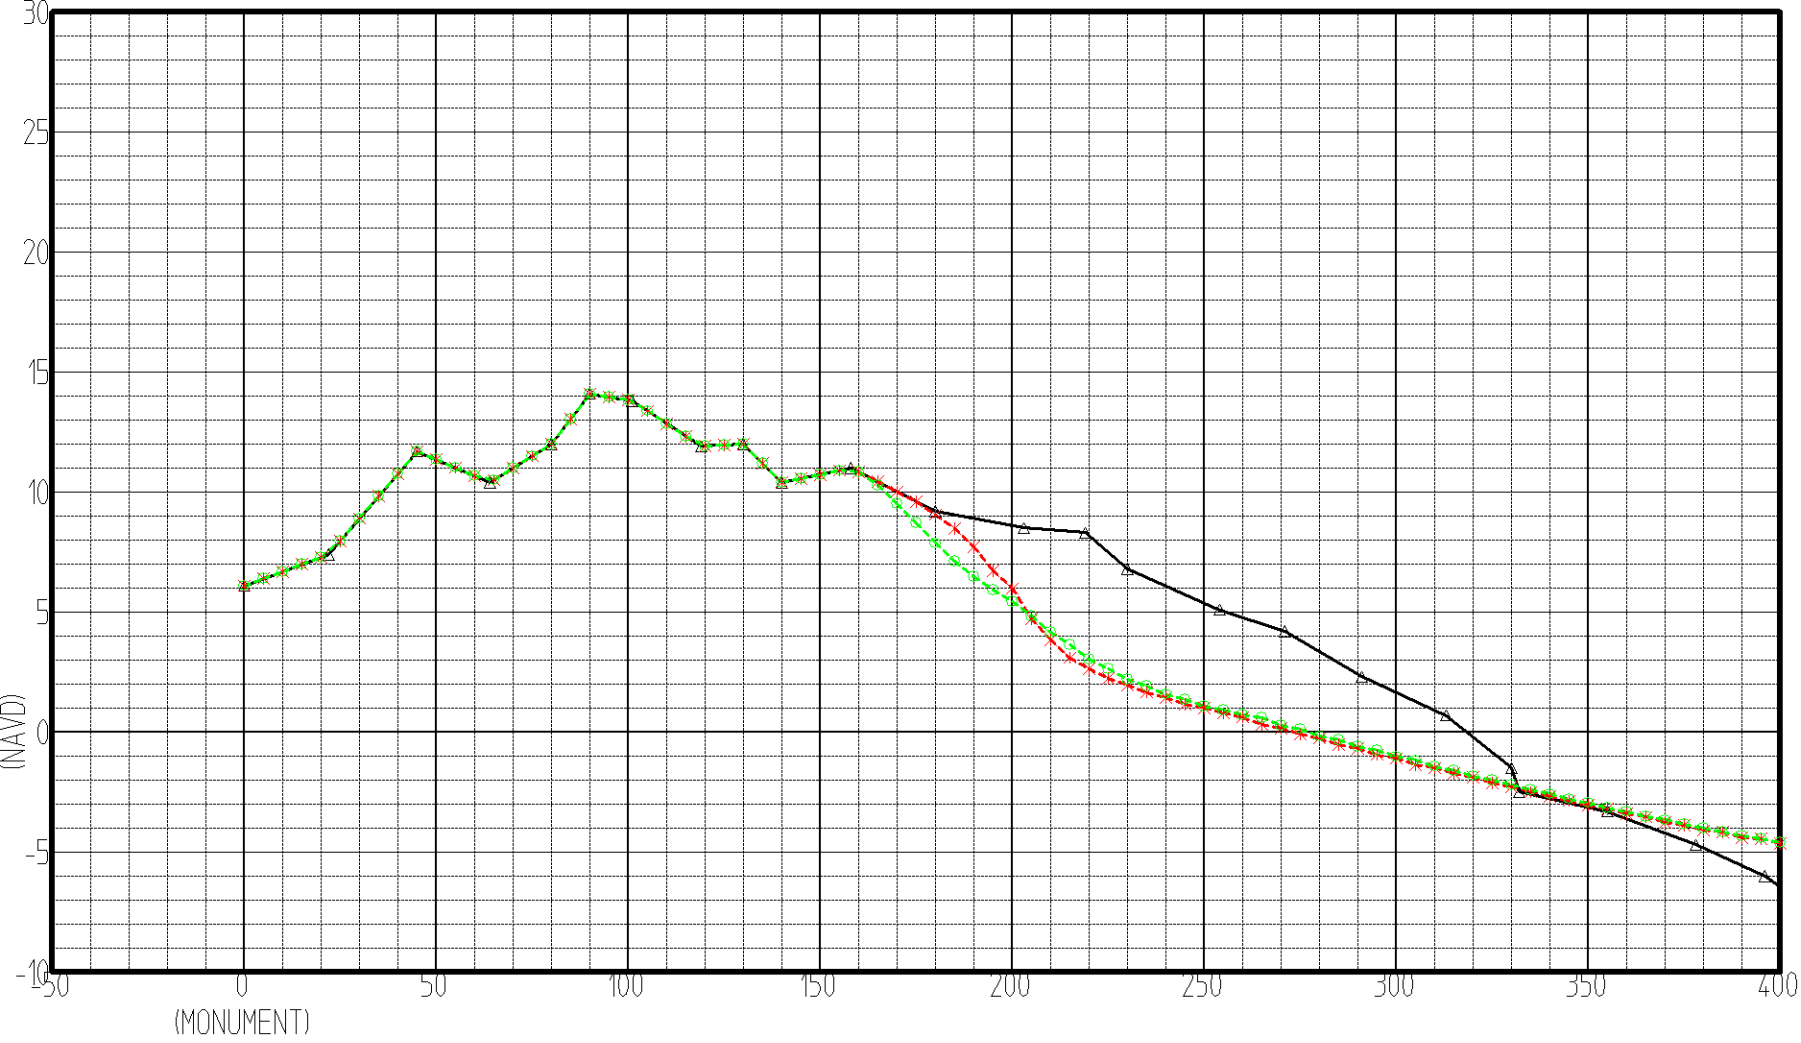
Range: R-2  
 BEARING: 70.00  
 1/2

BEACH PROFILE  
 —△—△— 2008-08 Indian River  
 - - \* - - 15YR SBEACH ERODED  
 - - o - - 25YR SBEACH ERODED

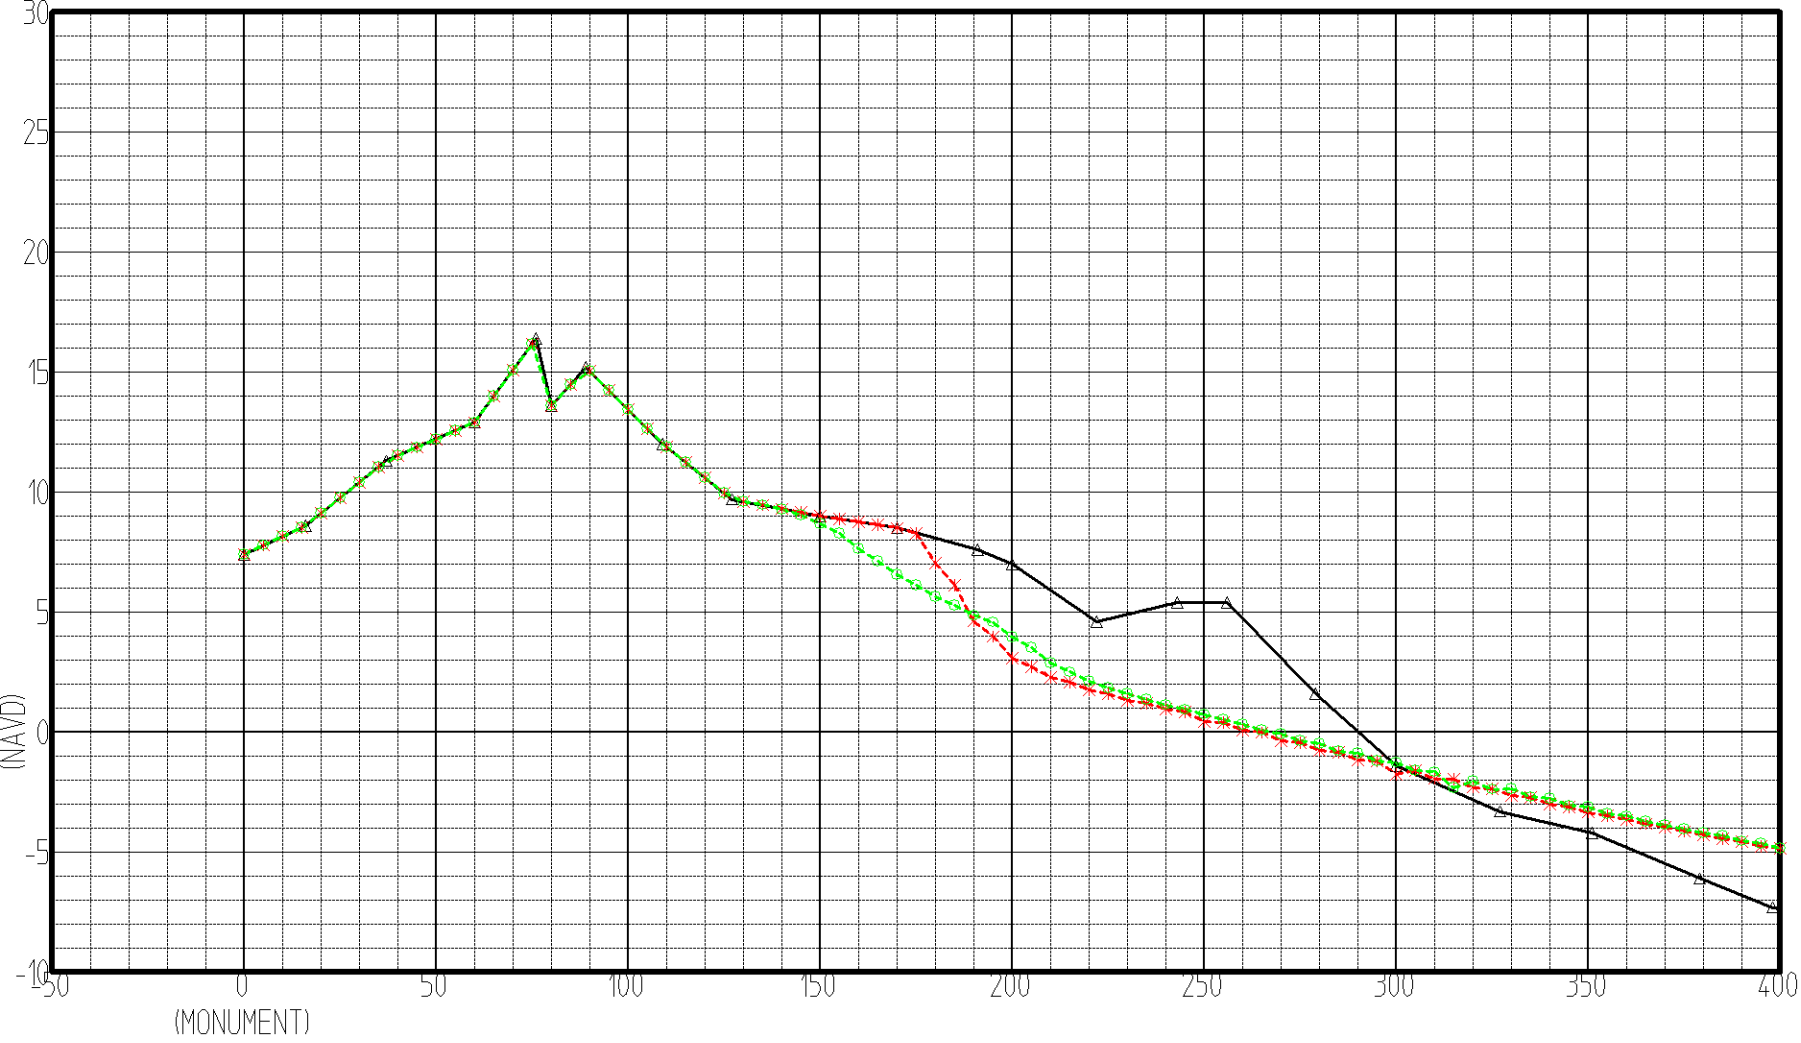
Range: R-3

BEACH PROFILE

—△—△— 2008-08 Indian River

- - - \* - - - 15YR SBEACH ERODED

- - - o - - - 25YR SBEACH ERODED

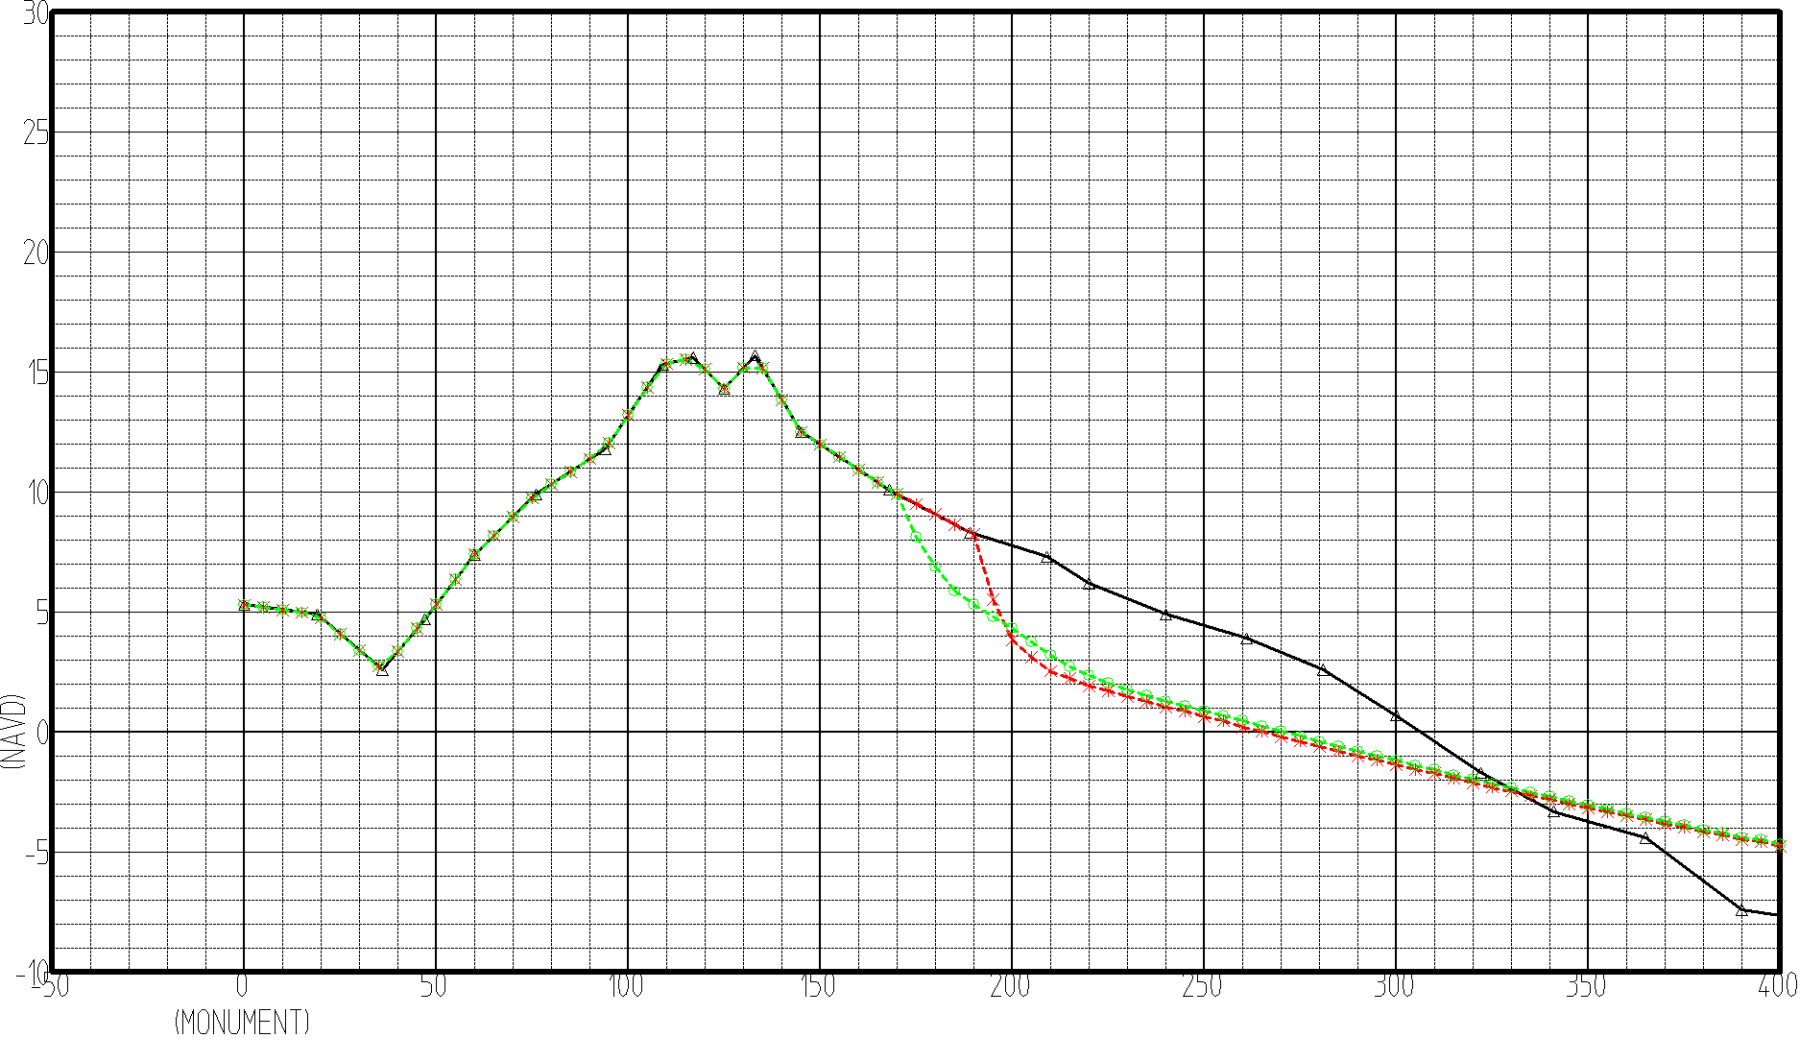
Range: R-4

BEACH PROFILE

—△—△— 2008-08 Indian River

- - - \* - - - 15YR SBEACH ERODED

- - - o - - - 25YR SBEACH ERODED

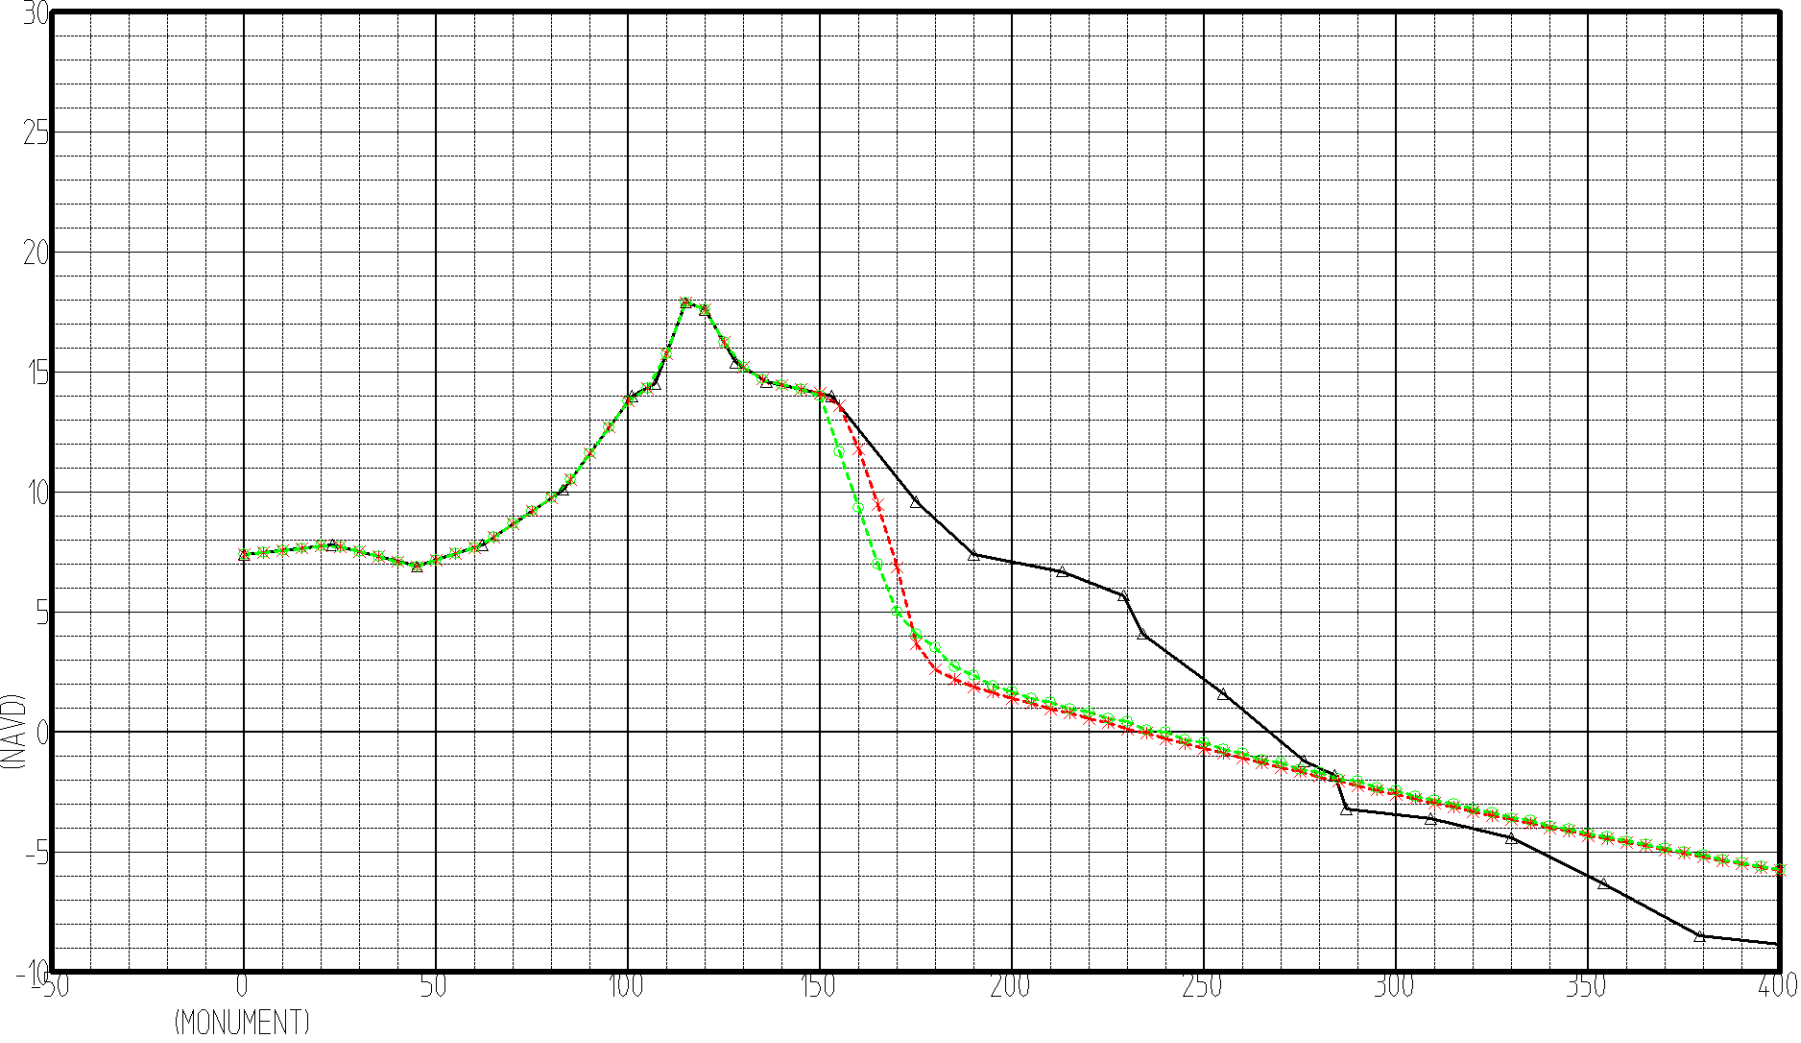
Range: R-5  
 BEARING: 70.00  
 1/2

BEACH PROFILE  
 —△—△— 2008-08 Indian River  
 - - \* - - 15YR SBEACH ERODED  
 - - o - - 25YR SBEACH ERODED

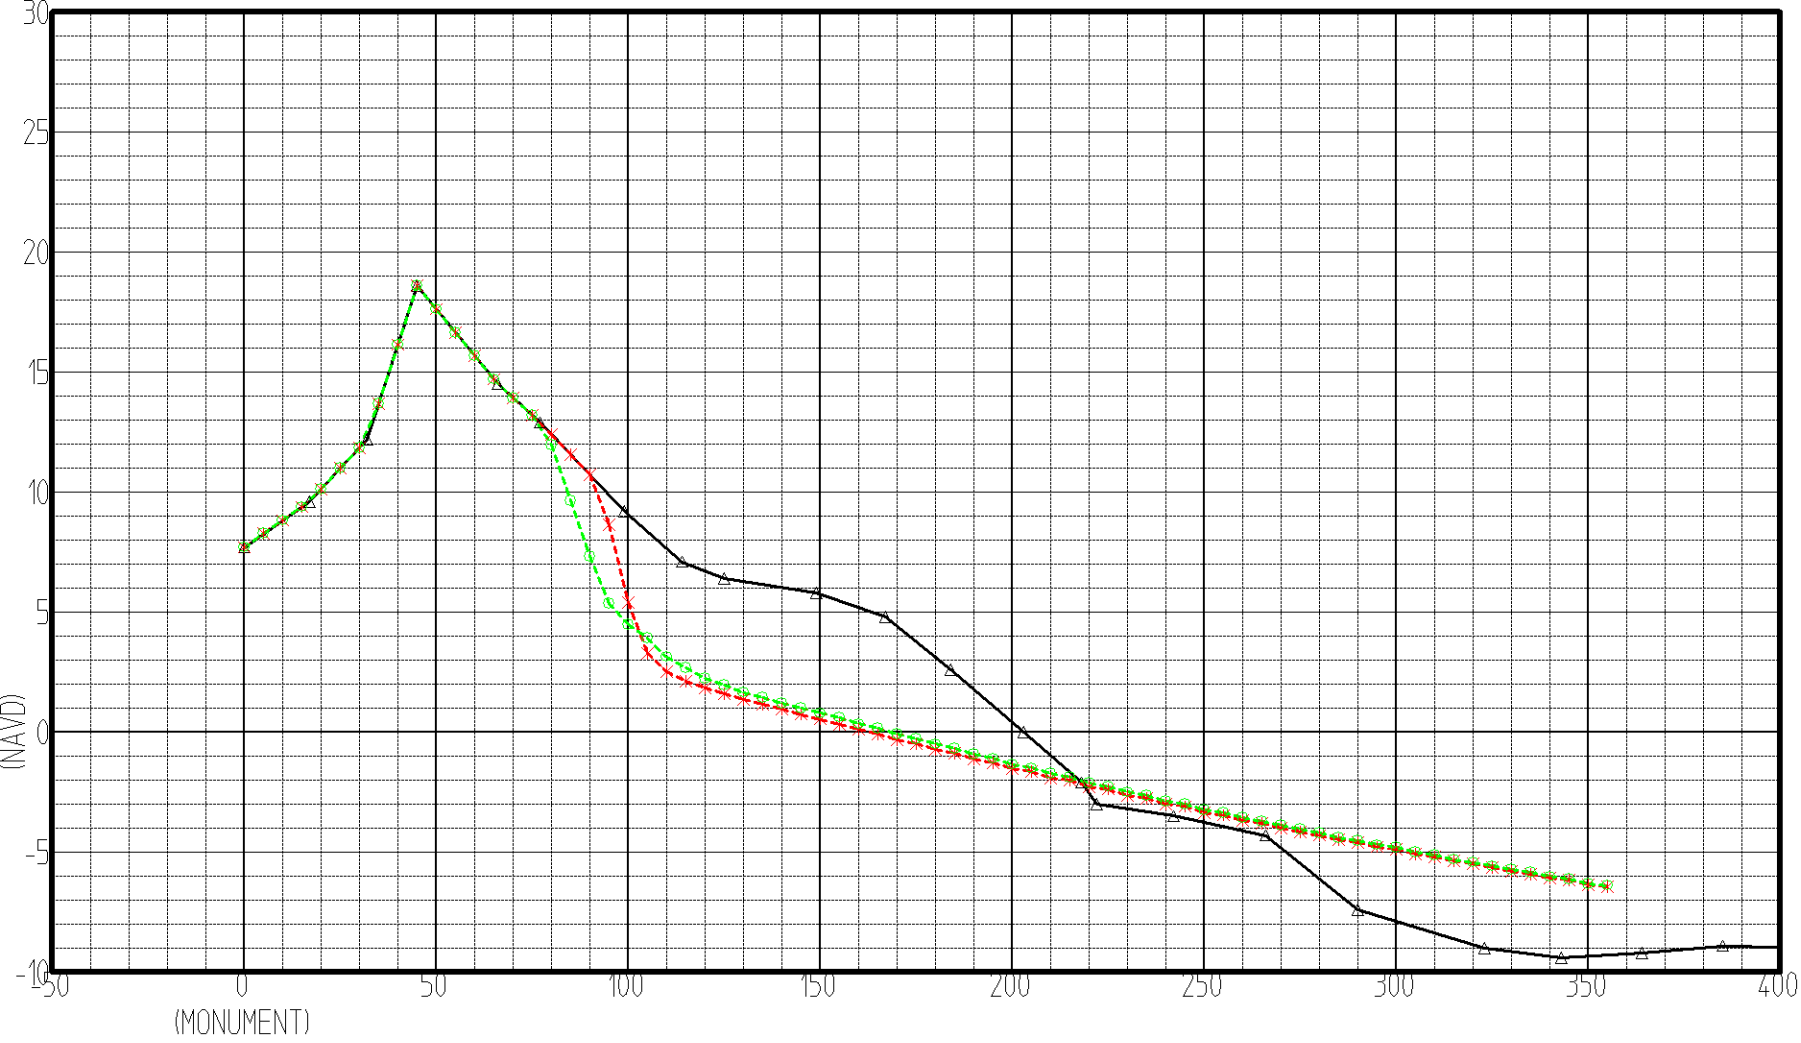
Range: R-6

BEACH PROFILE

- △—△— 2008-08 Indian River
- - - \* - - - 15YR SBEACH ERODED
- - - o - - - 25YR SBEACH ERODED

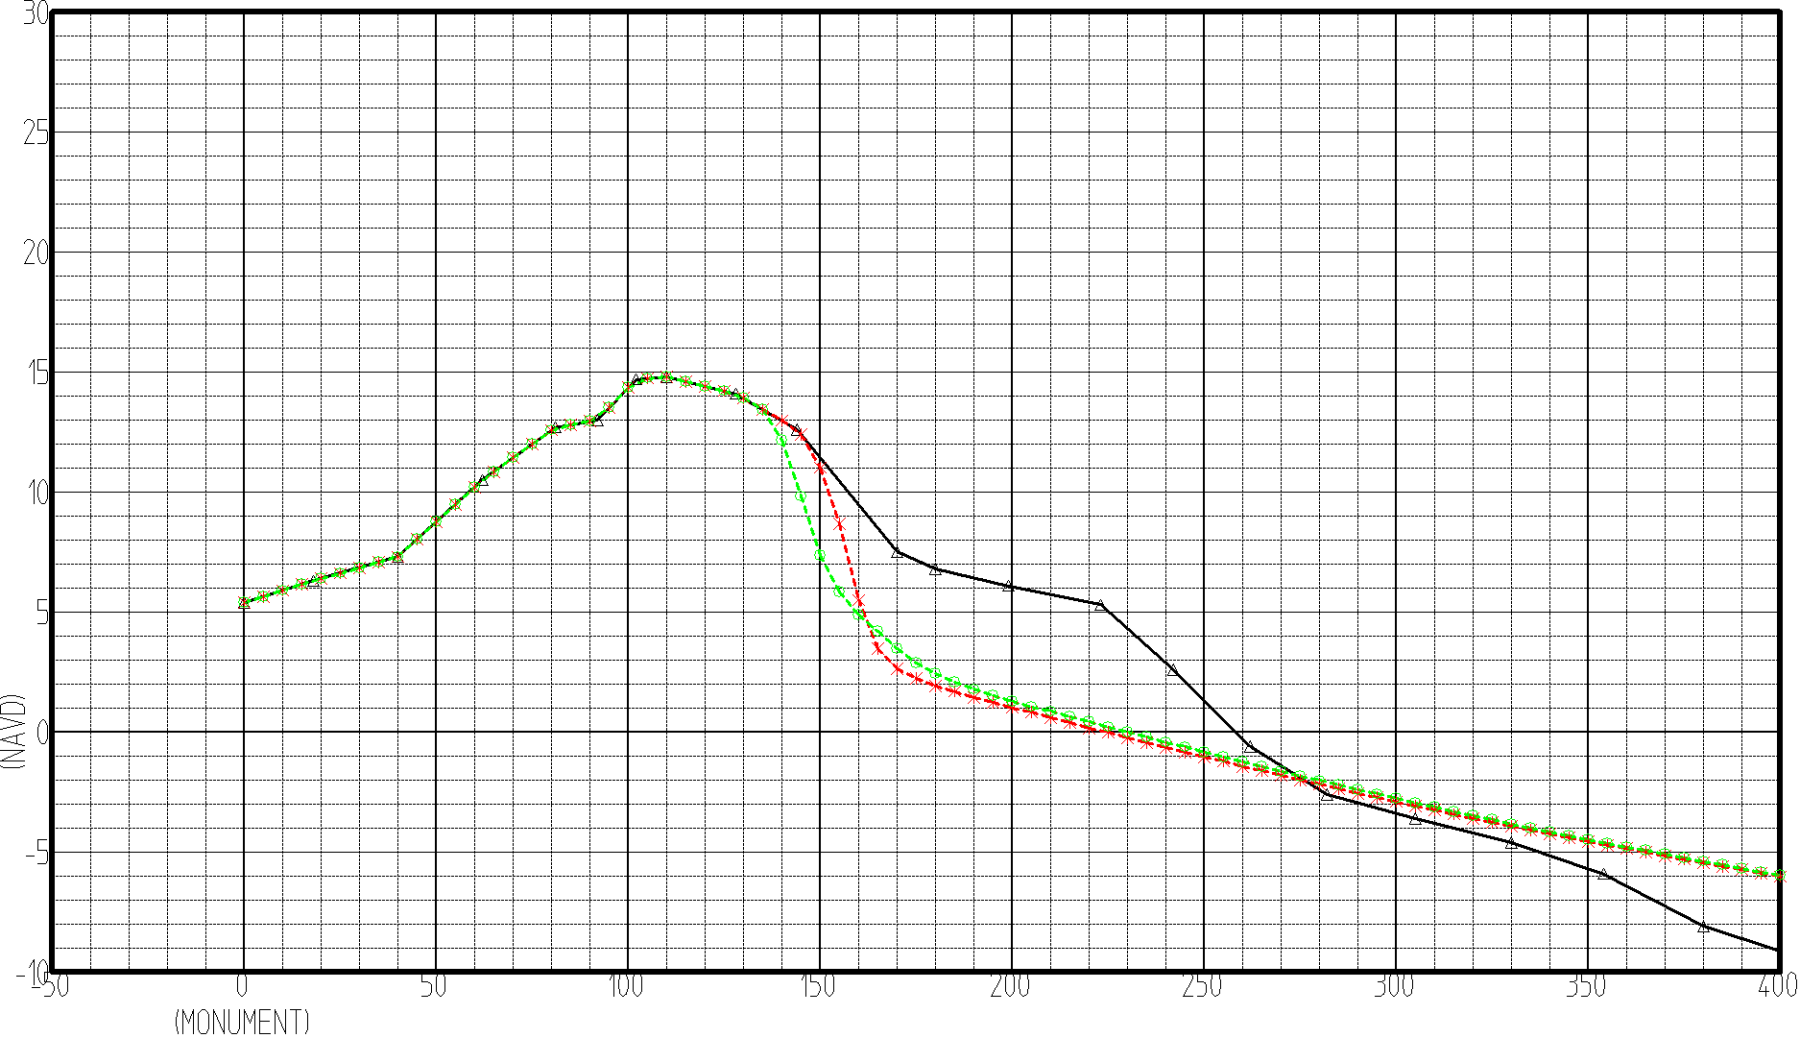
Range: R-7

BEACH PROFILE

—△—△— 2008-08 Indian River

- - - \* - - - 15YR SBEACH ERODED

- - - o - - - 25YR SBEACH ERODED

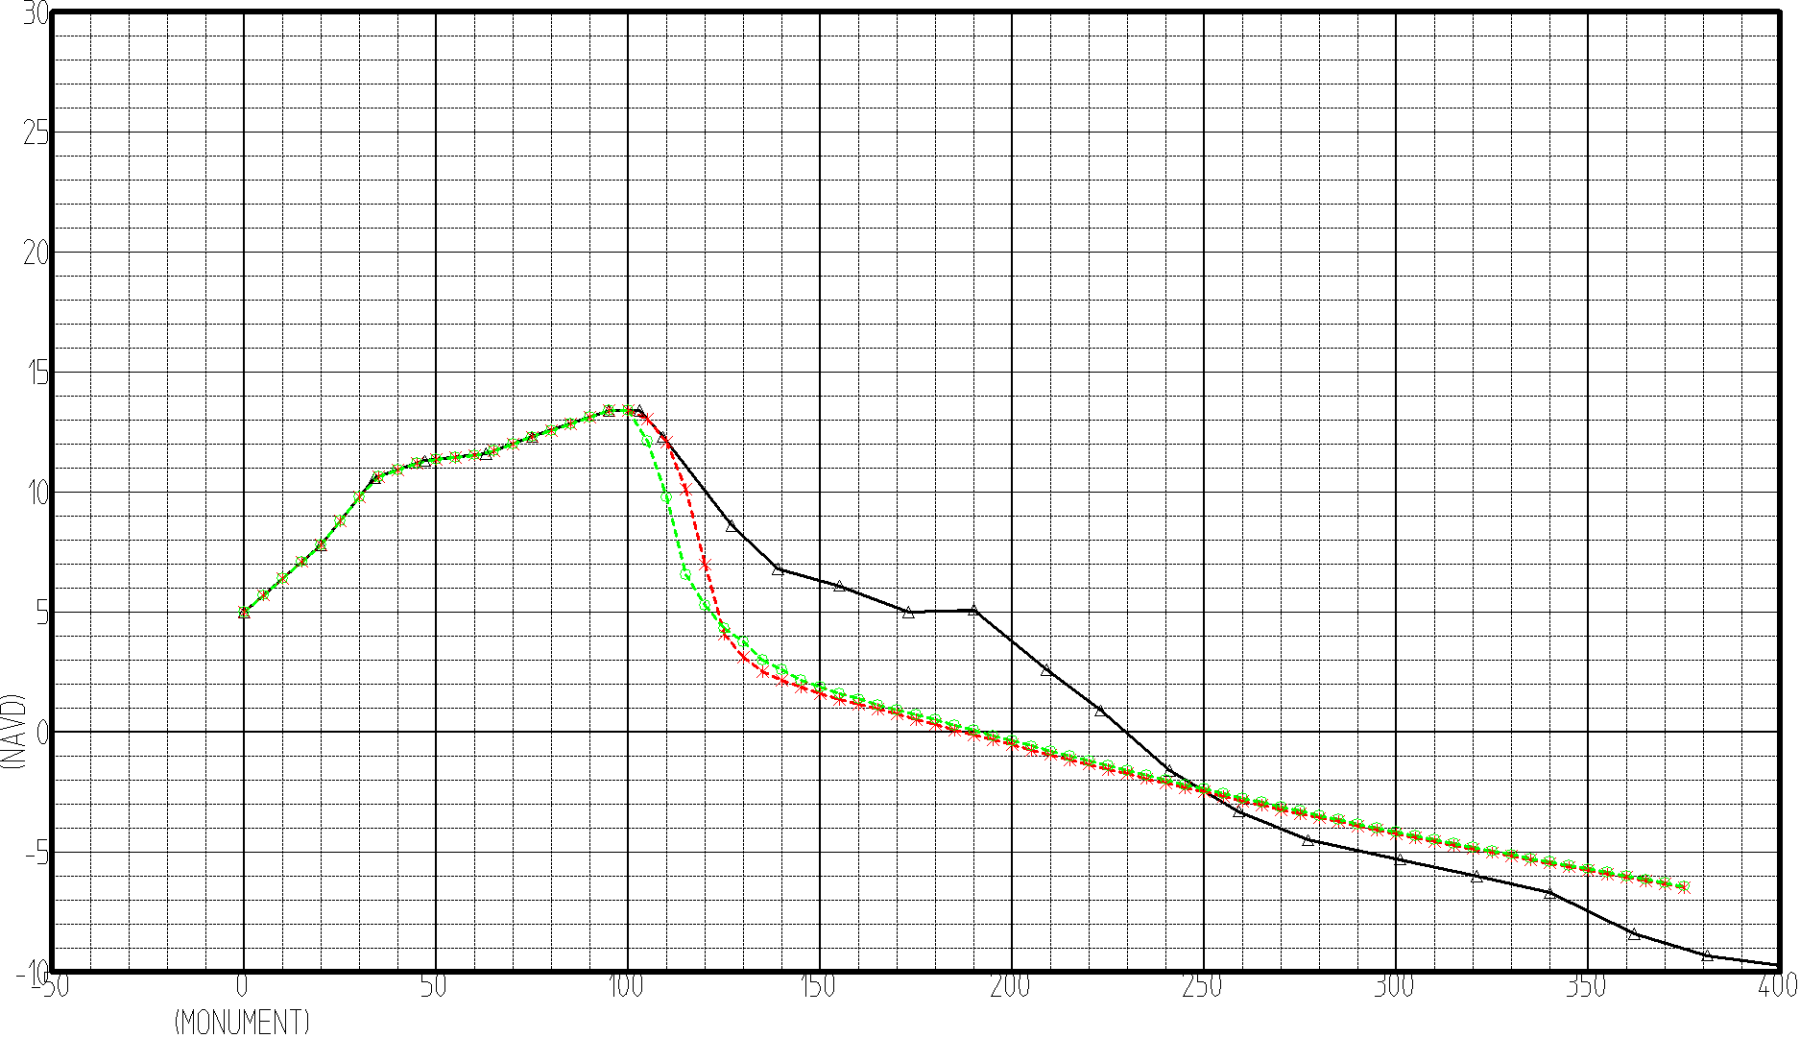
Range: R-8

BEACH PROFILE

—△—△— 2008-08 Indian River

- - - \* - - - 15YR SBEACH ERODED

- - - o - - - 25YR SBEACH ERODED

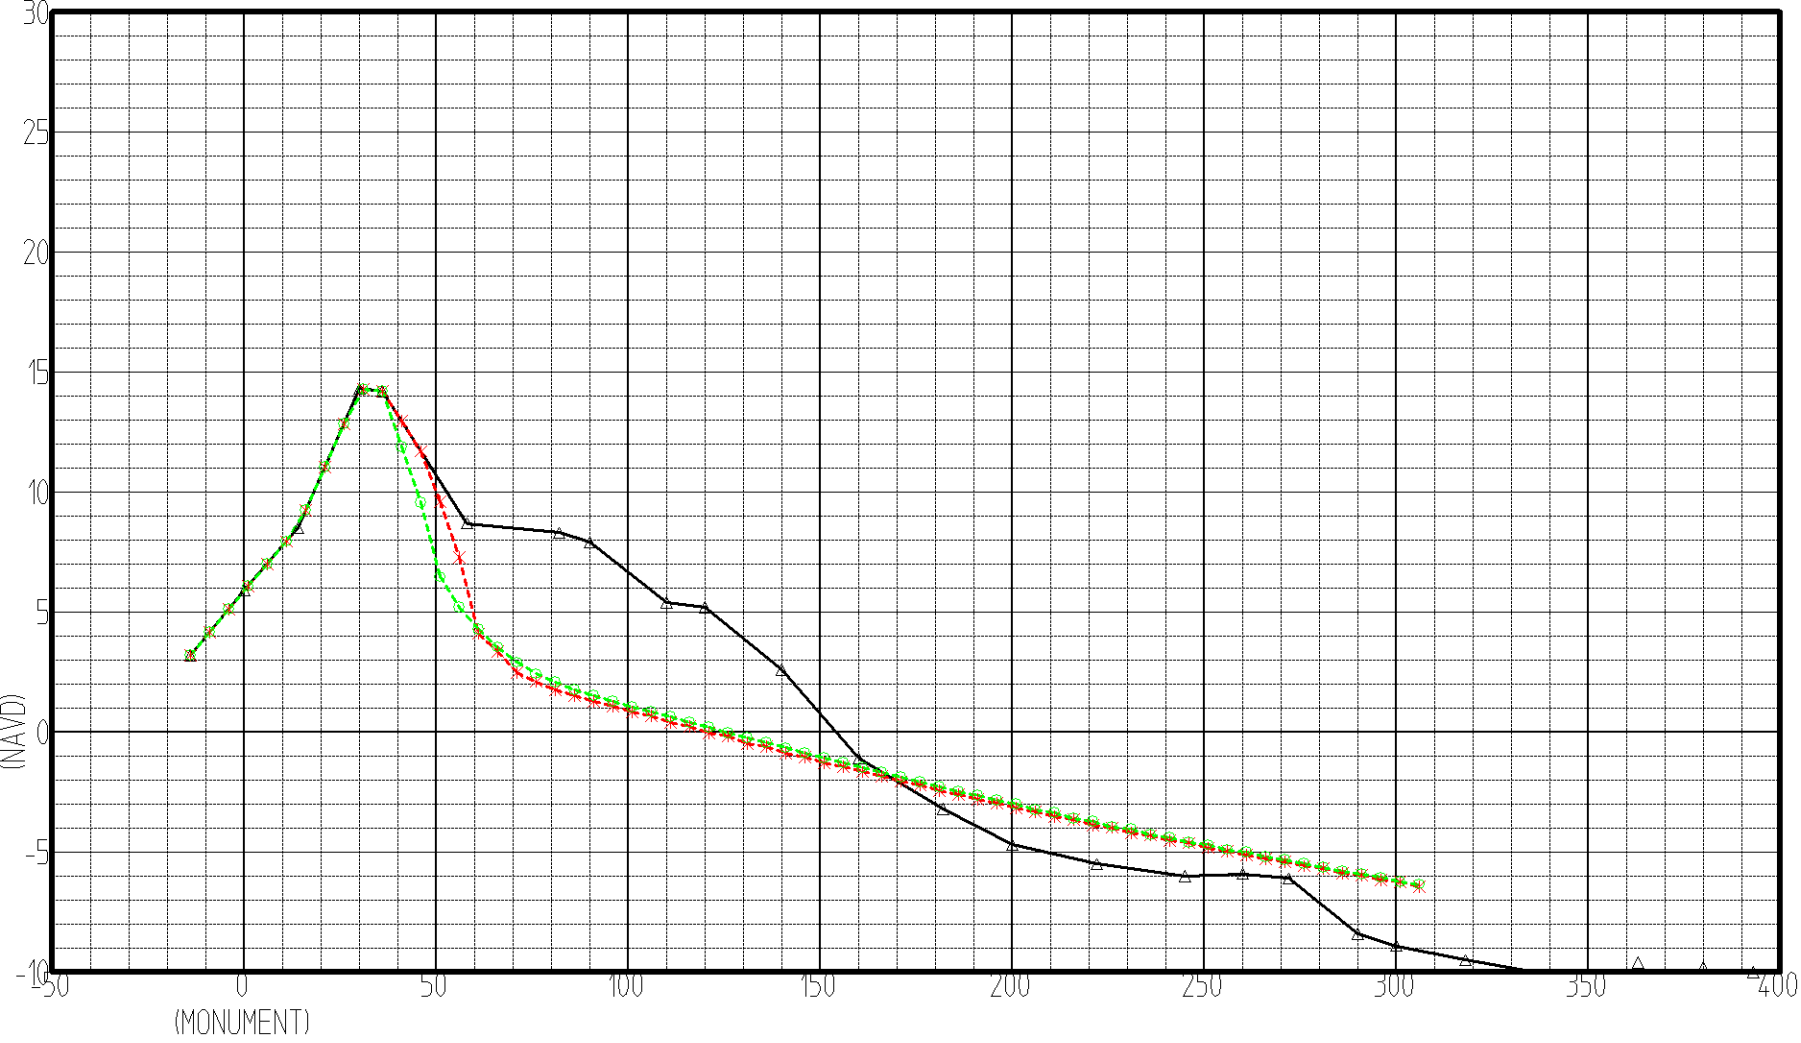
Range: R-9 1/1

BEACH PROFILE

- △—△— 2008-08 Indian River
- - - \* - - - 15YR SBEACH ERODED
- - - o - - - 25YR SBEACH ERODED

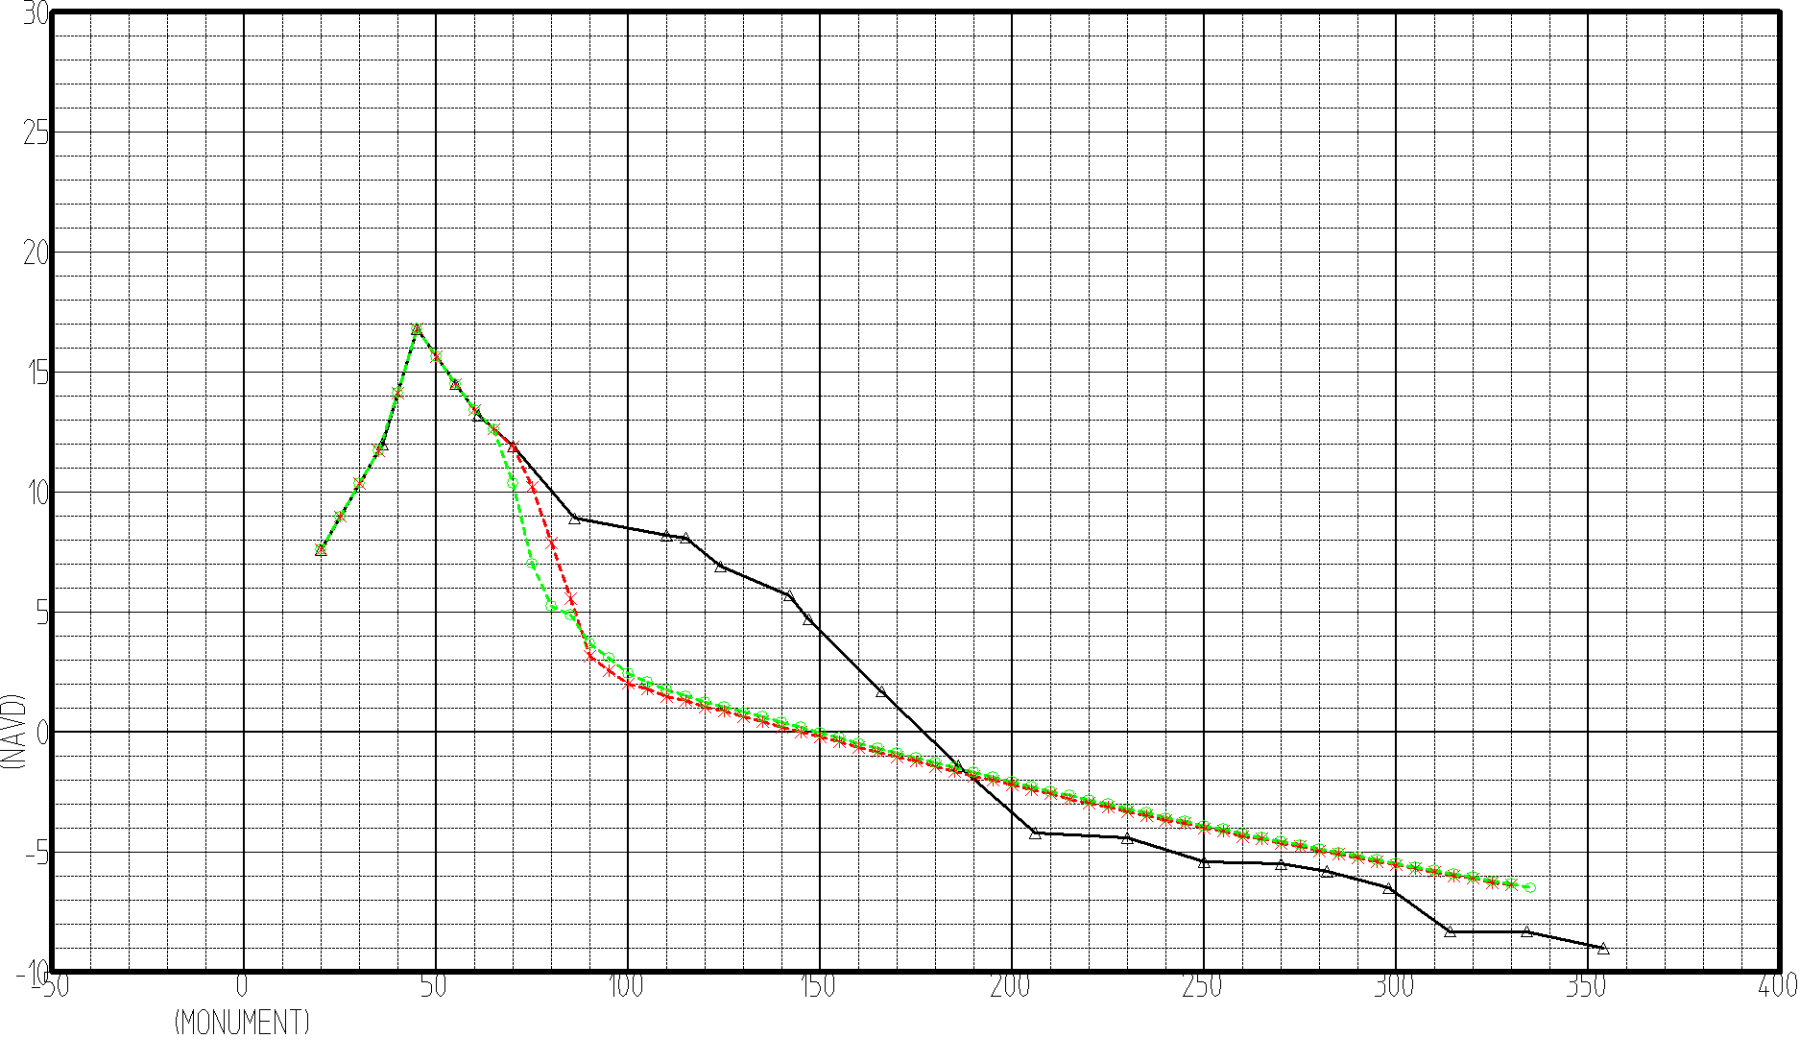
Range: R-10  
 BEARING: 70.00  
 1/1

BEACH PROFILE  
 —△—△— 2008-08 Indian River  
 - - \* - - 15YR SBEACH ERODED  
 - - o - - 25YR SBEACH ERODED

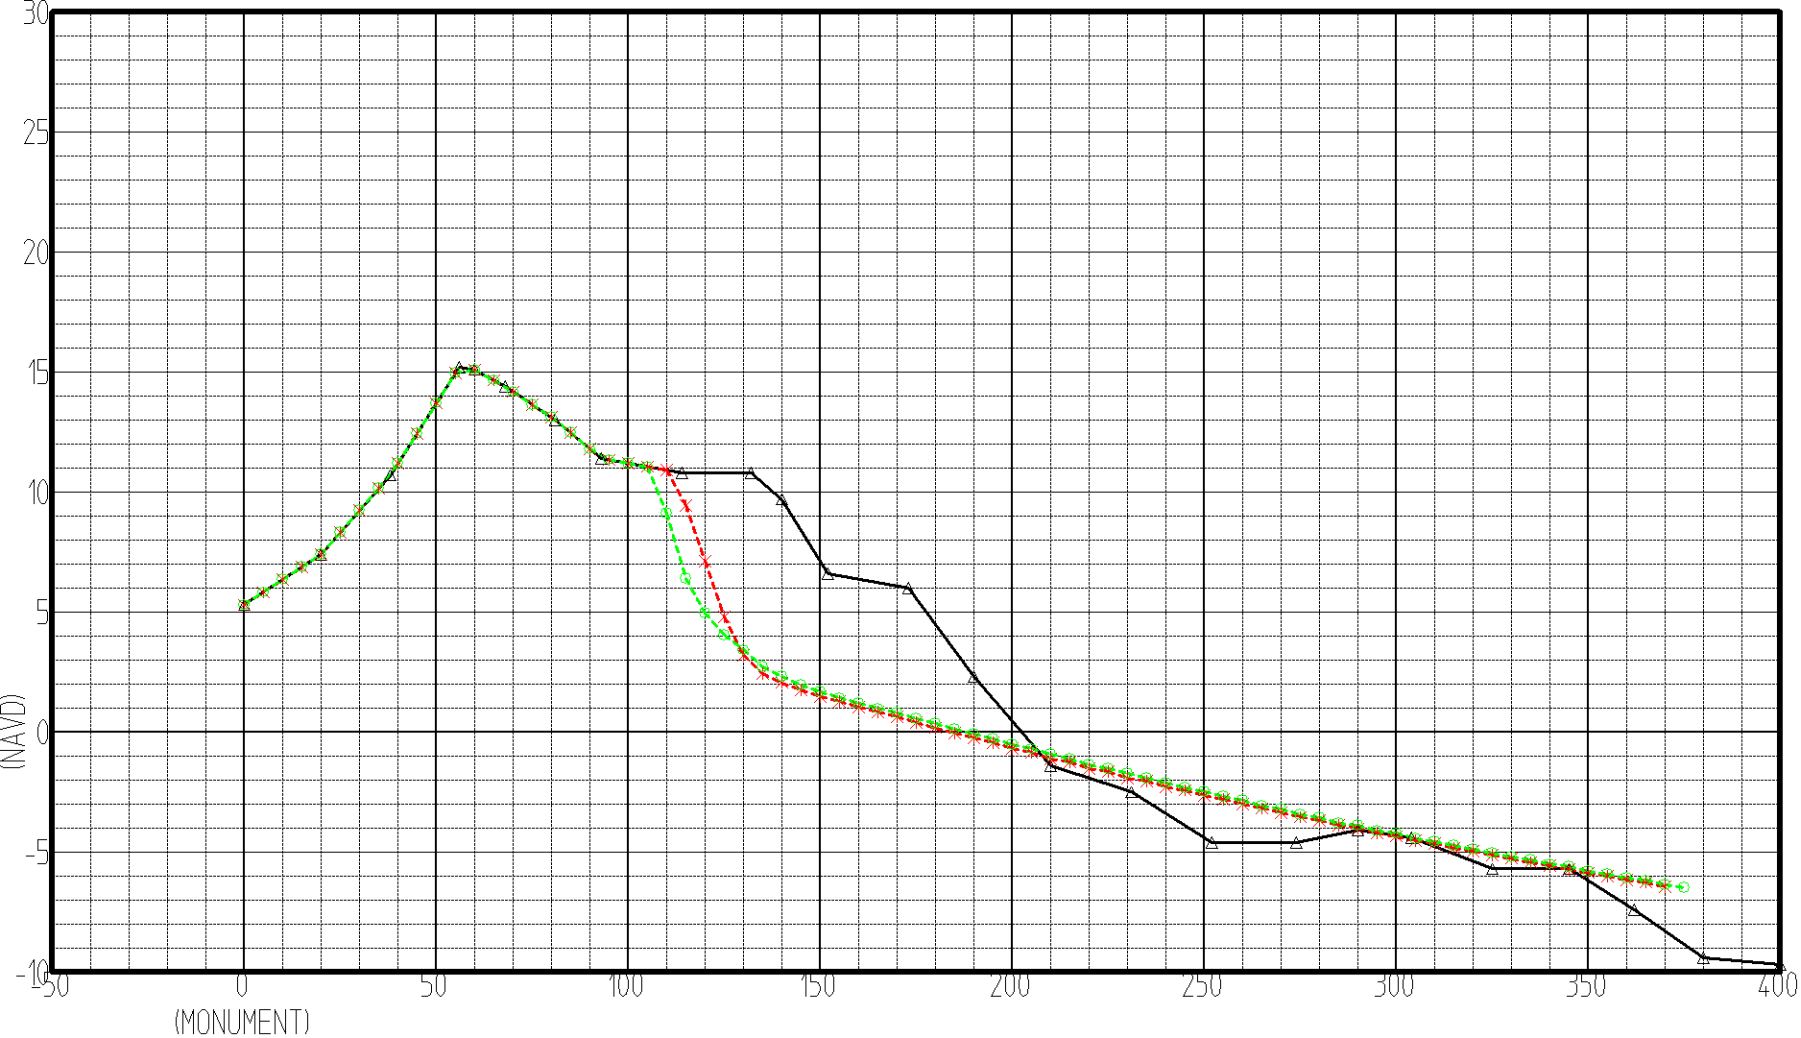
Range: T-11 1/1

BEACH PROFILE

- △—△— 2008-08 Indian River
- - - \* - - - 15YR SBEACH ERODED
- - - o - - - 25YR SBEACH ERODED

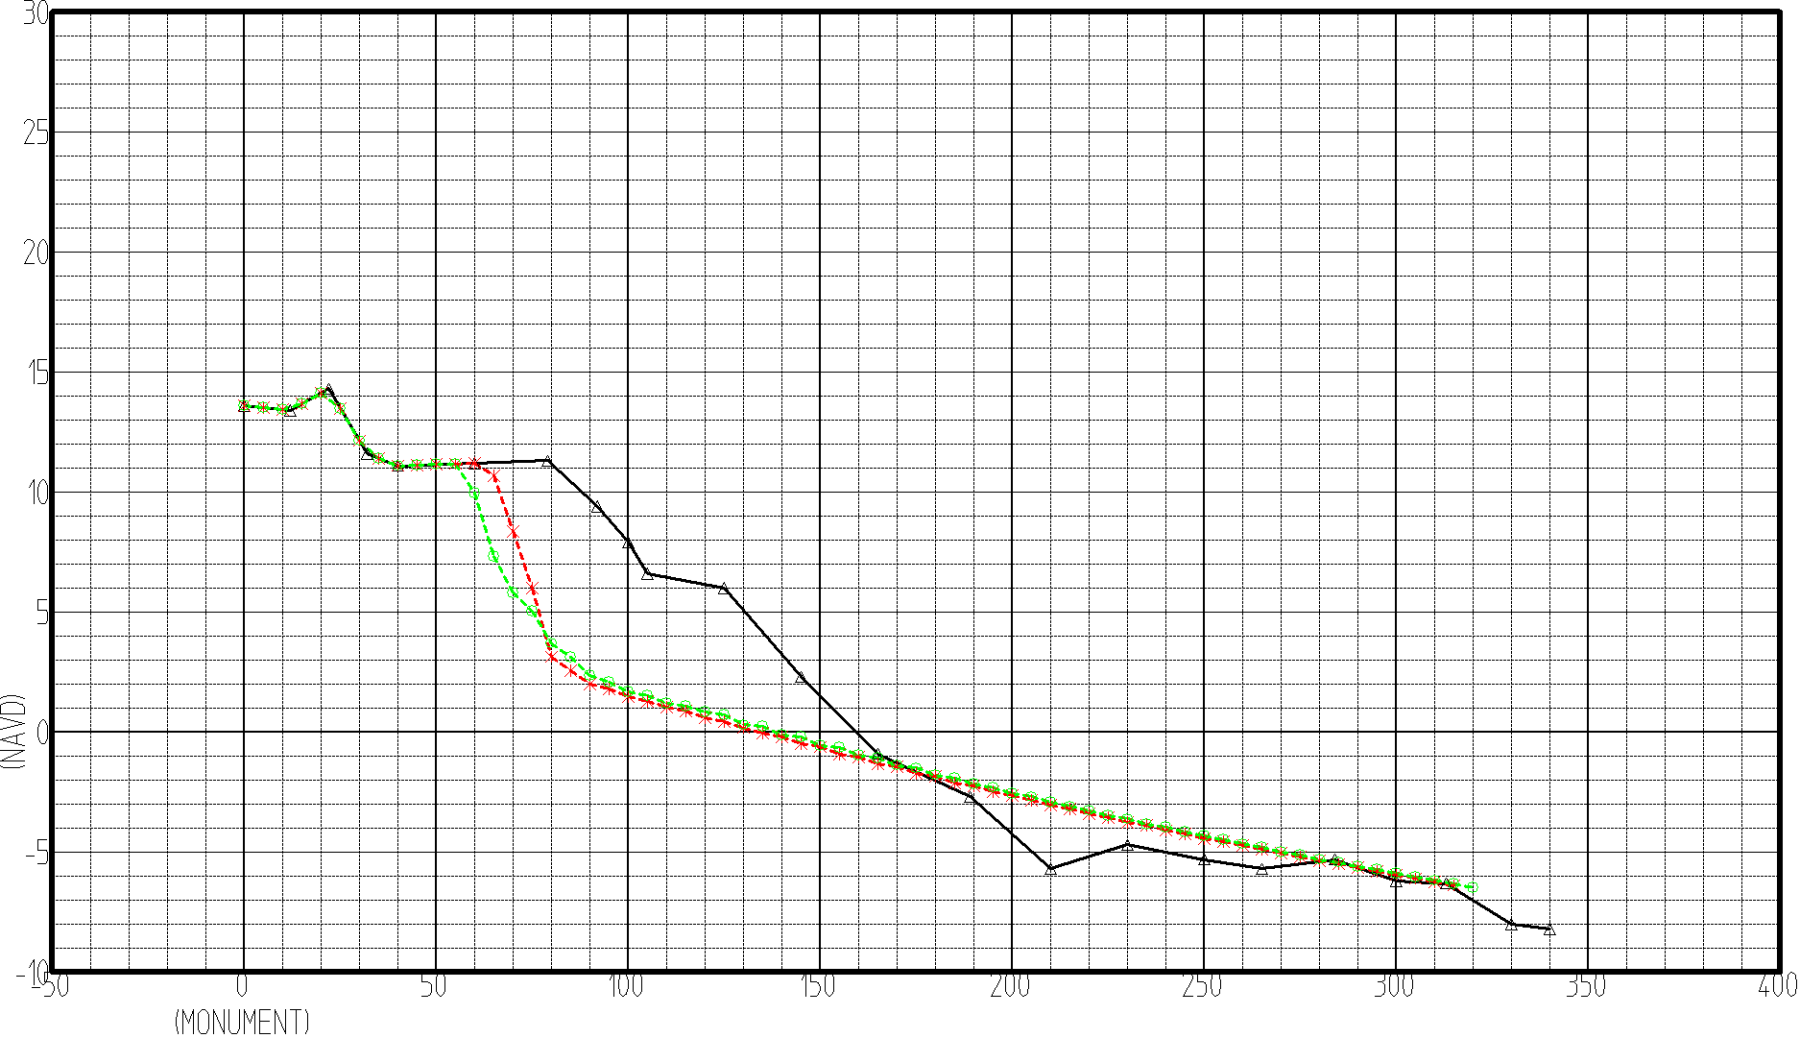
Range: R-12  
 BEARING: 70.00  
 1/1

BEACH PROFILE  
 —△—△— 2008-08 Indian River  
 - - \* - - \* - - 15YR SBEACH ERODED  
 - - o - - o - - 25YR SBEACH ERODED
