## **Appendix X**

SBEACH 15 and 25 yr. Storm Erosion Profiles

Indian River County

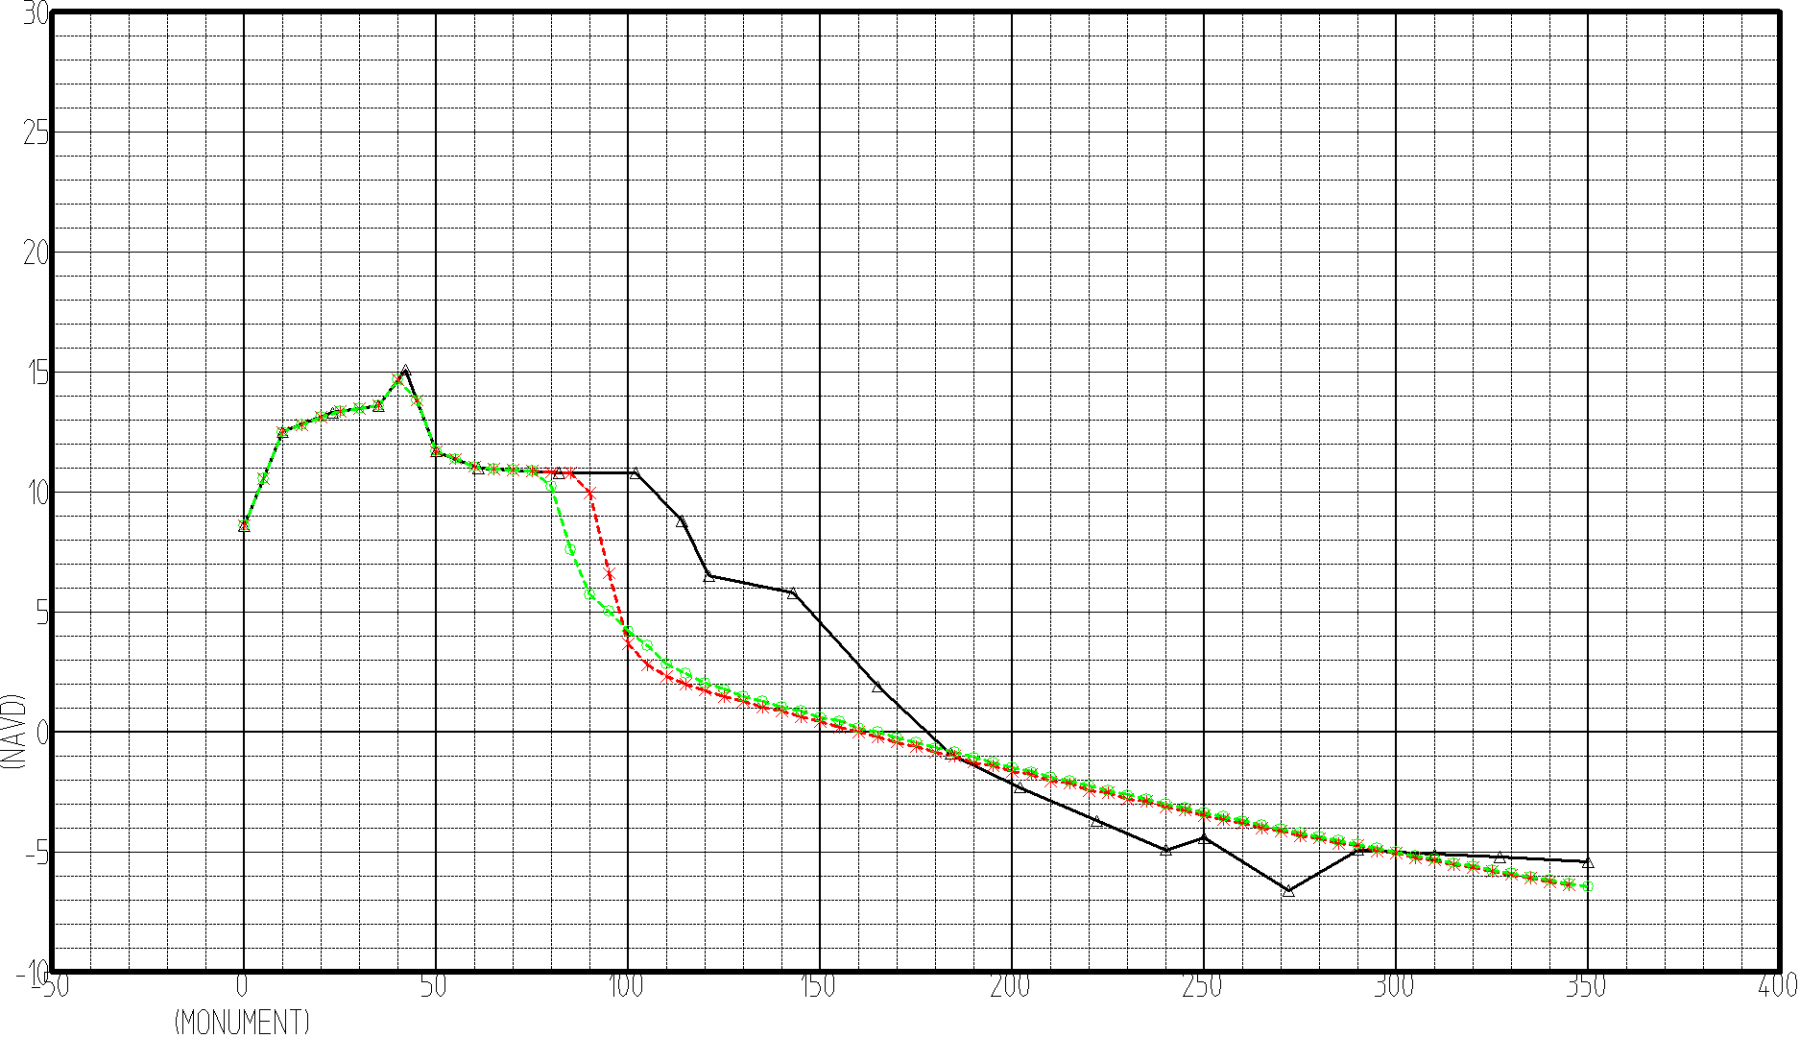
Range: T-13

BEACH PROFILE

- △—△— 2008-08 Indian River
- - - \* - - - 15YR SBEACH ERODED
- - - o - - - 25YR SBEACH ERODED

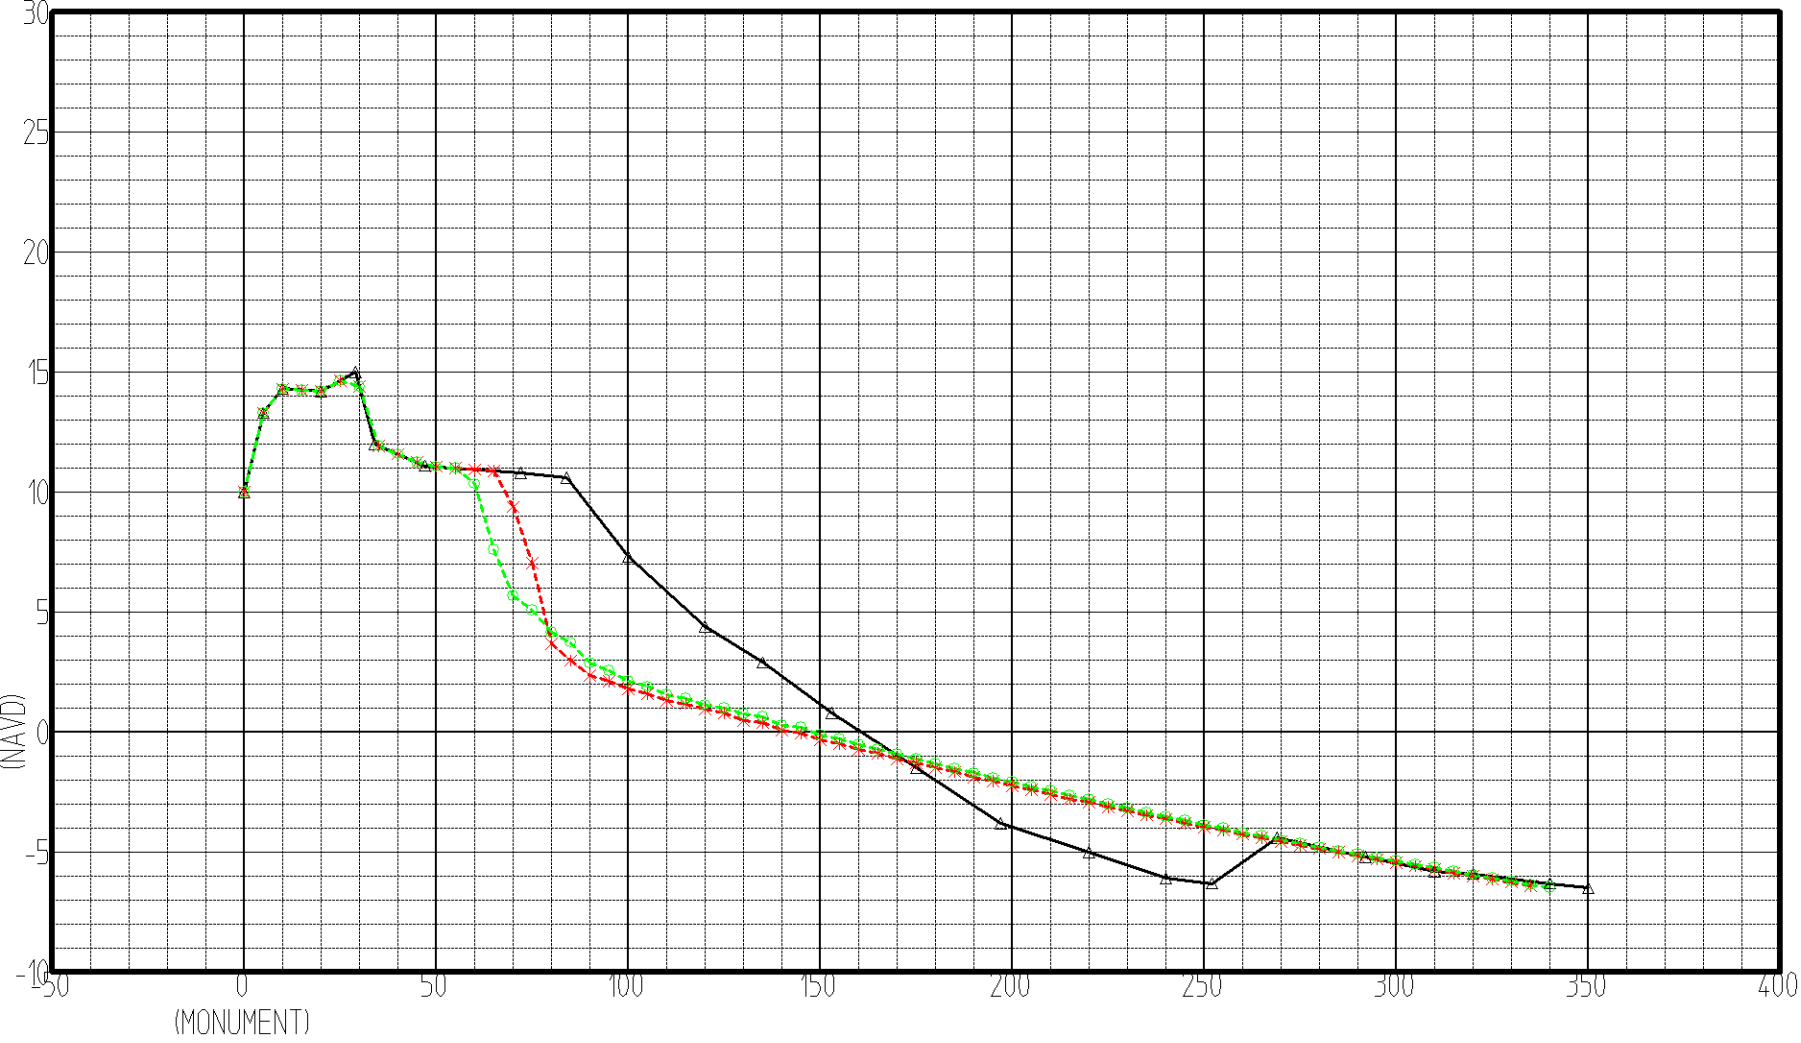
Range: R-14

BEACH PROFILE

—△—△— 2008-08 Indian River

- - - \* - - - 15YR SBEACH ERODED

- - - o - - - 25YR SBEACH ERODED

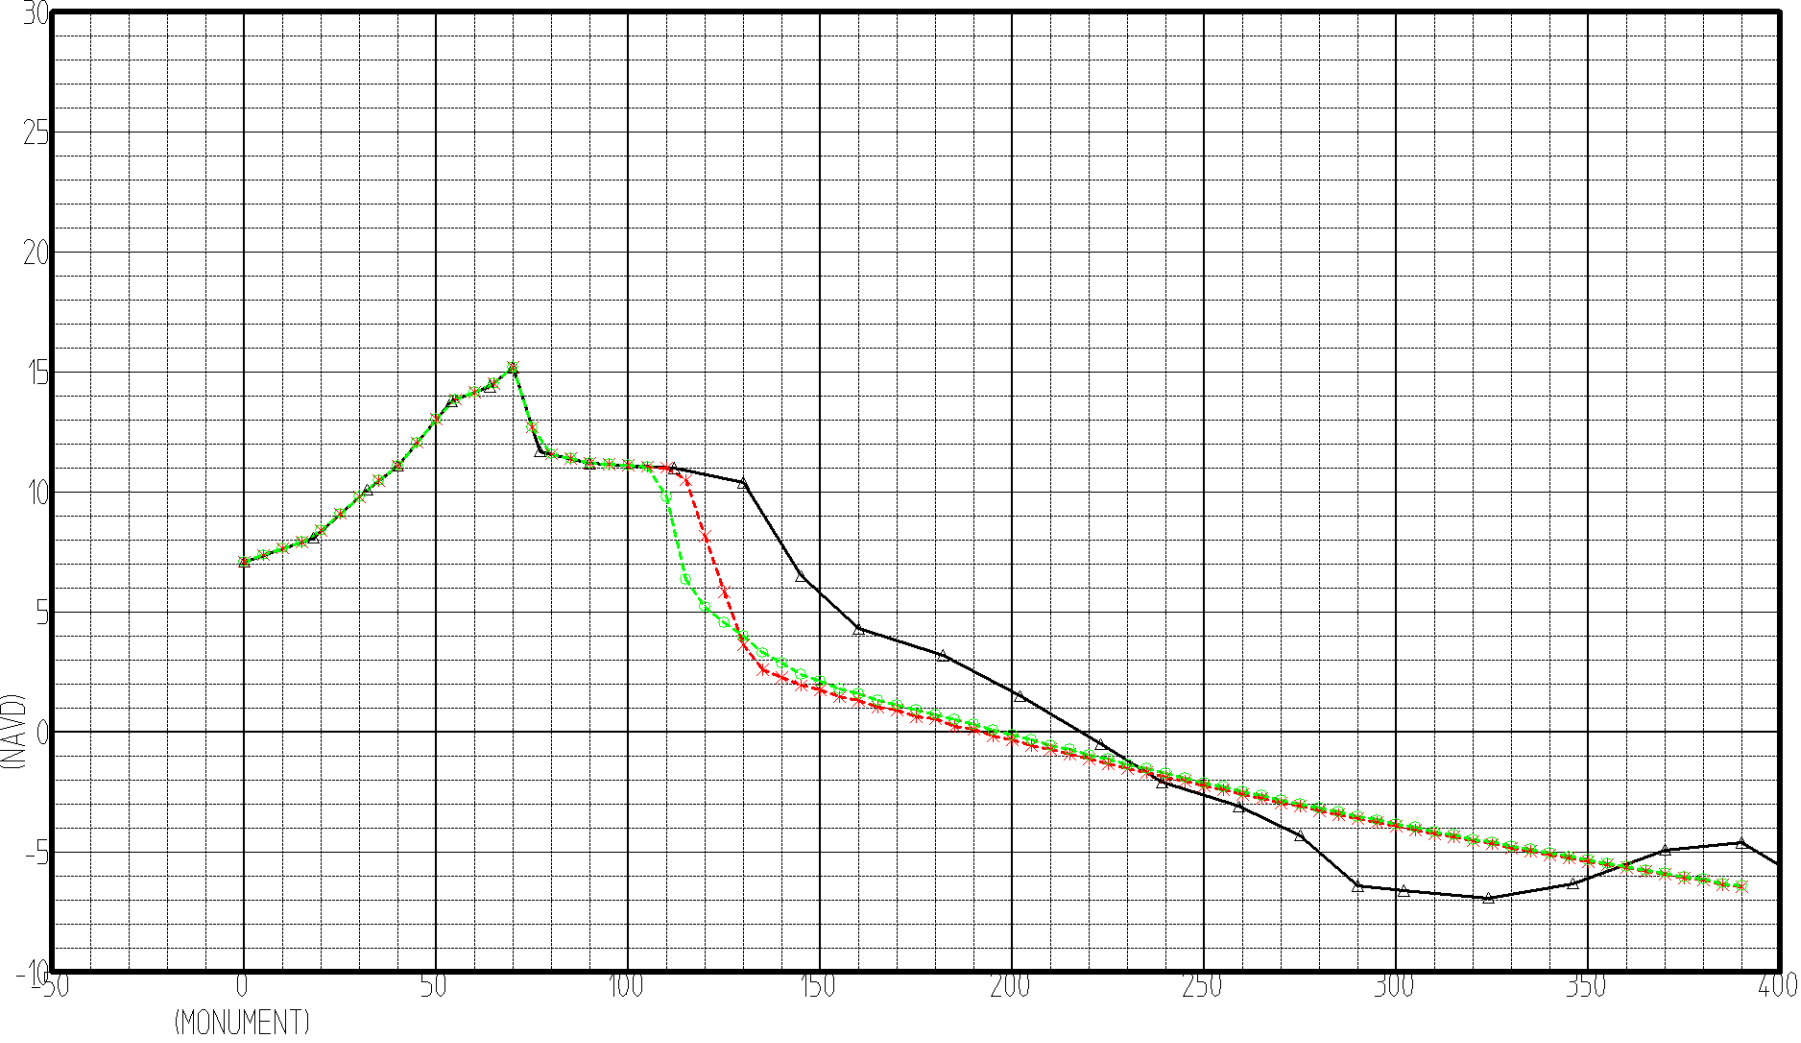
Range: R-15

BEACH PROFILE

- △—△— 2008-08 Indian River
- - - \* - - - 15YR SBEACH ERODED
- - - o - - - 25YR SBEACH ERODED

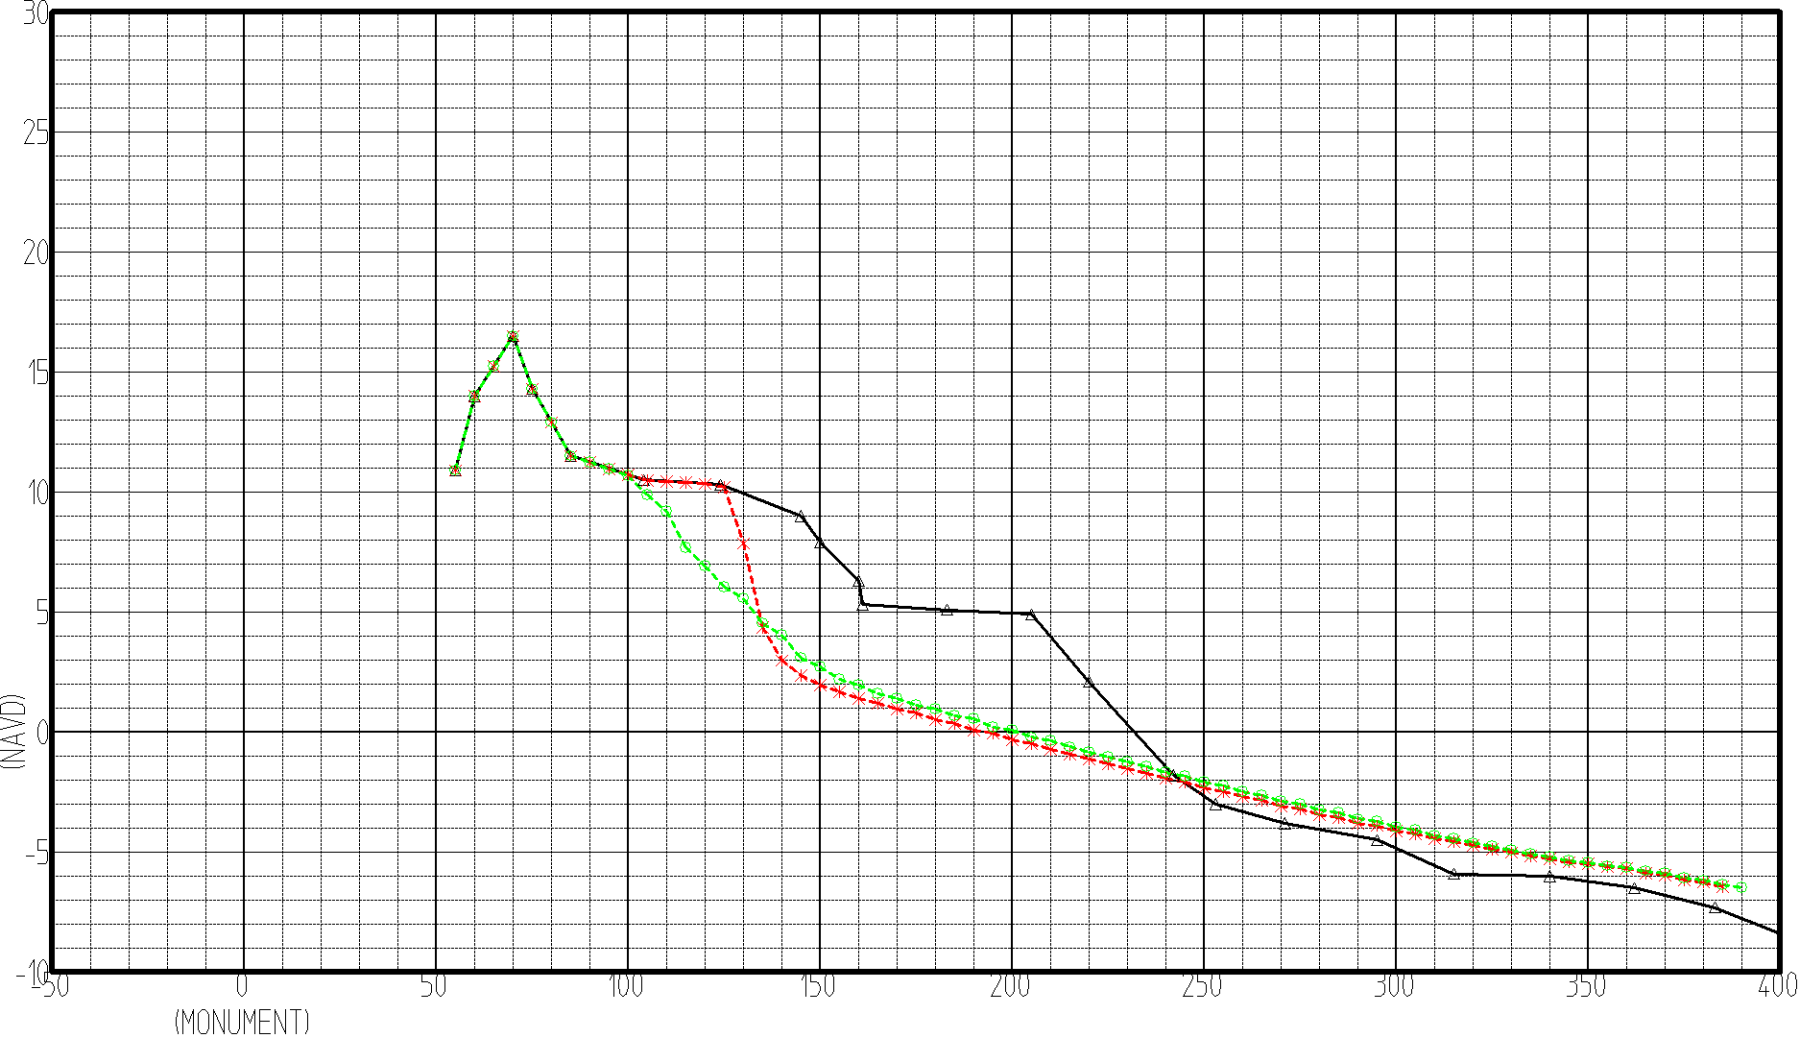
Range: T-16  
 BEARING: 70.00  
 1/2

BEACH PROFILE  
 —△—△— 2008-08 Indian River  
 - - \* - - 15YR SBEACH ERODED  
 - - o - - 25YR SBEACH ERODED

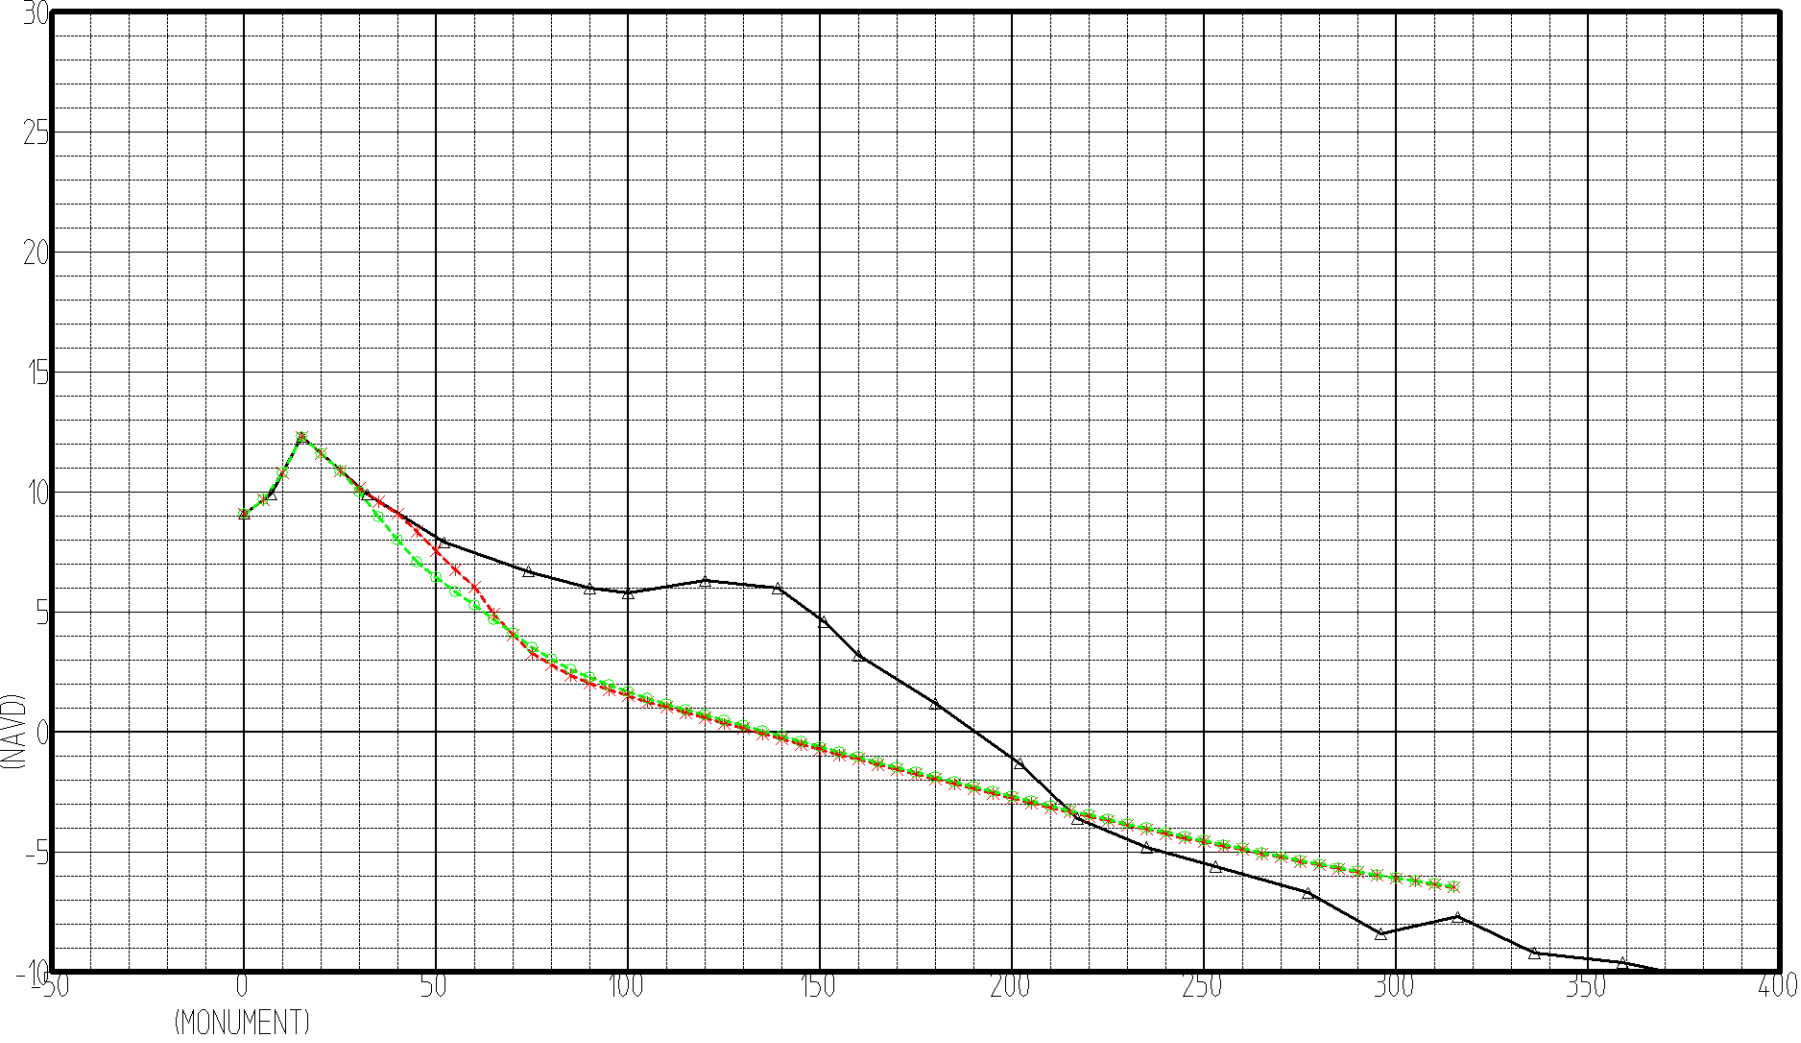
Range: T-17  
 BEARING: 70.00  
 1/1

BEACH PROFILE  
 —△—△— 2008-08 Indian River  
 - - \* - - 15YR SBEACH ERODED  
 - - o - - 25YR SBEACH ERODED

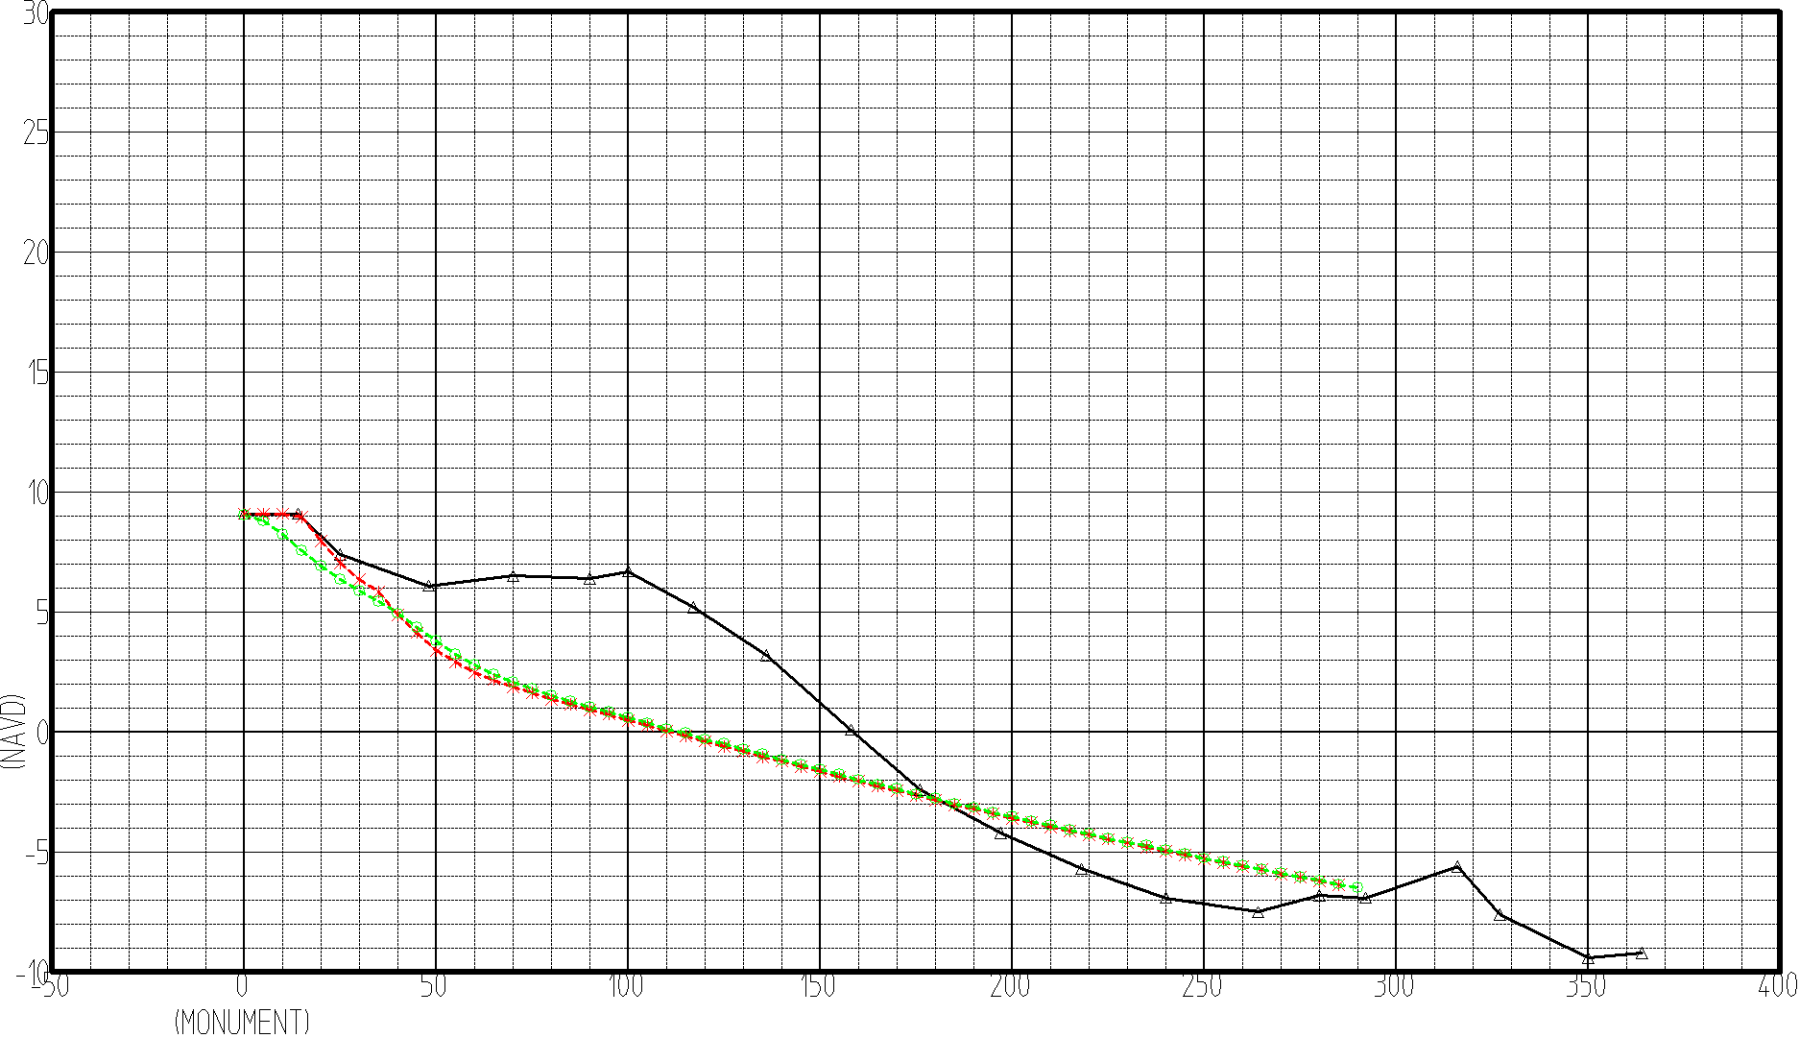
Range: R-18

BEACH PROFILE

- △—△— 2008-08 Indian River
- - - \* - - - 15YR SBEACH ERODED
- - - o - - - 25YR SBEACH ERODED

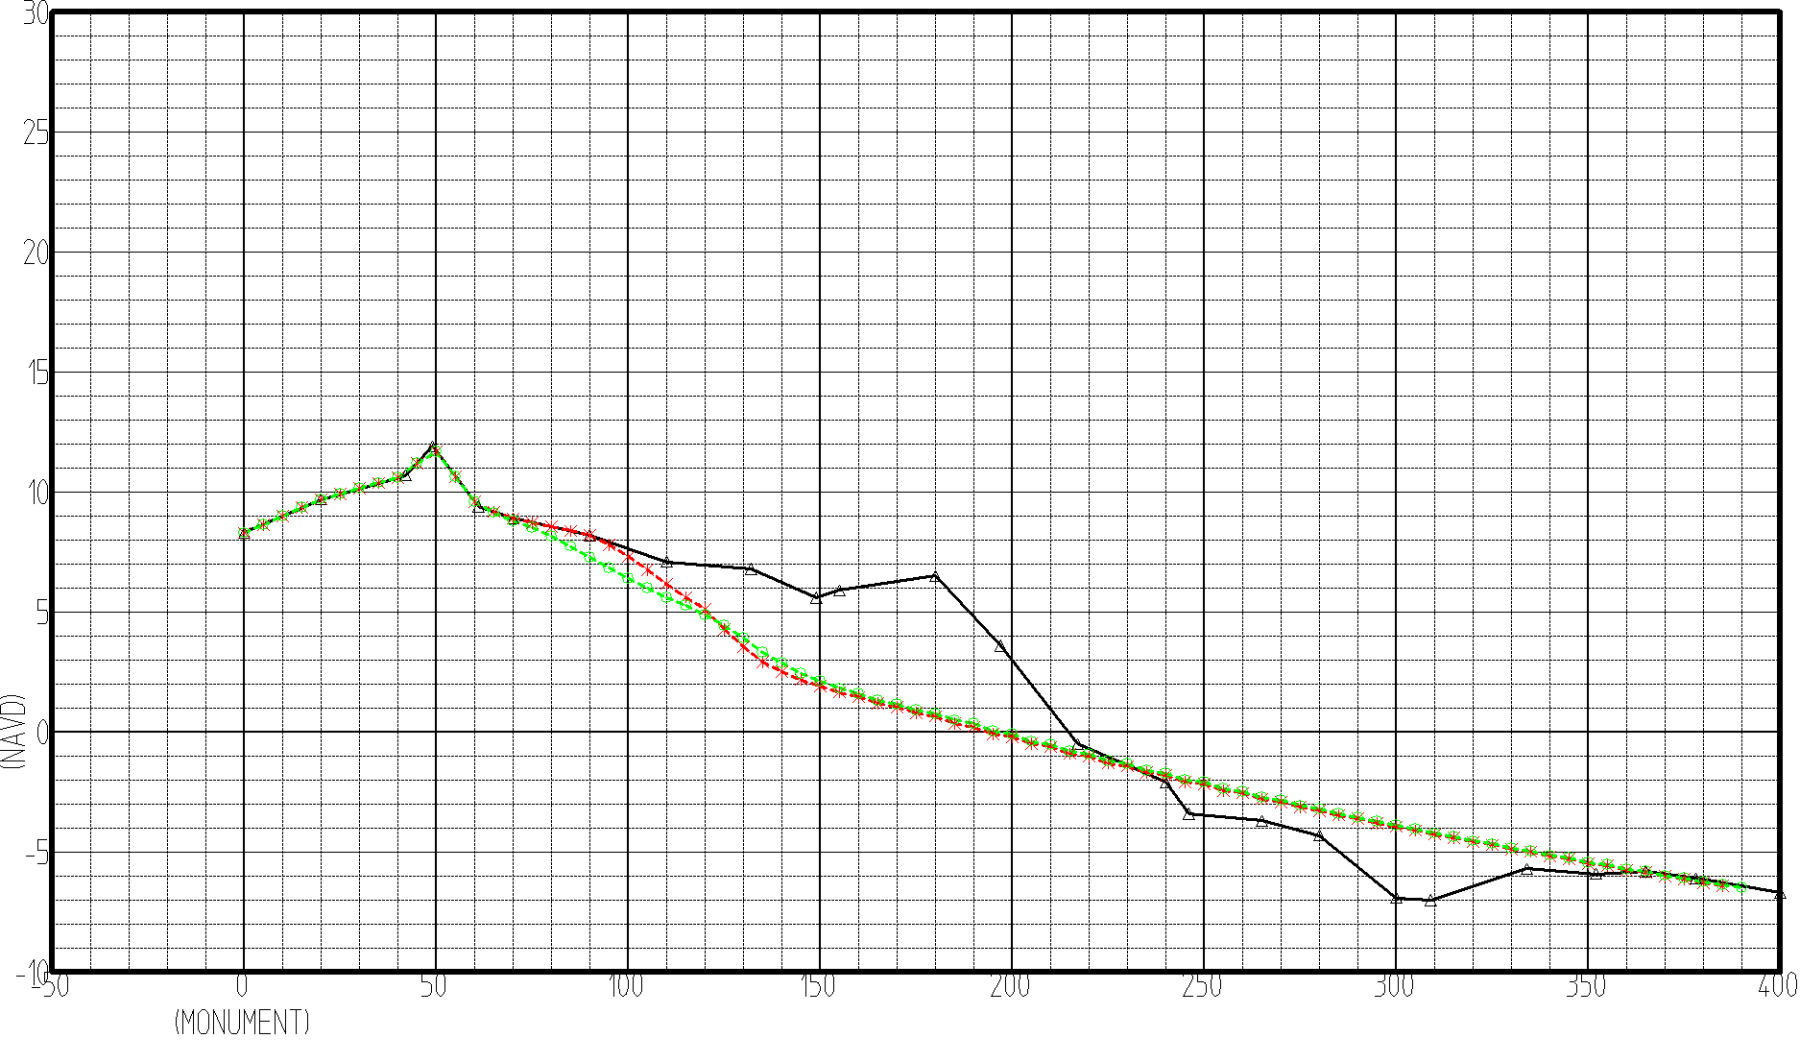
Range: R-19 1/1

BEACH PROFILE

- △—△— 2008-08 Indian River
- - \* - - 15YR SBEACH ERODED
- - o - - 25YR SBEACH ERODED

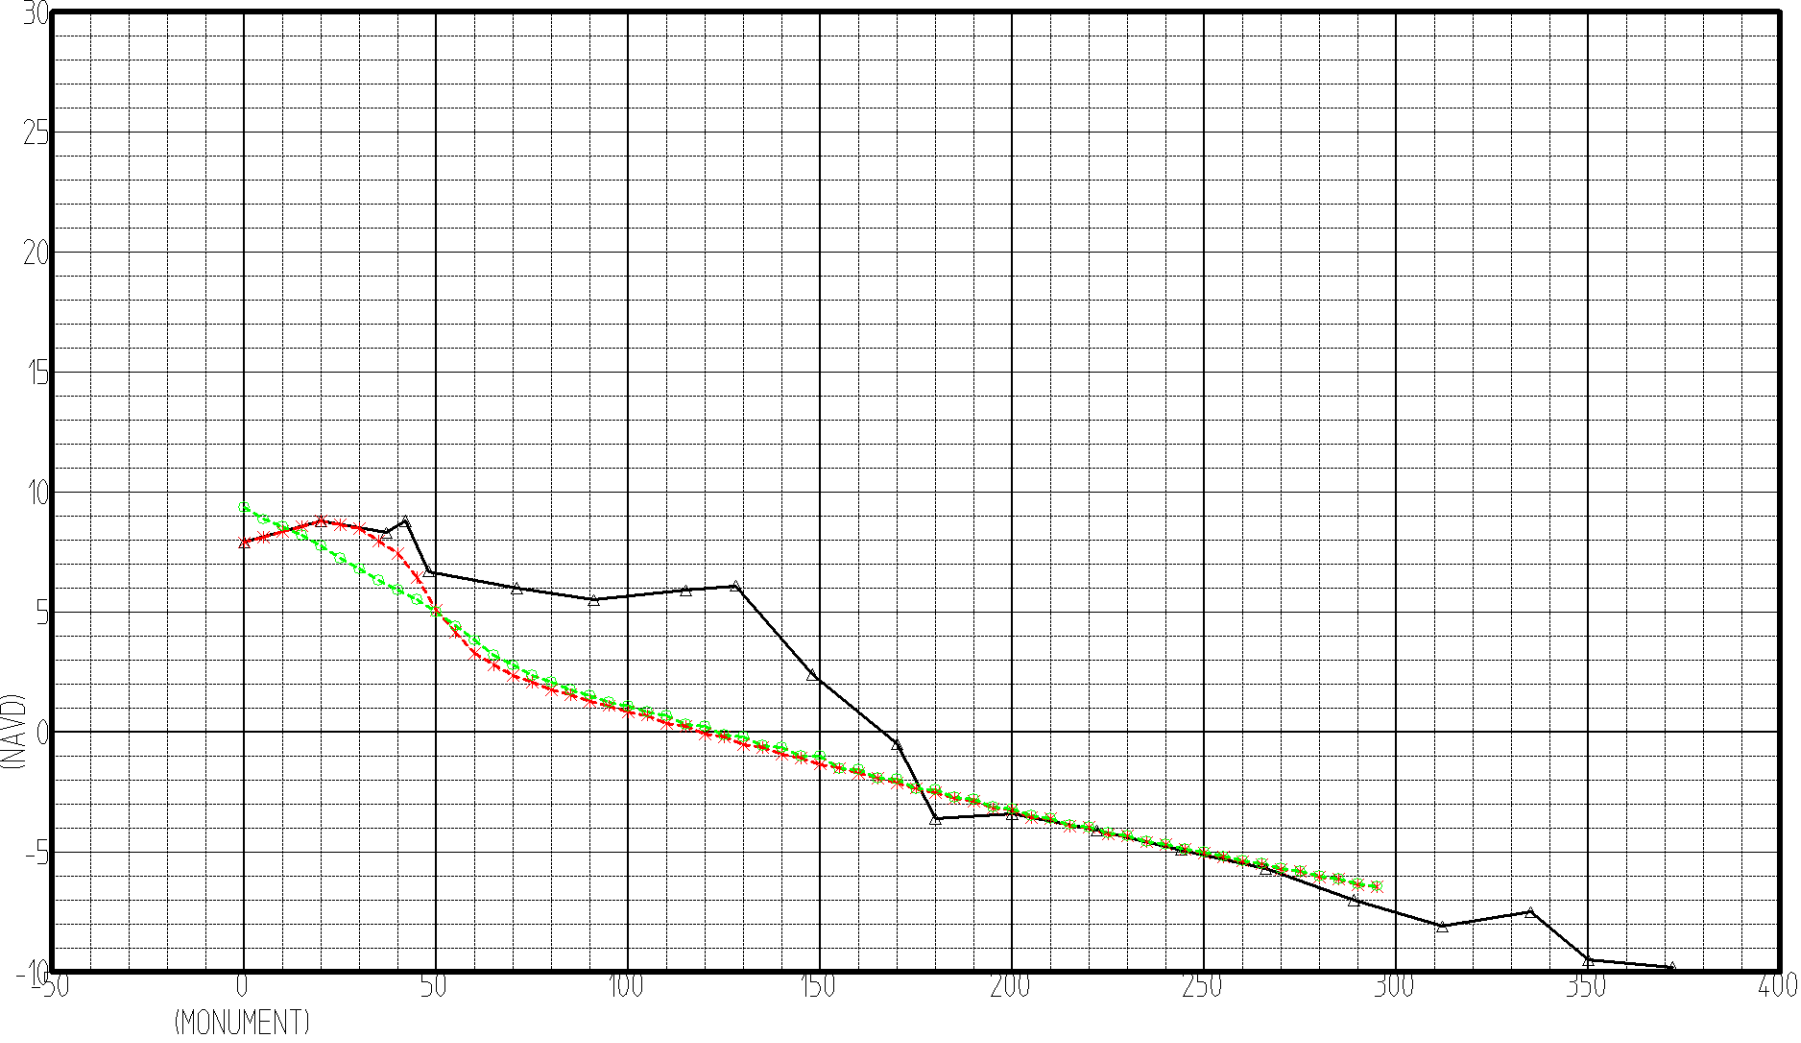
Range: R-20

BEACH PROFILE

—△—△— 2008-08 Indian River

- - - \* - - - 15YR SBEACH ERODED

- - - o - - - 25YR SBEACH ERODED

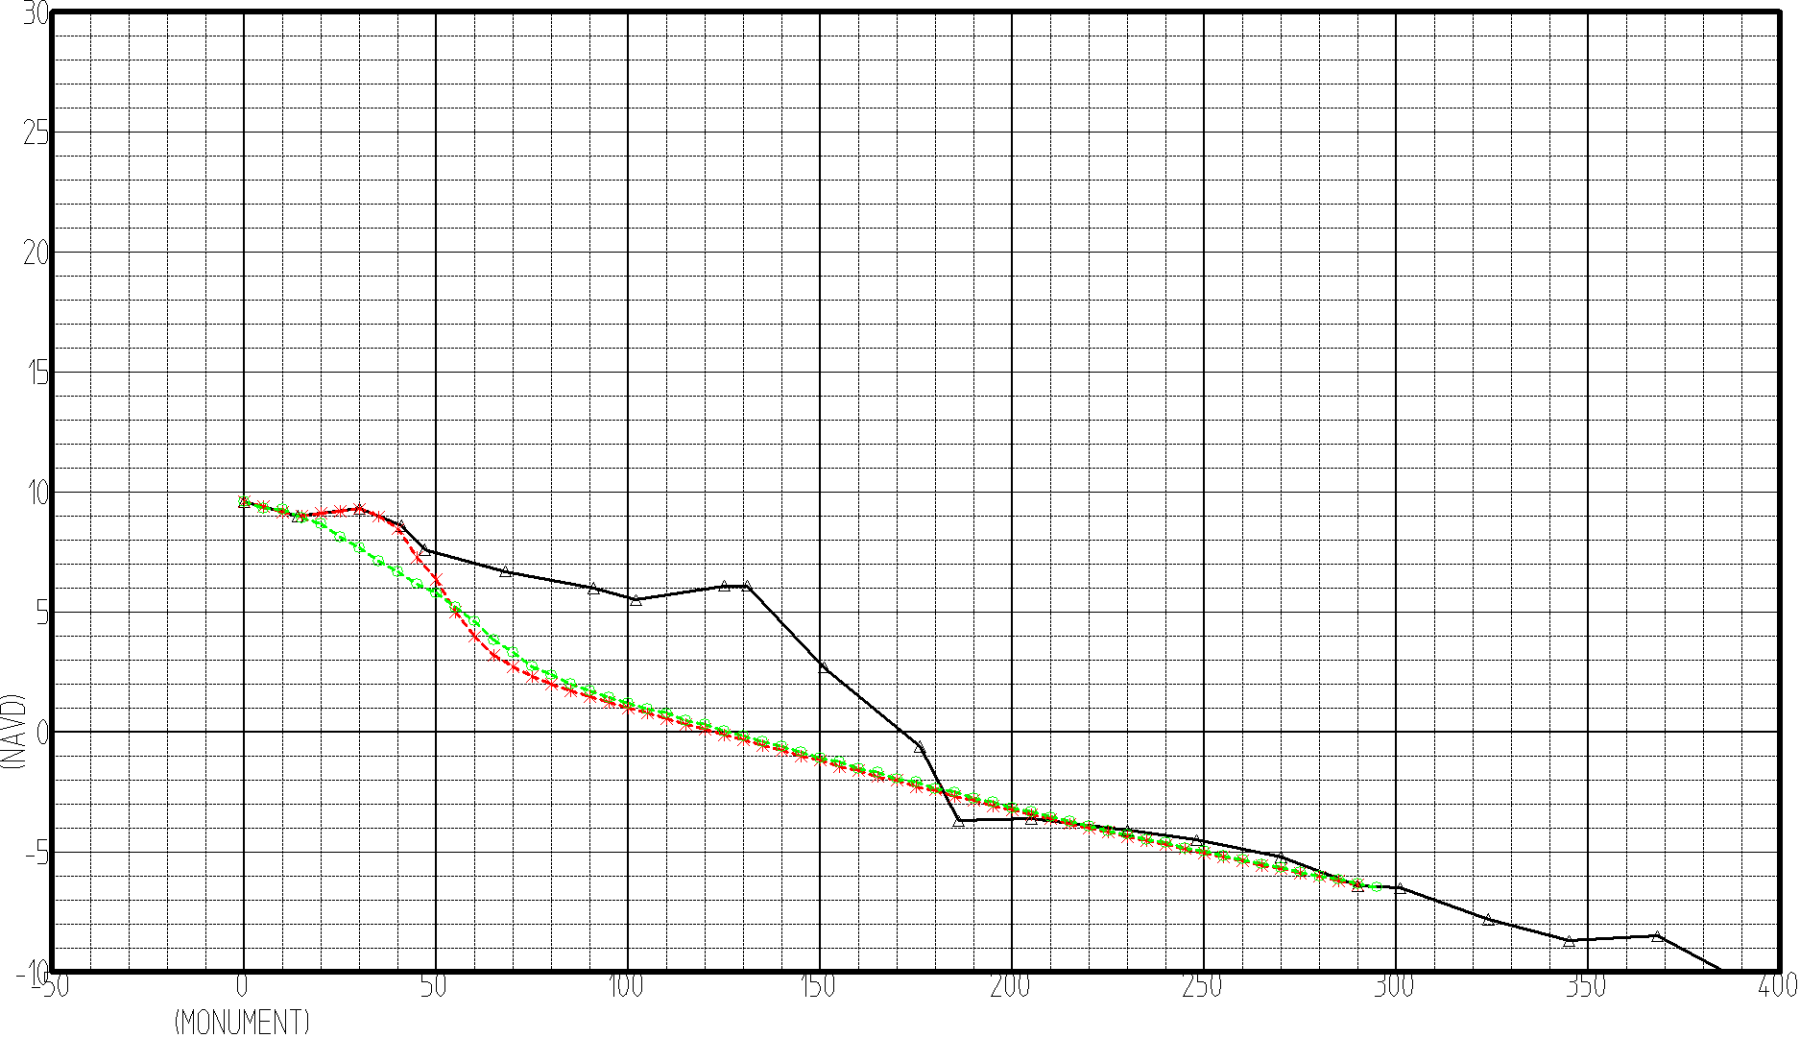
Range: R-21

BEACH PROFILE

—△—△— 2008-08 Indian River

- - - \* - - - 15YR SBEACH ERODED

- - - o - - - 25YR SBEACH ERODED

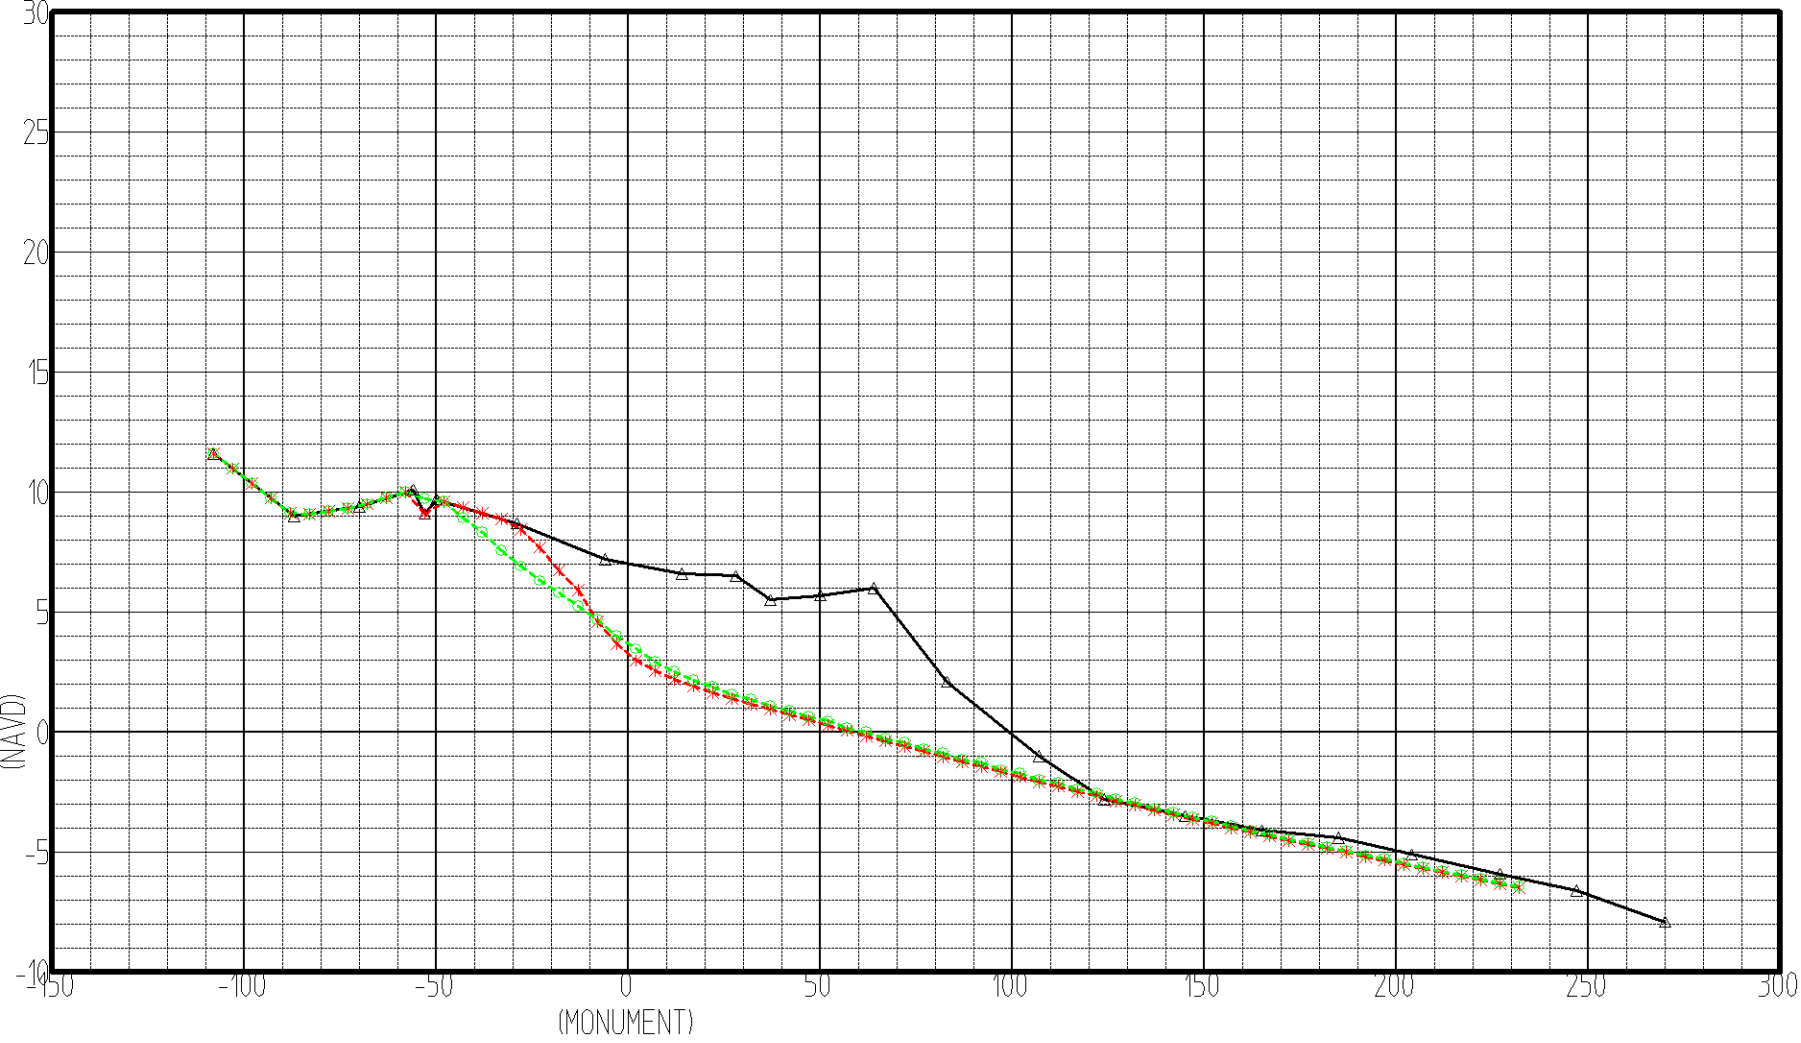
Range: R-22

BEACH PROFILE

—△—△— 2008-08 Indian River

- - - \* - - - 15YR SBEACH ERODED

- - - o - - - 25YR SBEACH ERODED

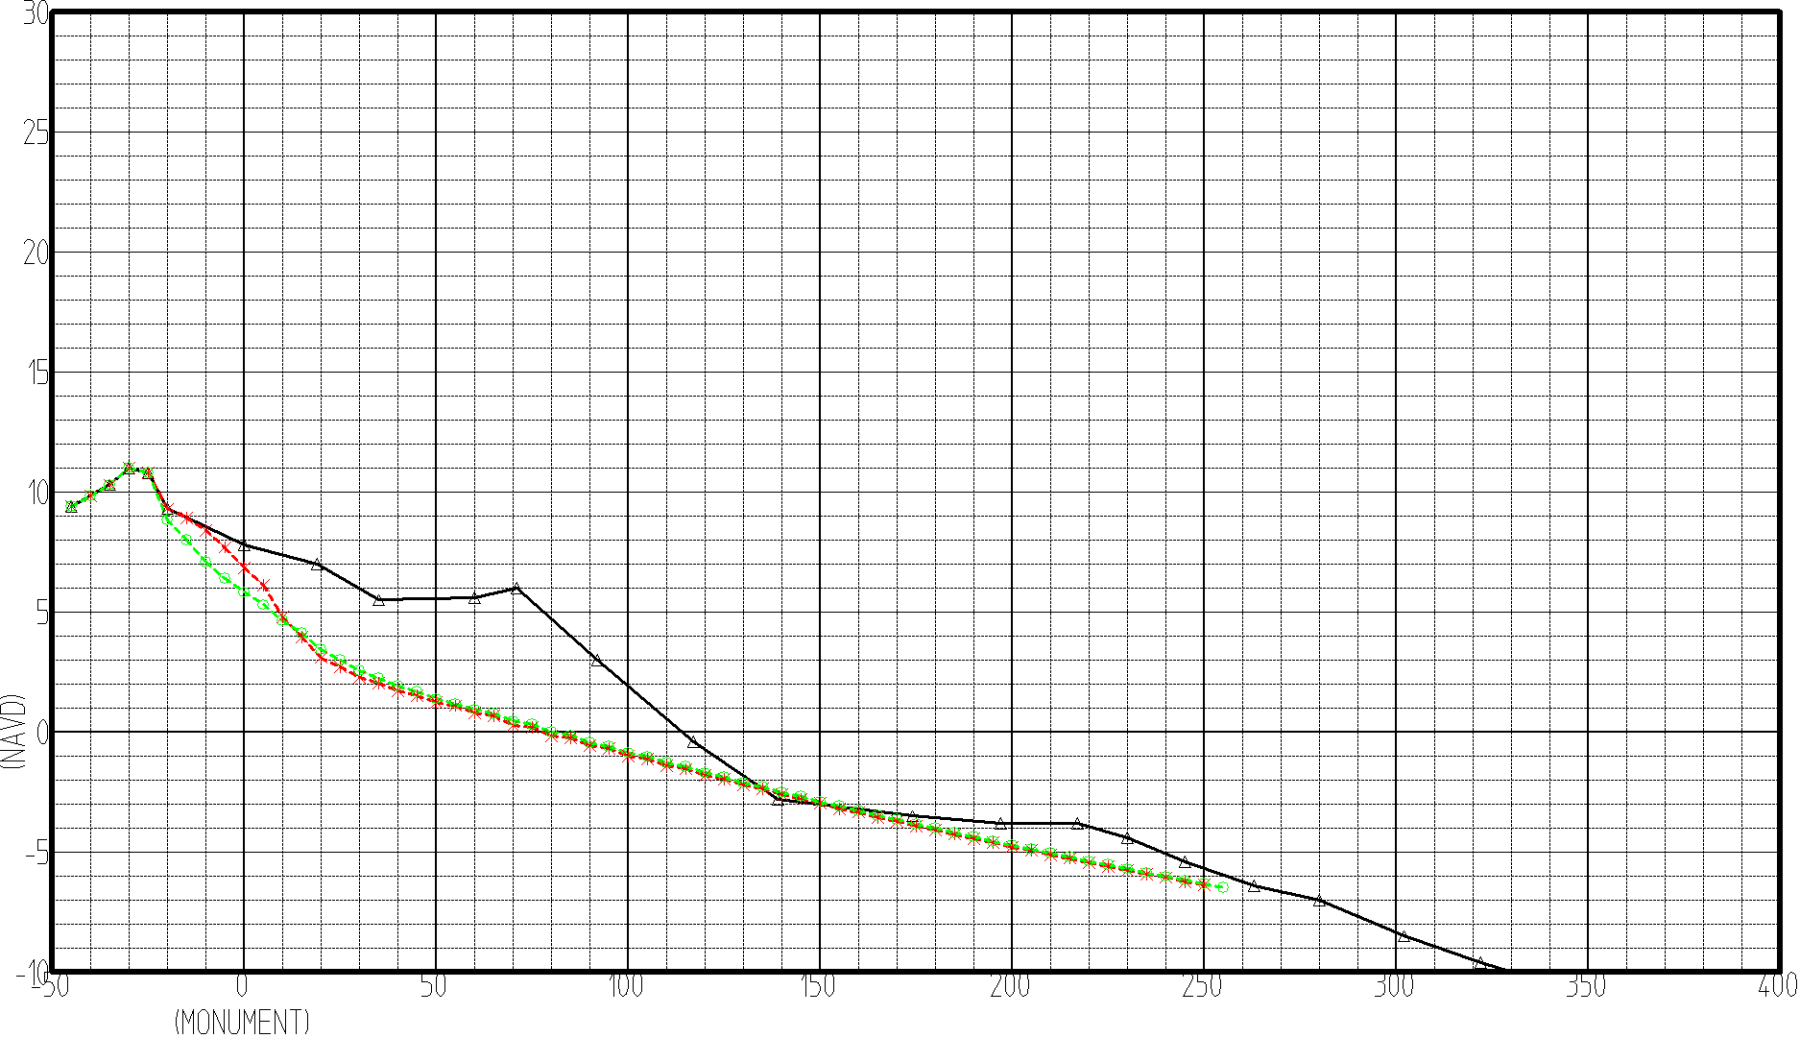
Range: R-23

BEACH PROFILE

—△—△— 2007-09 Indian River

- - - \* - - - 15YR SBEACH ERODED

- - - o - - - 25YR SBEACH ERODED

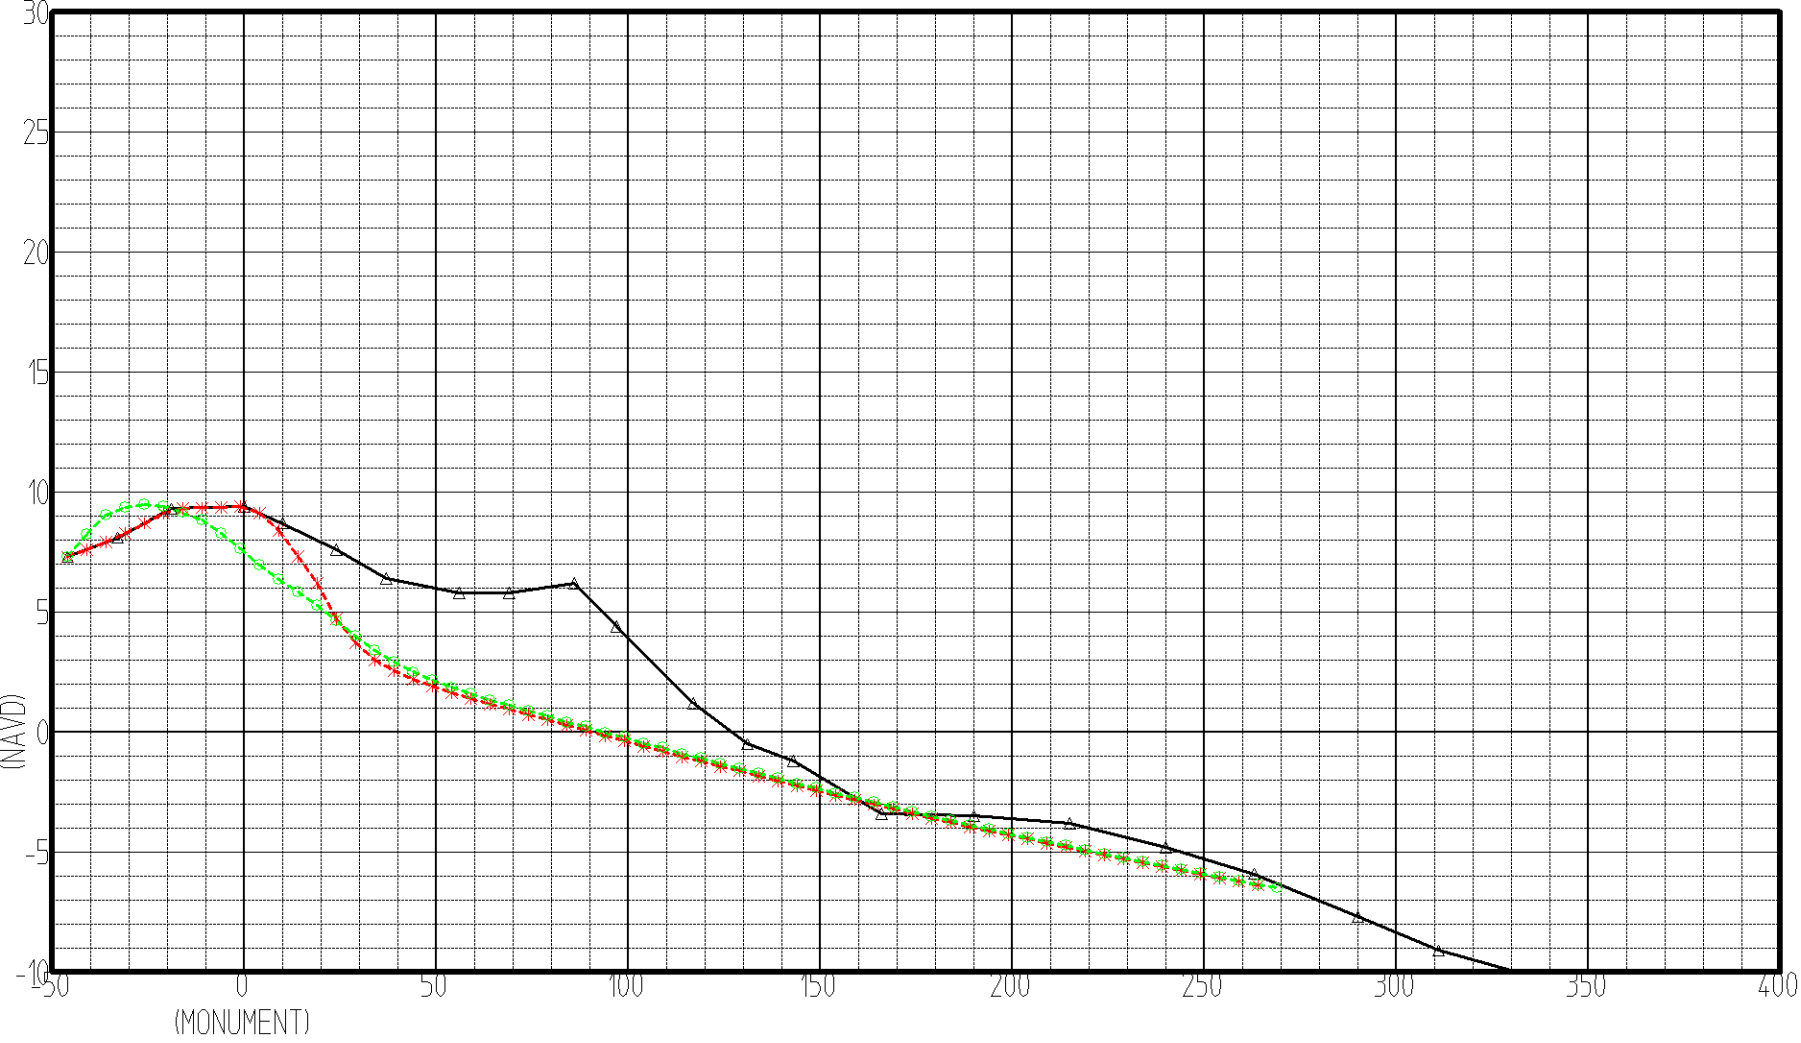
Range: R-24  
 BEARING: 70.00  
 1/2

BEACH PROFILE  
 —△—△— 2007-09 Indian River  
 - - \* - - \* - - 15YR SBEACH ERODED  
 - - o - - o - - 25YR SBEACH ERODED
