## **Appendix X**

SBEACH 15 and 25 yr. Storm Erosion Profiles

Indian River County

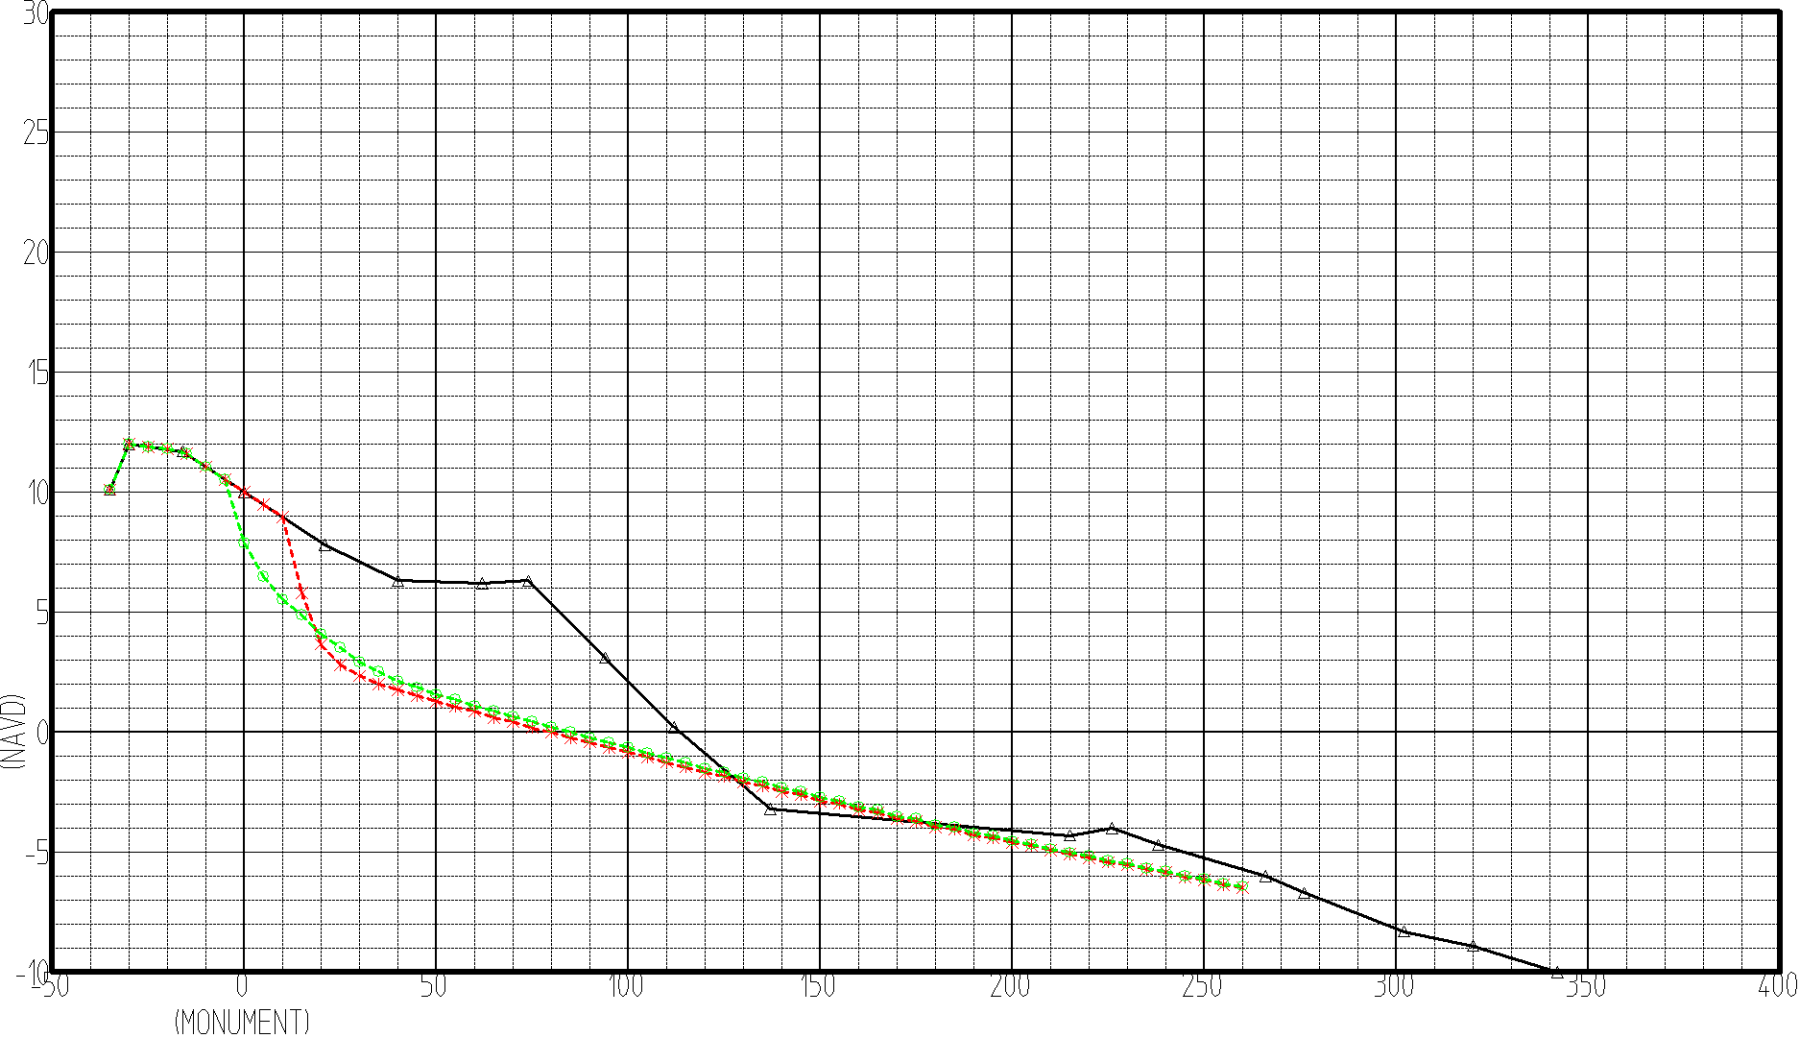
Range: R-25

BEACH PROFILE

- △—△— 2007-09 Indian River
- - - \* - - - 15YR SBEACH ERODED
- - - o - - - 25YR SBEACH ERODED

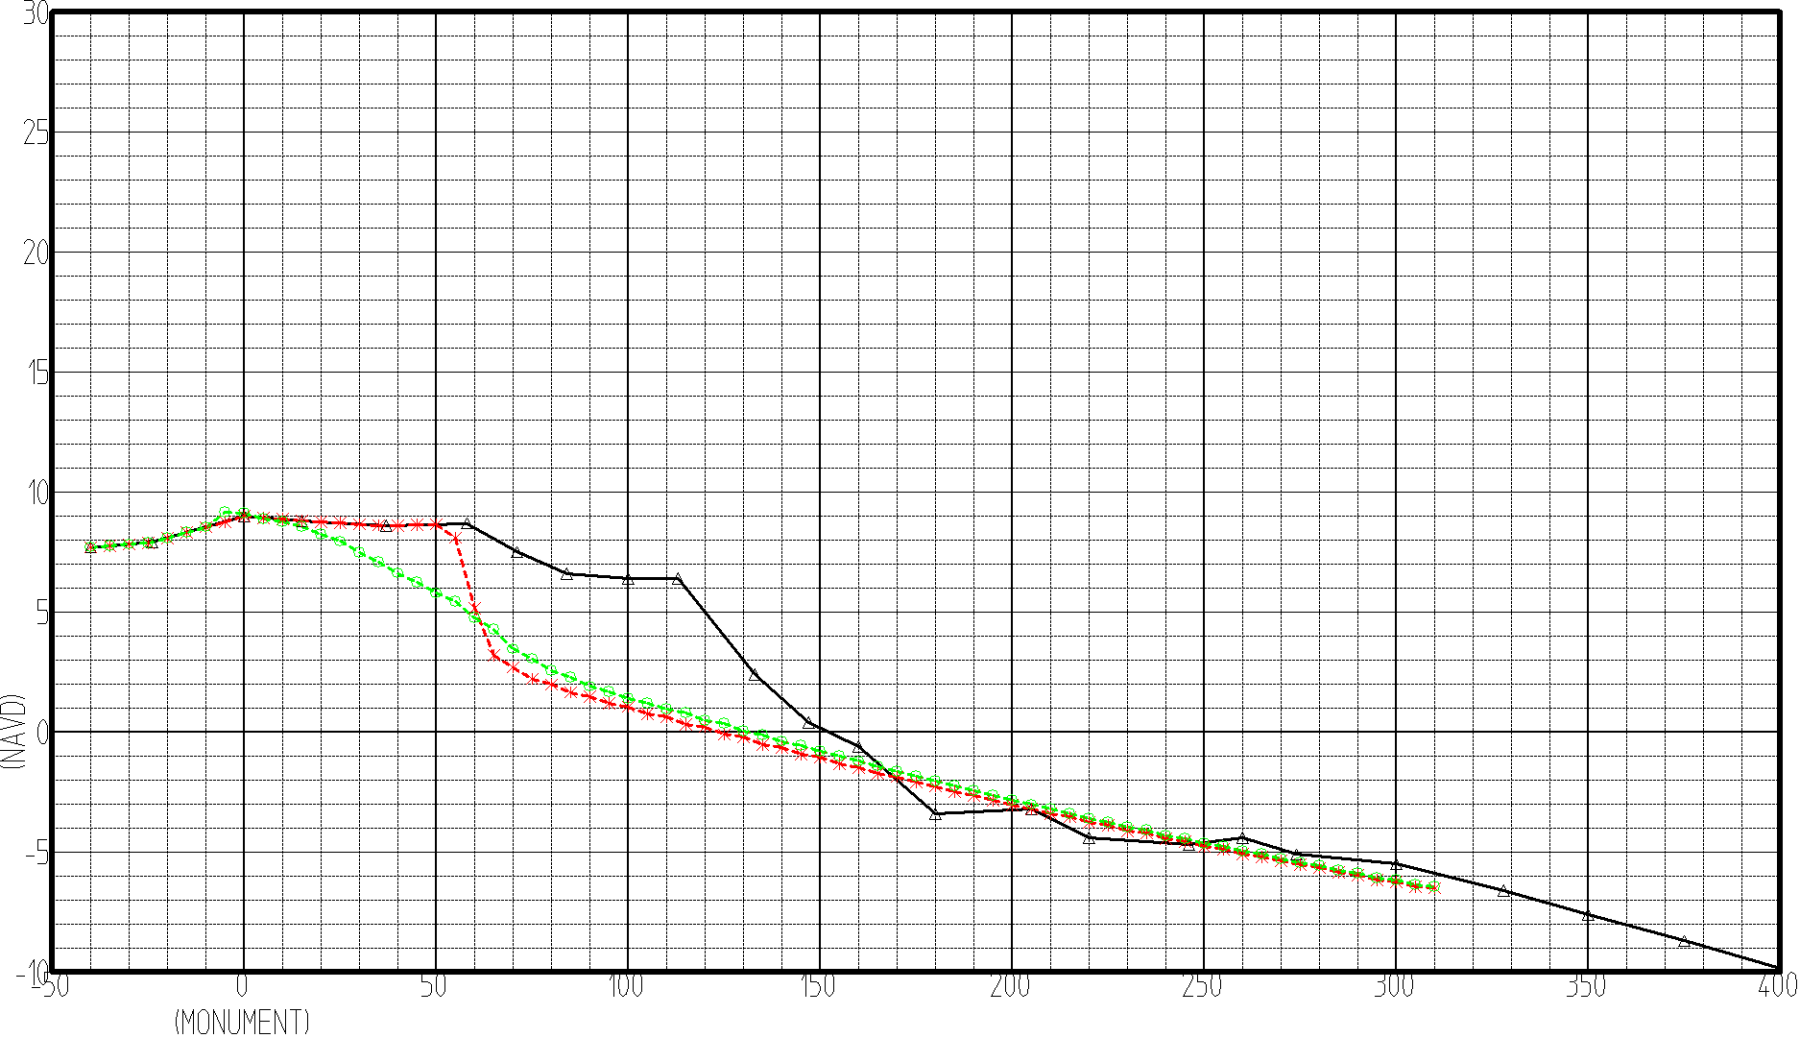
Range: R-26  
 BEARING: 70.00  
 1/2

BEACH PROFILE  
 —△—△— 2007-09 Indian River  
 - - \* - - 15YR SBEACH ERODED  
 - - o - - 25YR SBEACH ERODED

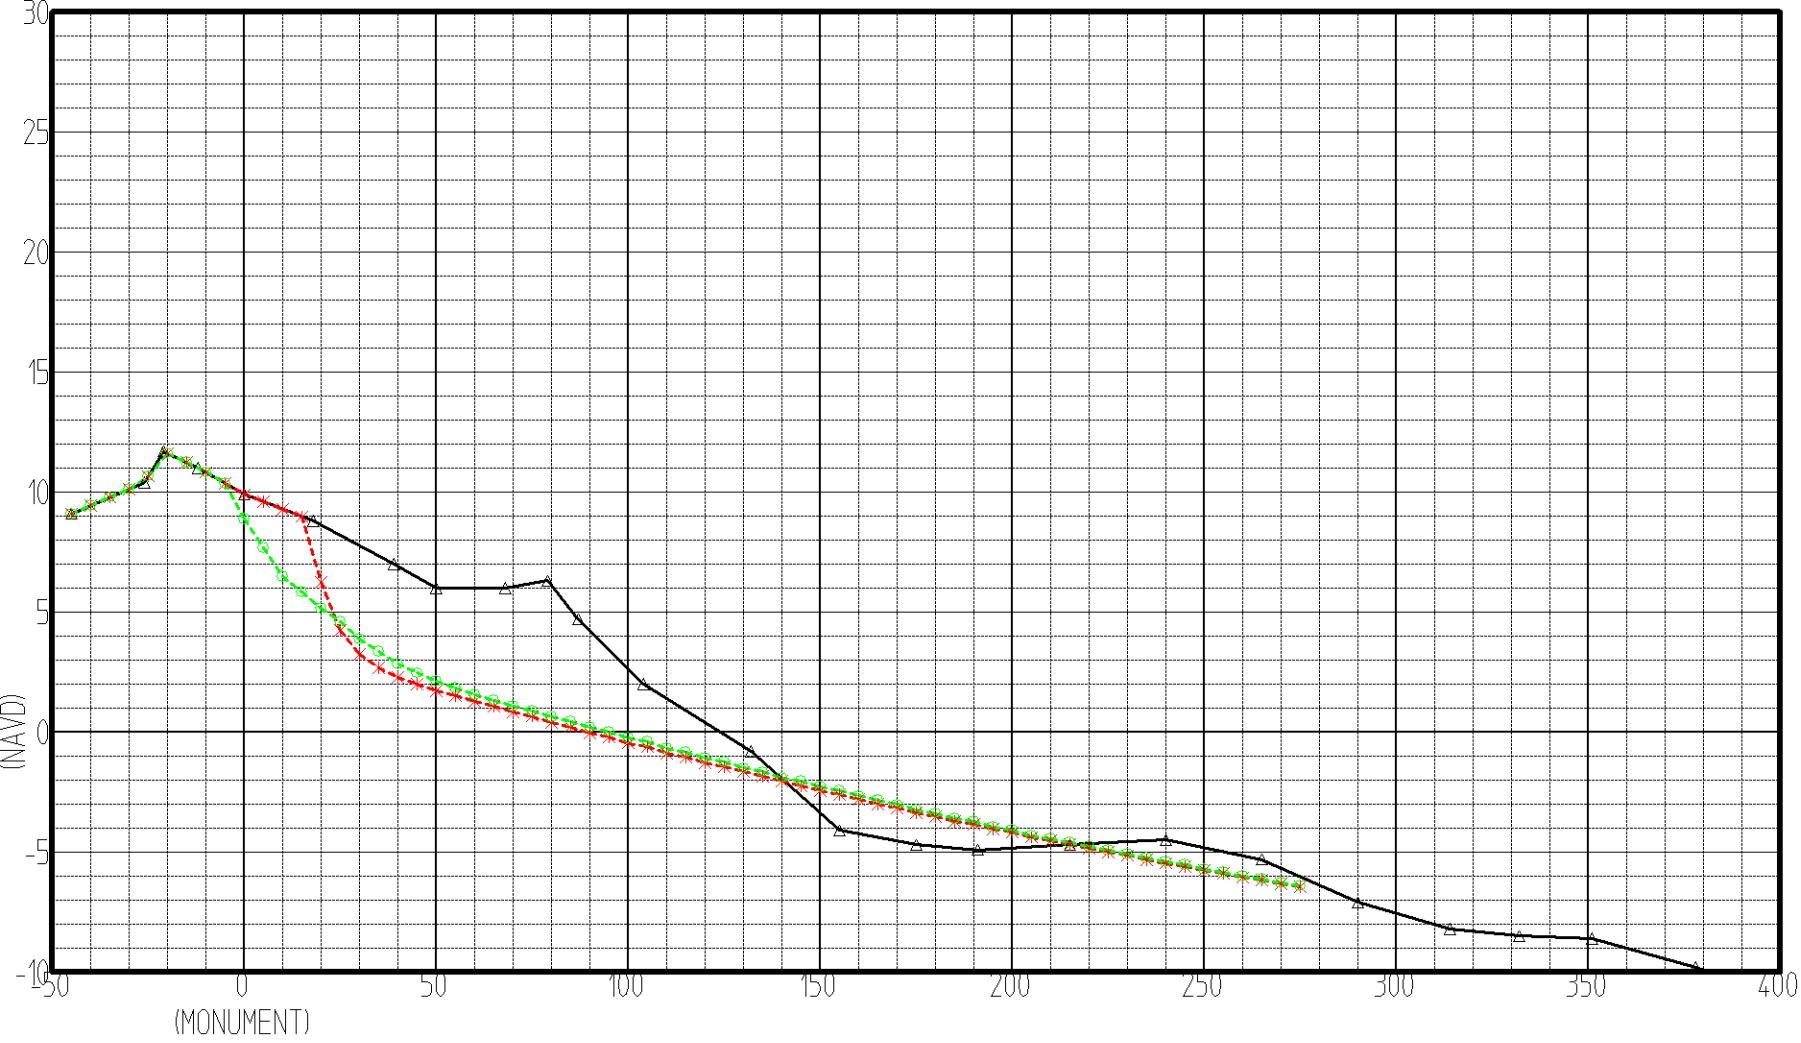
Range: R-27

BEACH PROFILE

—△—△— 2007-09 Indian River

- - - \* - - - 15YR SBEACH ERODED

- - - o - - - 25YR SBEACH ERODED

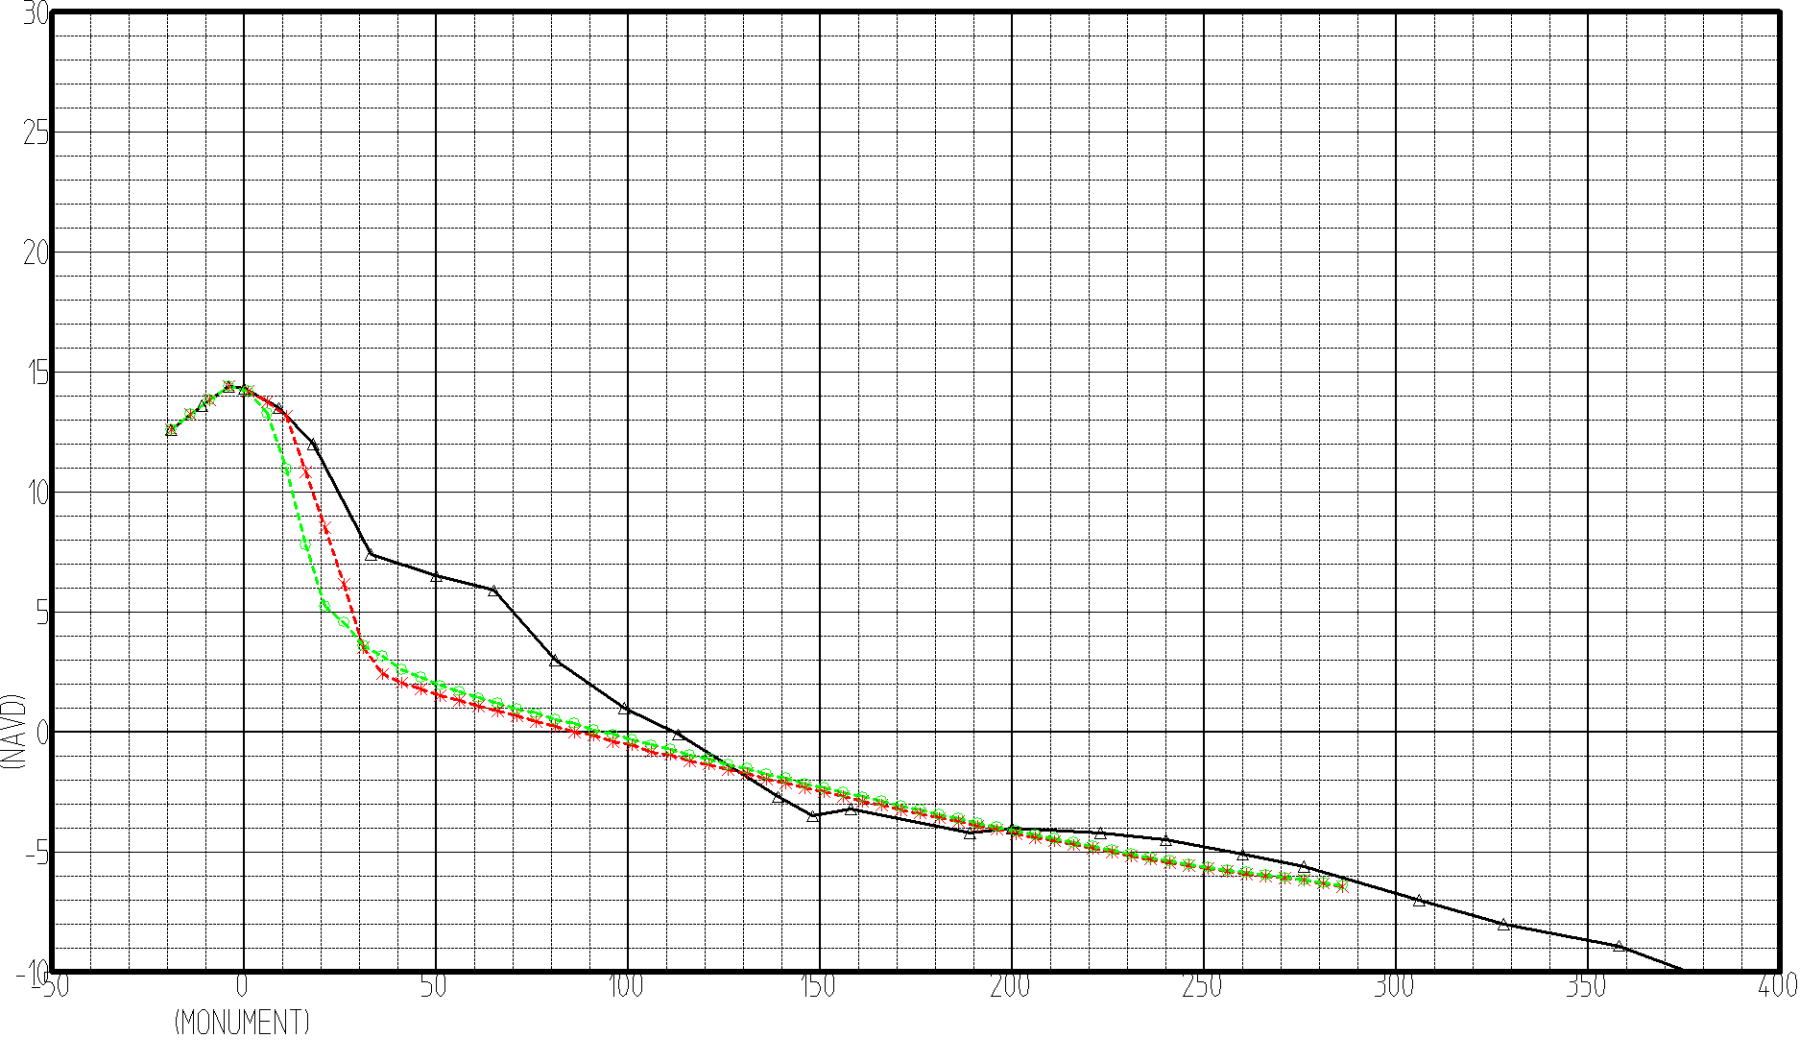
Range: R-28  
 BEARING: 70.00  
 1/1

BEACH PROFILE  
 —△—△— 2007-09 Indian River  
 - - \* - - 15YR SBEACH ERODED  
 - - o - - 25YR SBEACH ERODED

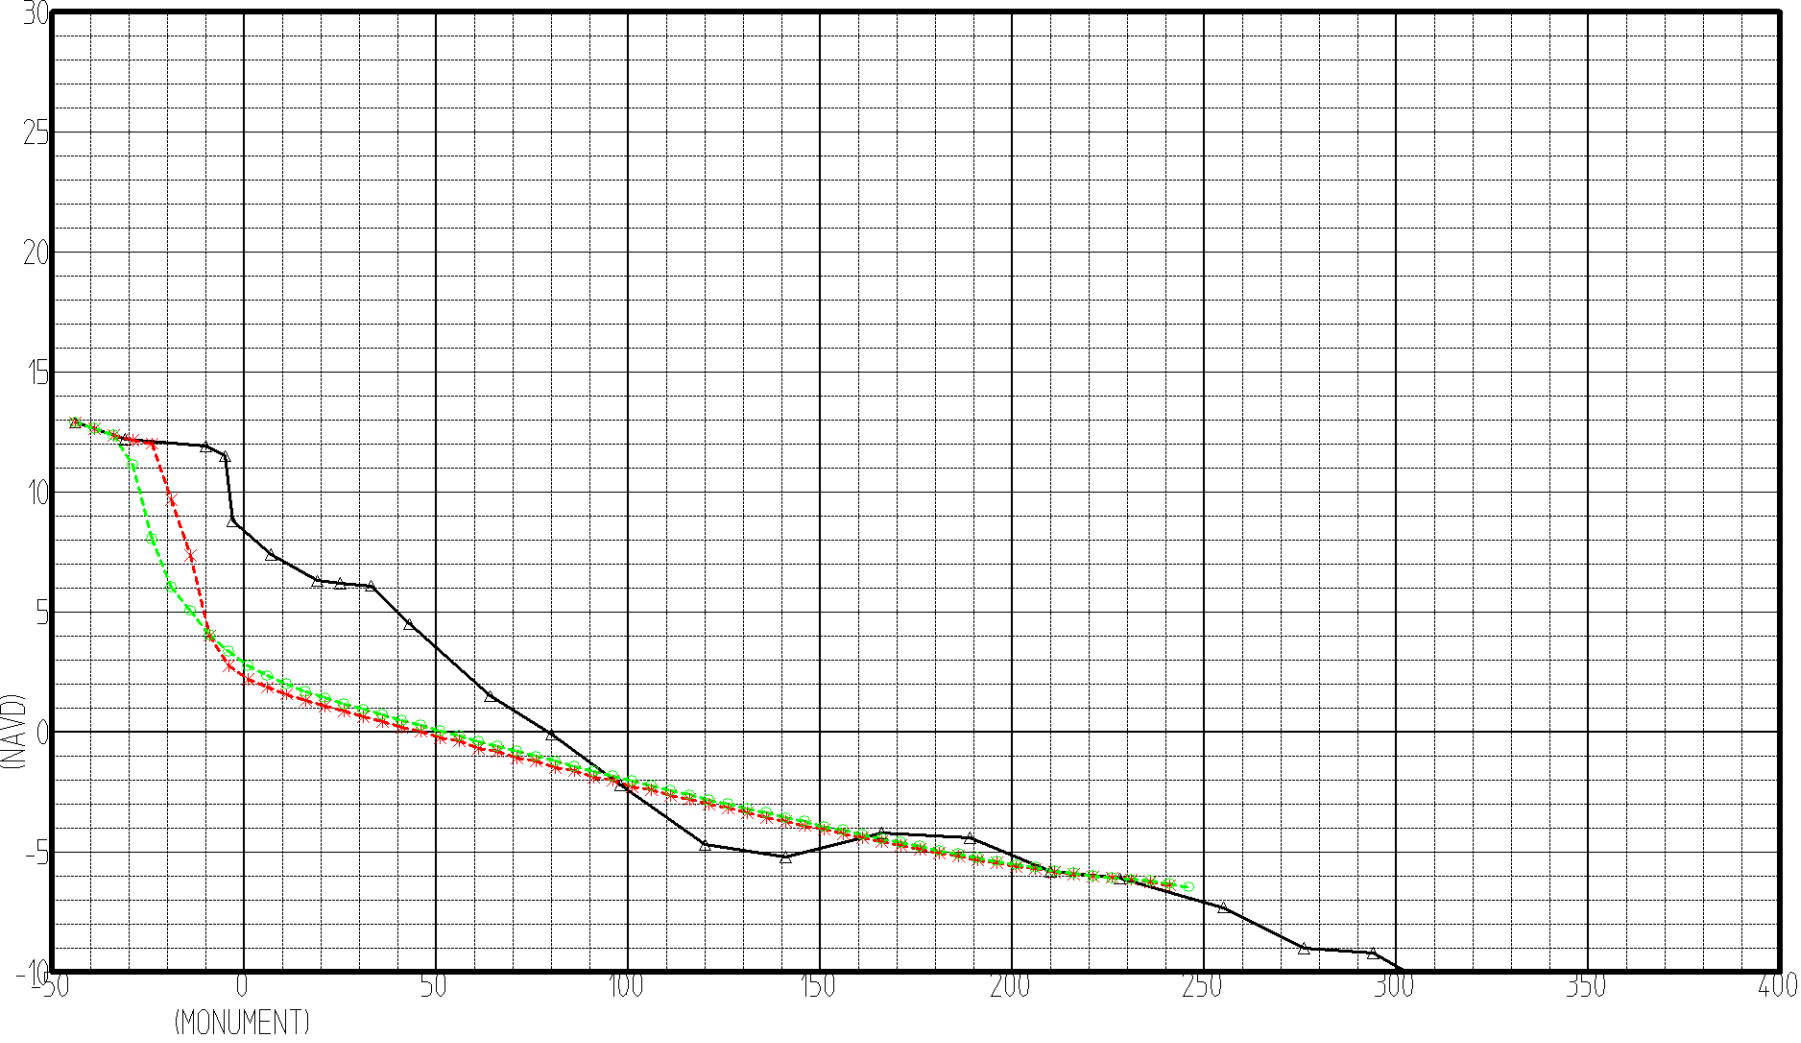
Range: R-29  
 BEARING: 70.00  
 1/1

BEACH PROFILE  
 —△—△— 2007-09 Indian River  
 - - \* - - 15YR SBEACH ERODED  
 - - o - - 25YR SBEACH ERODED

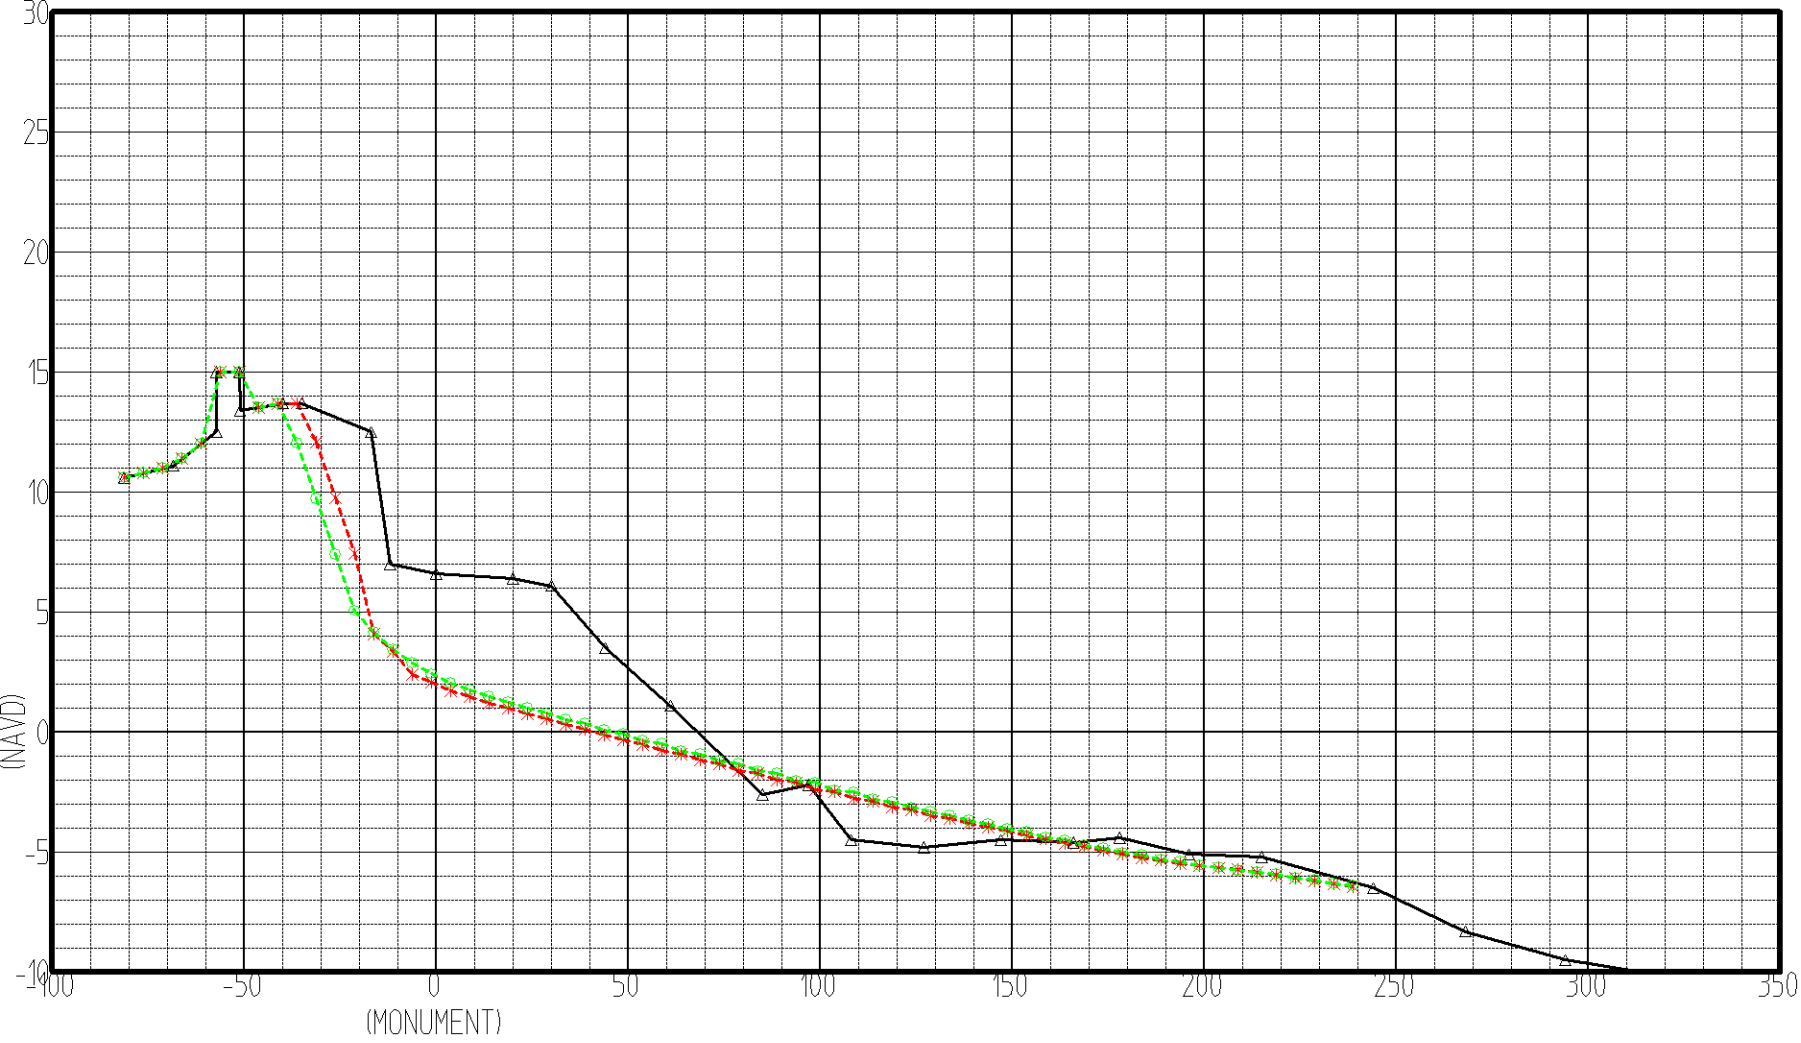
Range: R-30  
 BEARING: 70.00  
 1/1

BEACH PROFILE  
 —△—△— 2007-09 Indian River  
 - - \* - - 15YR SBEACH ERODED  
 - - o - - 25YR SBEACH ERODED

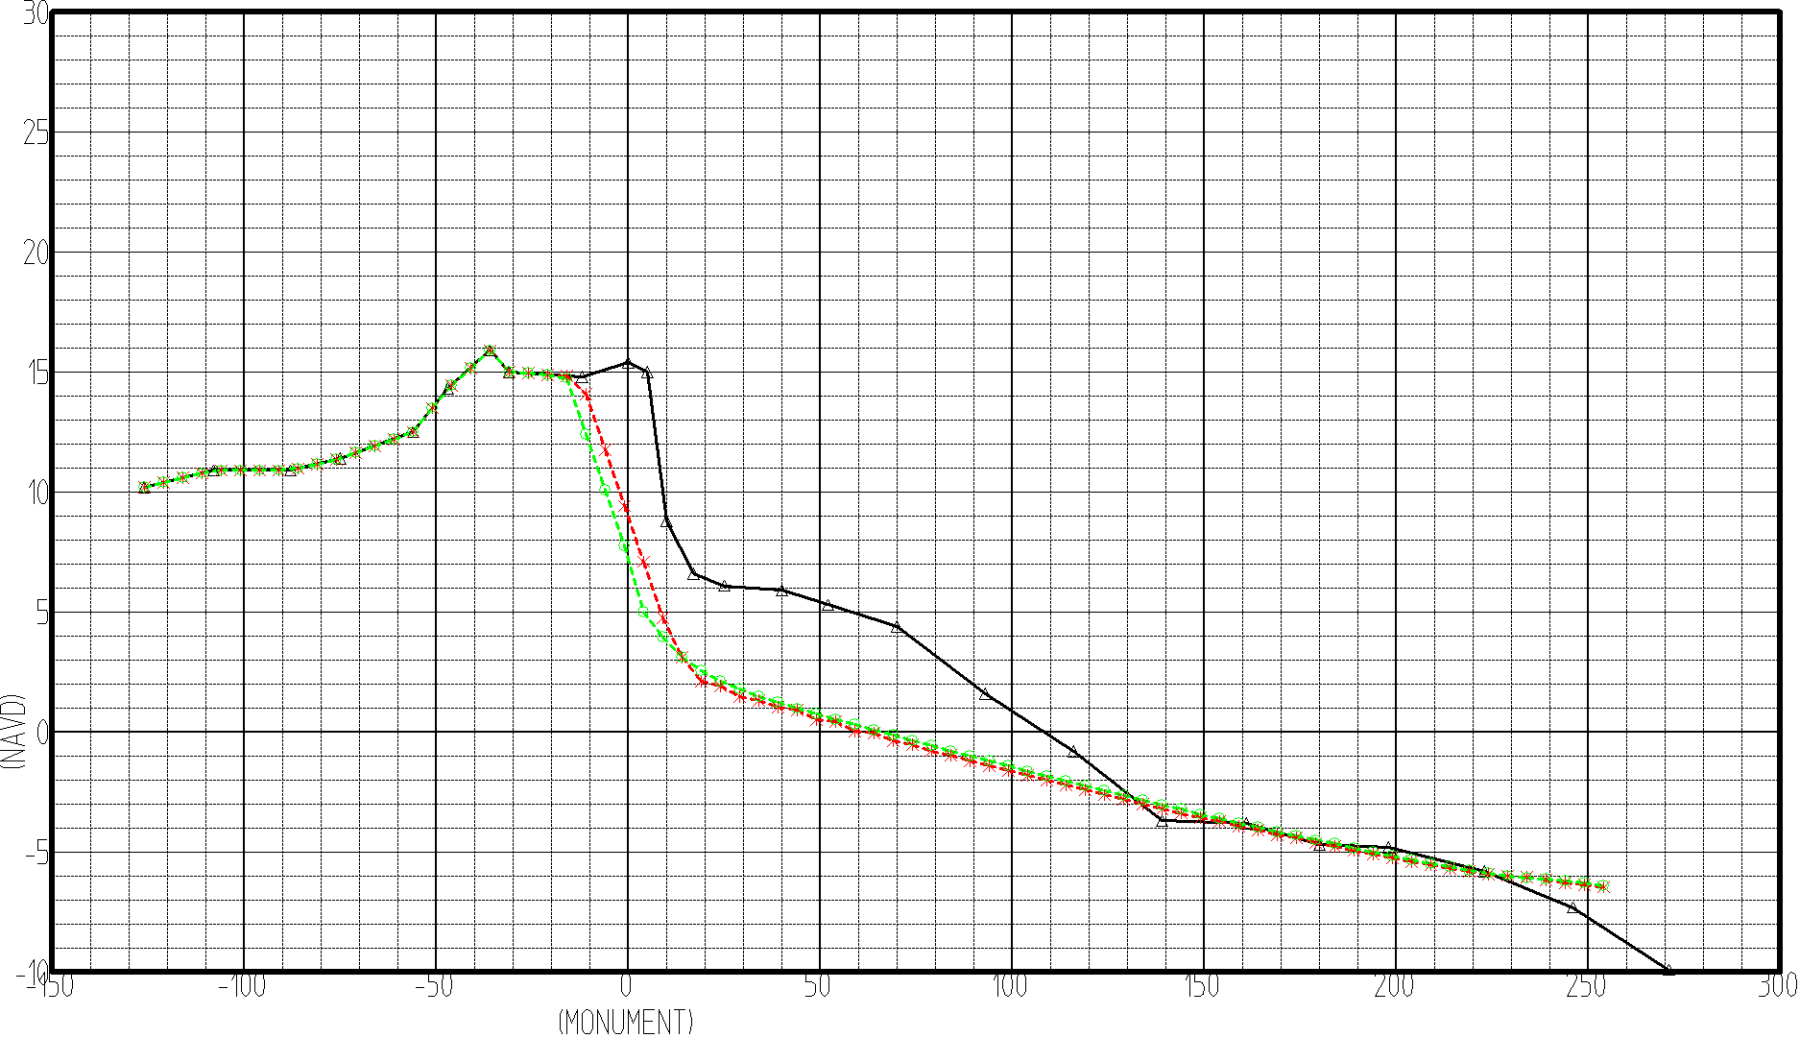
Range: T-31  
 BEARING: 70.00  
 1/2

BEACH PROFILE  
 —△—△— 2007-09 Indian River  
 - - - \* - - - 15YR SBEACH ERODED  
 - - - o - - - 25YR SBEACH ERODED

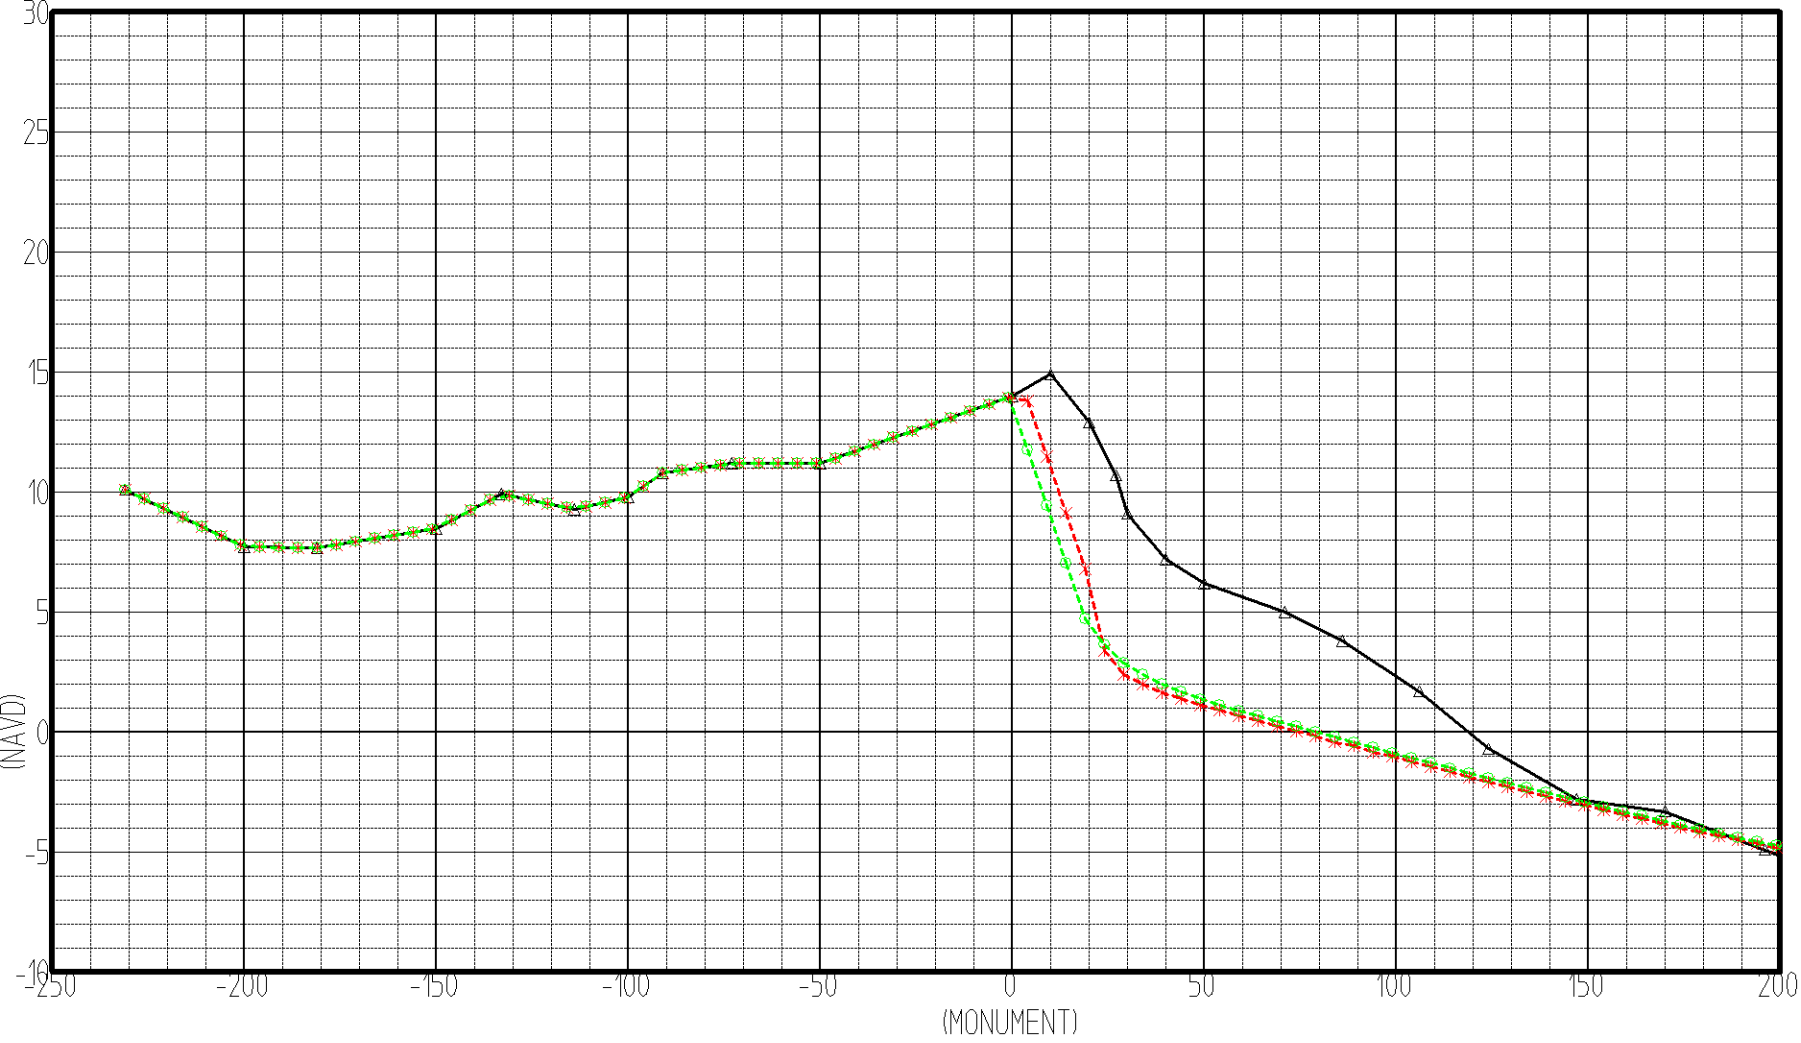
Range: R-32

BEACH PROFILE

—△—△— 2007-09 Indian River

- - - \* - - - 15YR SBEACH ERODED

- - - o - - - 25YR SBEACH ERODED

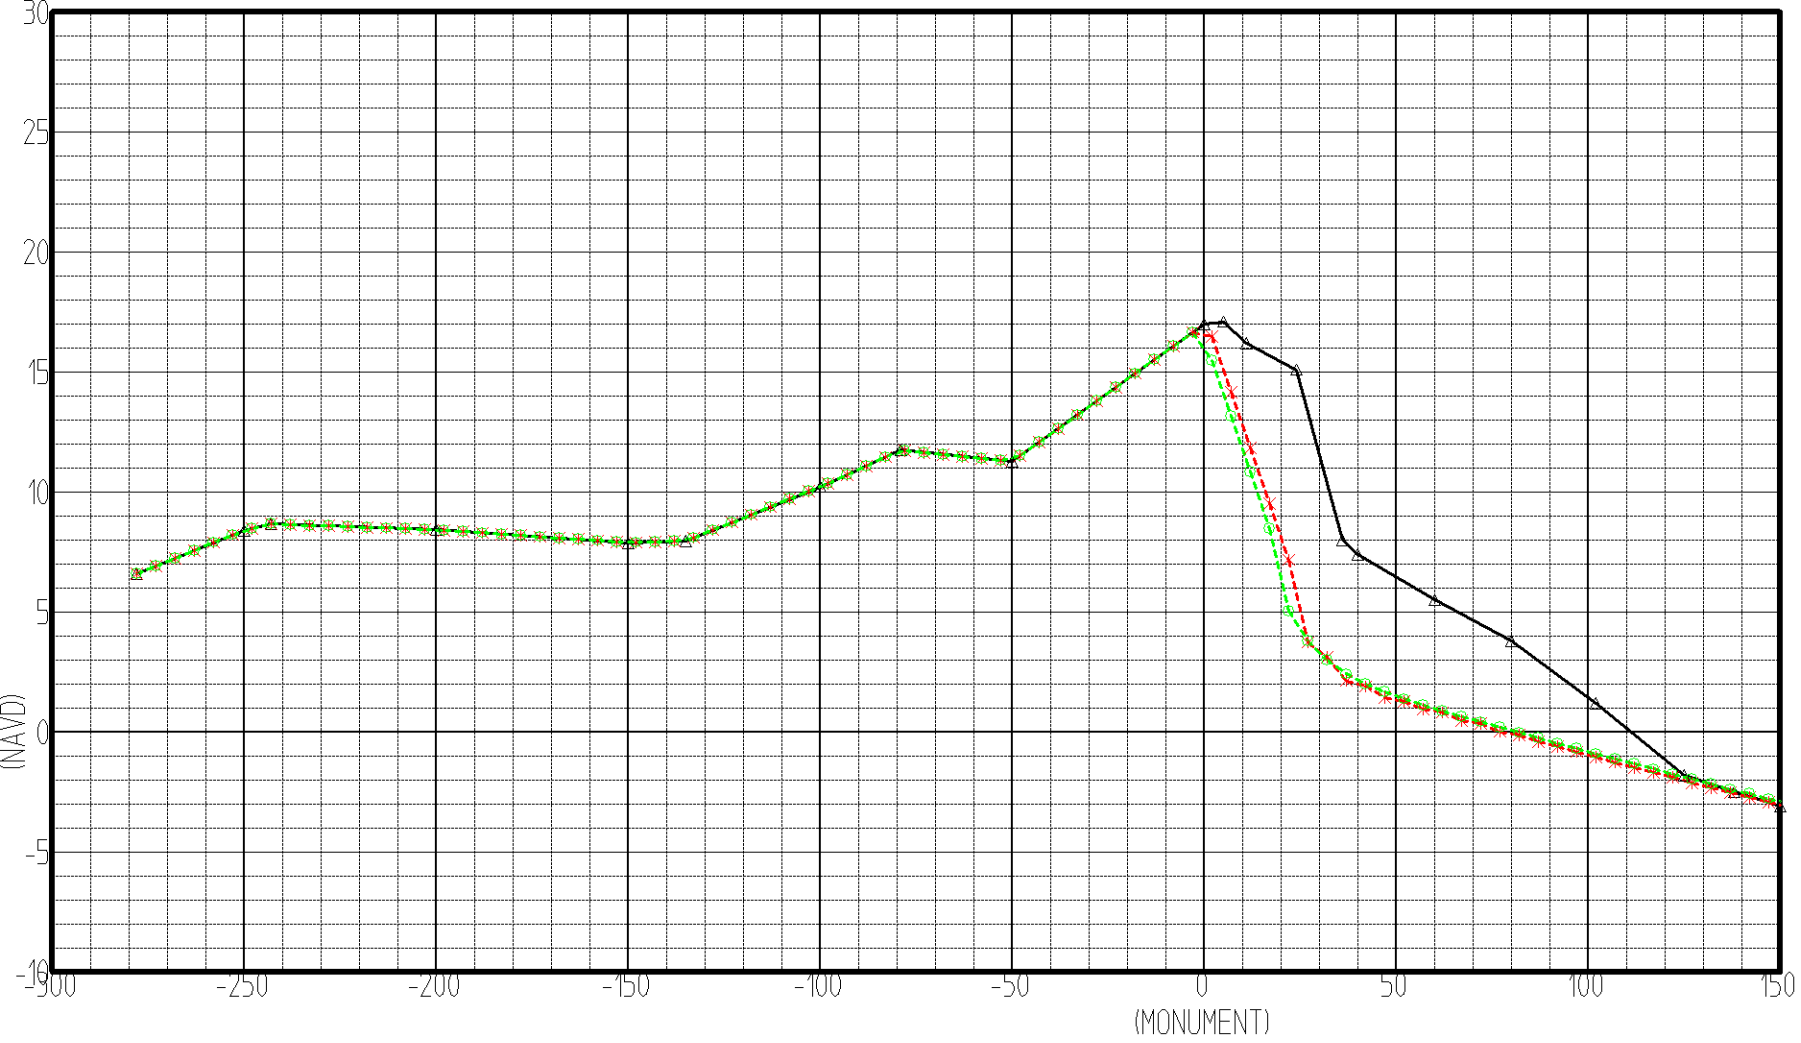
Range: R-33

BEACH PROFILE

—△—△— 2007-09 Indian River

- - \* - - \* - - 15YR SBEACH ERODED

- - o - - o - - 25YR SBEACH ERODED

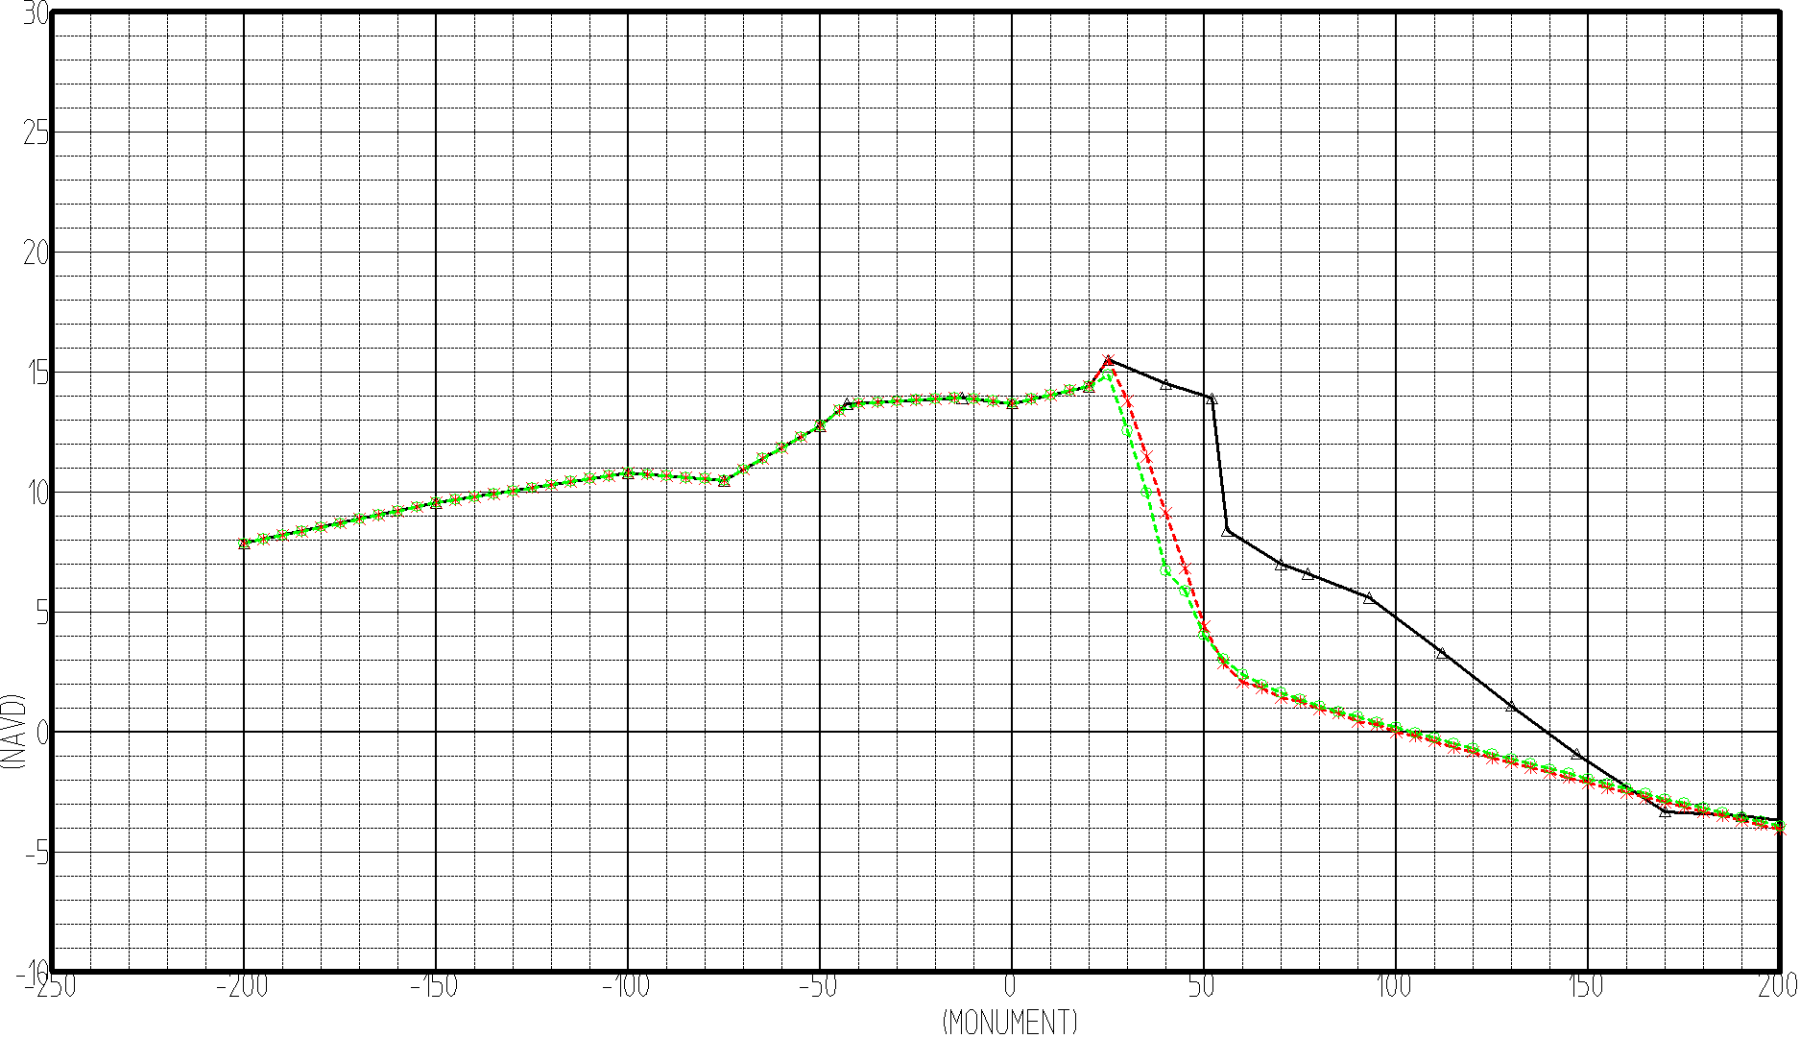
Range: R-34

BEACH PROFILE

—△—△— 2007-09 Indian River

- - - \* - - - 15YR SBEACH ERODED

- - - o - - - 25YR SBEACH ERODED

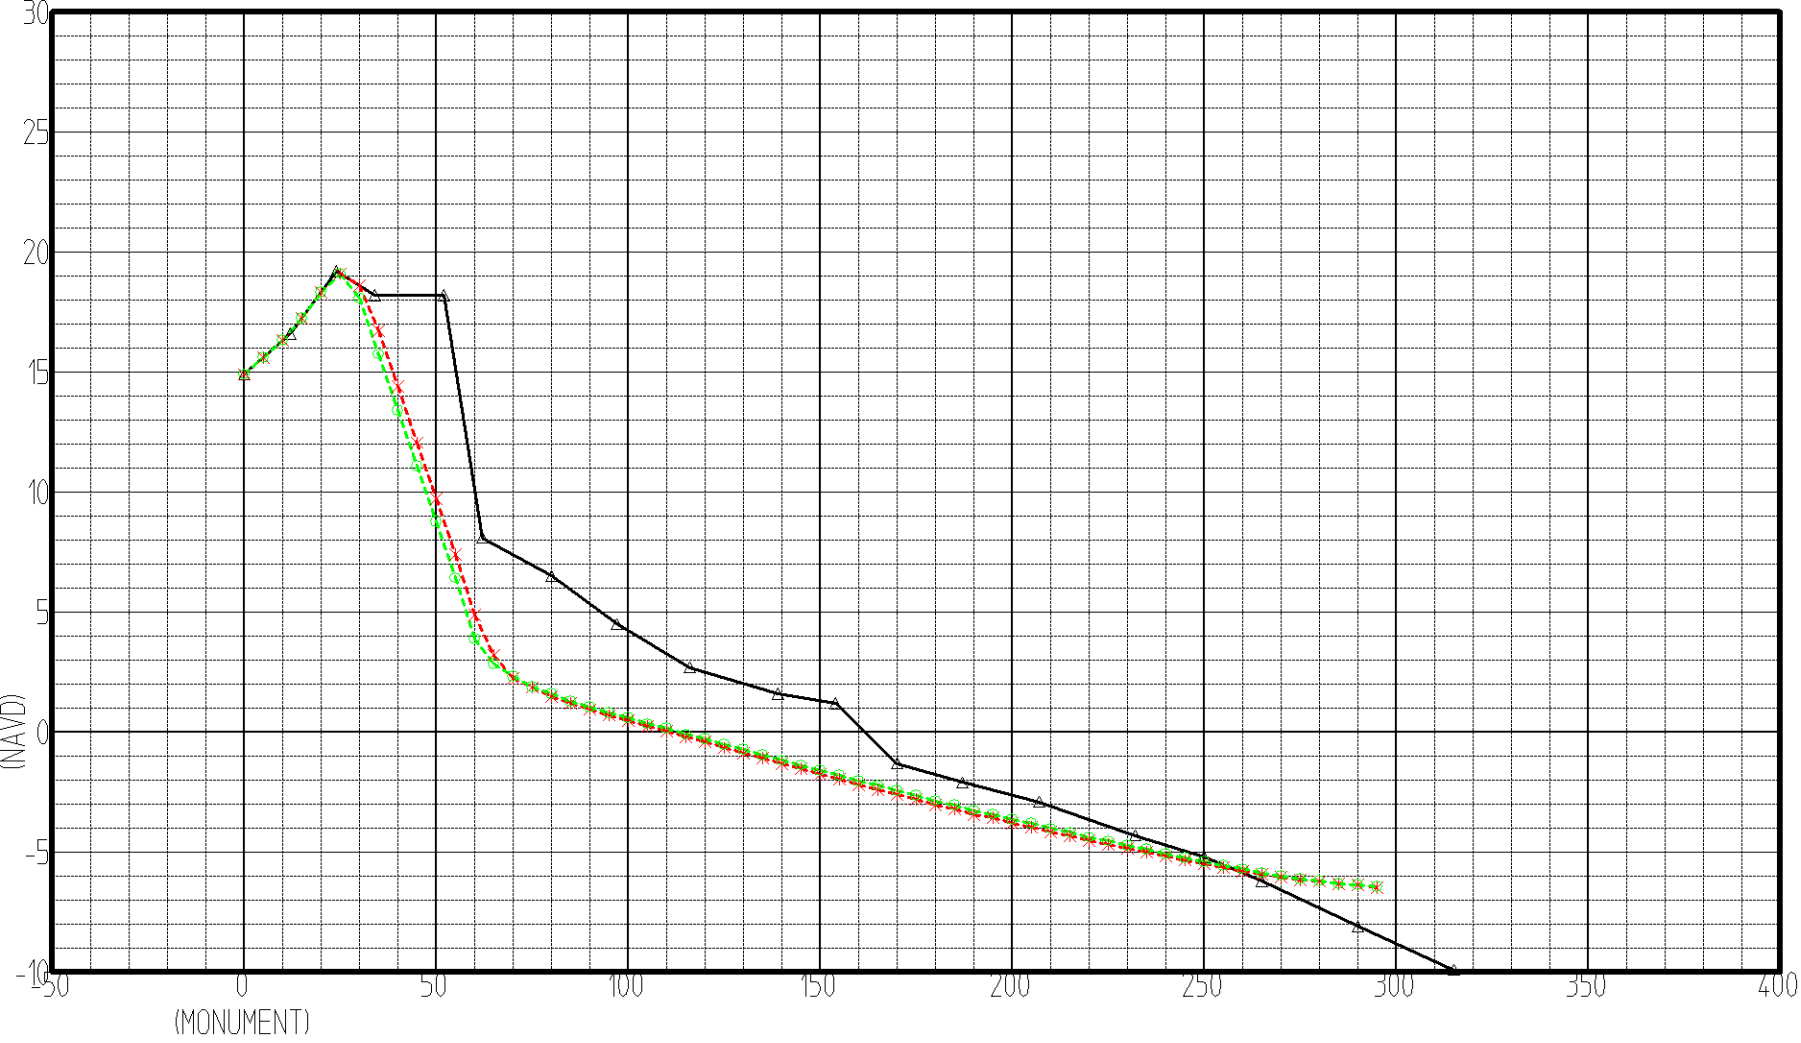
Range: R-35  
 BEARING: 70.00  
 1/2

BEACH PROFILE  
 —△—△— 2007-09 Indian River  
 - - \* - - 15YR SBEACH ERODED  
 - - o - - 25YR SBEACH ERODED

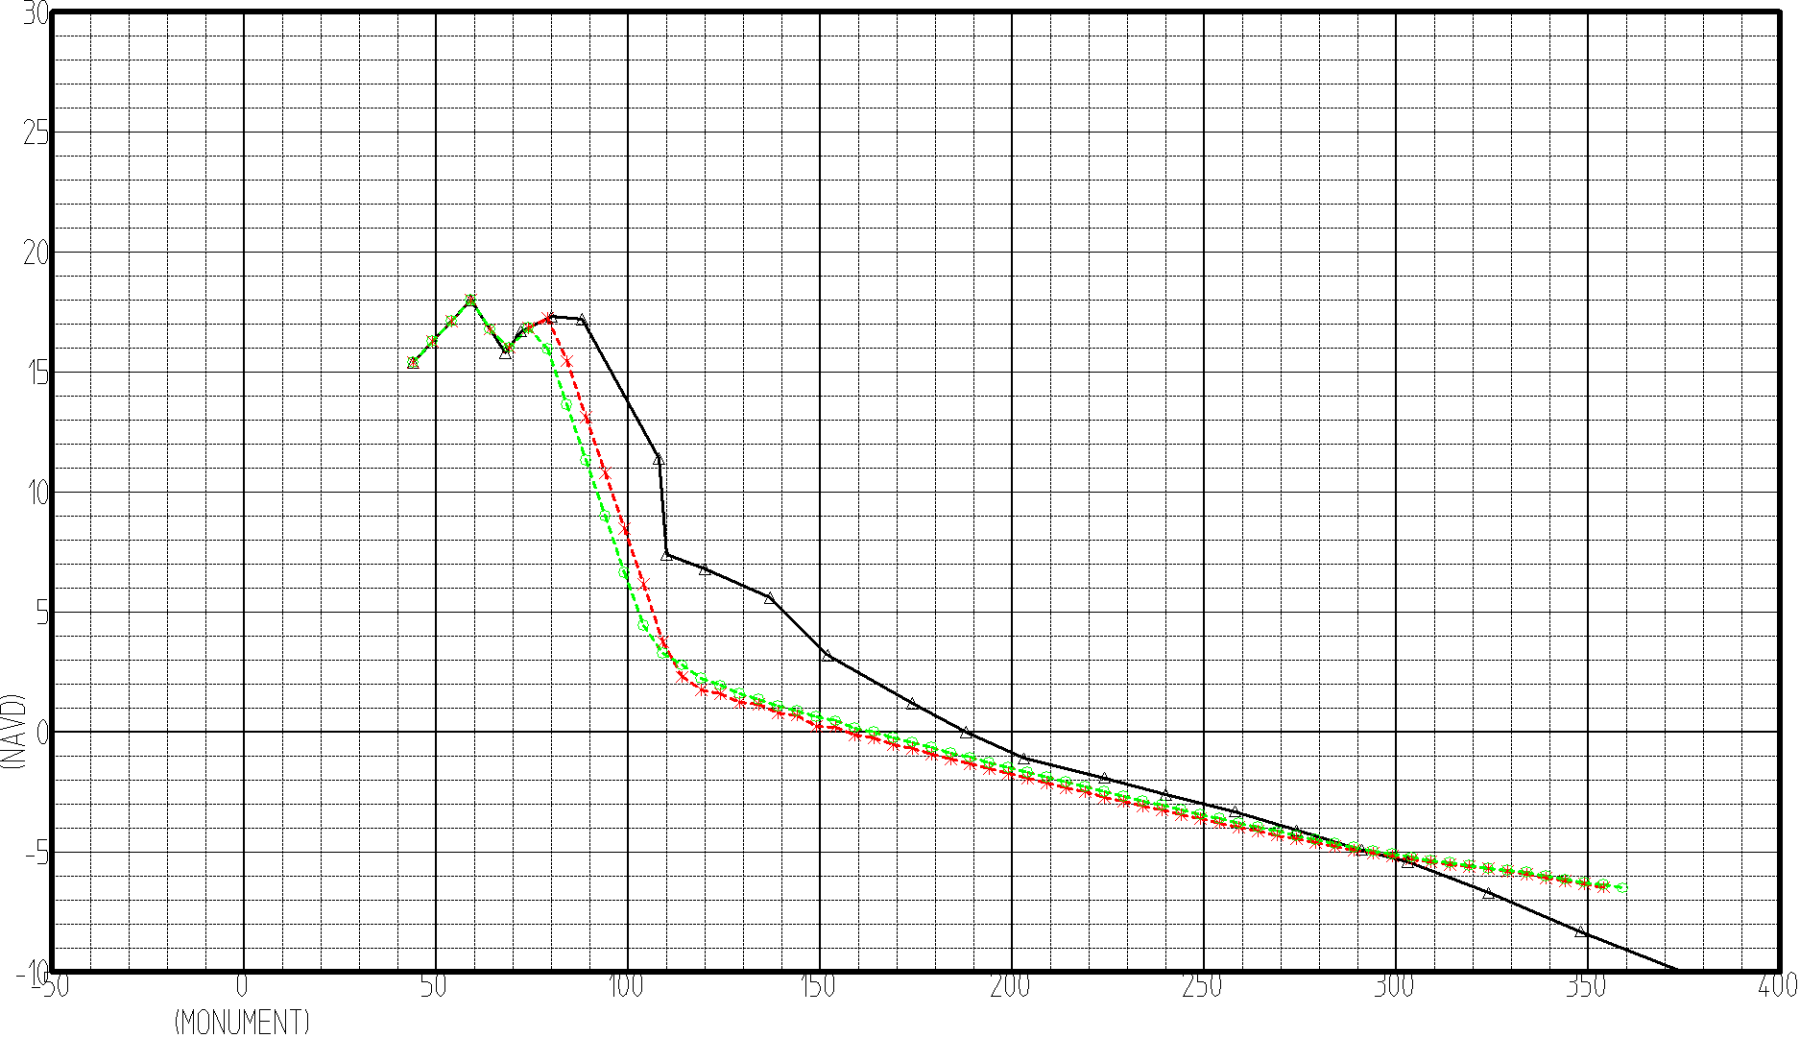
Range: T-36 1/2

BEACH PROFILE

- △—△— 2007-09 Indian River
- - - \* - - - 15YR SBEACH ERODED
- - - o - - - 25YR SBEACH ERODED
