## **Appendix X**

SBEACH 15 and 25 yr. Storm Erosion Profiles

Indian River County

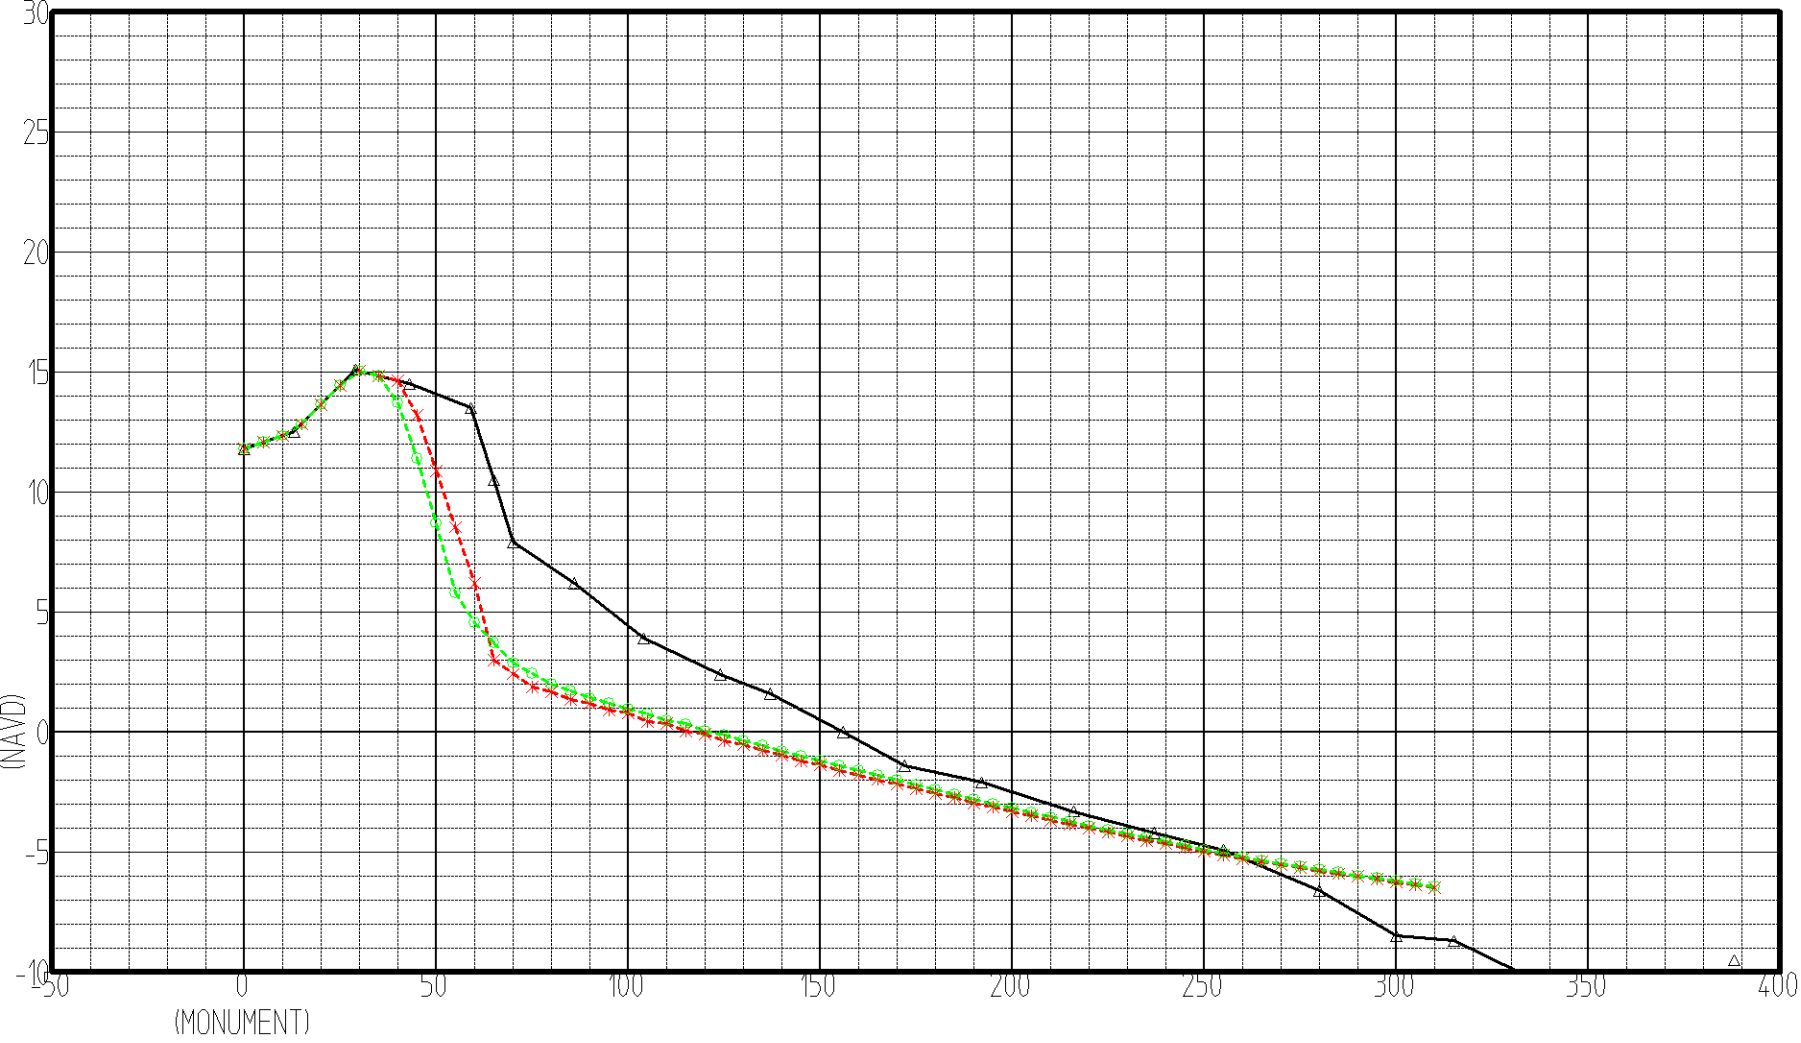
Range: R-37  
 BEARING: 70.00  
 1/2

BEACH PROFILE  
 —△—△— 2007-09 Indian River  
 - - \* - - 15YR SBEACH ERODED  
 - - o - - 25YR SBEACH ERODED

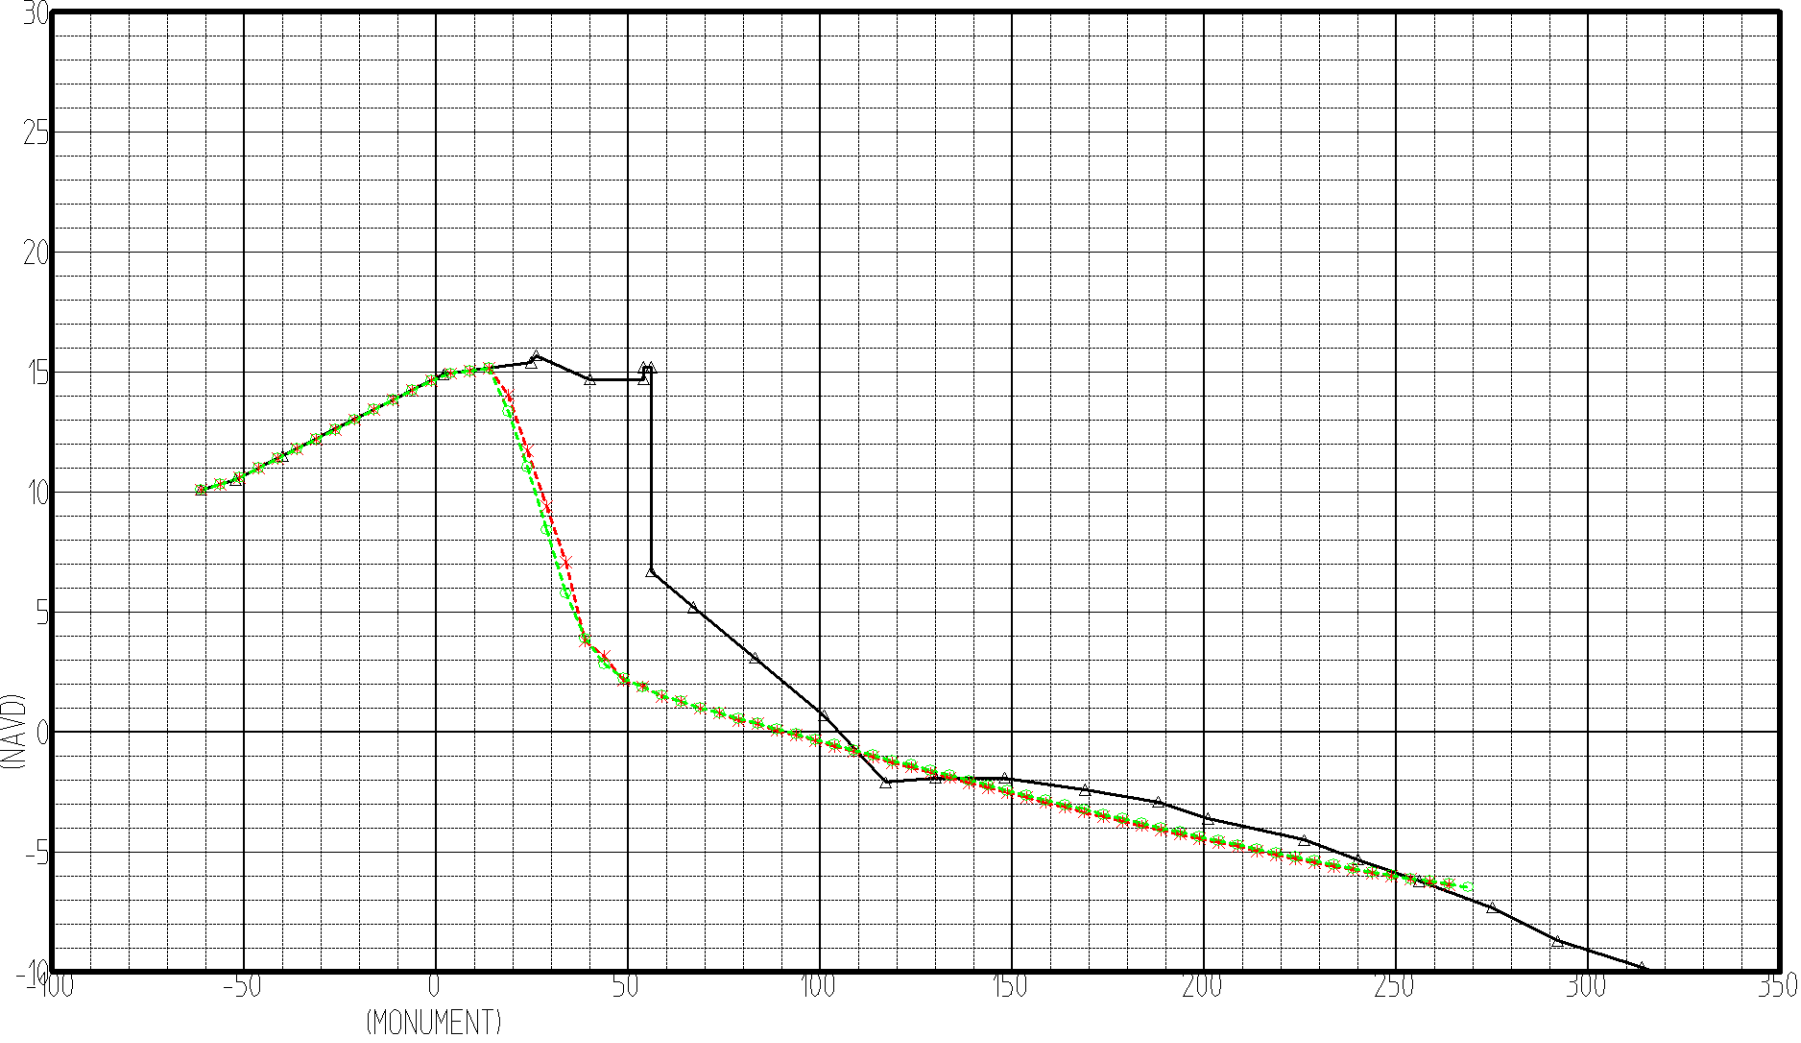
Range: T-38

BEACH PROFILE

—△—△— 2007-09 Indian River

- - - \* - - - 15YR SBEACH ERODED

- - - o - - - 25YR SBEACH ERODED

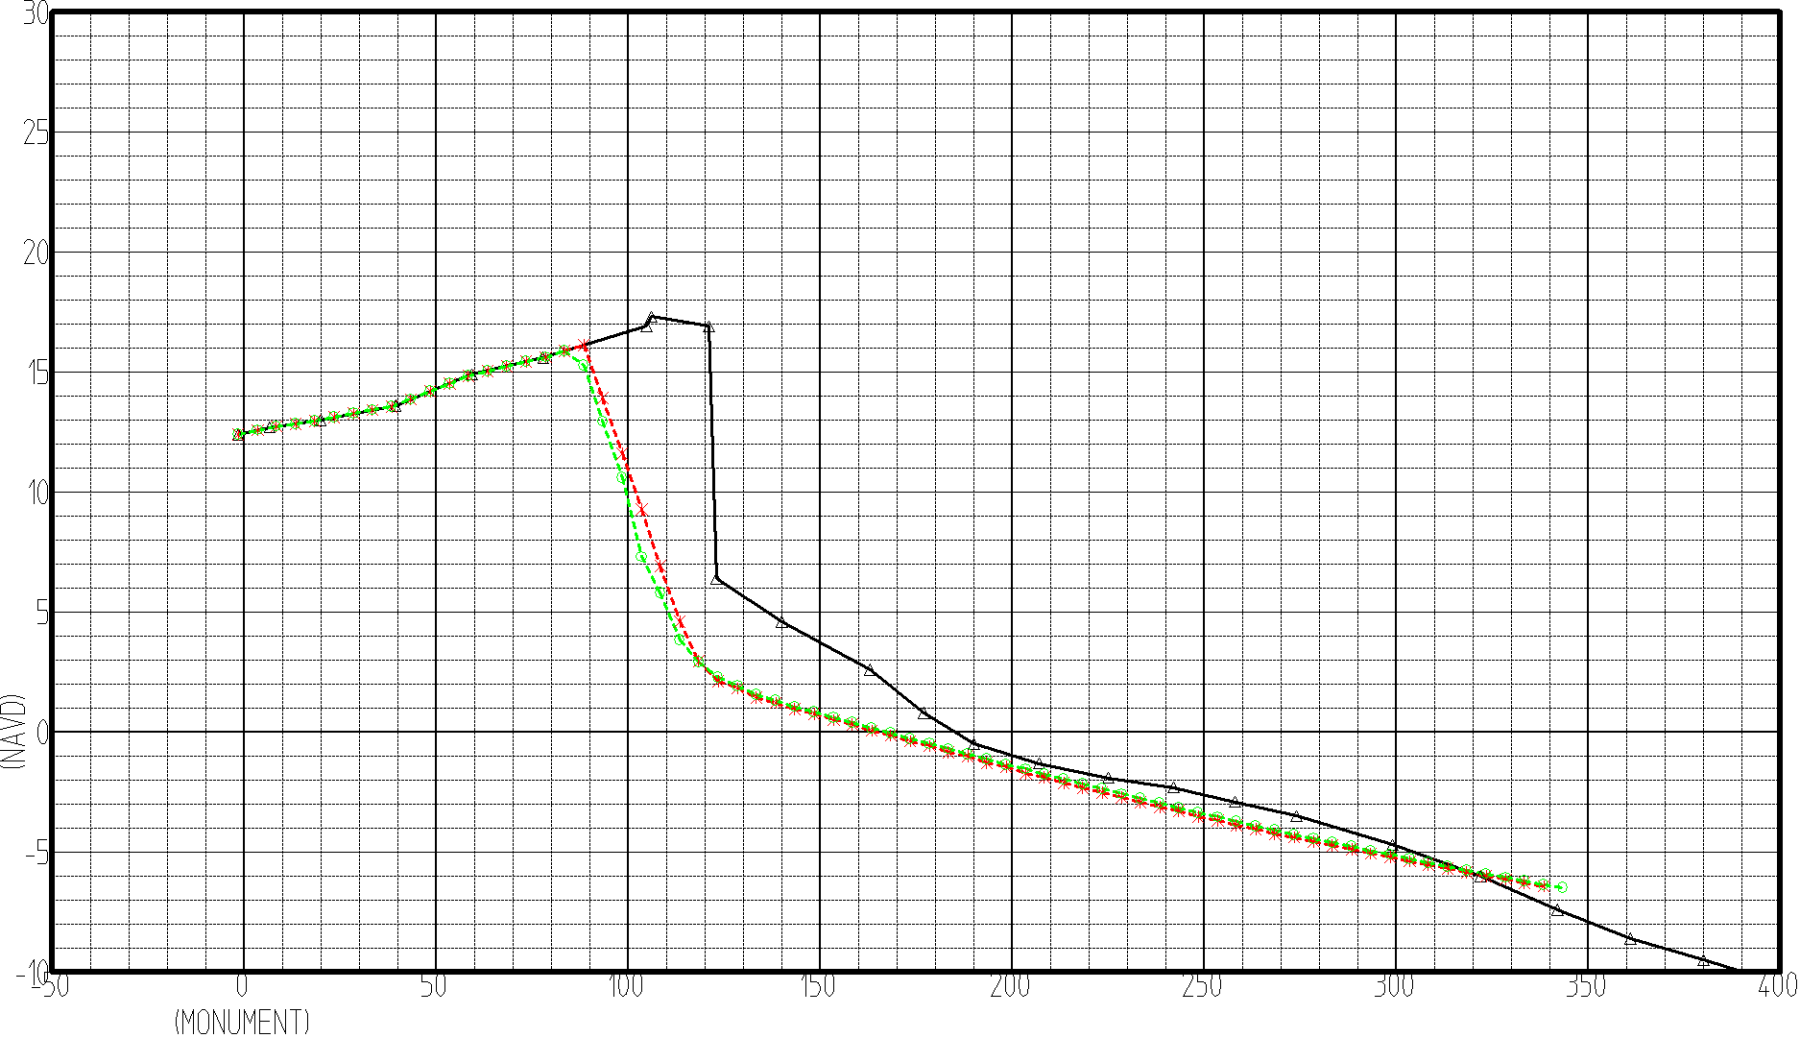
BEACH PROFILE

- △—△— 2007-09 Indian River
- - - \* - - - 15YR SBEACH ERODED
- - - o - - - 25YR SBEACH ERODED

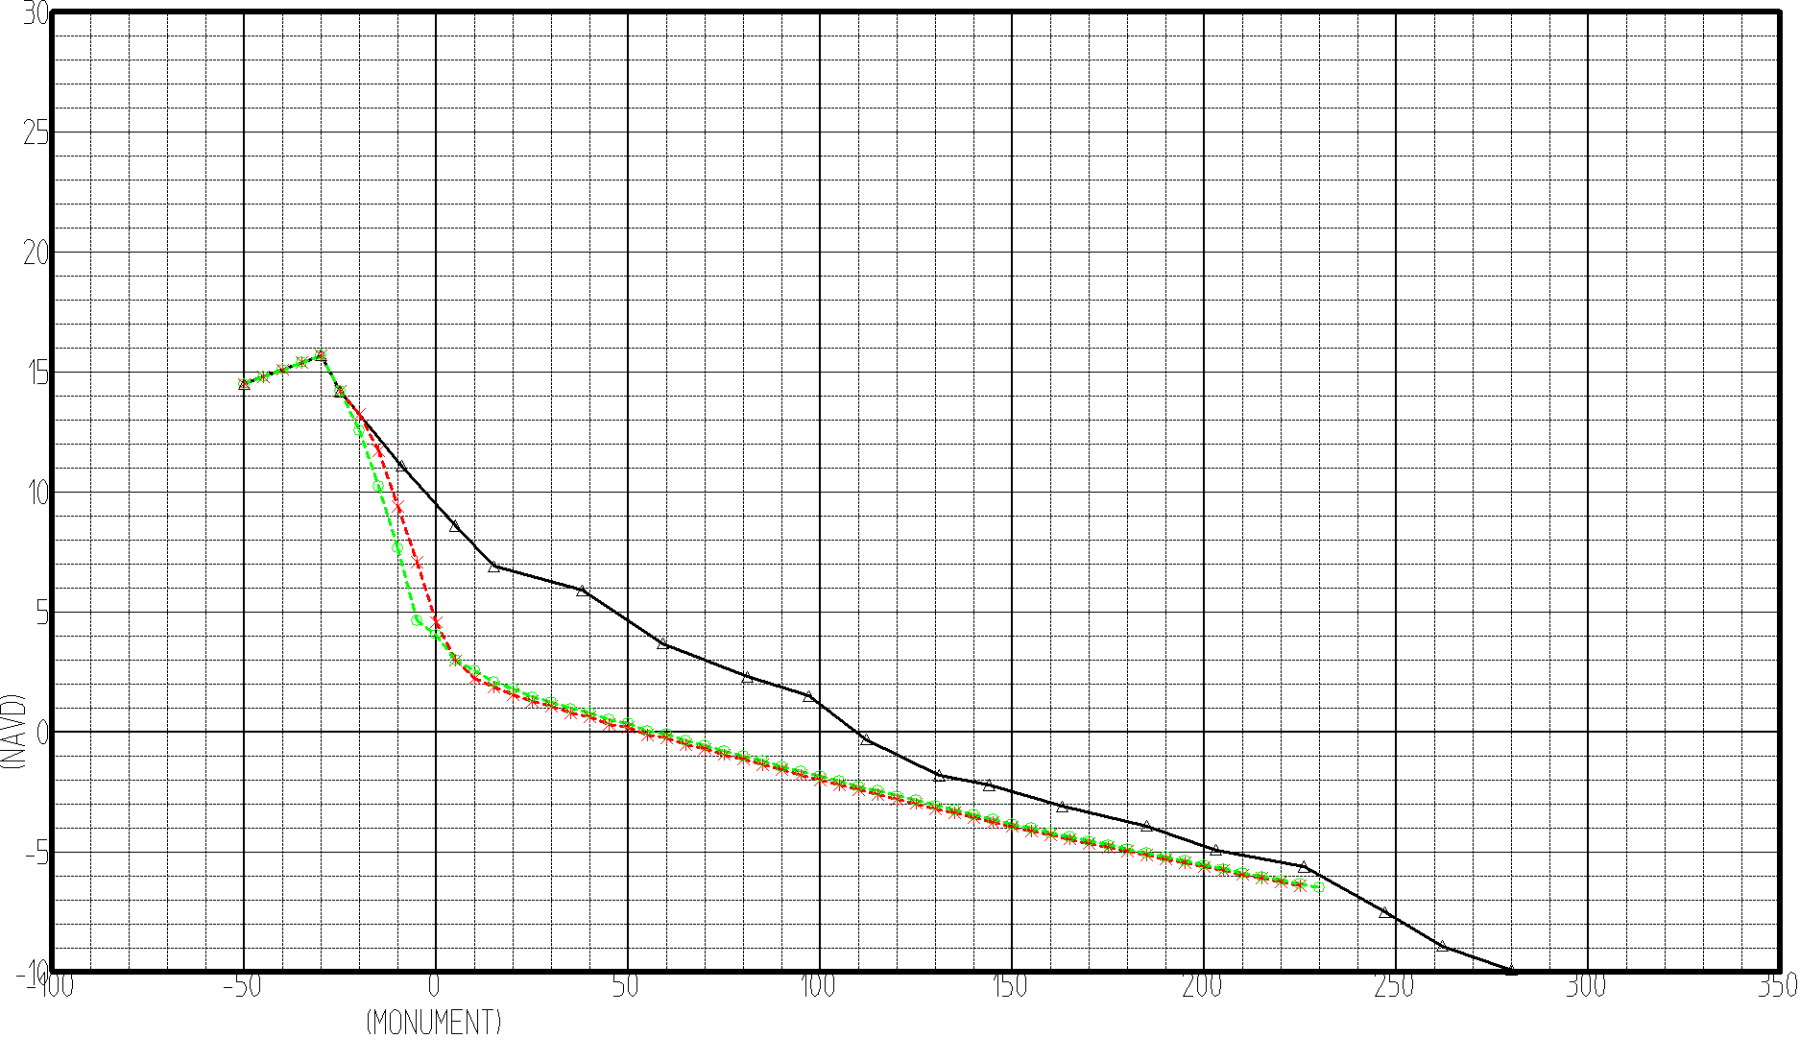
Range: R-40

BEACH PROFILE

—△—△— 2007-09 Indian River

- - \* - - \* - - 15YR SBEACH ERODED

- - o - - o - - 25YR SBEACH ERODED

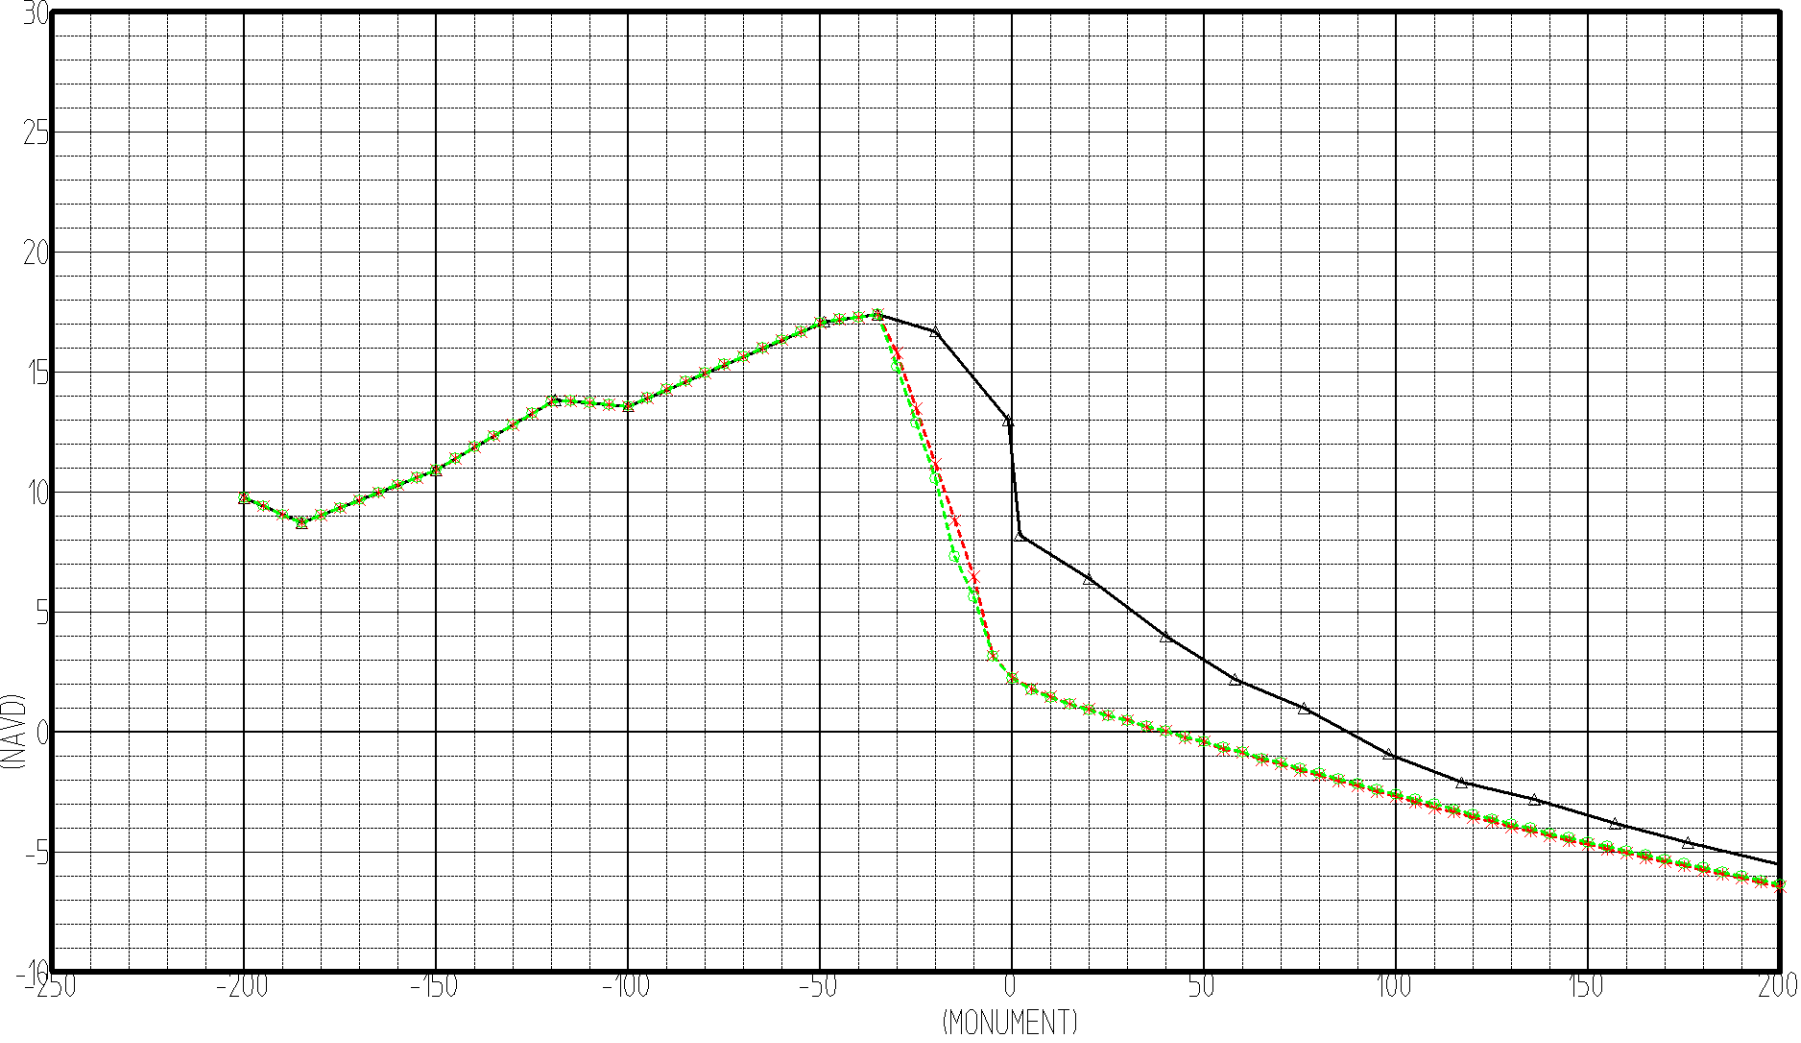
Range: R-41  
 BEARING: 70.00  
 1/2

BEACH PROFILE  
 —△—△— 2007-09 Indian River  
 - - \* - - 15YR SBEACH ERODED  
 - - o - - 25YR SBEACH ERODED

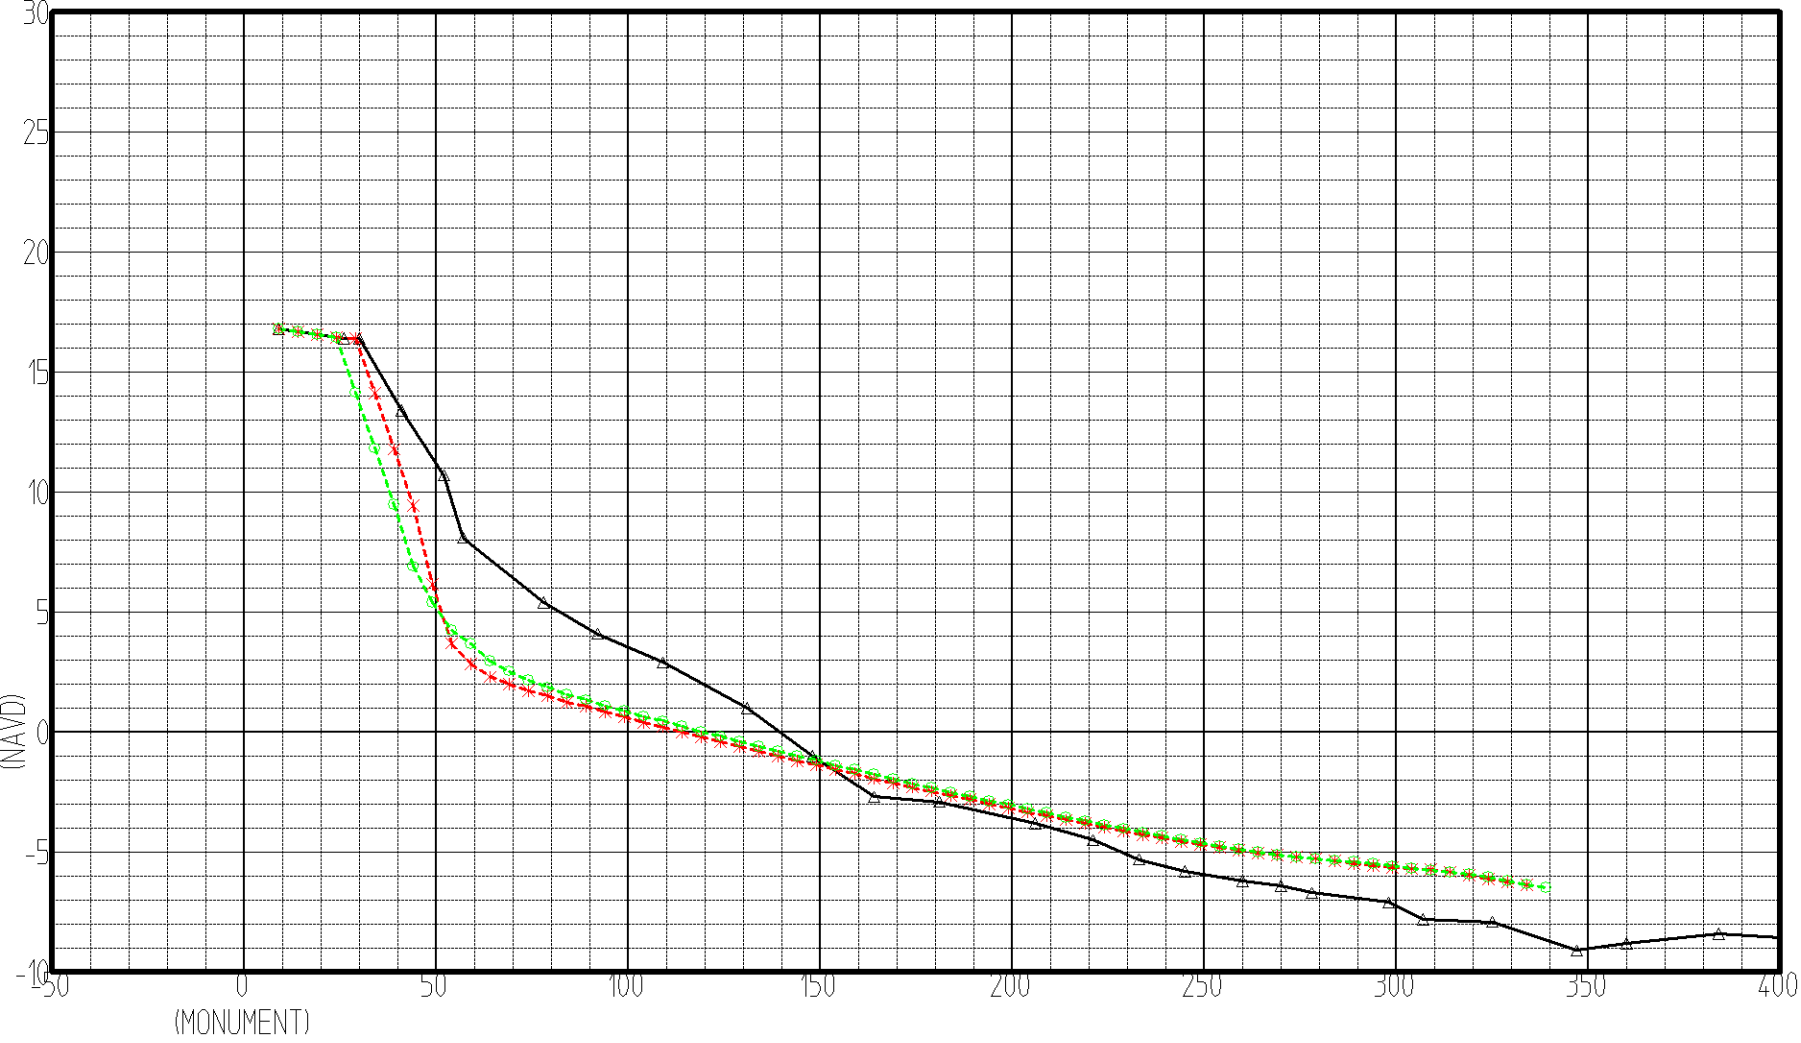
Range: R-42 1/2

BEACH PROFILE

- △—△— 2007-09 Indian River
- - - \* - - - 15YR SBEACH ERODED
- - - o - - - 25YR SBEACH ERODED

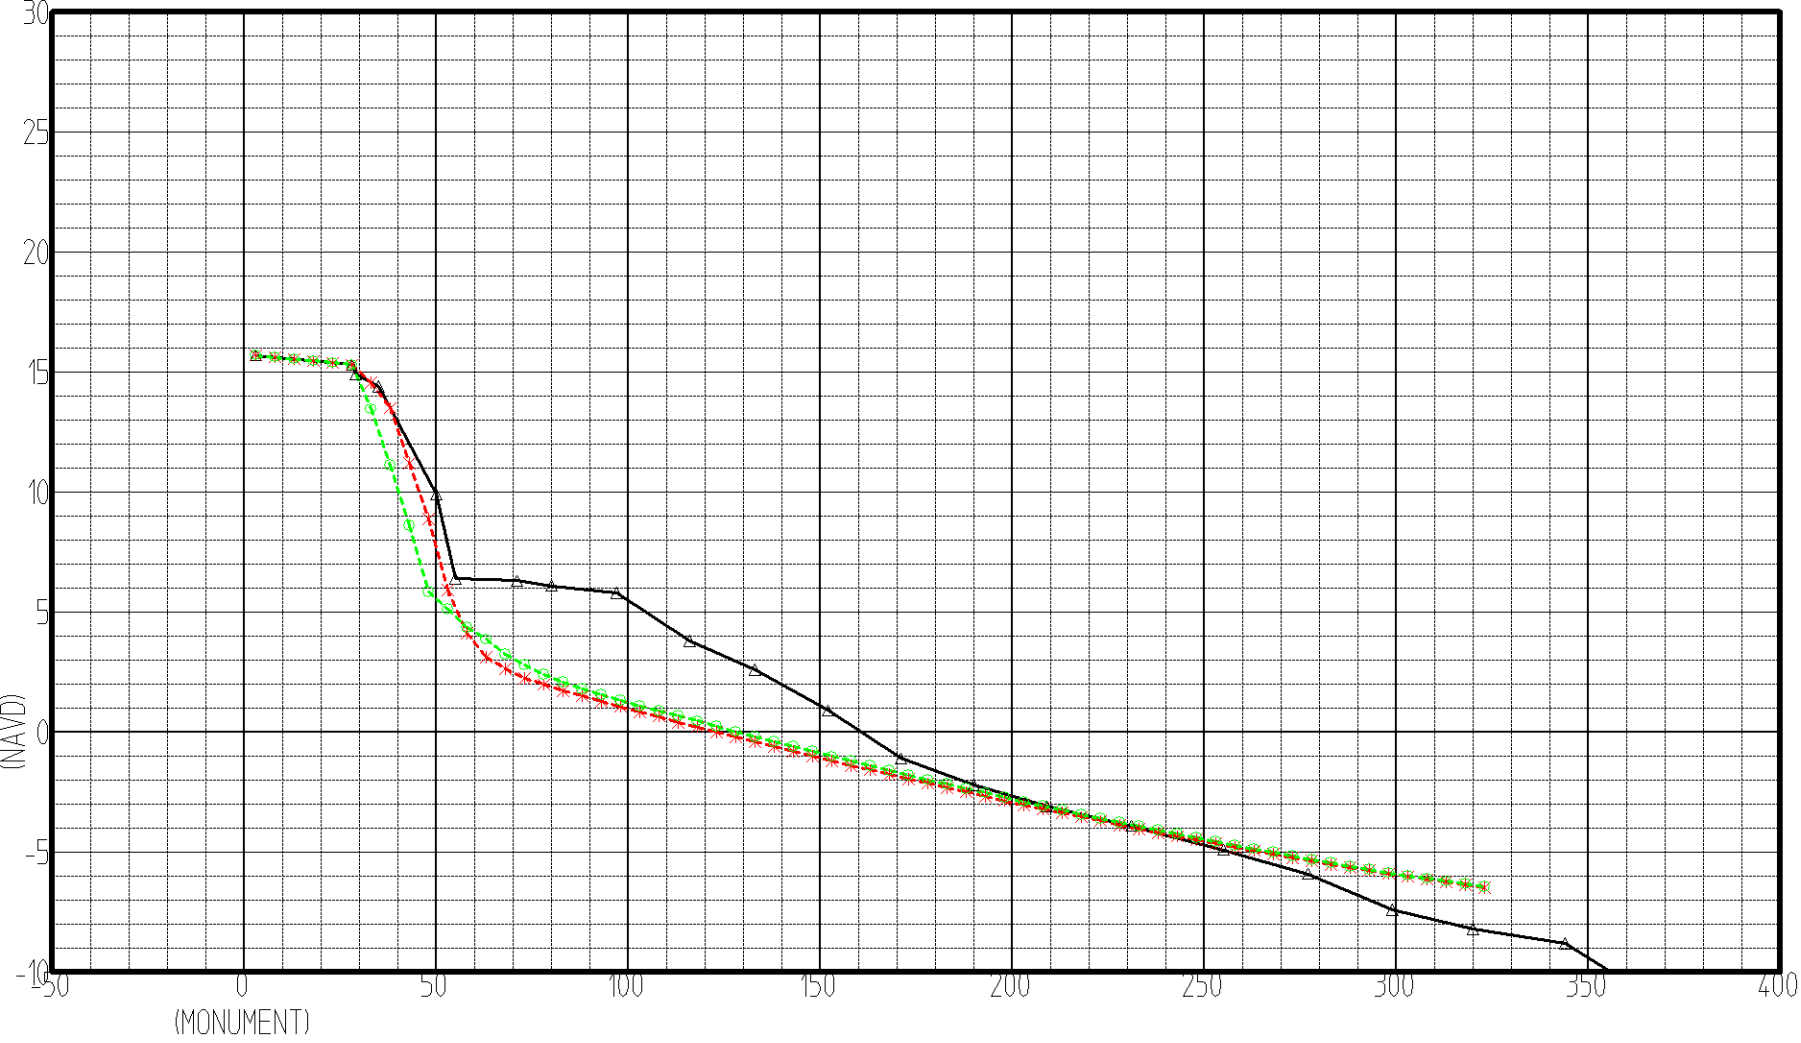
Range: R-43  
 BEARING: 70.00  
 1/2

BEACH PROFILE  
 —△—△— 2007-09 Indian River  
 - - \* - - 15YR SBEACH ERODED  
 - - o - - 25YR SBEACH ERODED

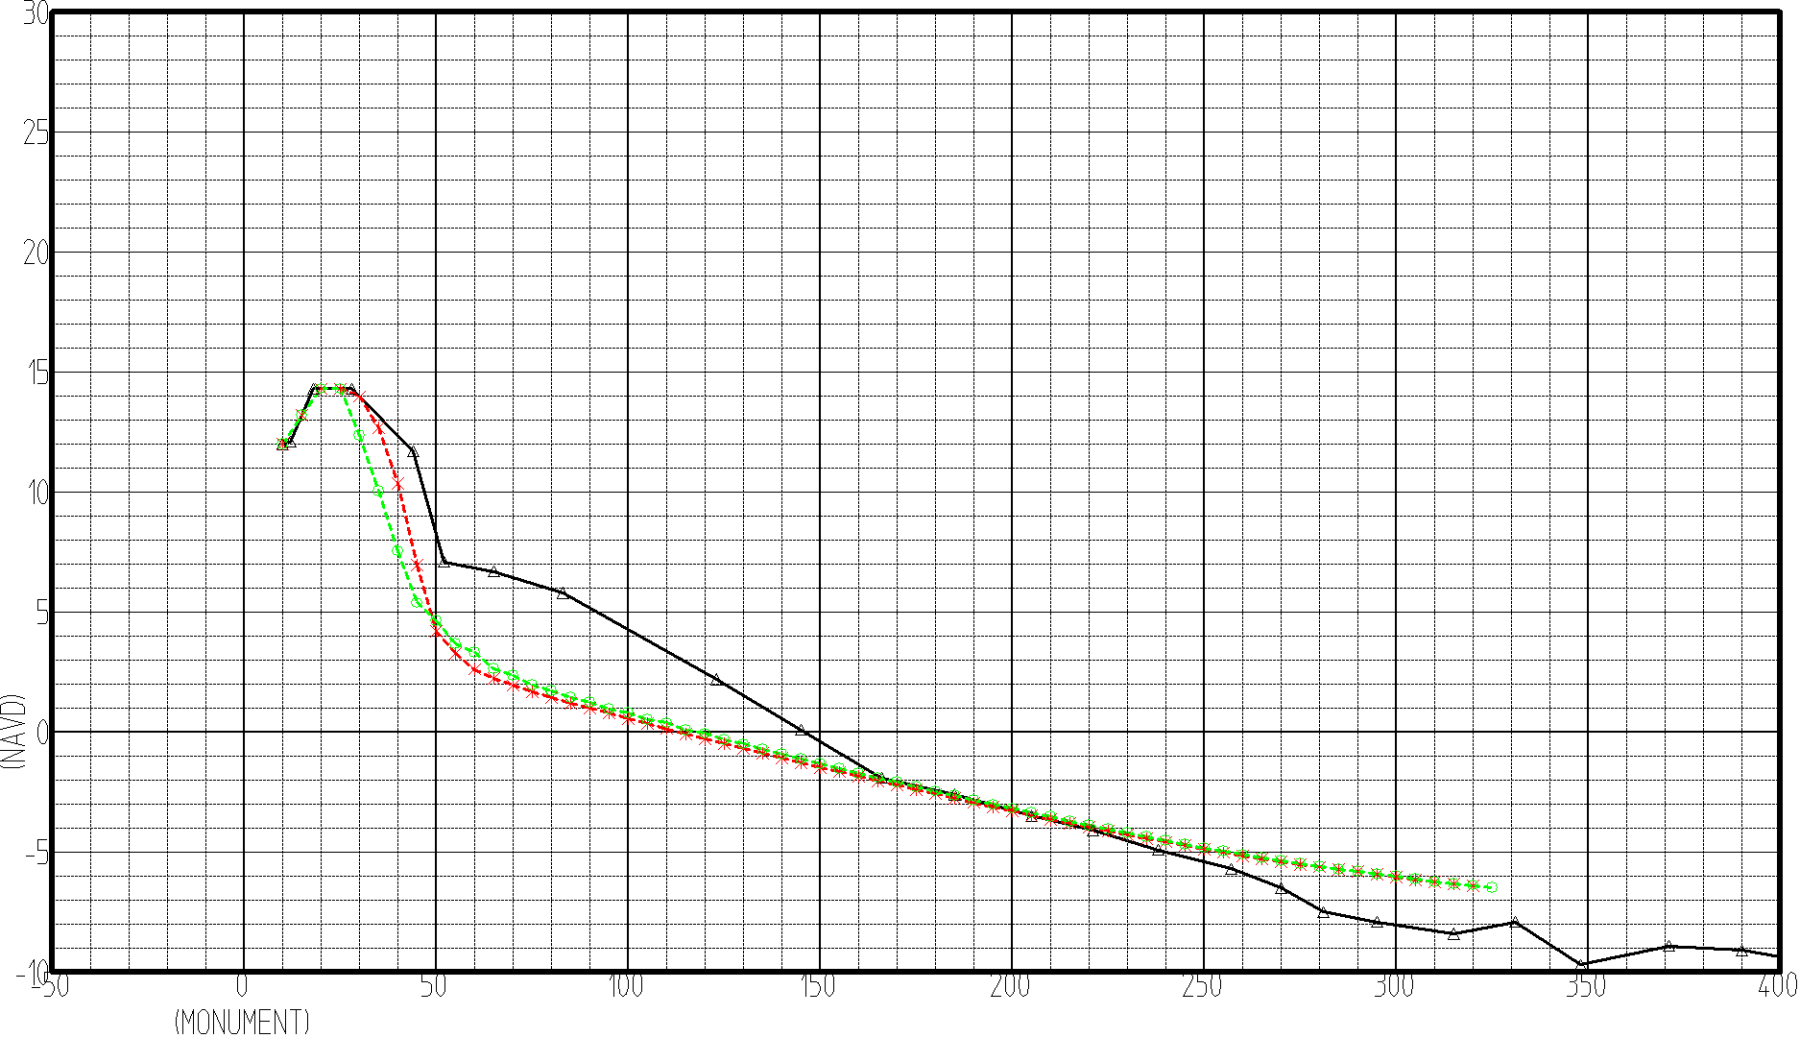
Range: R-44  
 BEARING: 70.00  
 1/2

BEACH PROFILE  
 —△—△— 2007-09 Indian River  
 - - \* - - 15YR SBEACH ERODED  
 - - o - - 25YR SBEACH ERODED

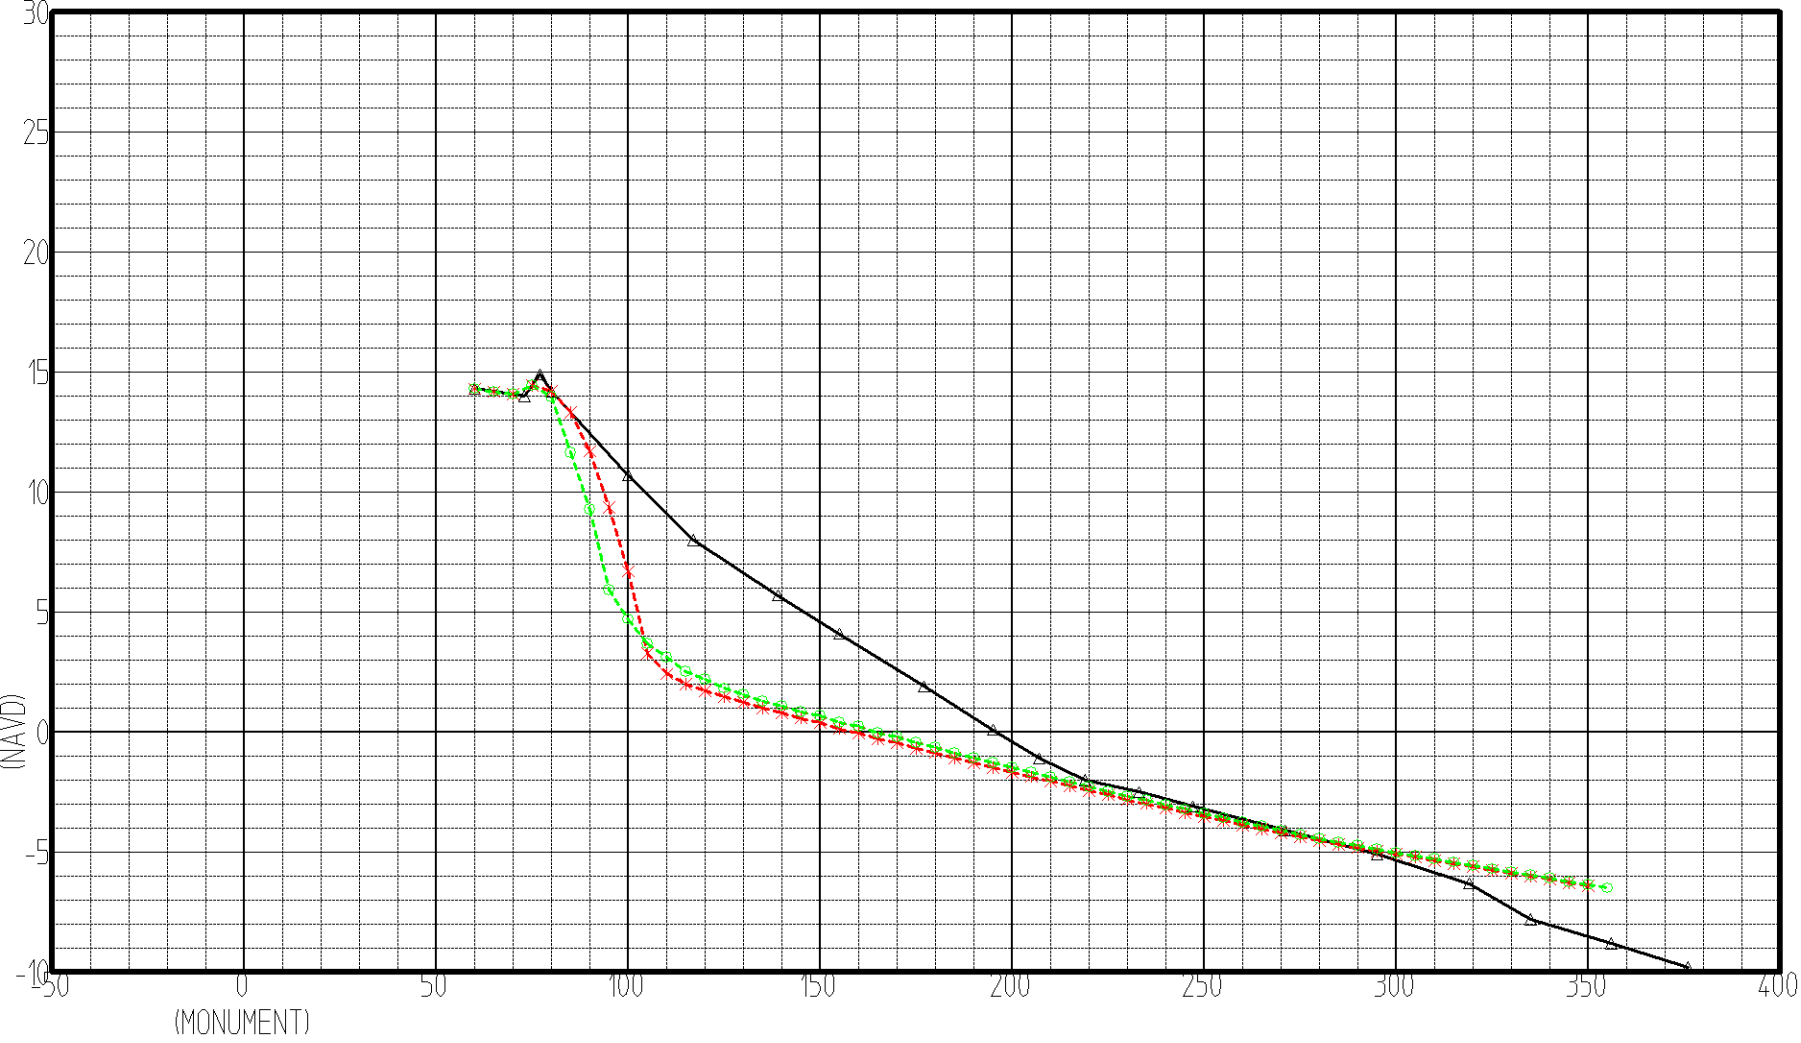
Range: T-45  
 BEARING: 70.00  
 1/2

BEACH PROFILE  
 —△—△— 2007-09 Indian River  
 - - \* - - \* - - 15YR SBEACH ERODED  
 - - o - - o - - 25YR SBEACH ERODED

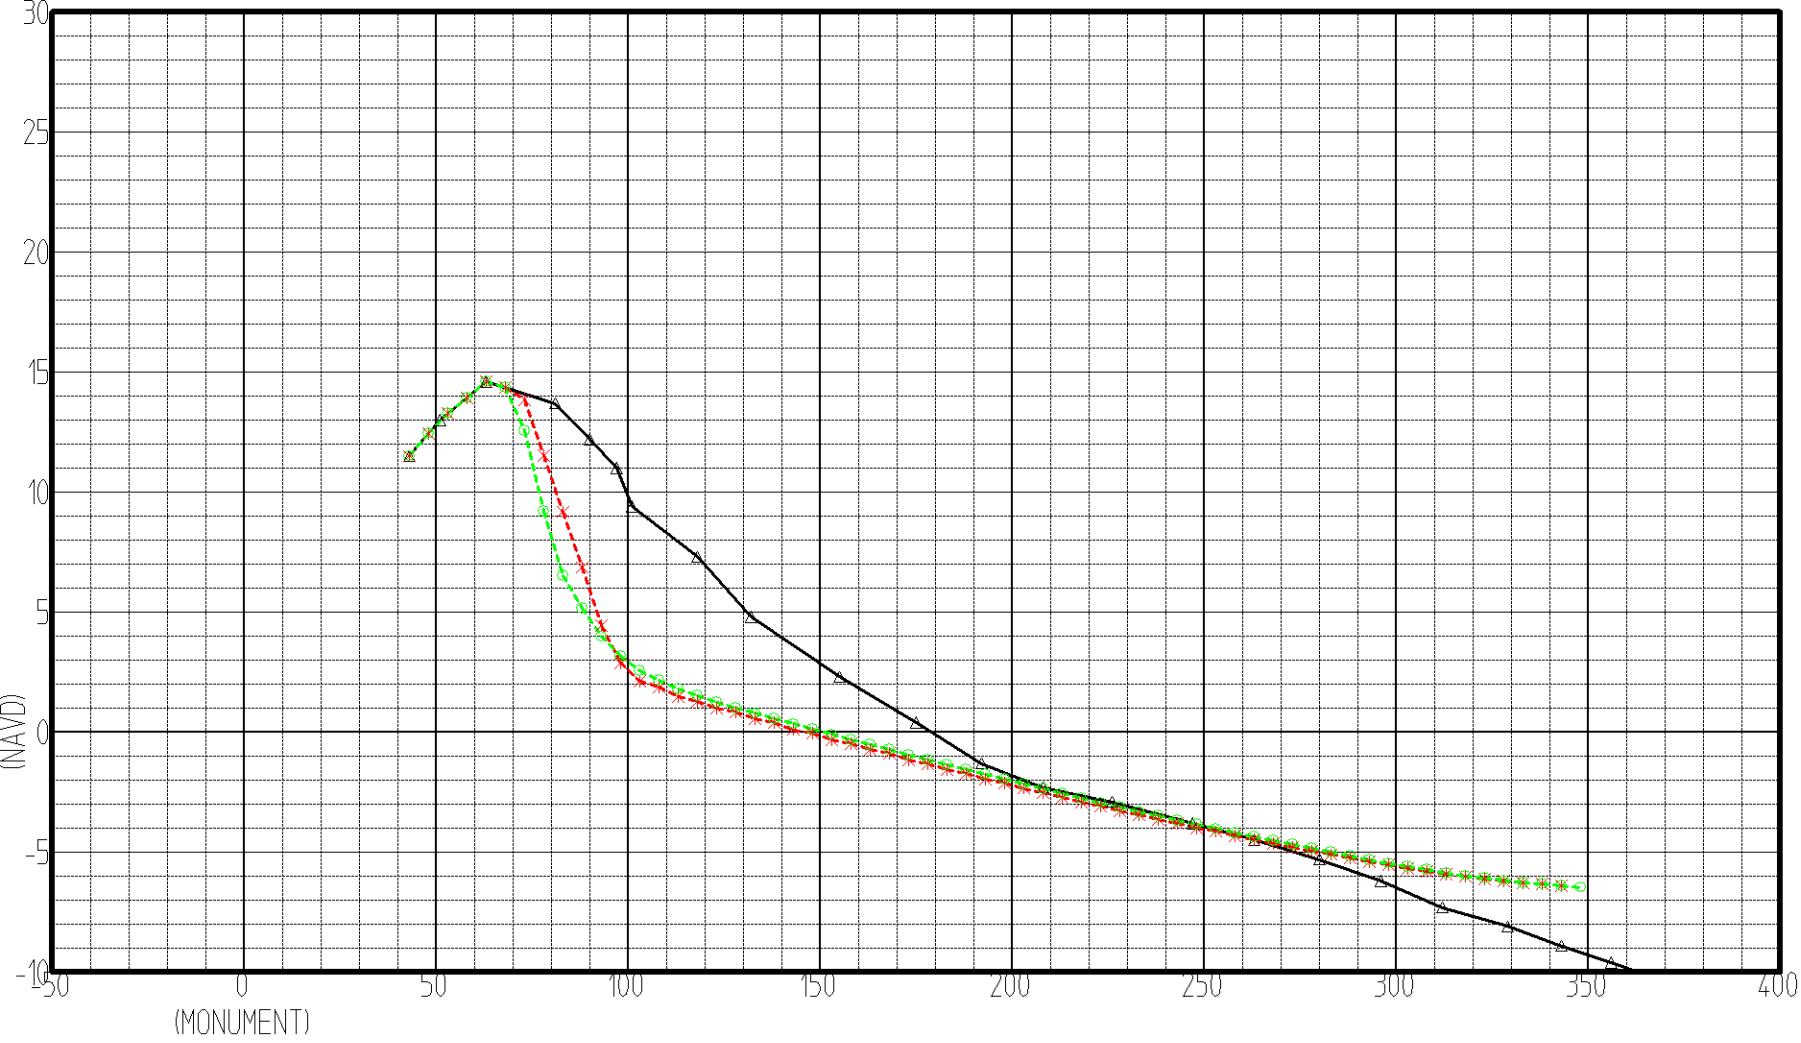
Range: T-46  
 BEARING: 70.00  
 1/2

BEACH PROFILE  
 —△—△— 2007-09 Indian River  
 - - \* - - 15YR SBEACH ERODED  
 - - o - - 25YR SBEACH ERODED

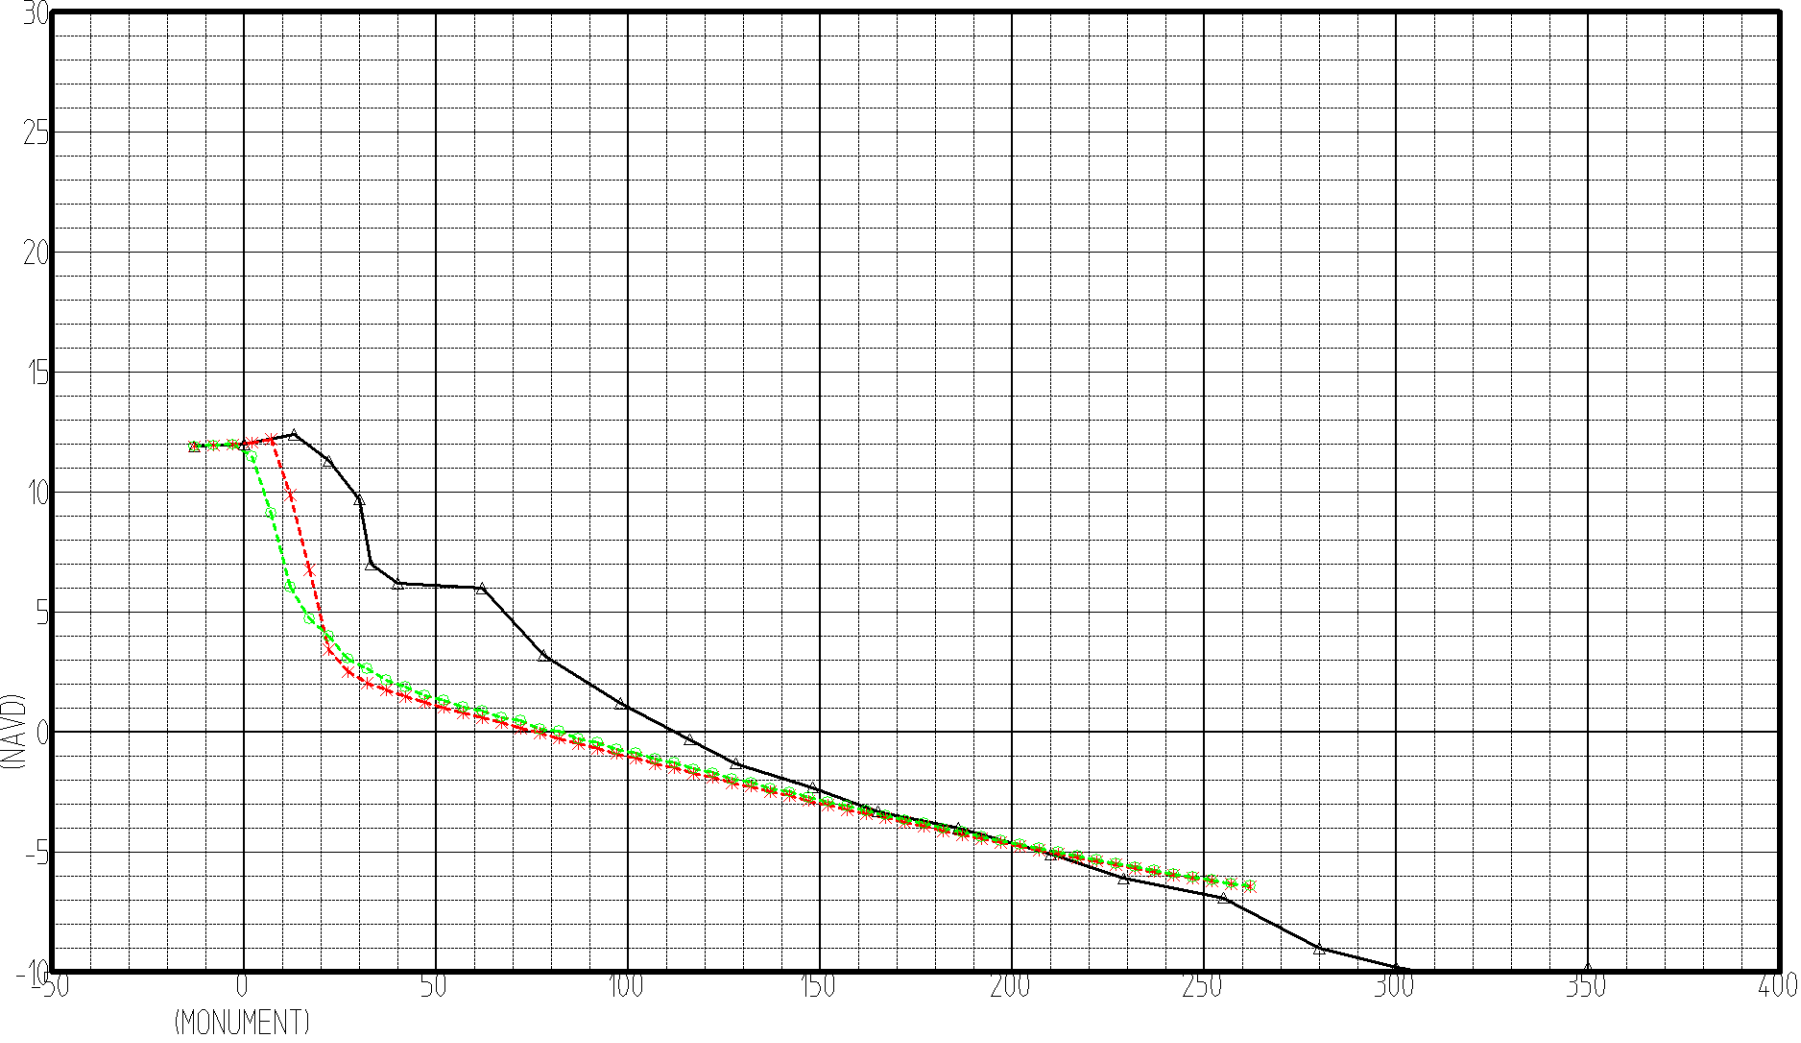
Range: R-47  
 BEARING: 70.00  
 1/2

BEACH PROFILE  
 —△—△— 2007-09 Indian River  
 - - \* - - 15YR SBEACH ERODED  
 - - o - - 25YR SBEACH ERODED

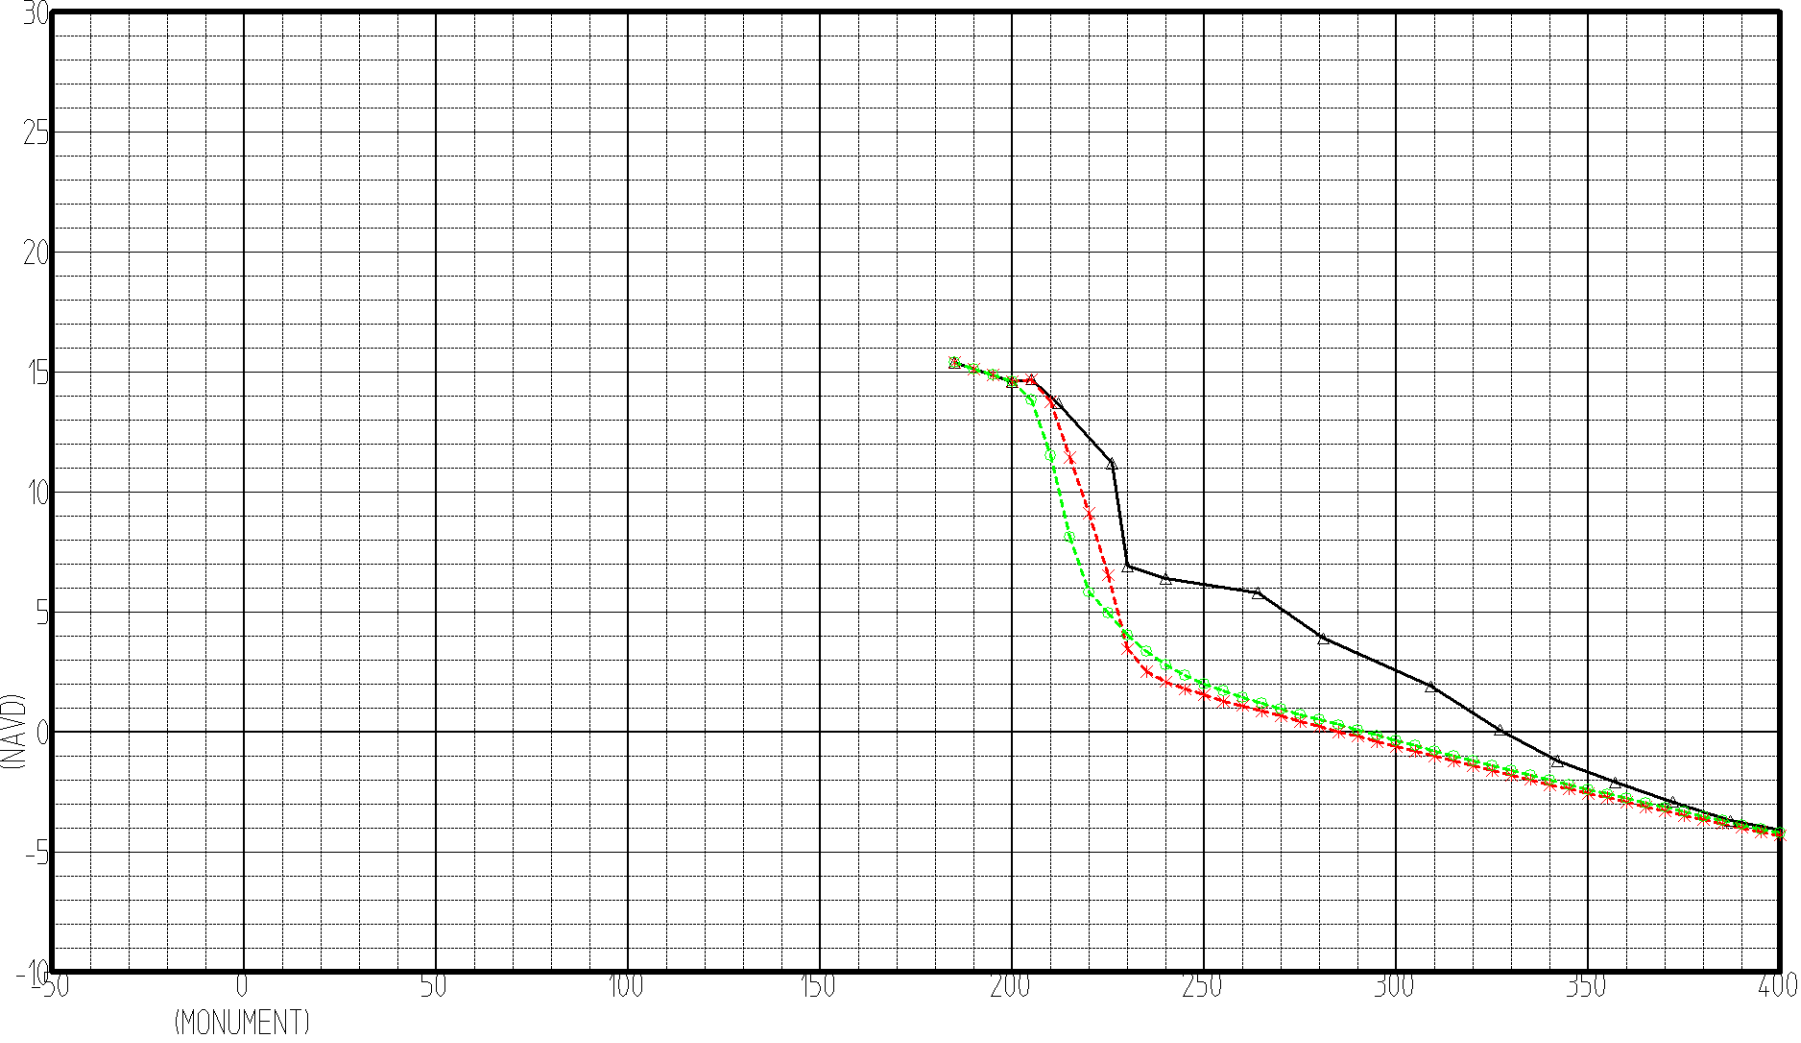
Range: R-48

BEACH PROFILE

—△—△— 2007-09 Indian River

- - - \* - - - 15YR SBEACH ERODED

- - - o - - - 25YR SBEACH ERODED
