## **Appendix X**

SBEACH 15 and 25 yr. Storm Erosion Profiles

Indian River County

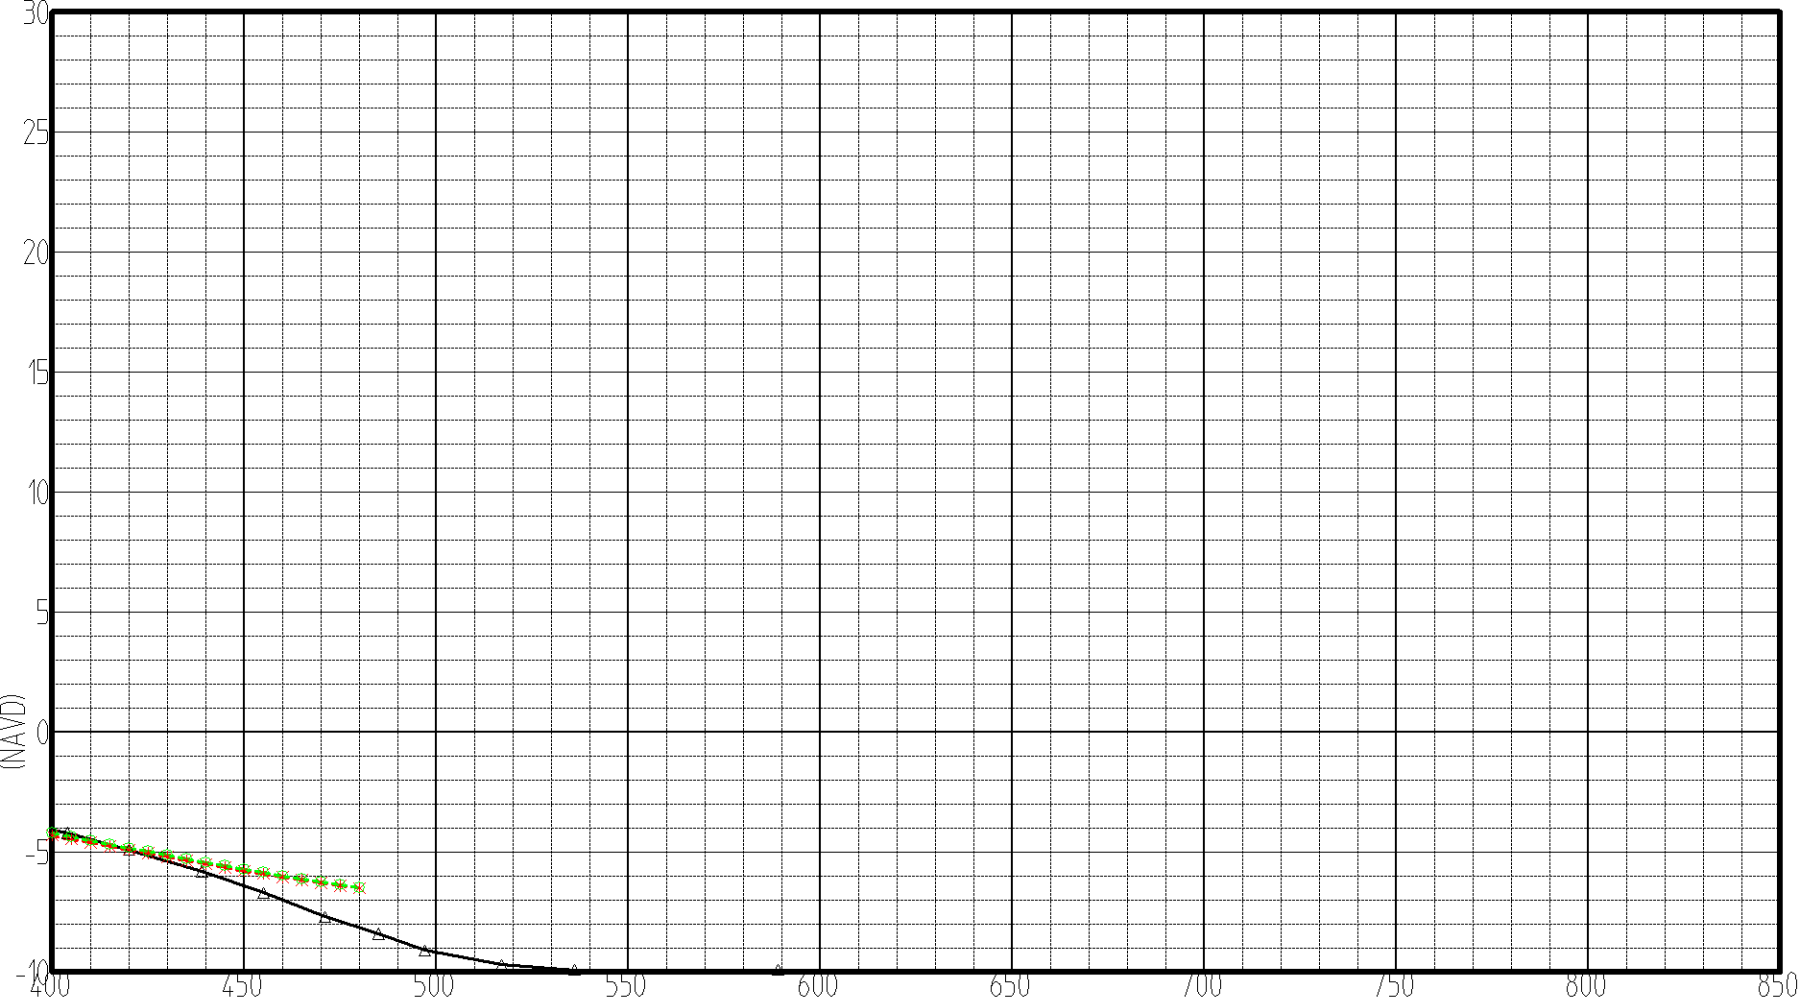
BEACH PROFILE

- △—△— 2007-09 Indian River
- - - \* - - - 15YR SBEACH ERODED
- - - o - - - 25YR SBEACH ERODED

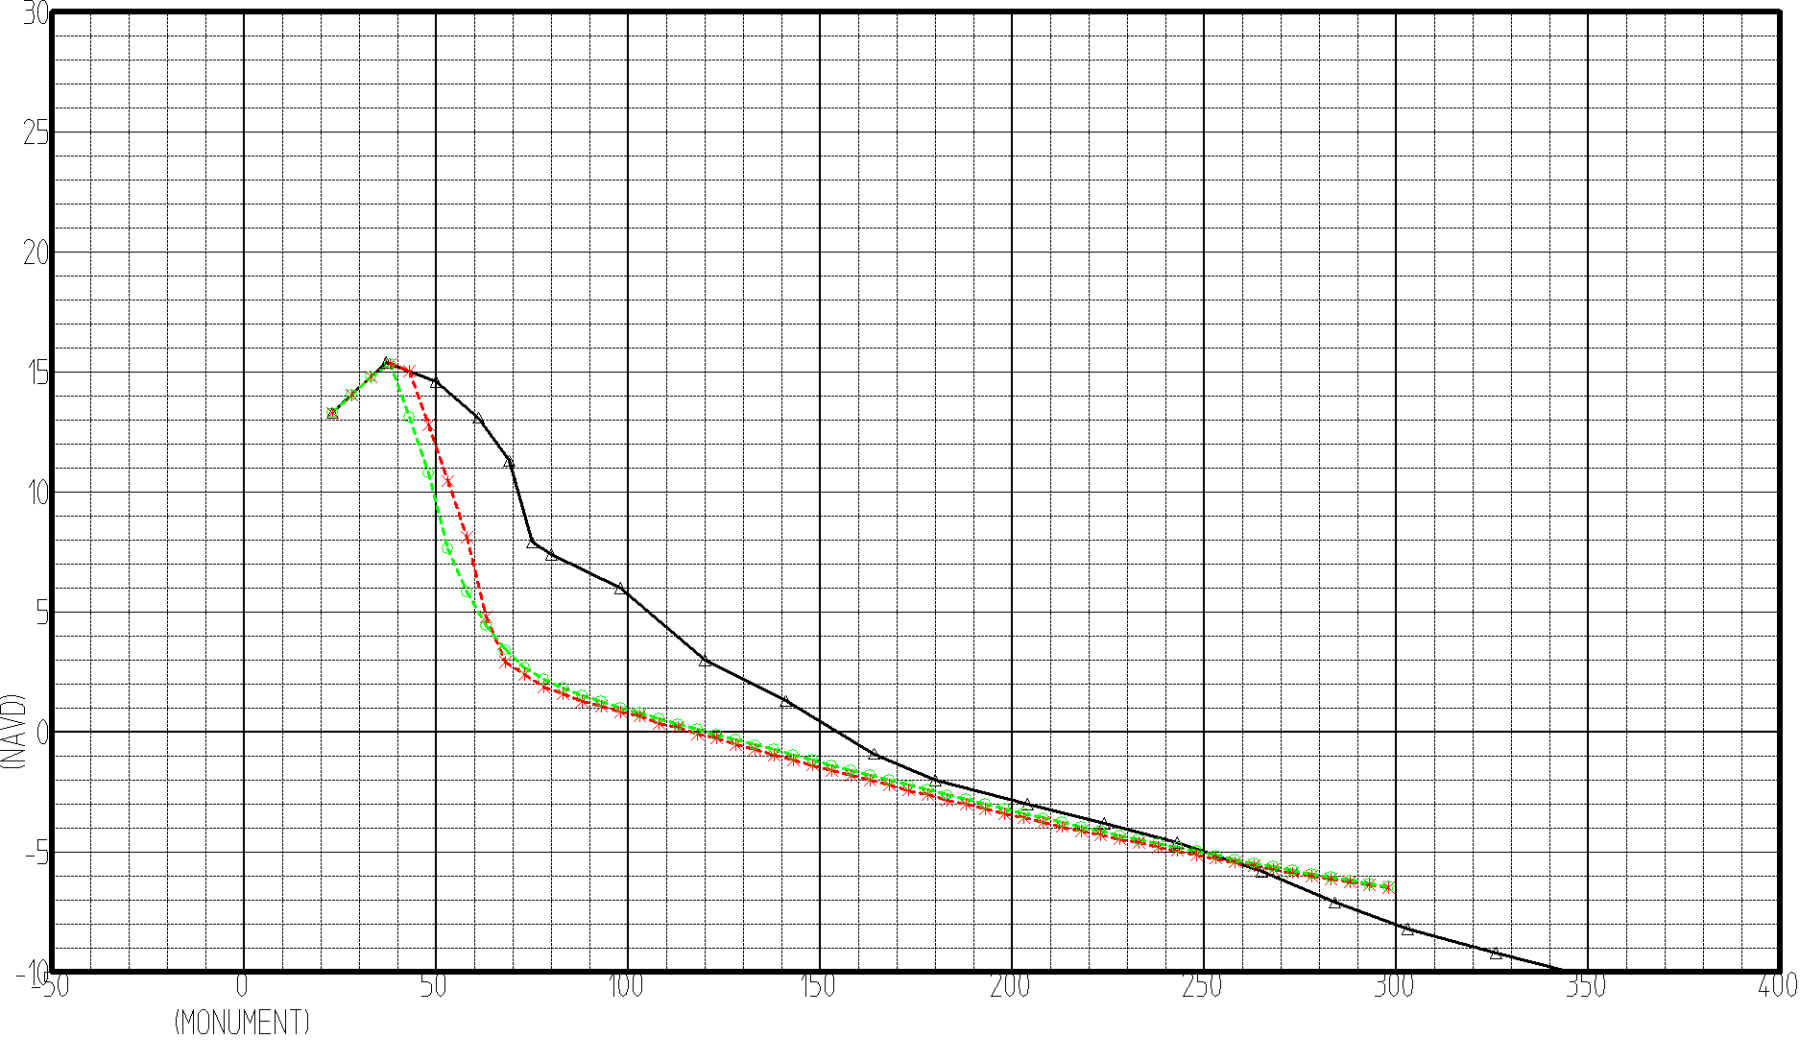
Range: R-49

BEACH PROFILE

—△—△— 2007-09 Indian River

- - - \* - - - 15YR SBEACH ERODED

- - - o - - - 25YR SBEACH ERODED

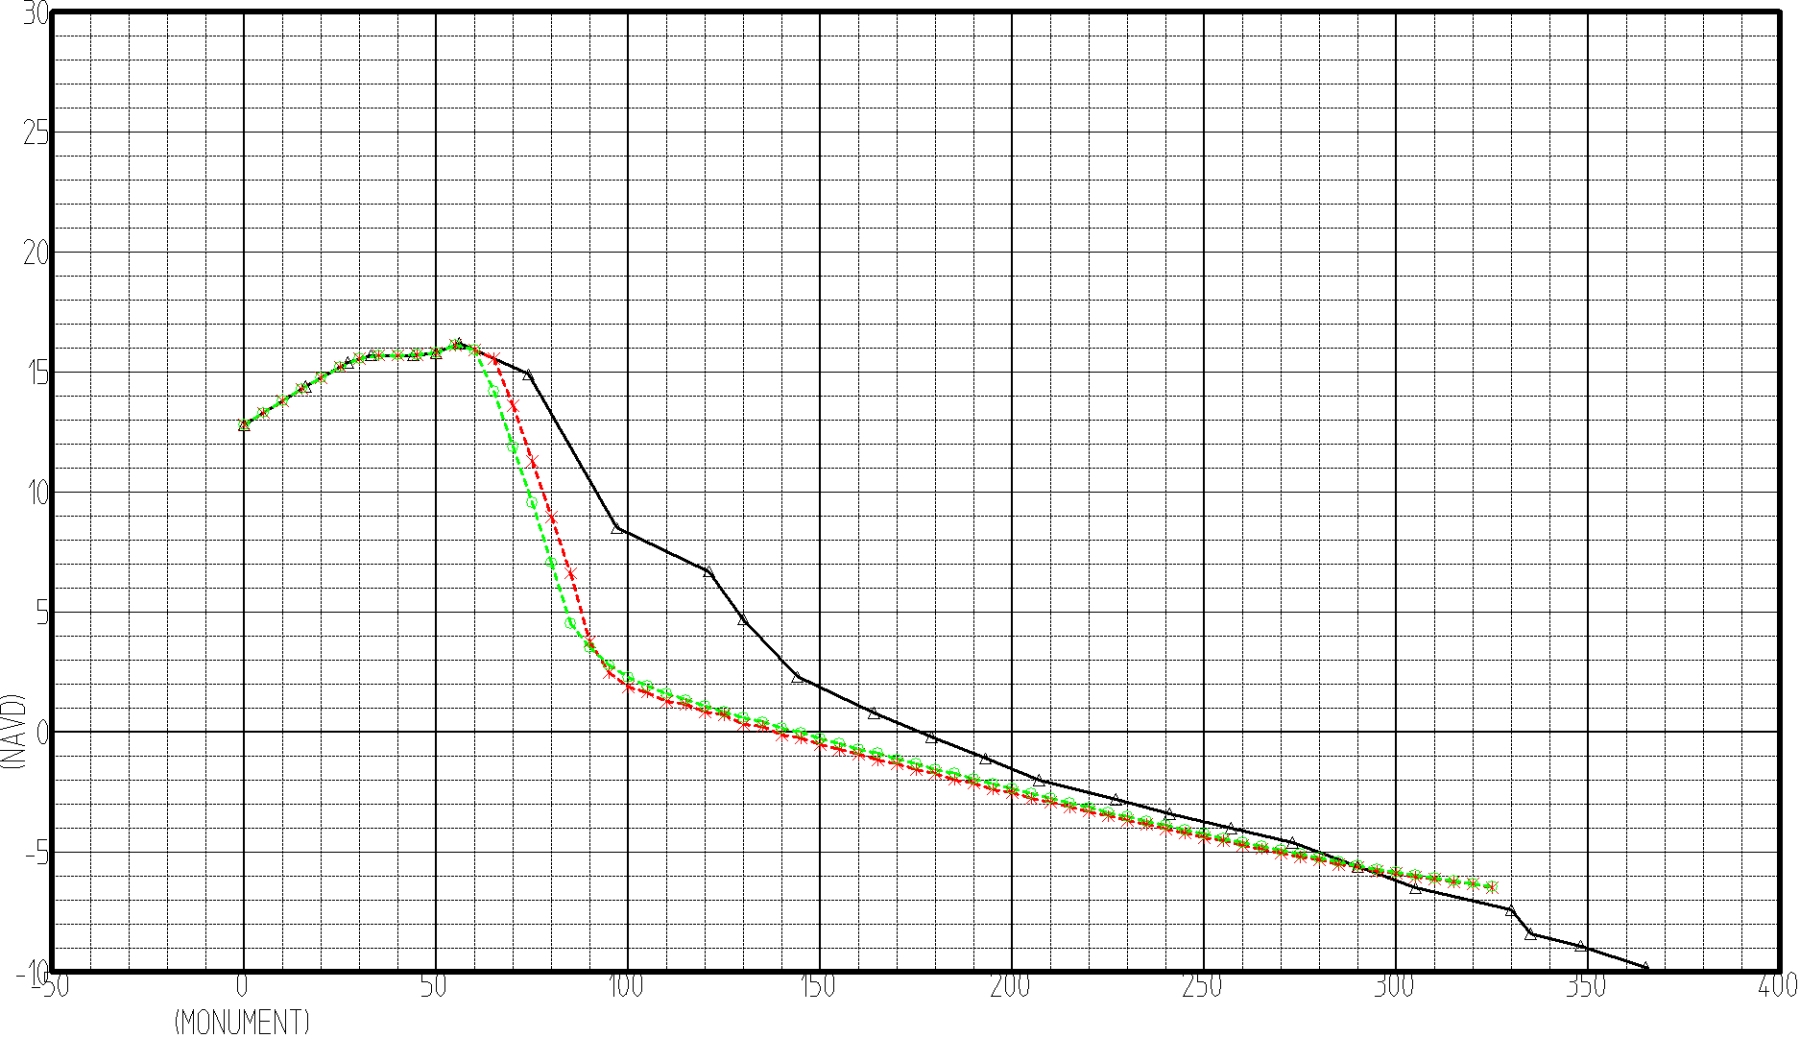
Range: R-50  
 BEARING: 70.00  
 1/2

BEACH PROFILE  
 —△—△— 2007-09 Indian River  
 - - \* - - 15YR SBEACH ERODED  
 - - o - - 25YR SBEACH ERODED

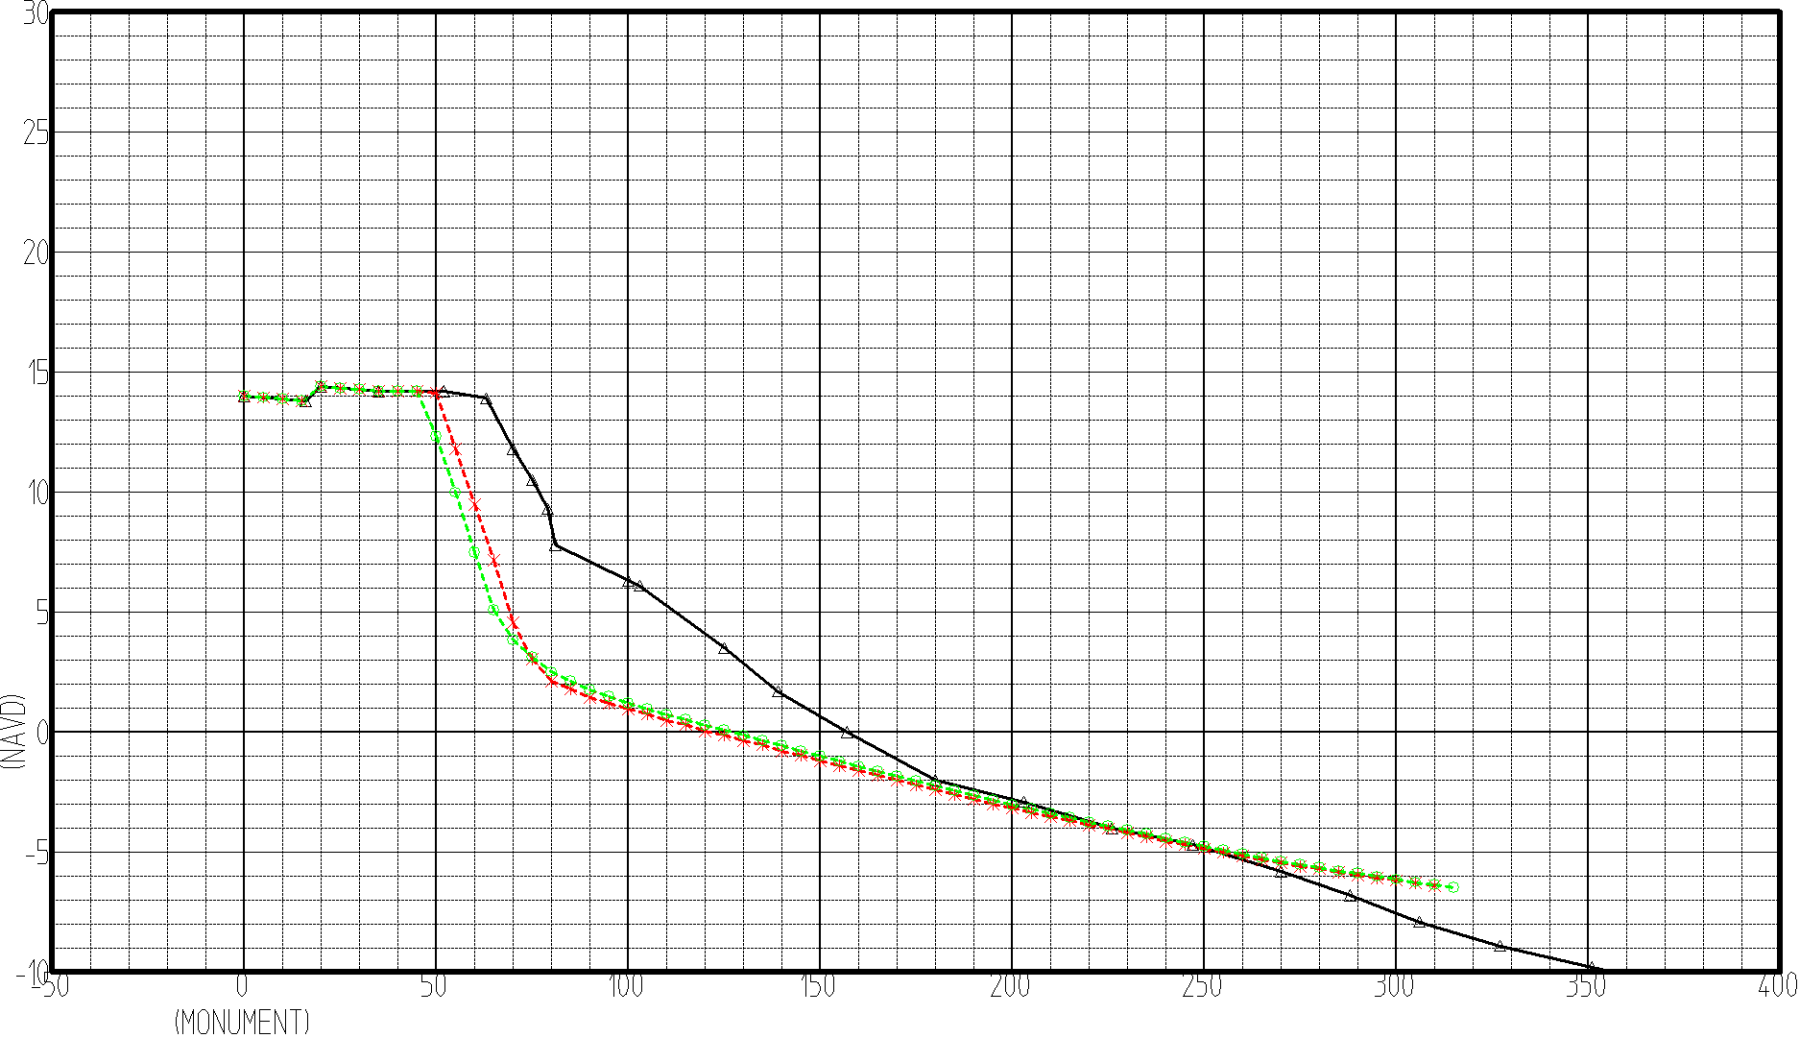
Range: R-51  
 BEARING: 70.00  
 1/2

BEACH PROFILE  
 —△—△— 2007-09 Indian River  
 - - \* - - 15YR SBEACH ERODED  
 - - ○ - - 25YR SBEACH ERODED

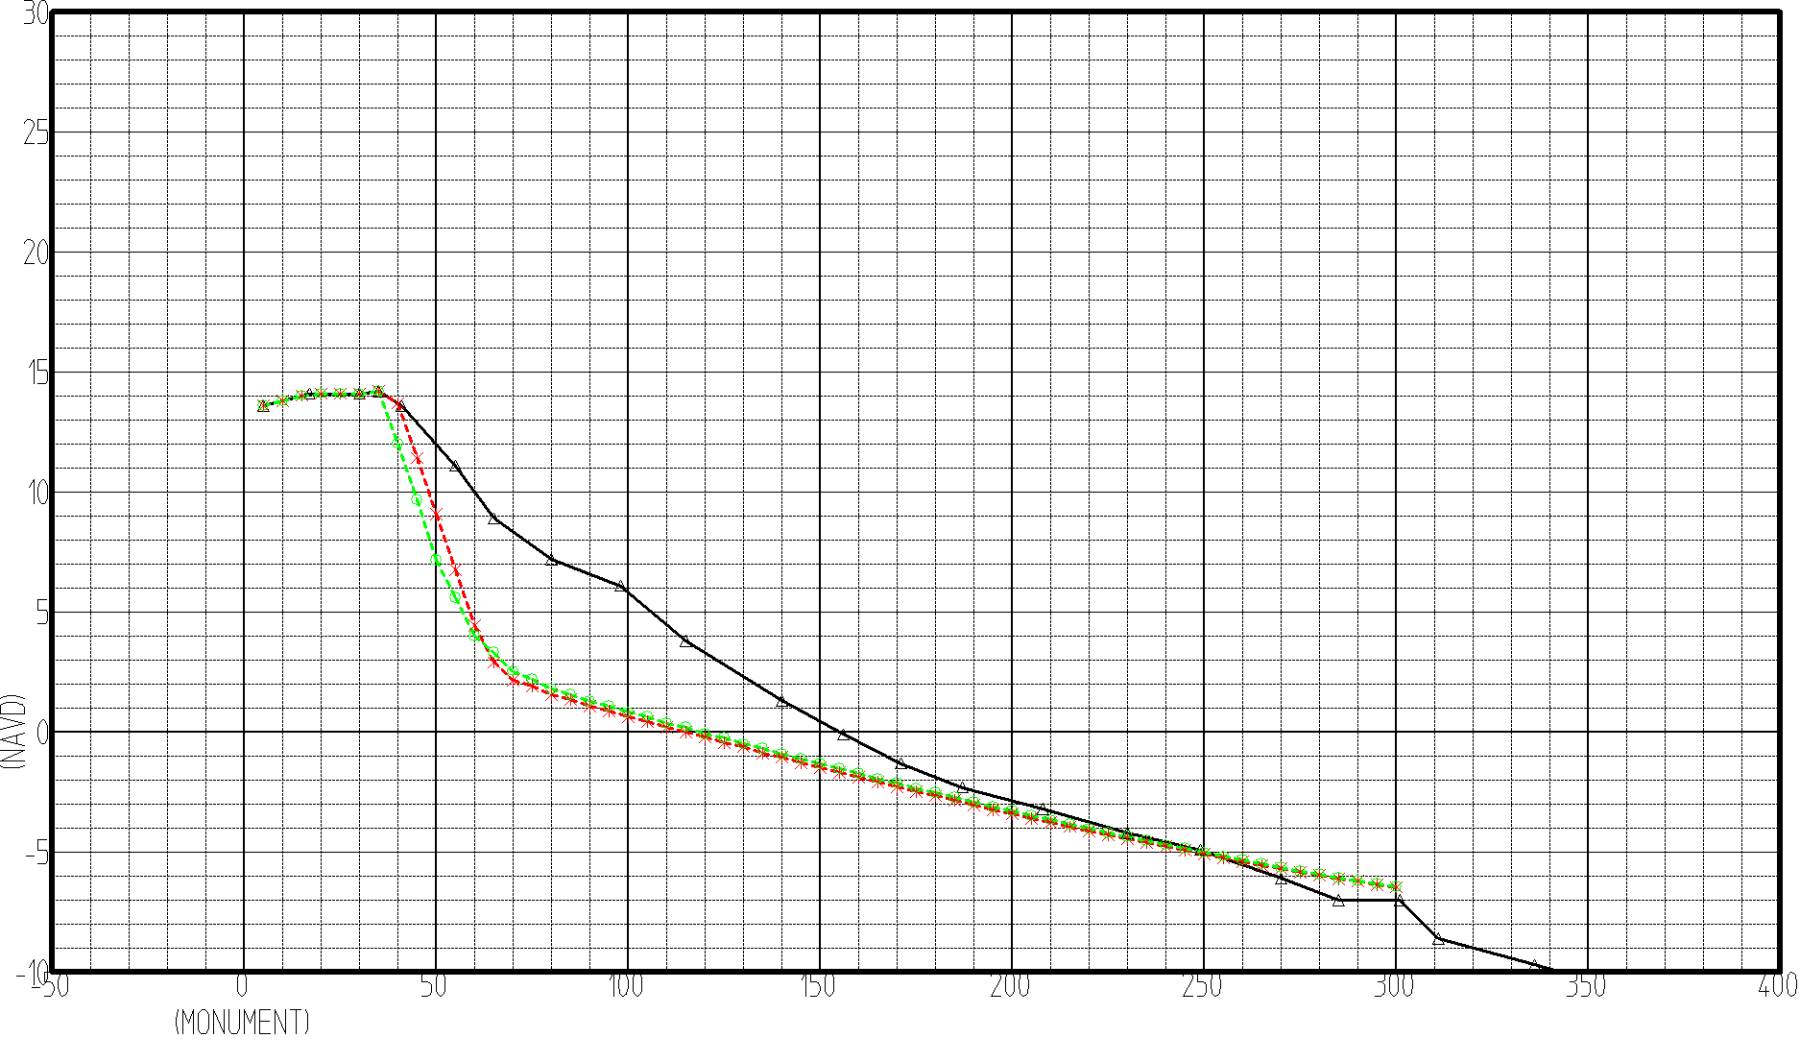
Range: R-52  
 BEARING: 70.00  
 1/2

BEACH PROFILE  
 —△—△— 2007-09 Indian River  
 - - \* - - 15YR SBEACH ERODED  
 - - o - - 25YR SBEACH ERODED

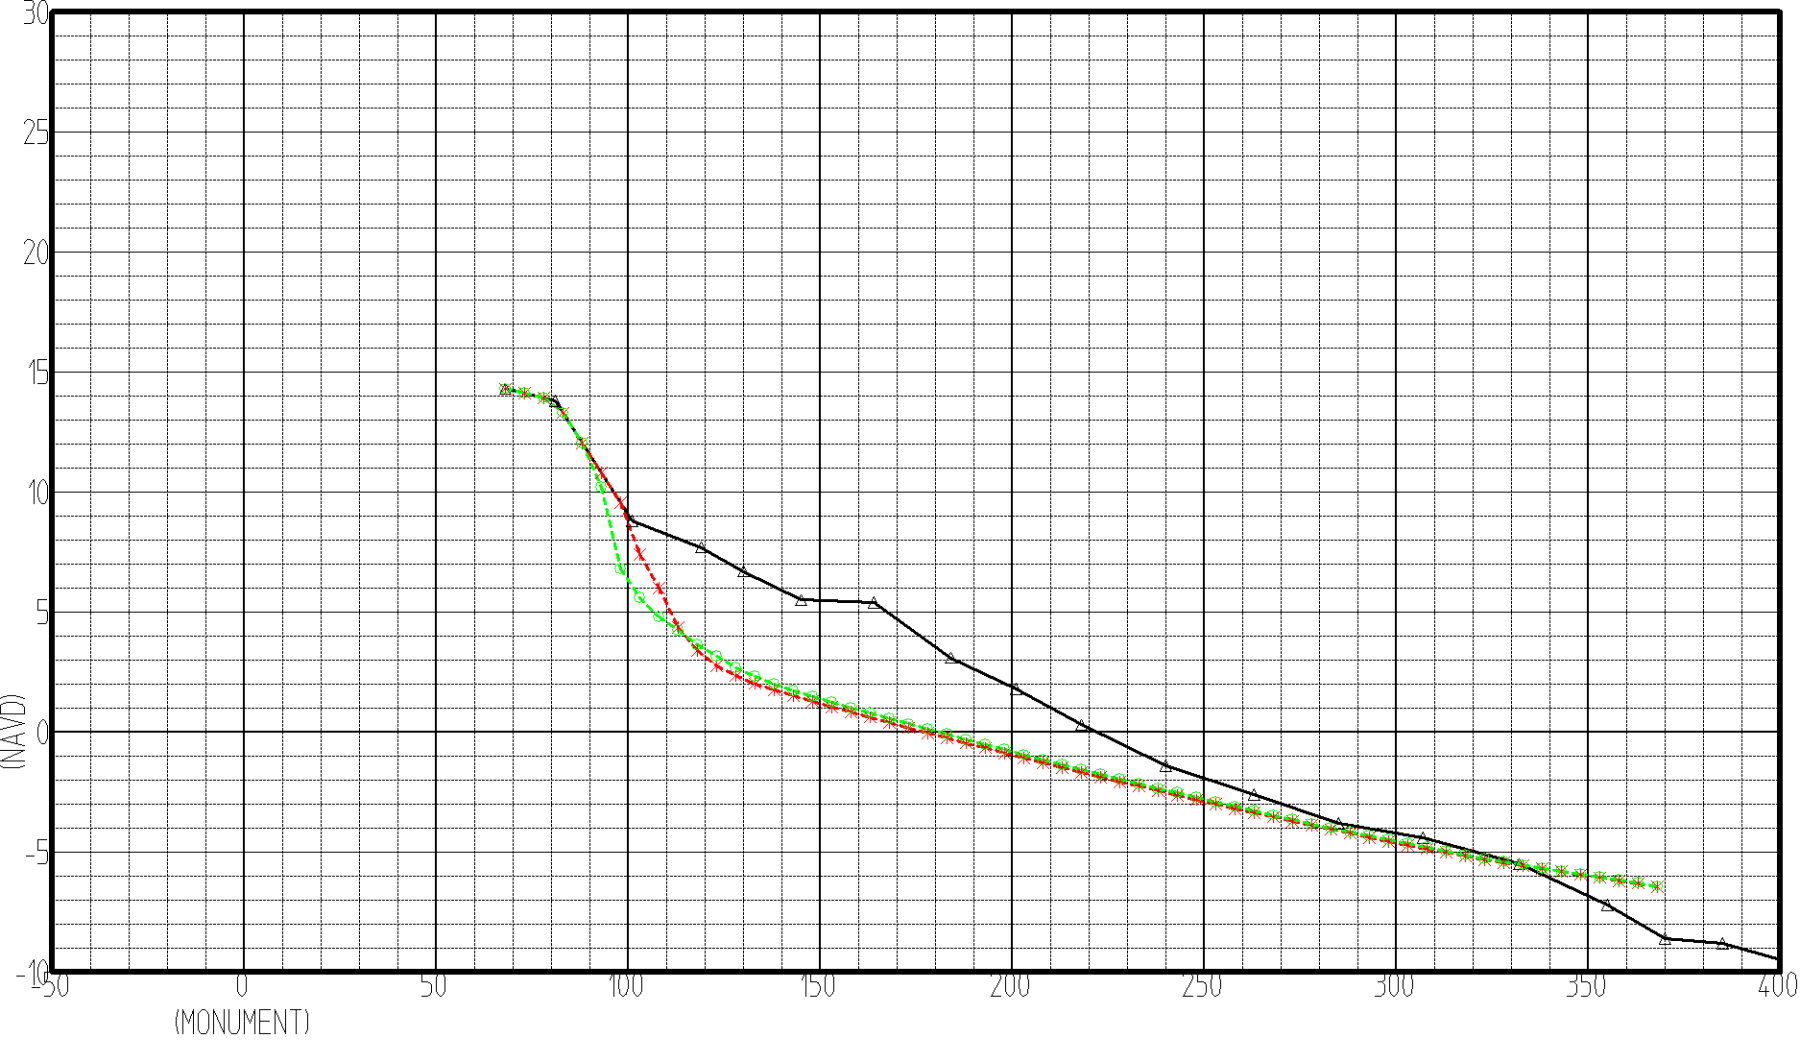
Range: R-53

BEACH PROFILE

- △—△— 2007-09 Indian River
- - - \* - - - 15YR SBEACH ERODED
- - - o - - - 25YR SBEACH ERODED

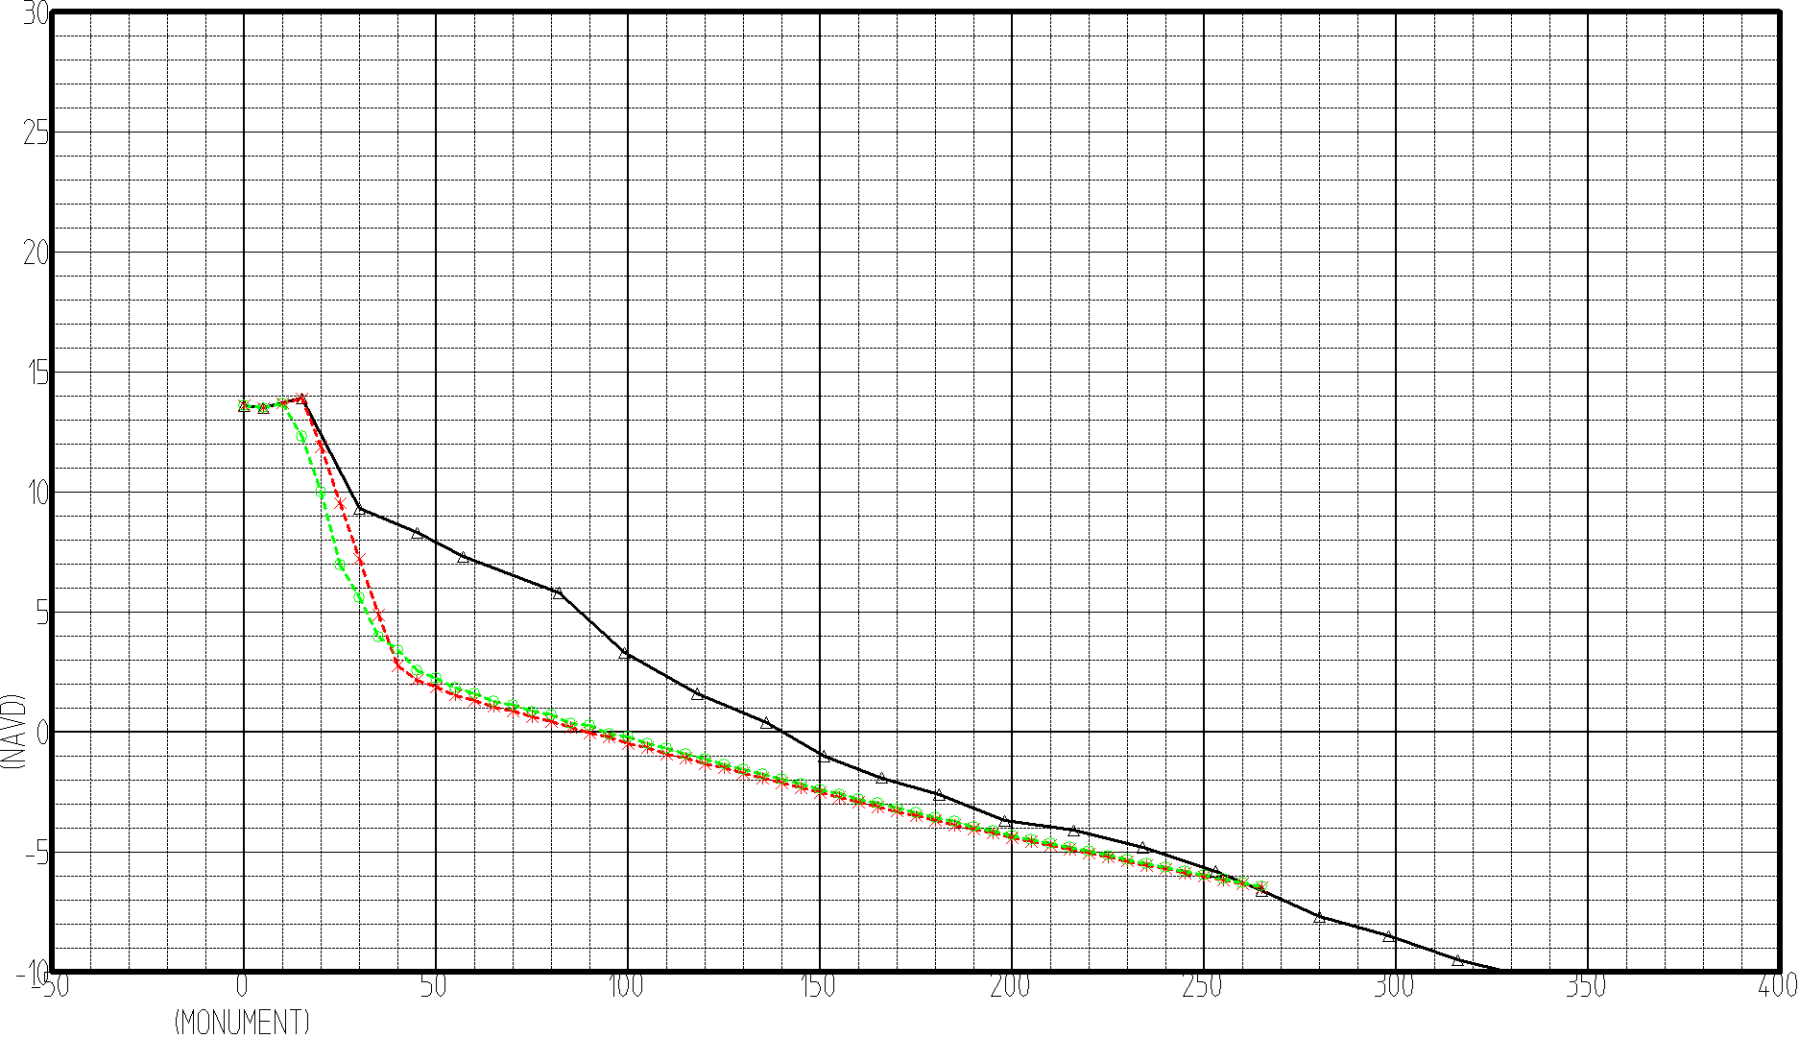
Range: R-54  
 BEARING: 70.00  
 1/2

BEACH PROFILE  
 —△—△— 2007-09 Indian River  
 - - \* - - 15YR SBEACH ERODED  
 - - o - - 25YR SBEACH ERODED

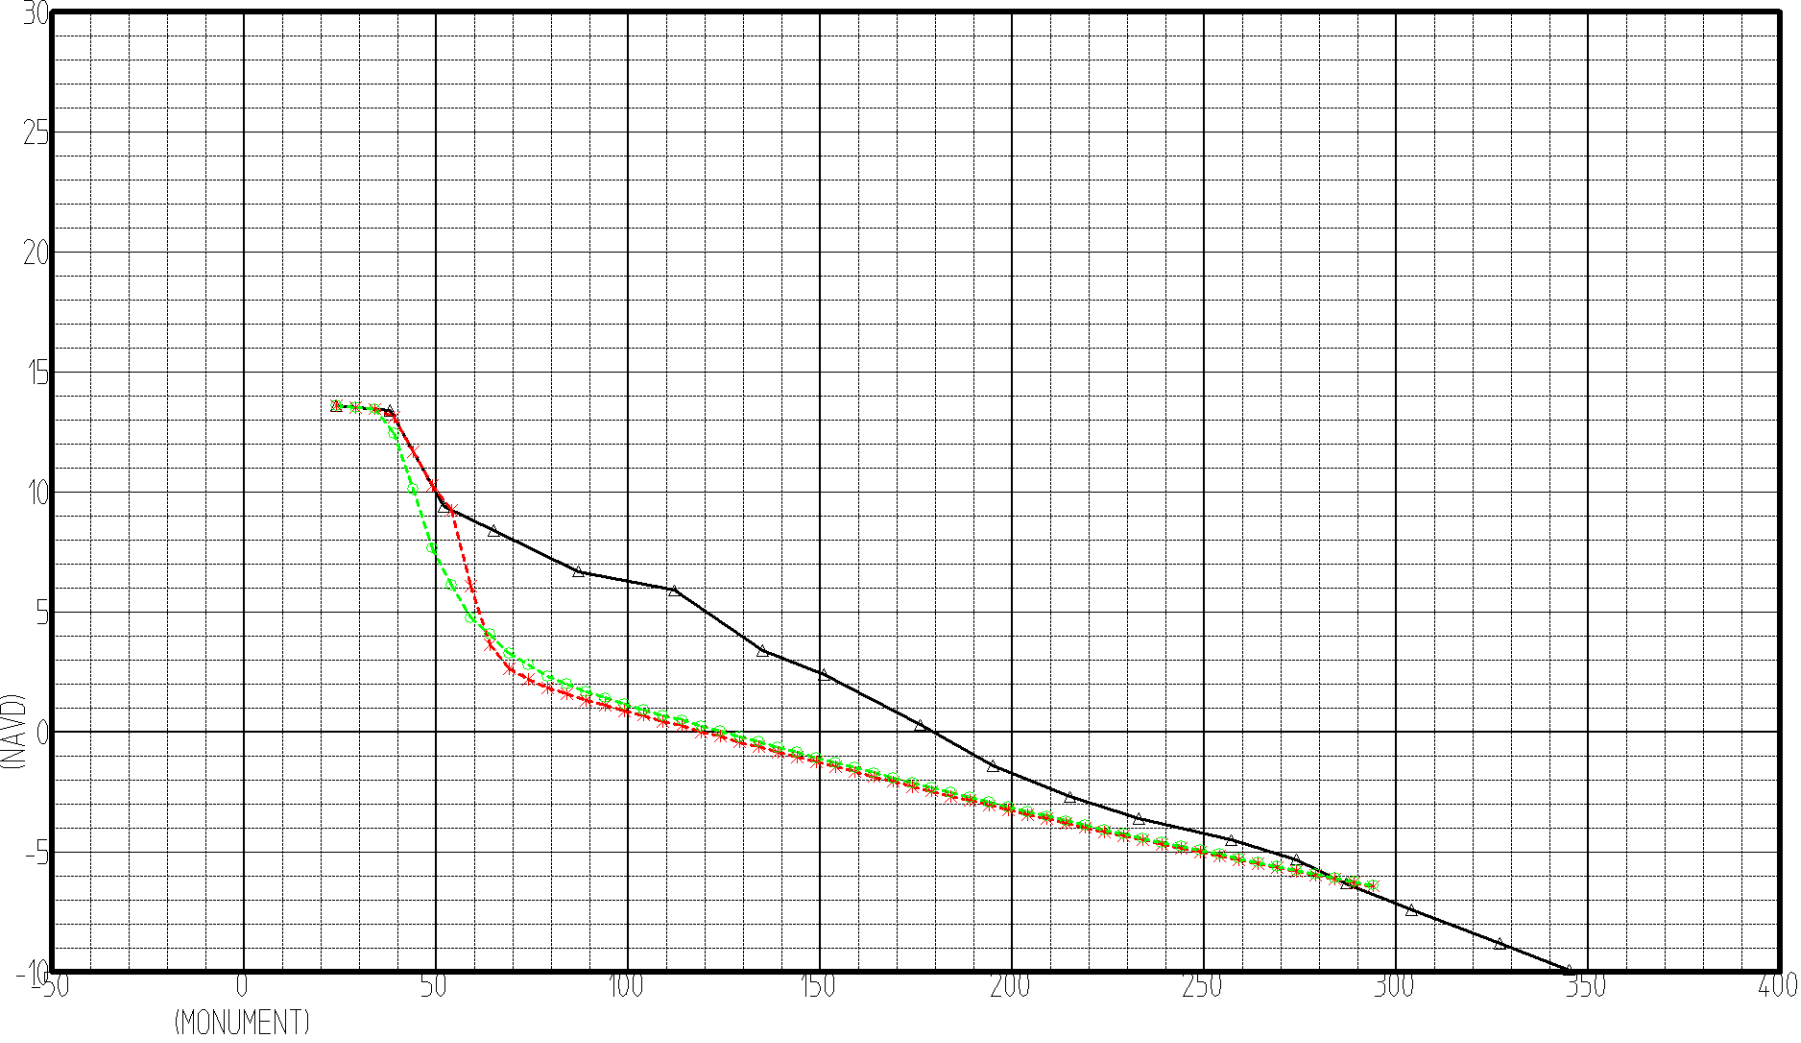
Range: R-55  
 BEARING: 70.00  
 1/2

BEACH PROFILE  
 —△—△— 2007-09 Indian River  
 - - \* - - \* - - 15YR SBEACH ERODED  
 - - o - - o - - 25YR SBEACH ERODED

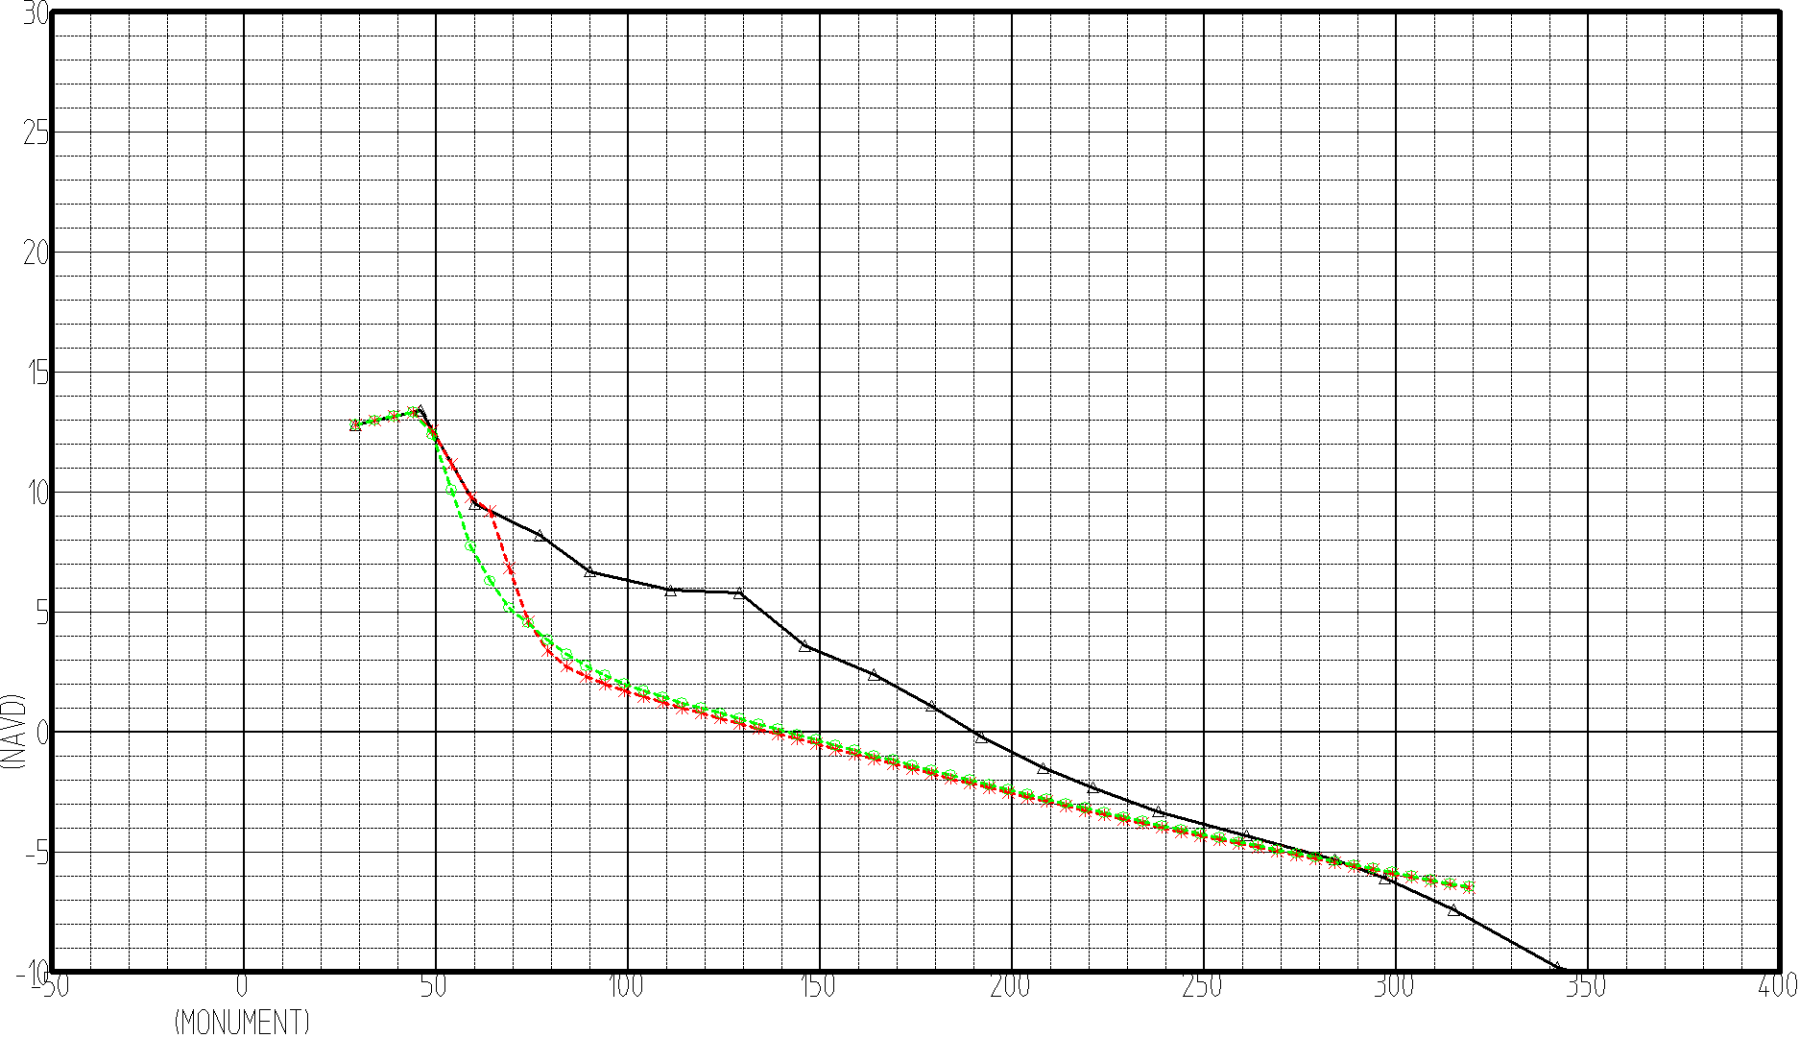
Range: R-56  
 BEARING: 70.00  
 1/2

BEACH PROFILE  
 —△—△— 2007-09 Indian River  
 - - \* - - 15YR SBEACH ERODED  
 - - o - - 25YR SBEACH ERODED

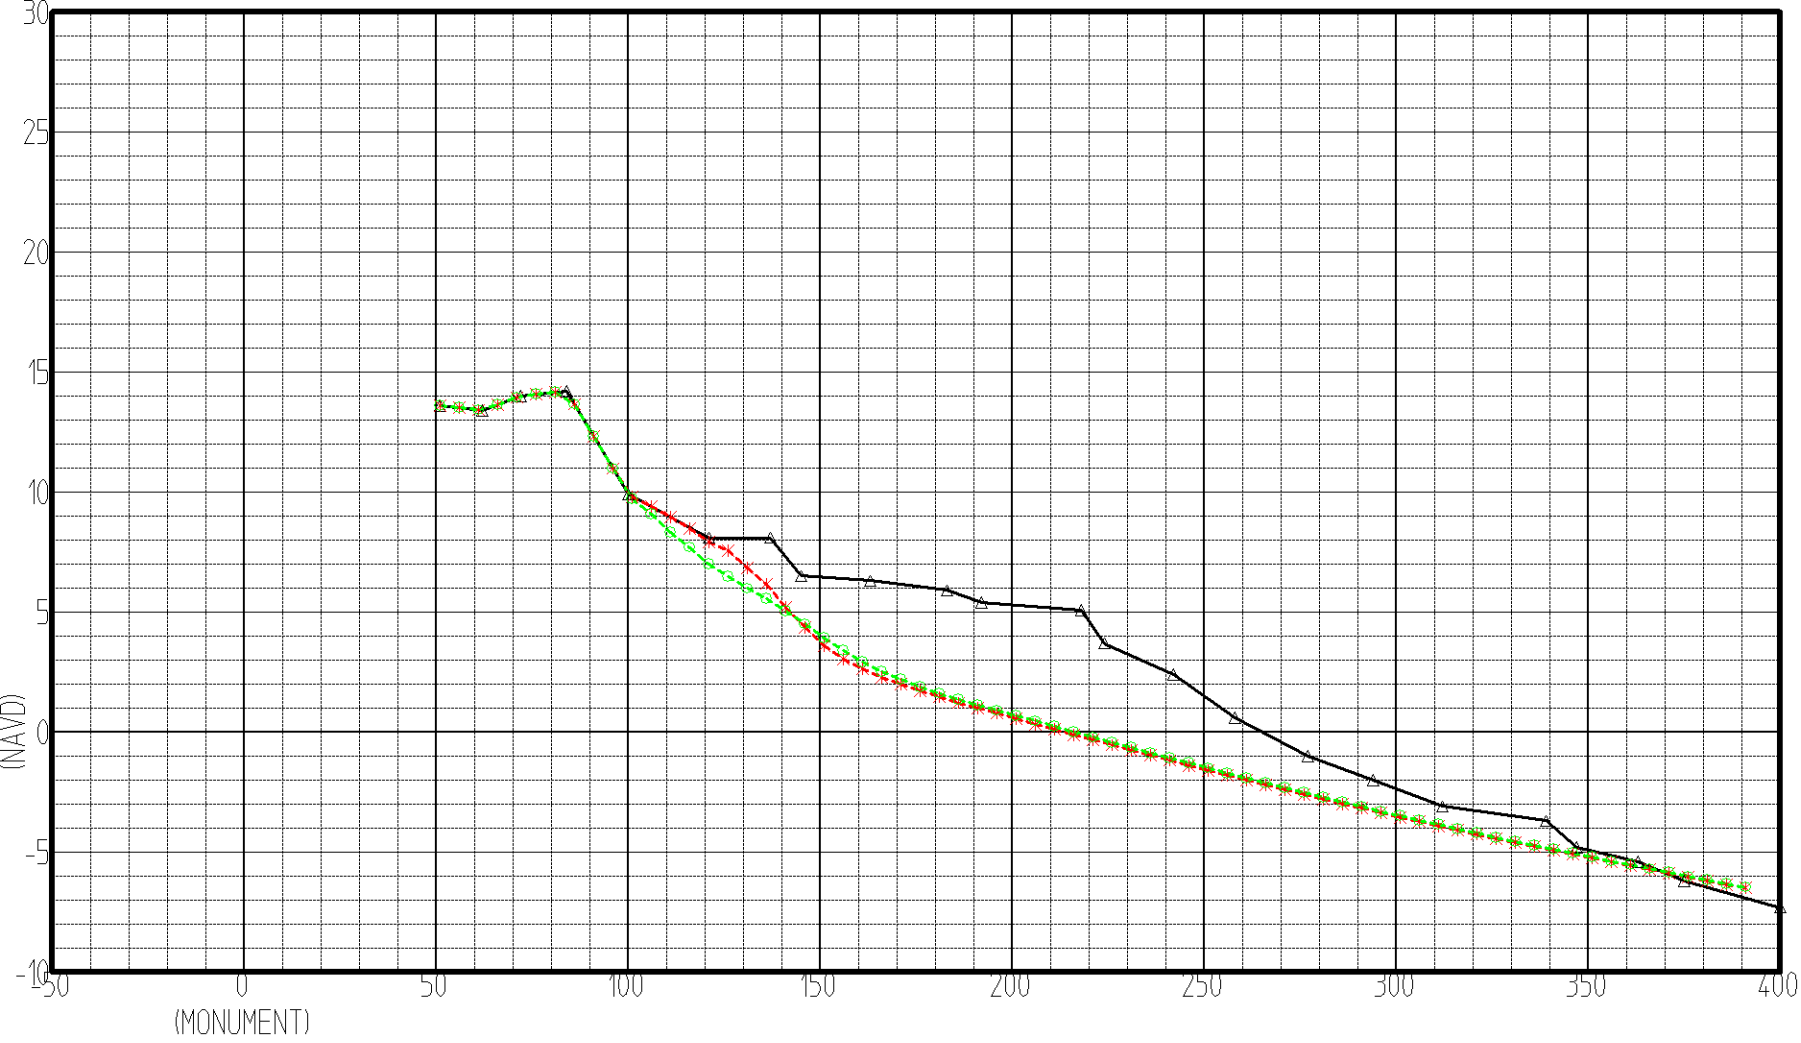
Range: R-57

BEACH PROFILE

- △—△— 2007-09 Indian River
- - \* - - \* - - 15YR SBEACH ERODED
- - o - - o - - 25YR SBEACH ERODED

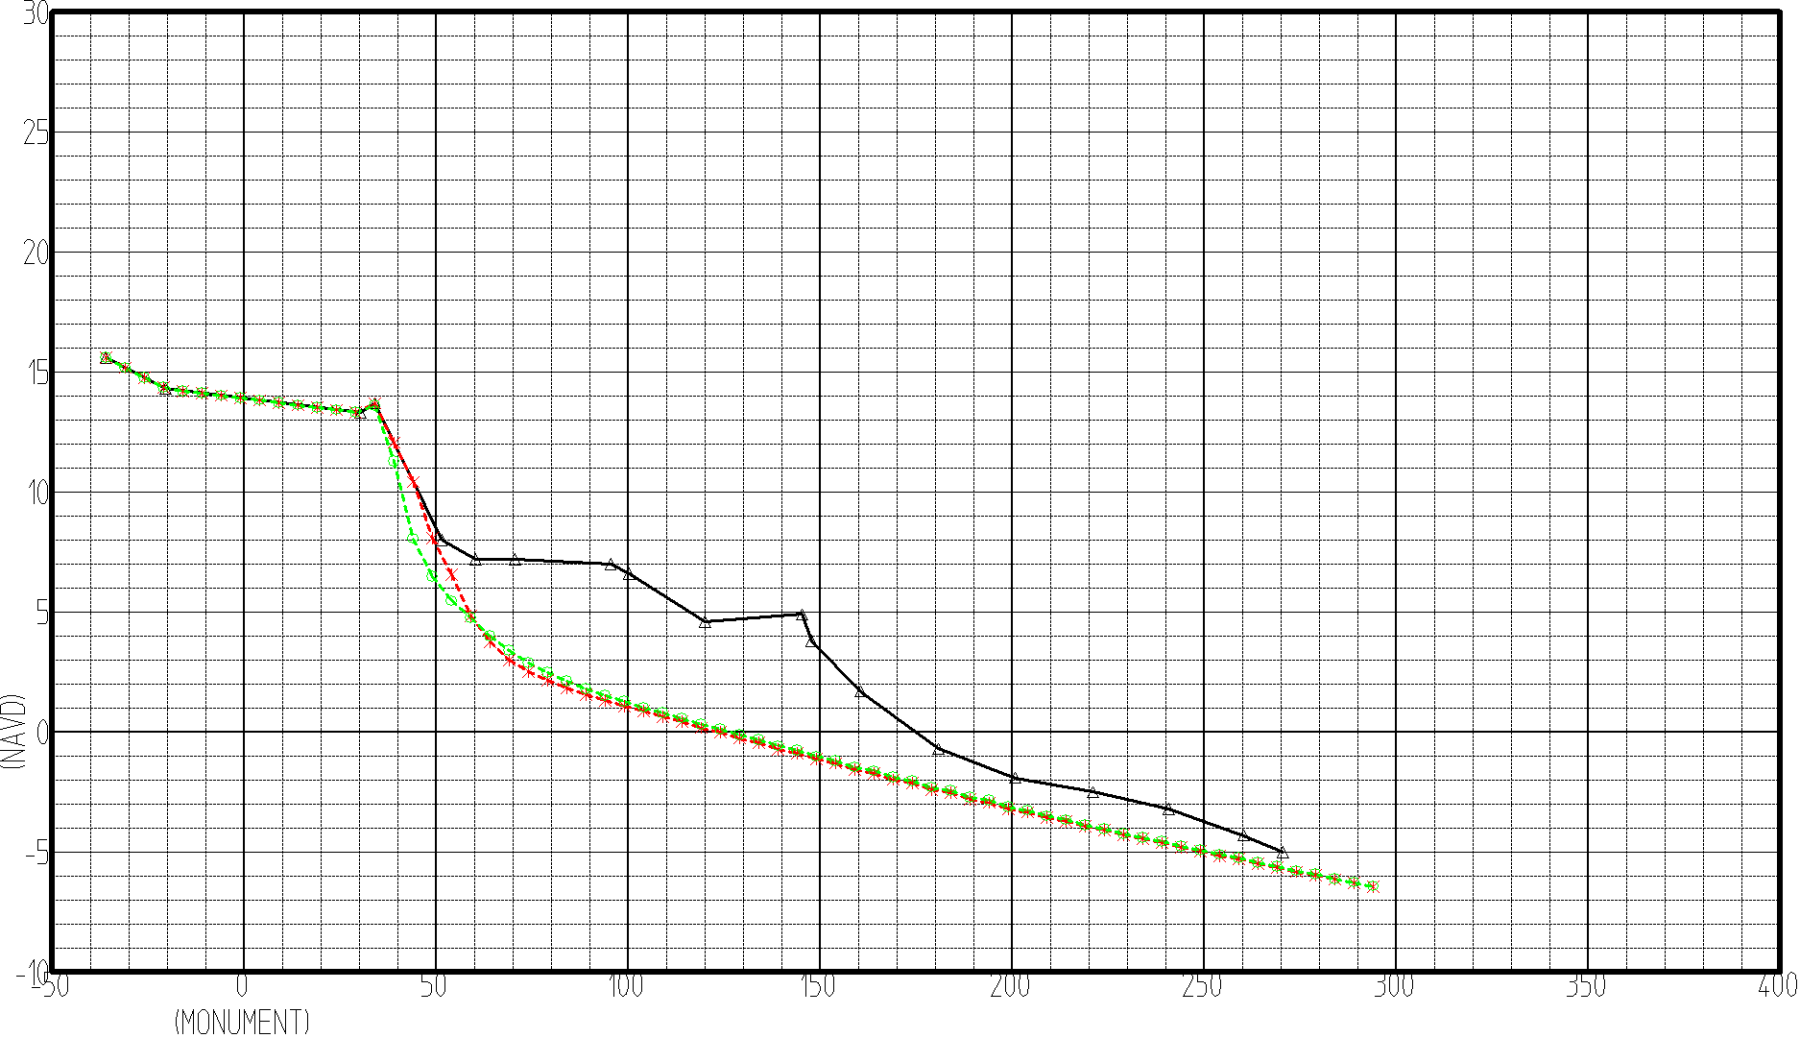
Range: R-58  
 BEARING: 70.00  
 1/1

BEACH PROFILE  
 —△—△— 2006-07 Indian River  
 - - \* - - 15YR SBEACH ERODED  
 - - o - - 25YR SBEACH ERODED

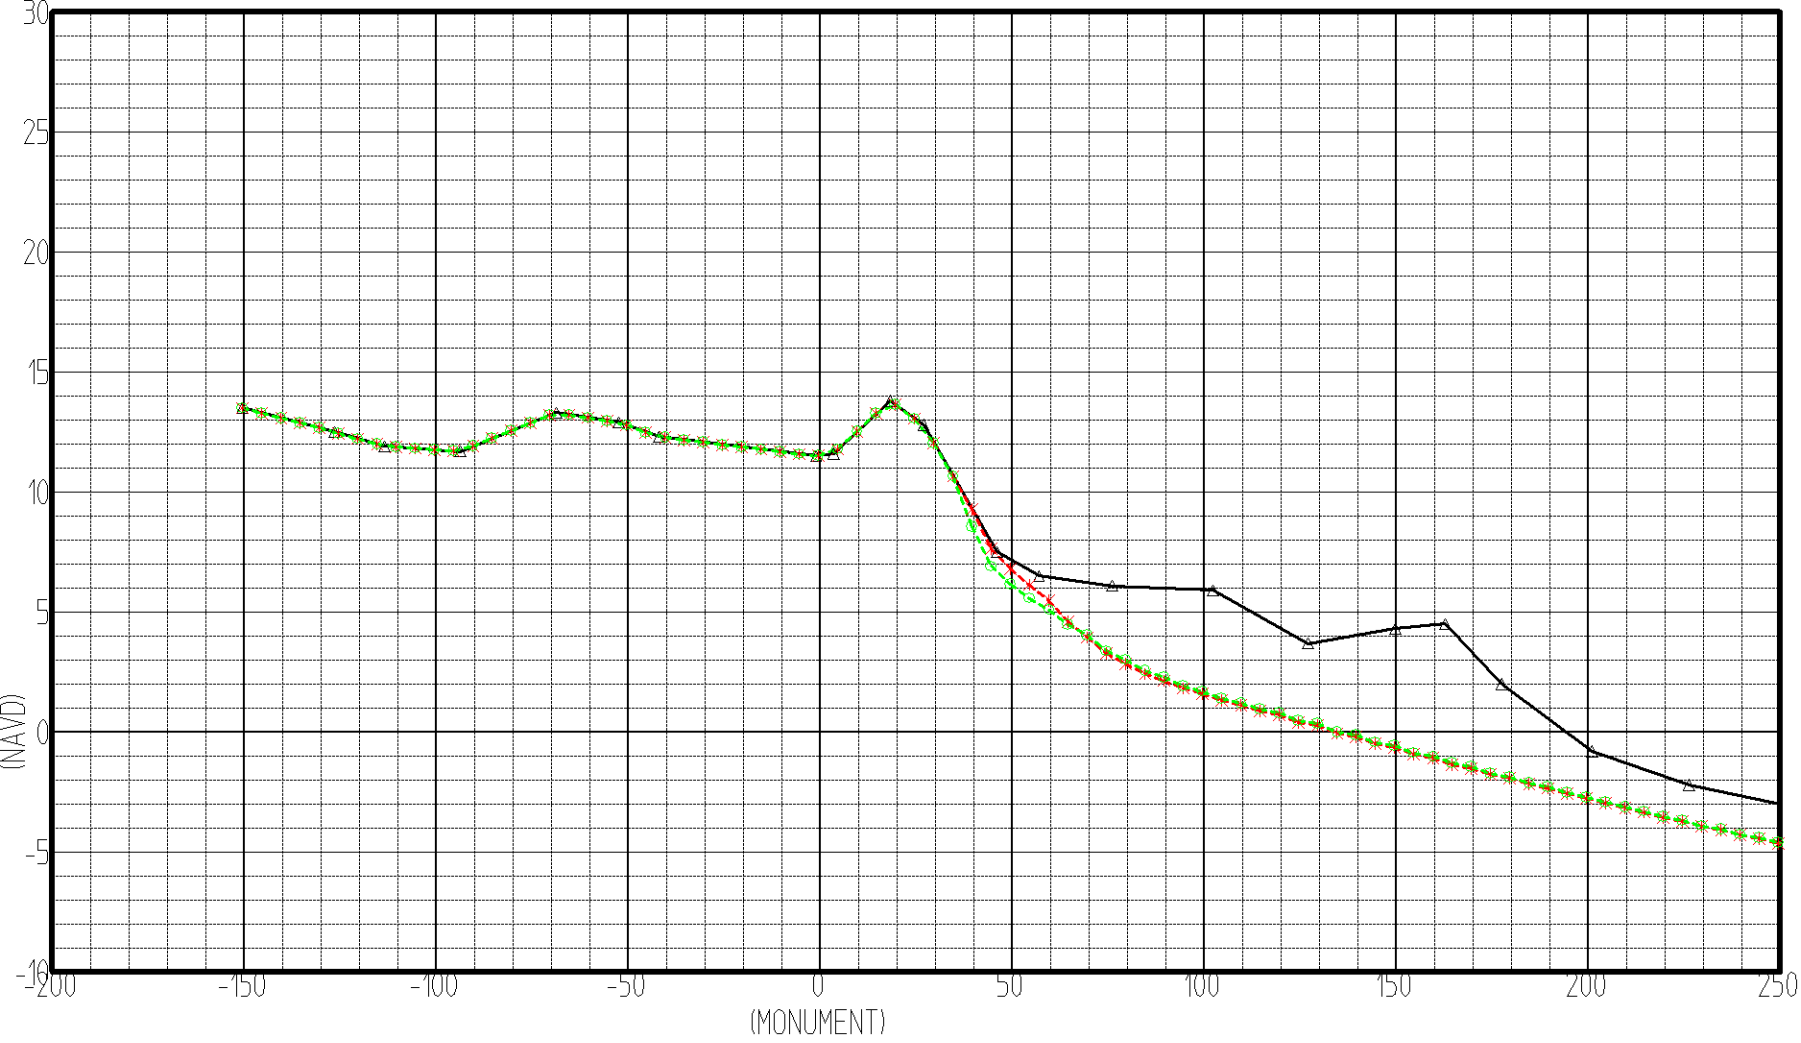
Range: T-59 1/2

BEACH PROFILE

—△—△— 2006-07 Indian River

- - - \* - - - 15YR SBEACH ERODED

- - - o - - - 25YR SBEACH ERODED
