## **Appendix X**

SBEACH 15 and 25 yr. Storm Erosion Profiles

Indian River County

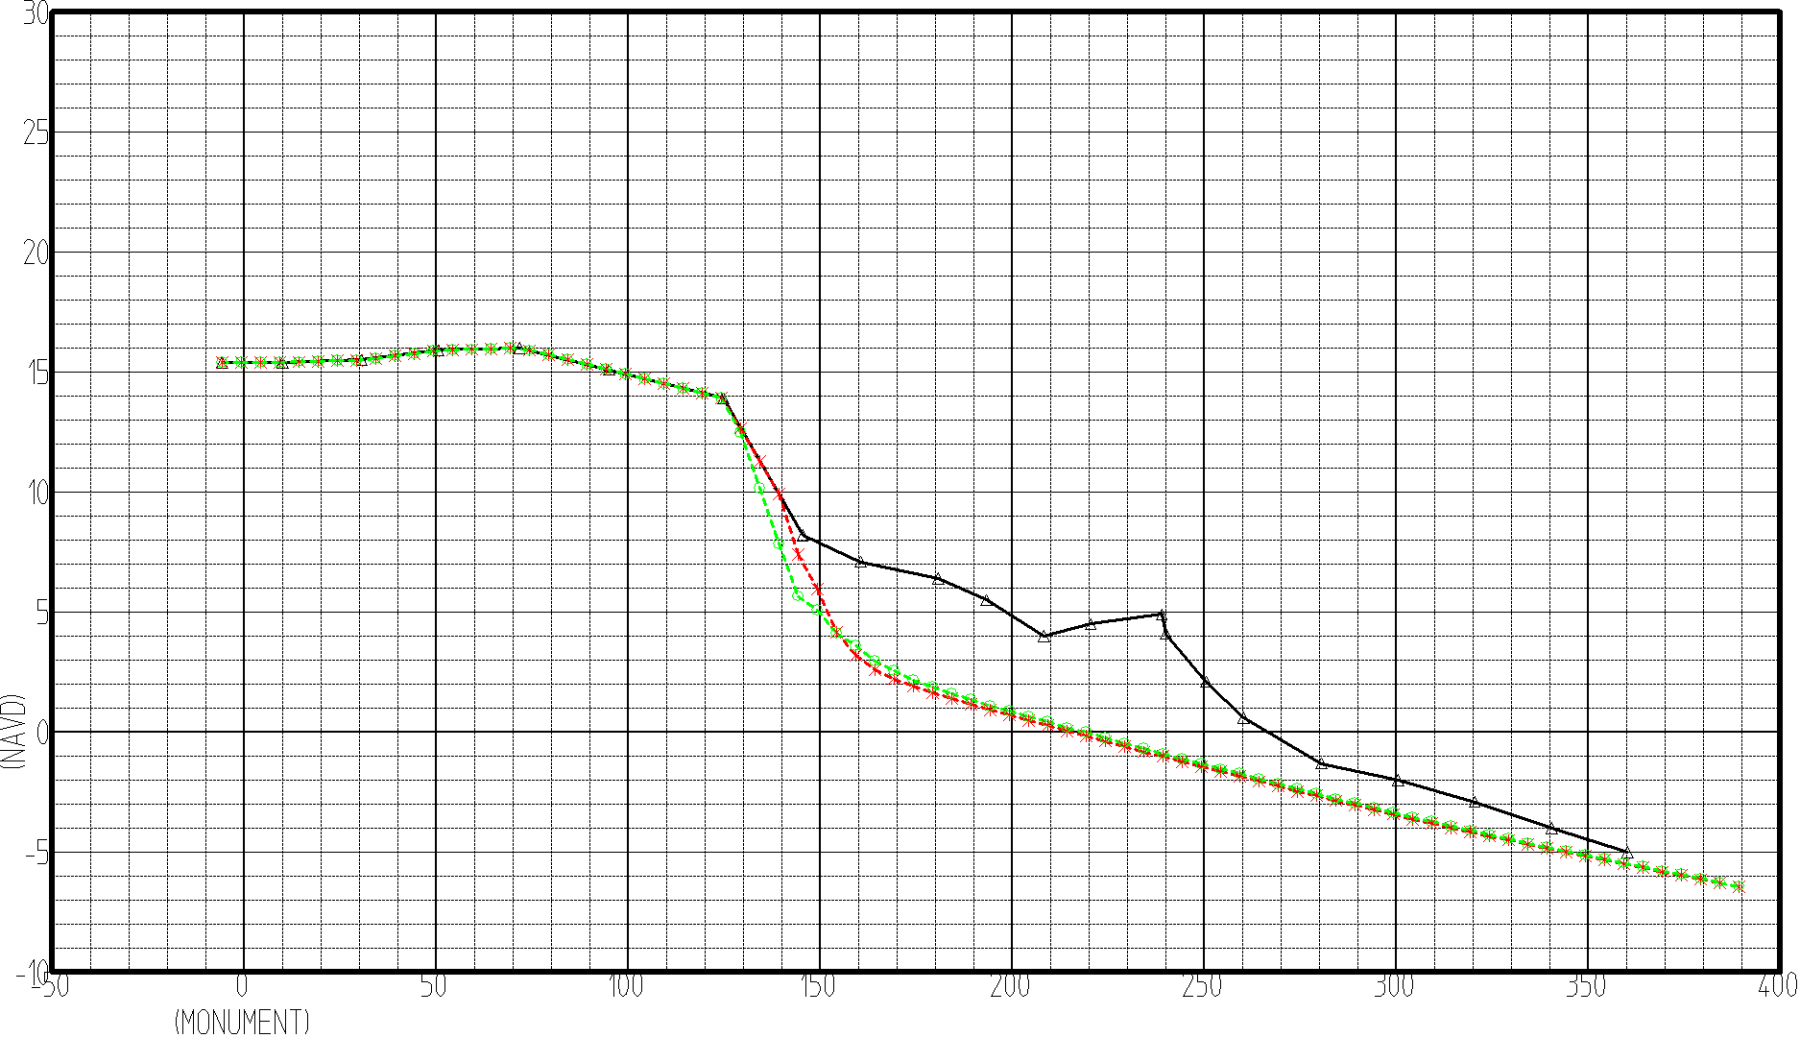
Range: T-60 1/1

BEACH PROFILE

- △—△— 2006-07 Indian River
- - - \* - - - 15YR SBEACH ERODED
- - - o - - - 25YR SBEACH ERODED

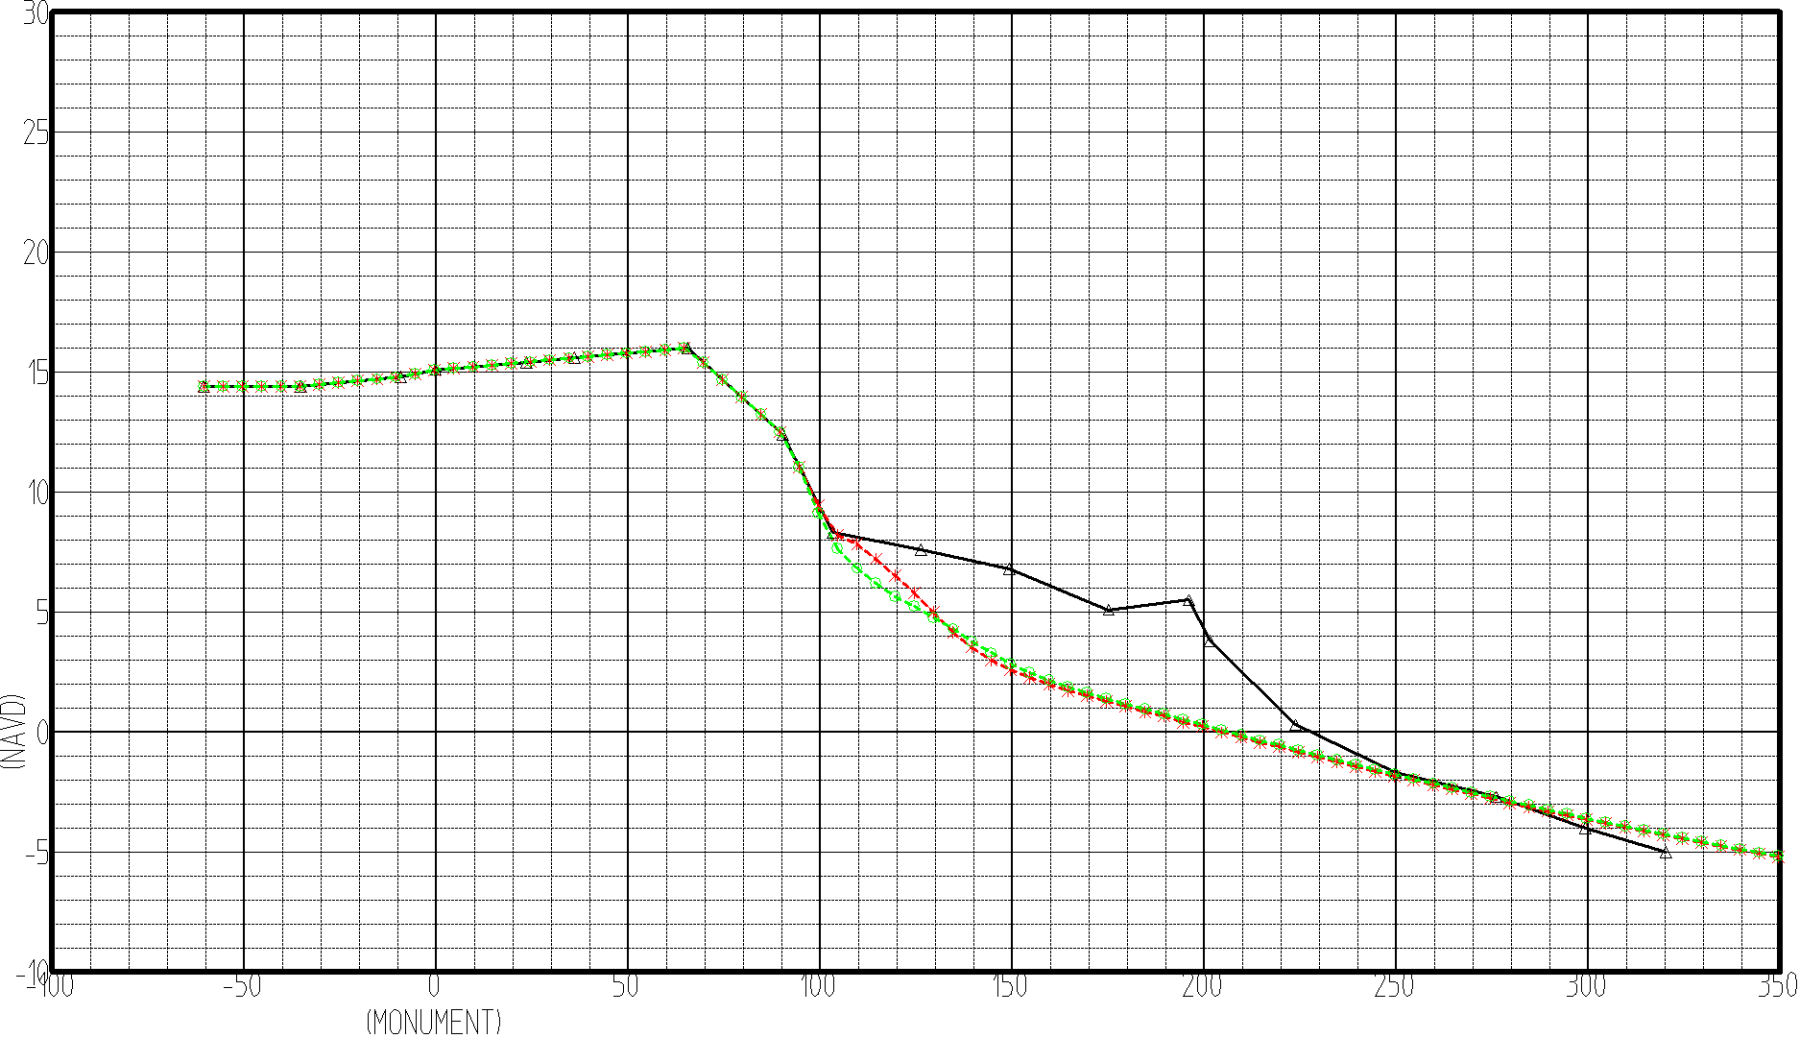
Range: R-61

BEACH PROFILE

—△—△— 2006-07 Indian River

- - - \* - - - 15YR SBEACH ERODED

- - - o - - - 25YR SBEACH ERODED

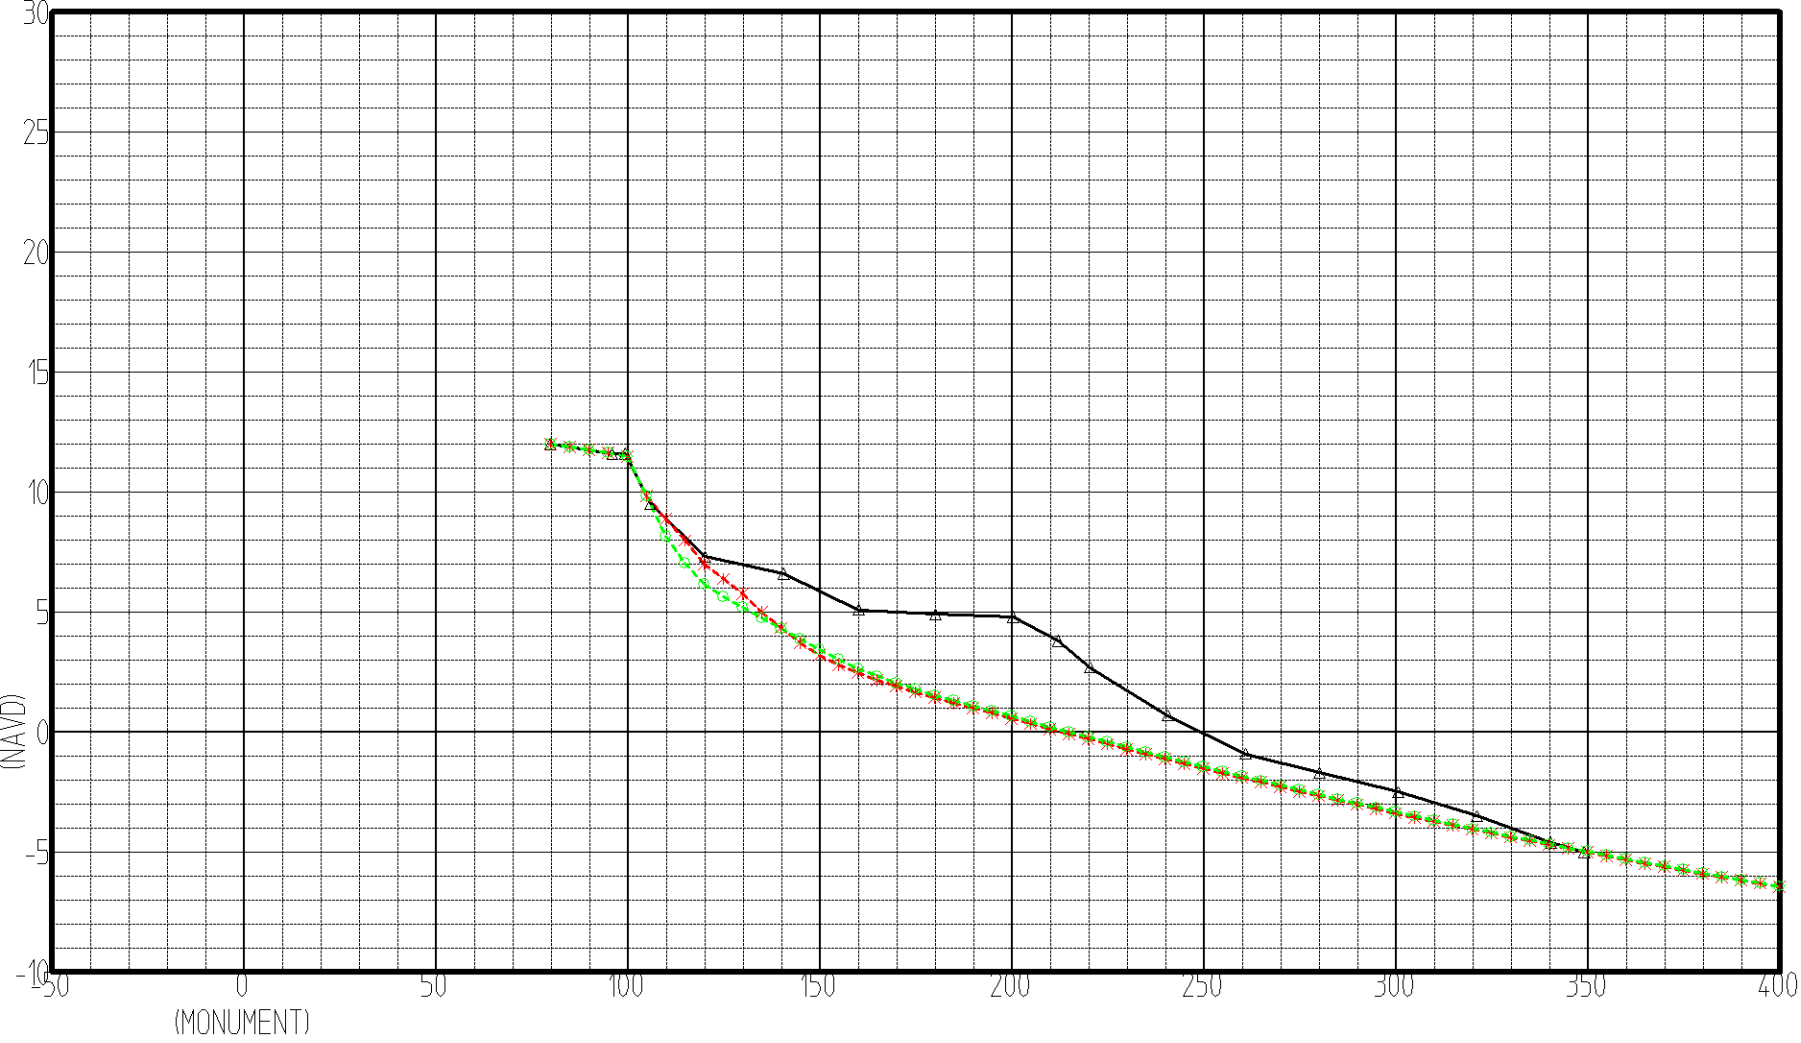
Range: R-62  
 BEARING: 70.00  
 1/1

BEACH PROFILE  
 —△—△— 2006-07 Indian River  
 - - - \* - - - 15YR SBEACH ERODED  
 - - - o - - - 25YR SBEACH ERODED

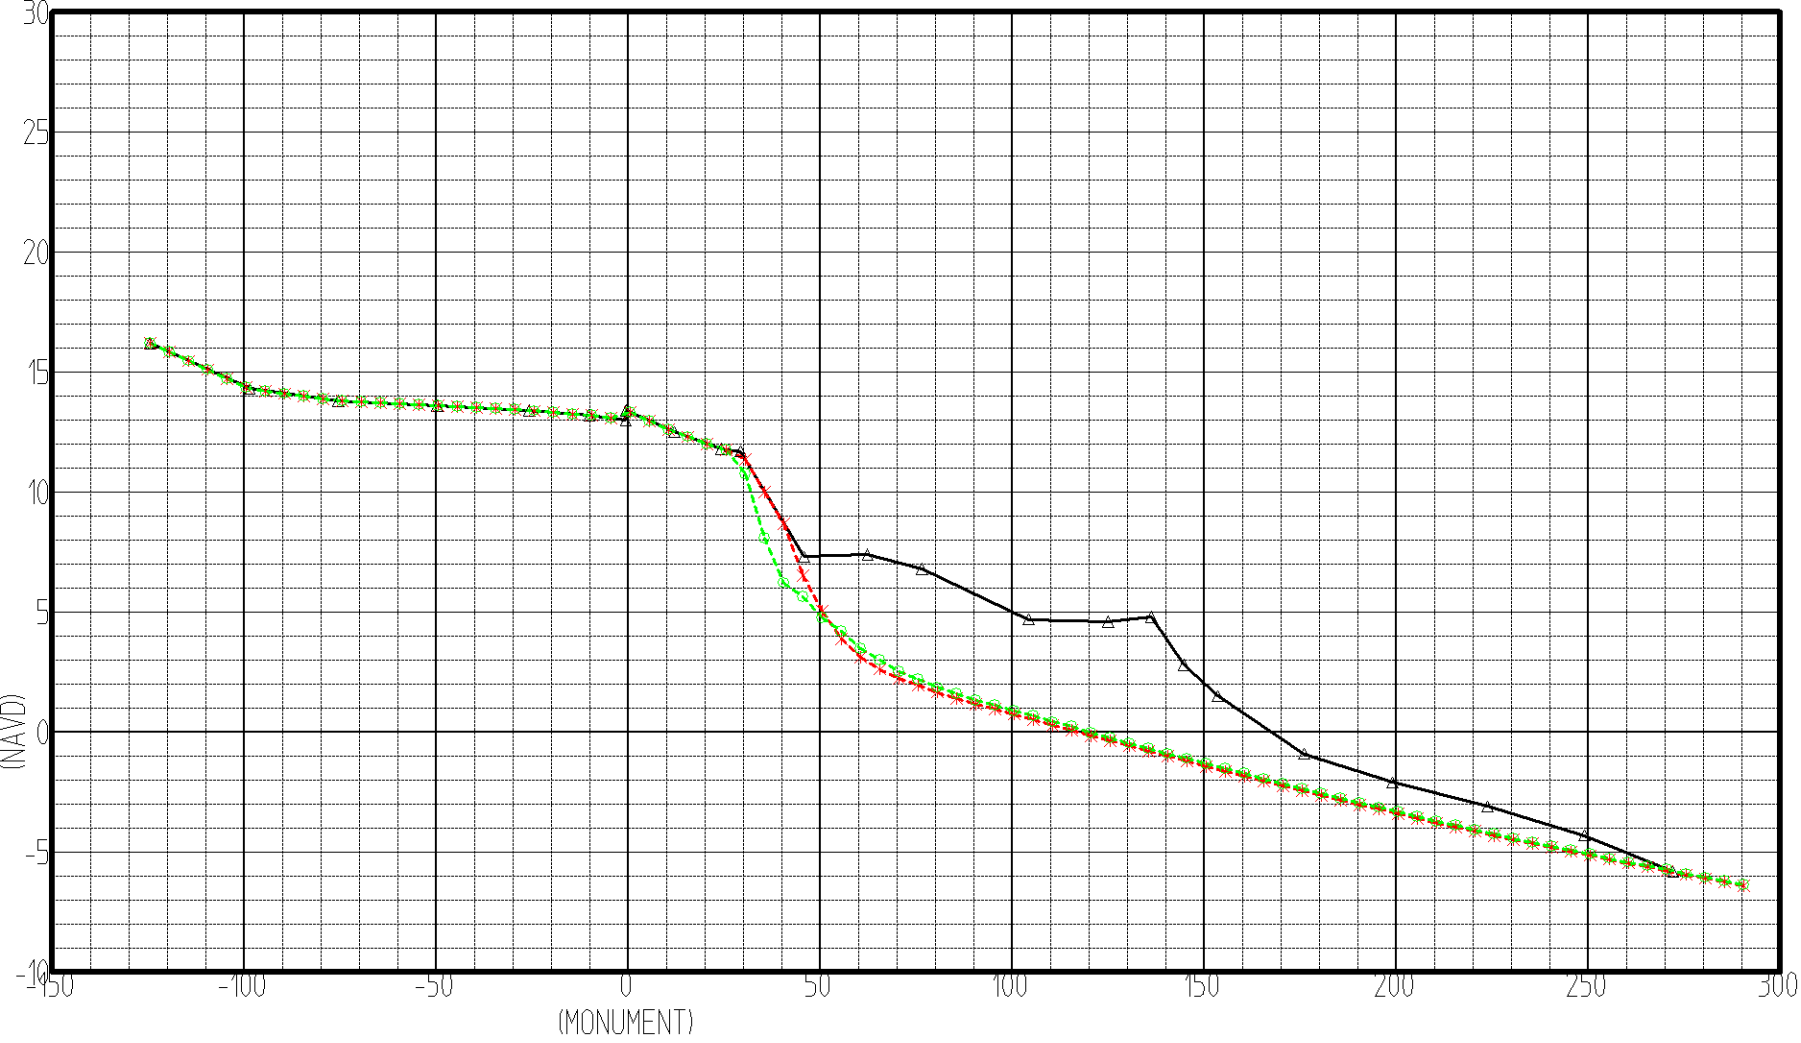
Range: R-63 1/1

BEACH PROFILE

- △—△— 2006-07 Indian River
- - \* - - \* - - 15YR SBEACH ERODED
- - o - - o - - 25YR SBEACH ERODED

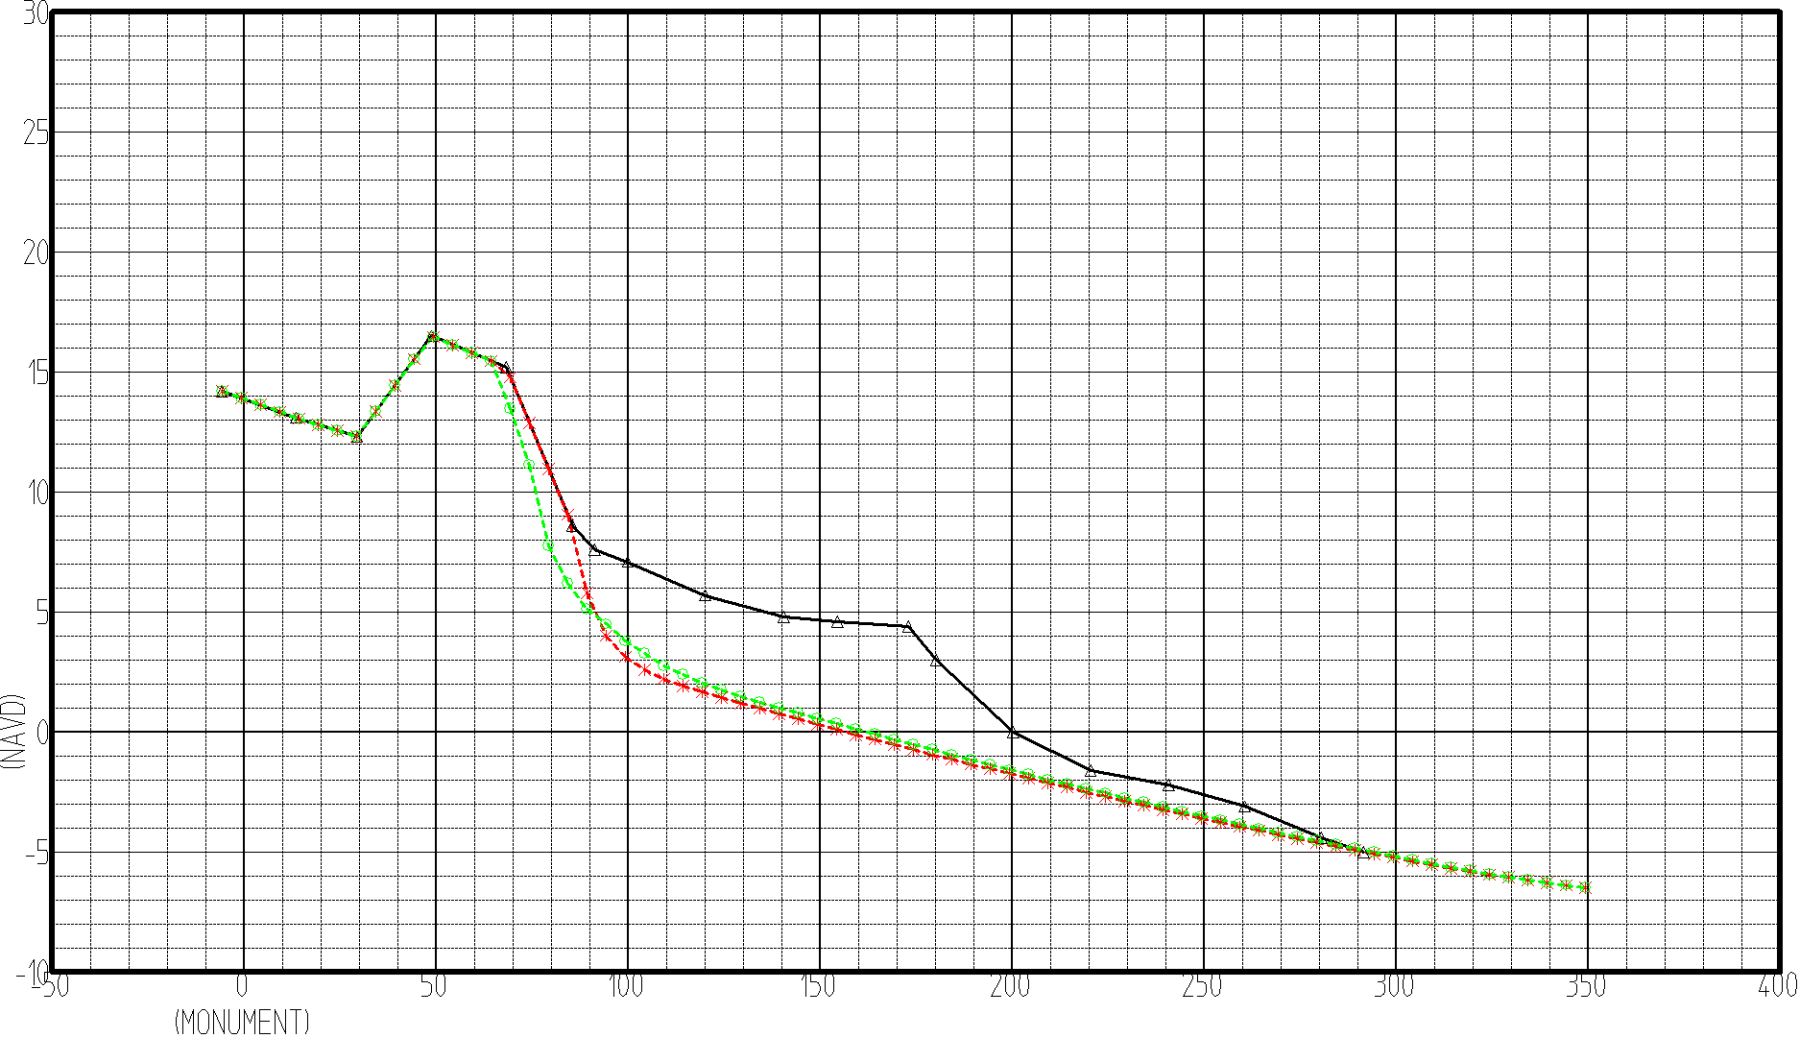
Range: R-64 1/1

BEACH PROFILE

- △—△— 2006-07 Indian River
- - - \* - - - 15YR SBEACH ERODED
- - - o - - - 25YR SBEACH ERODED

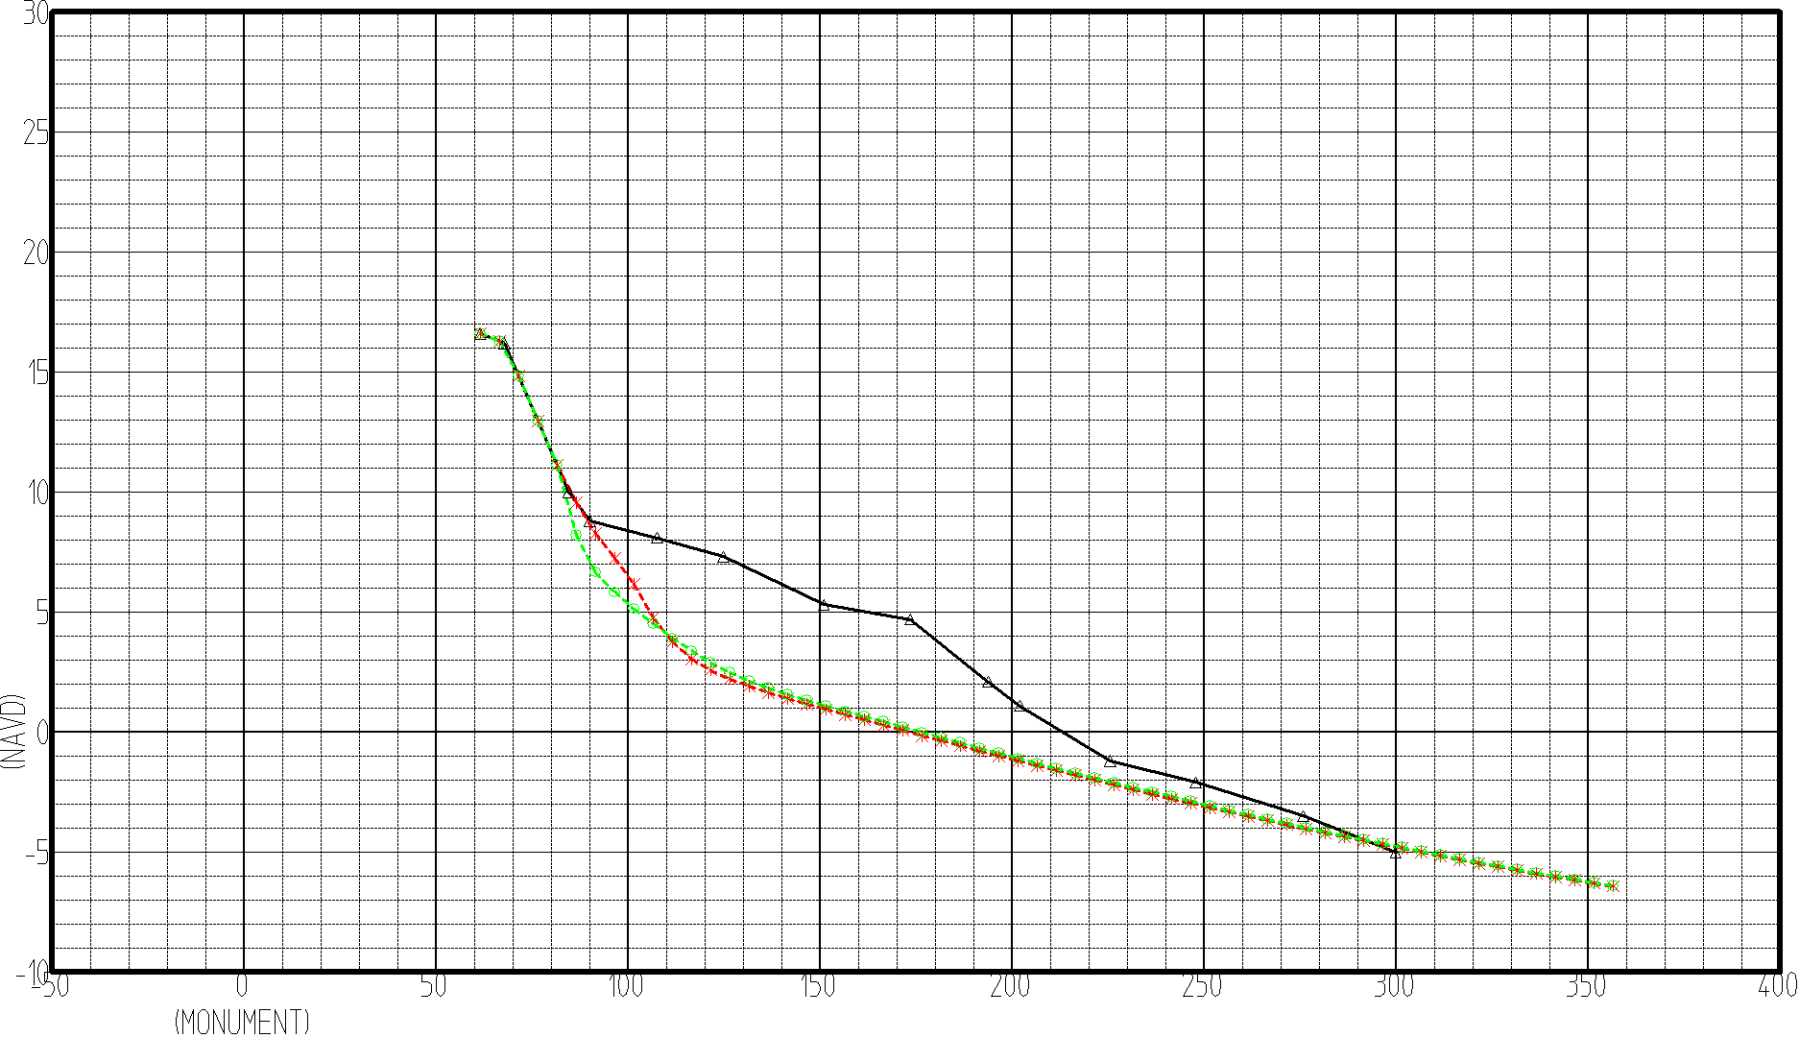
BEACH PROFILE  
 —△—△— 2006-07 Indian River  
 - - \* - - \* - - 15YR SBEACH ERODED  
 - - o - - o - - 25YR SBEACH ERODED

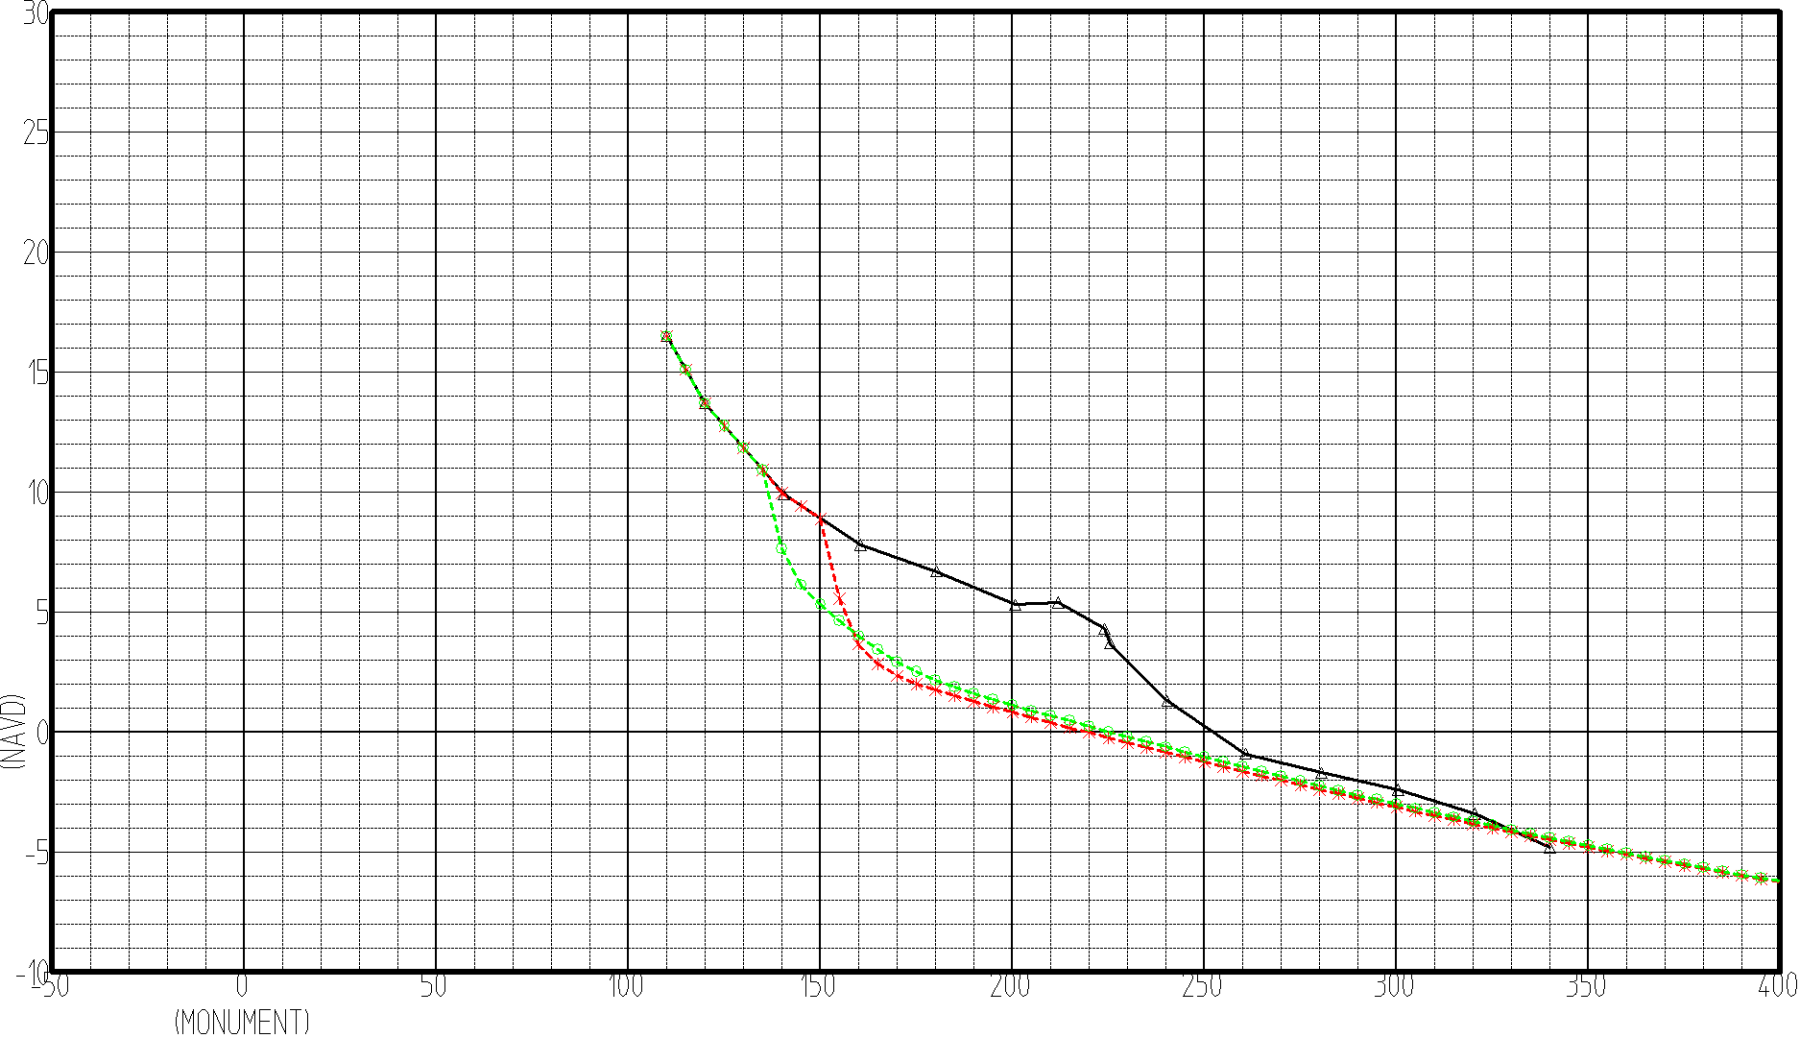
Range: R-66 1/2

BEACH PROFILE

- △—△— 2006-07 Indian River
- - - \* - - - 15YR SBEACH ERODED
- - - o - - - 25YR SBEACH ERODED

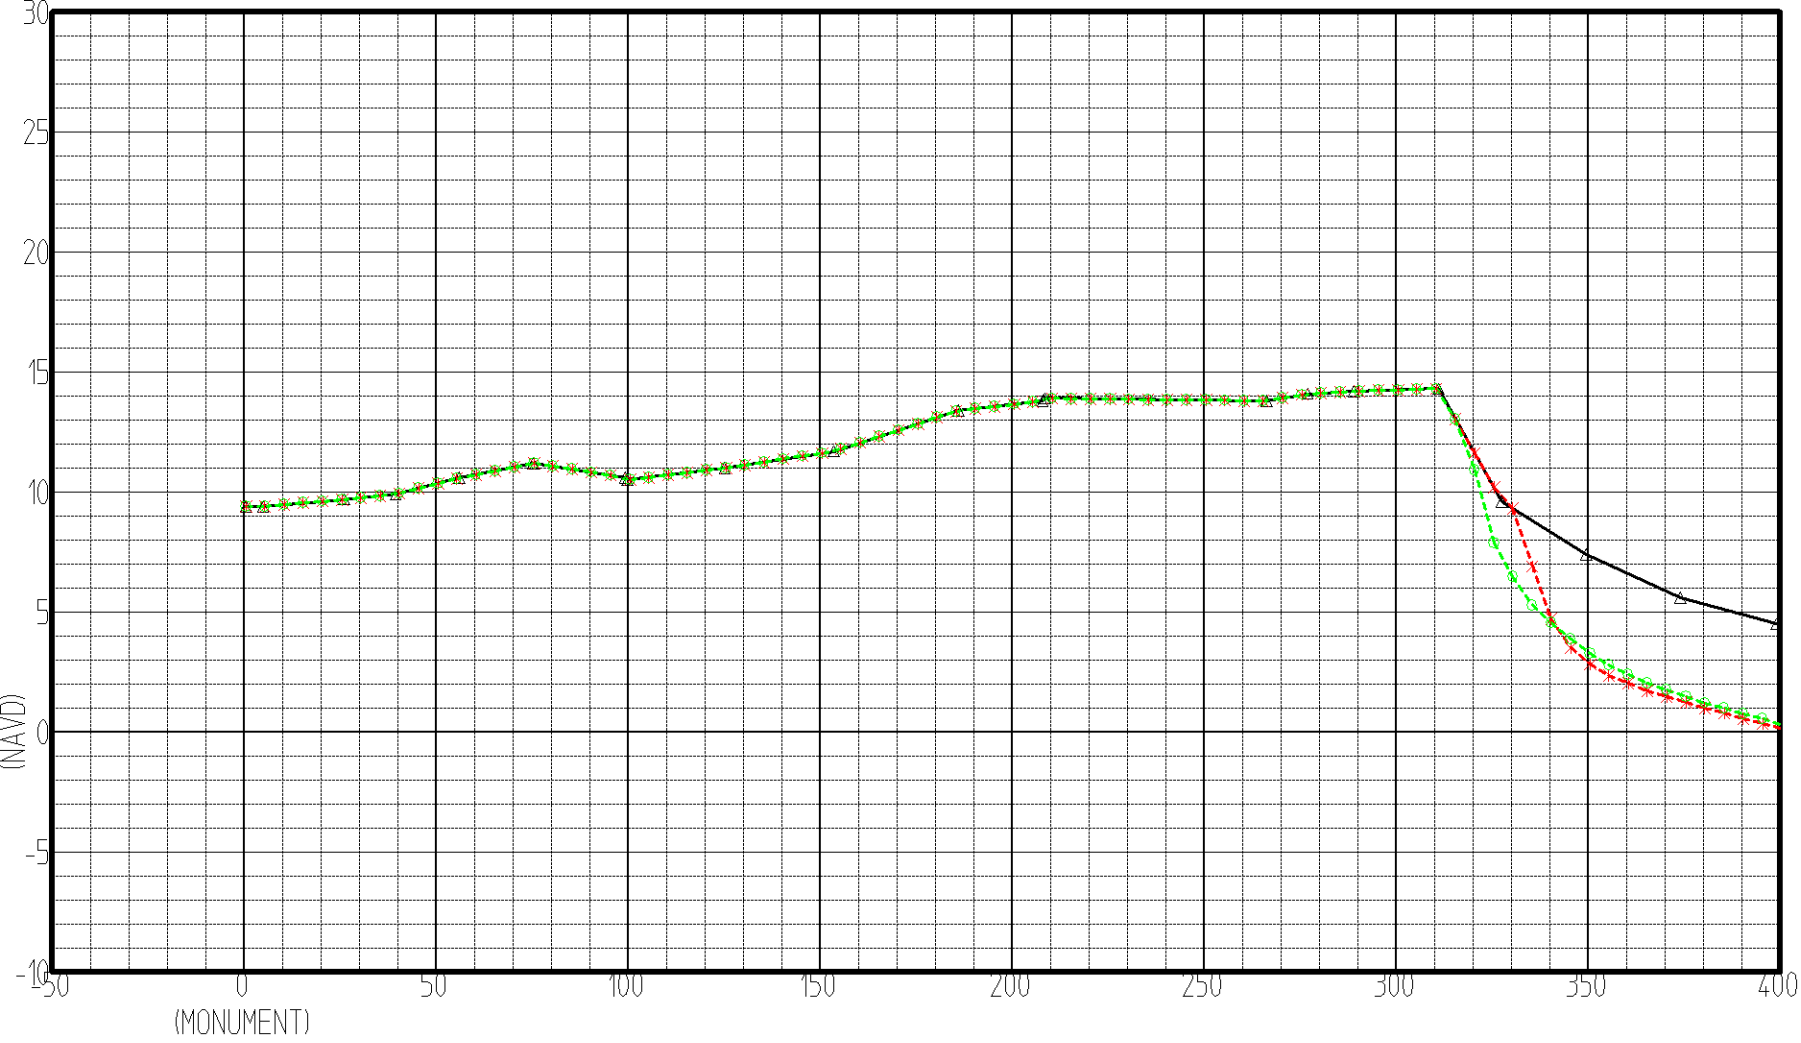
Range: R-67  
 BEARING: 70.00  
 1/2

BEACH PROFILE  
 —△—△— 2006-07 Indian River  
 - - \* - - 15YR SBEACH ERODED  
 - - o - - 25YR SBEACH ERODED

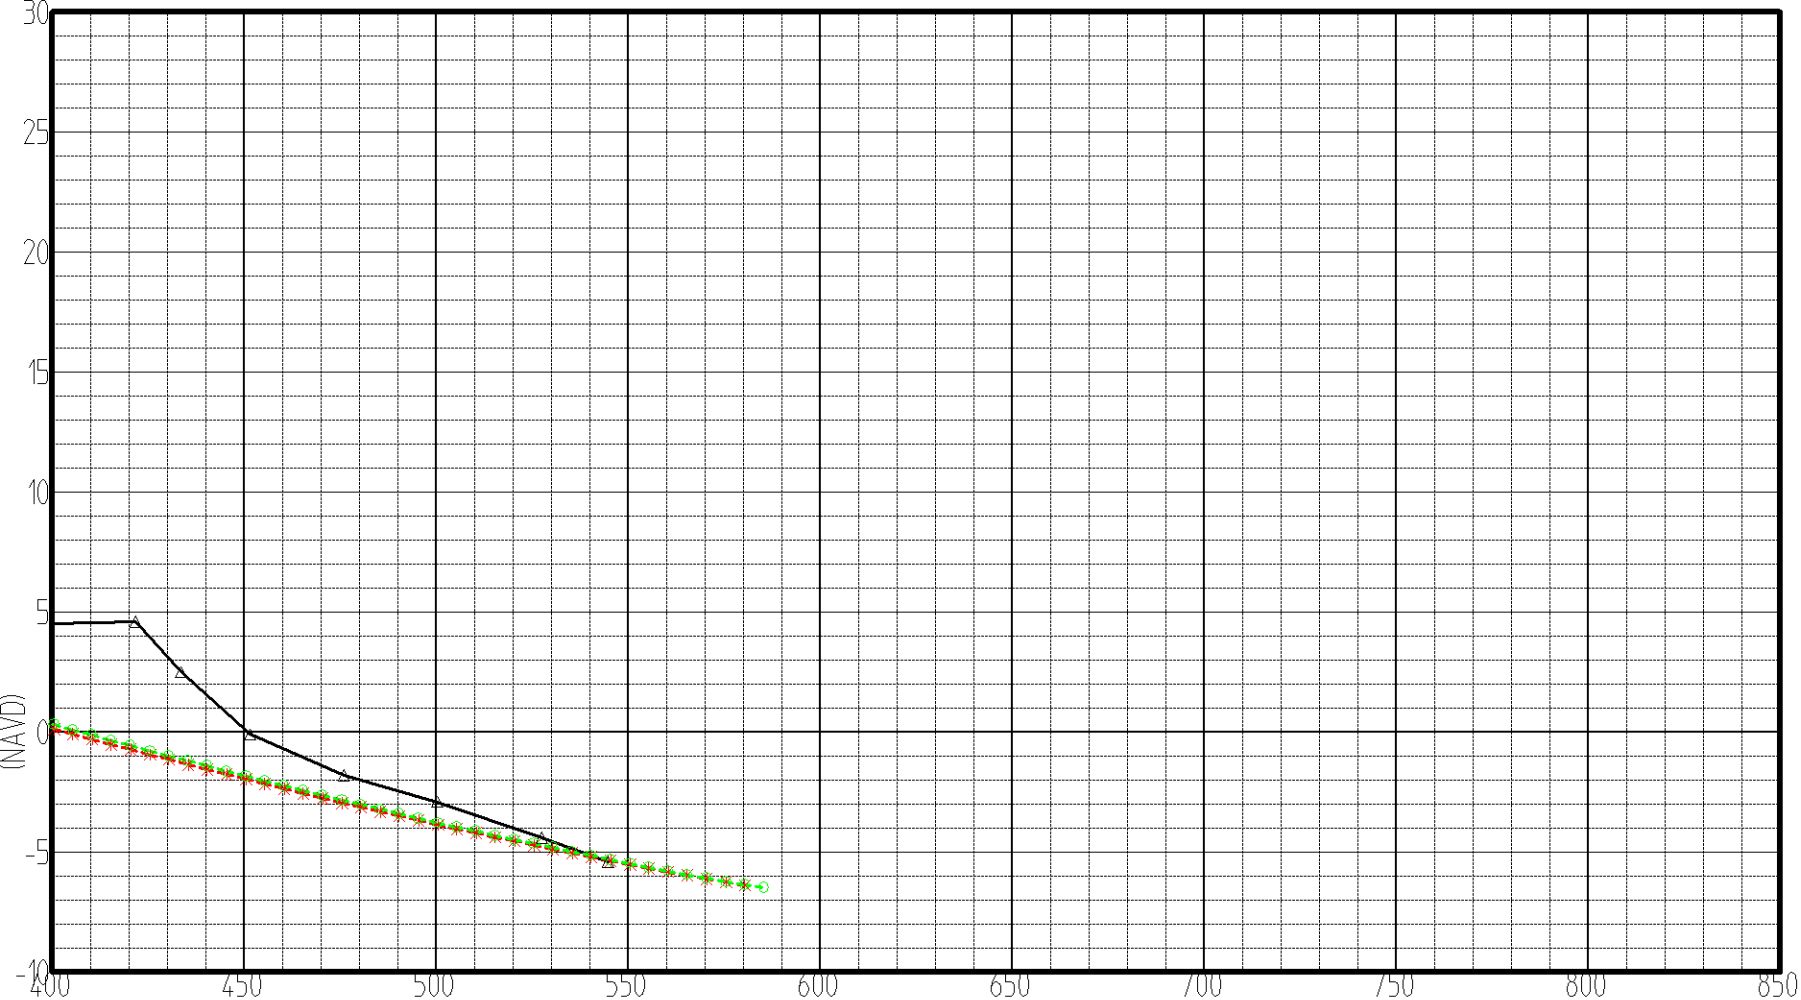
BEACH PROFILE  
 —△—△— 2006-07 Indian River  
 - - \* - - 15YR SBEACH ERODED  
 - - ○ - - 25YR SBEACH ERODED

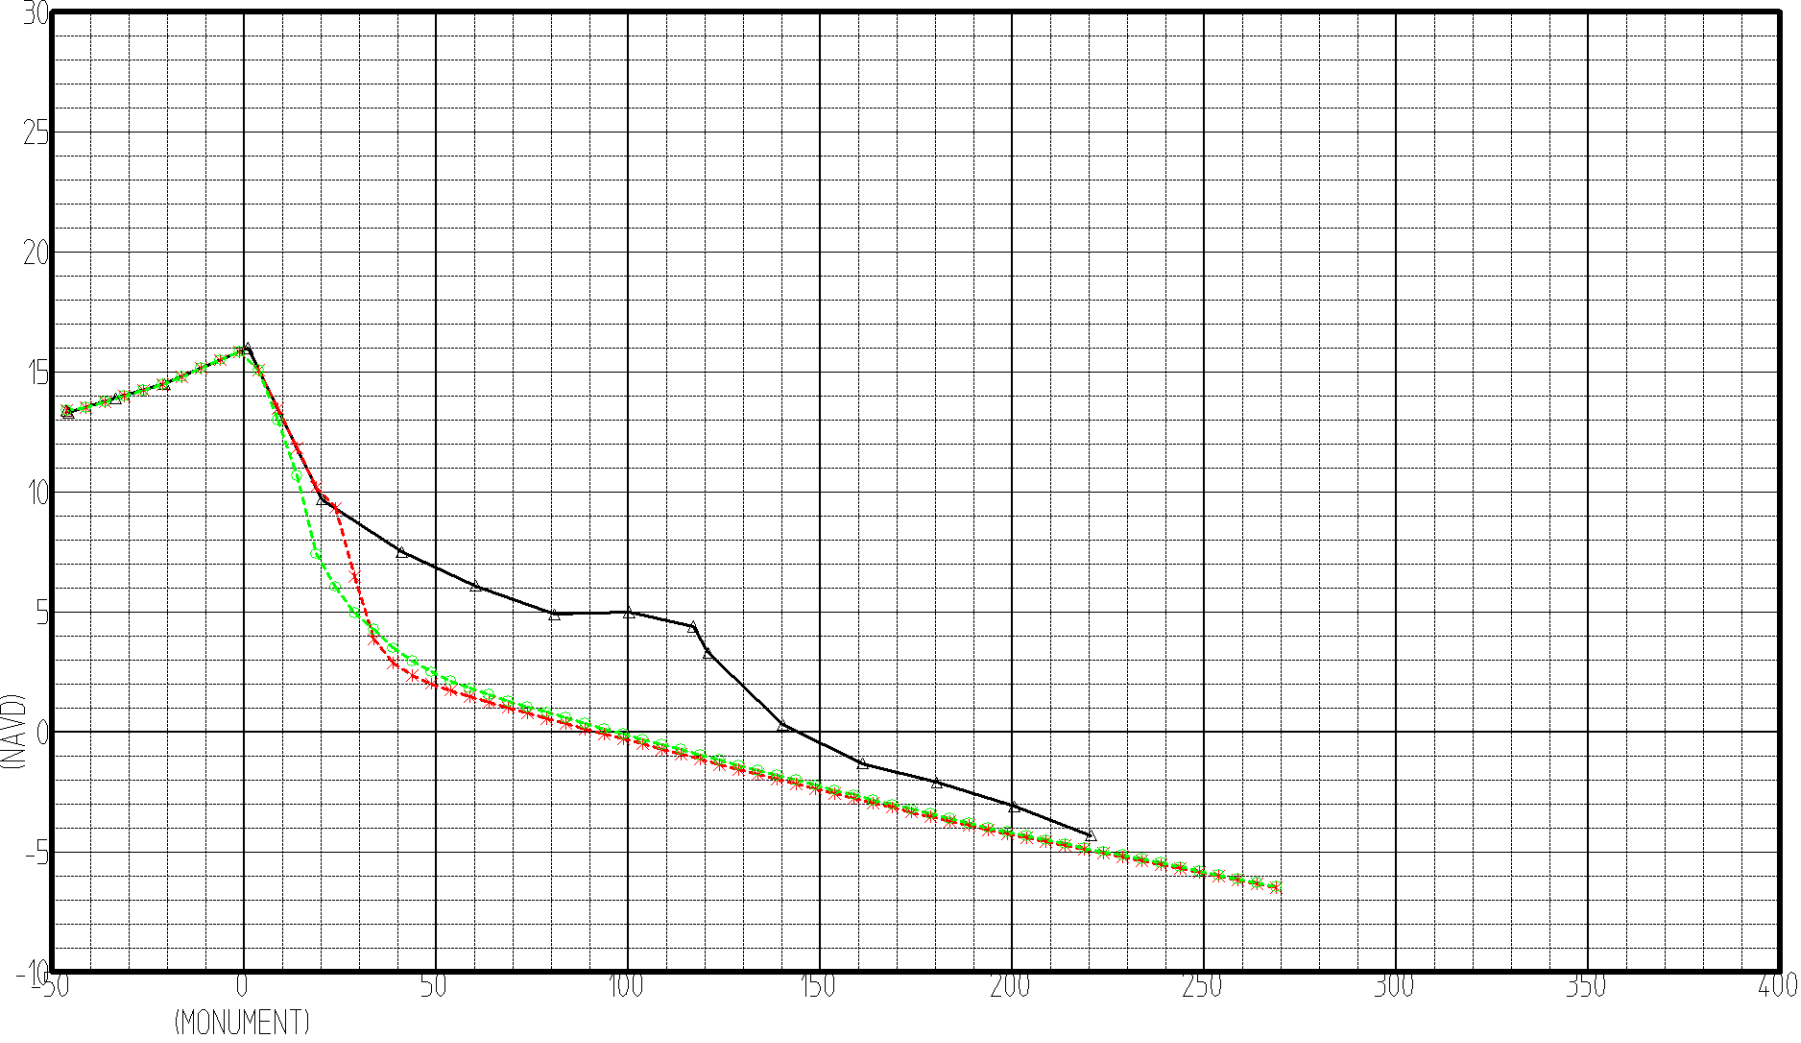
Range: R-68  
 BEARING: 70.00  
 1/1

BEACH PROFILE  
 —△—△— 2006-07 Indian River  
 - - \* - - \* - - 15YR SBEACH ERODED  
 - - o - - o - - 25YR SBEACH ERODED

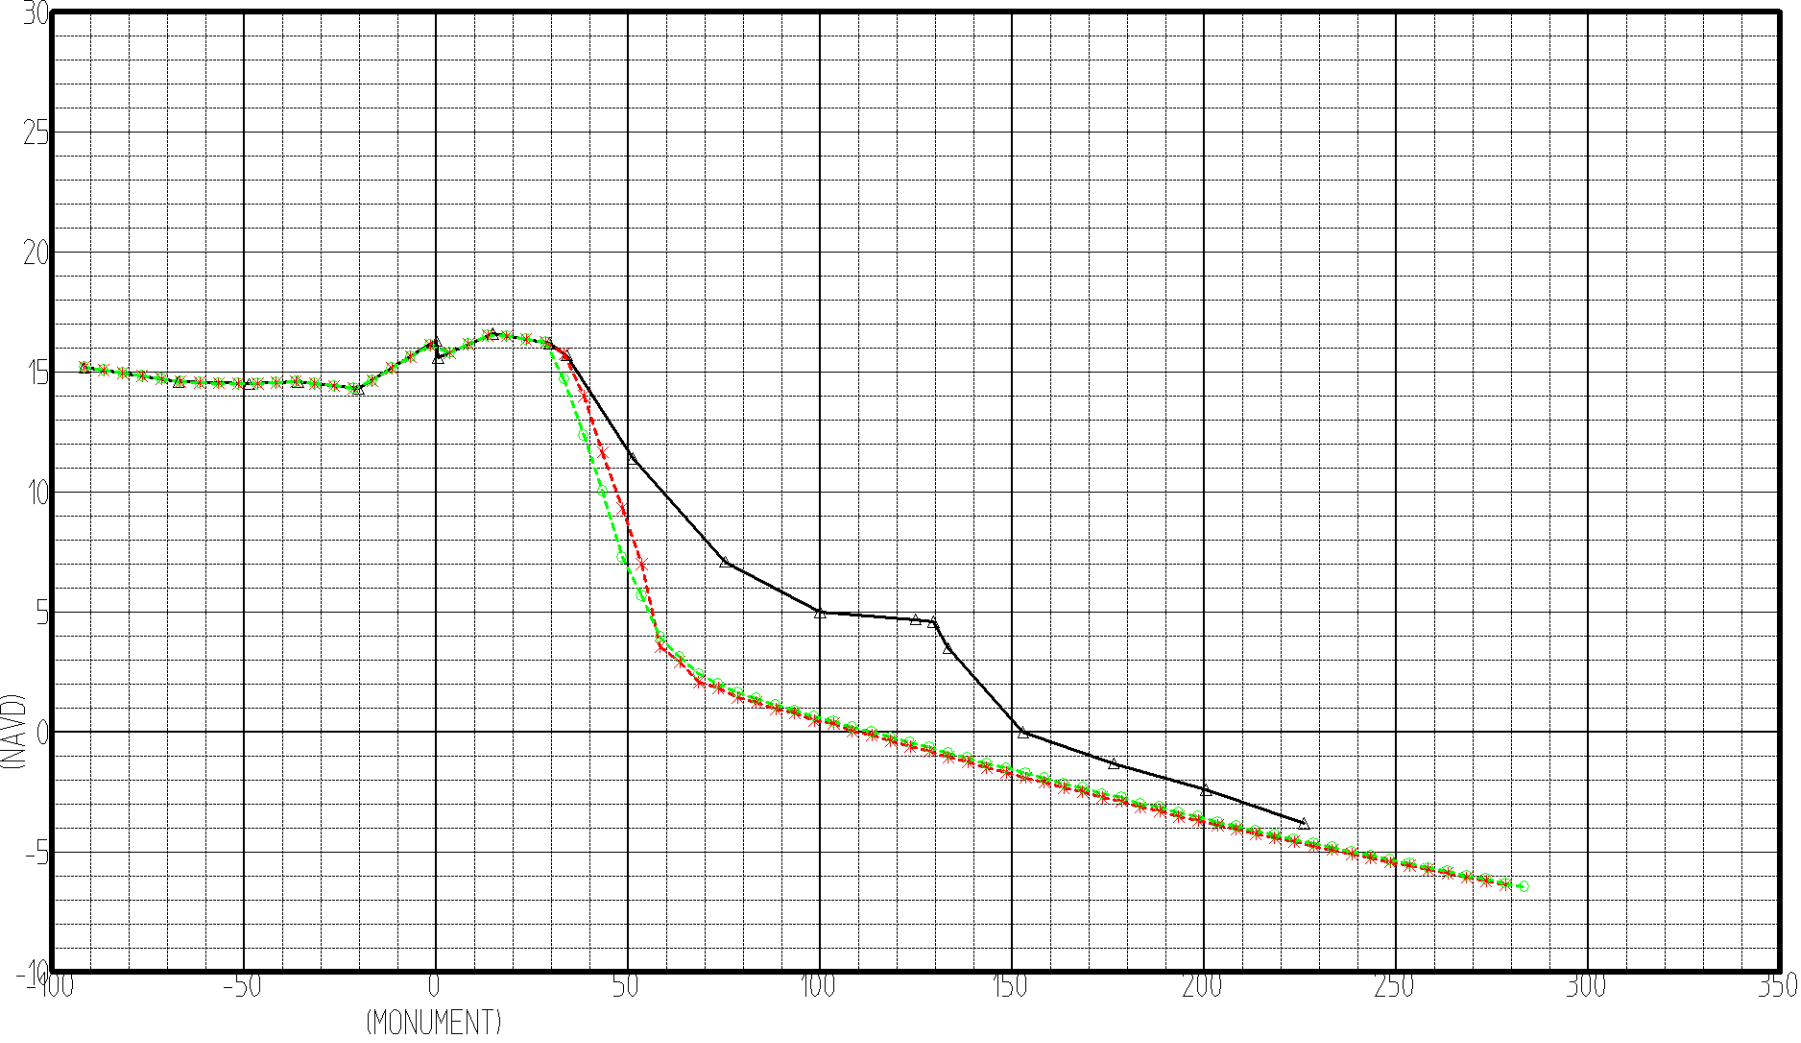
Range: R-69 1/1

BEACH PROFILE

- △—△— 2006-07 Indian River
- - - \* - - - 15YR SBEACH ERODED
- - - o - - - 25YR SBEACH ERODED

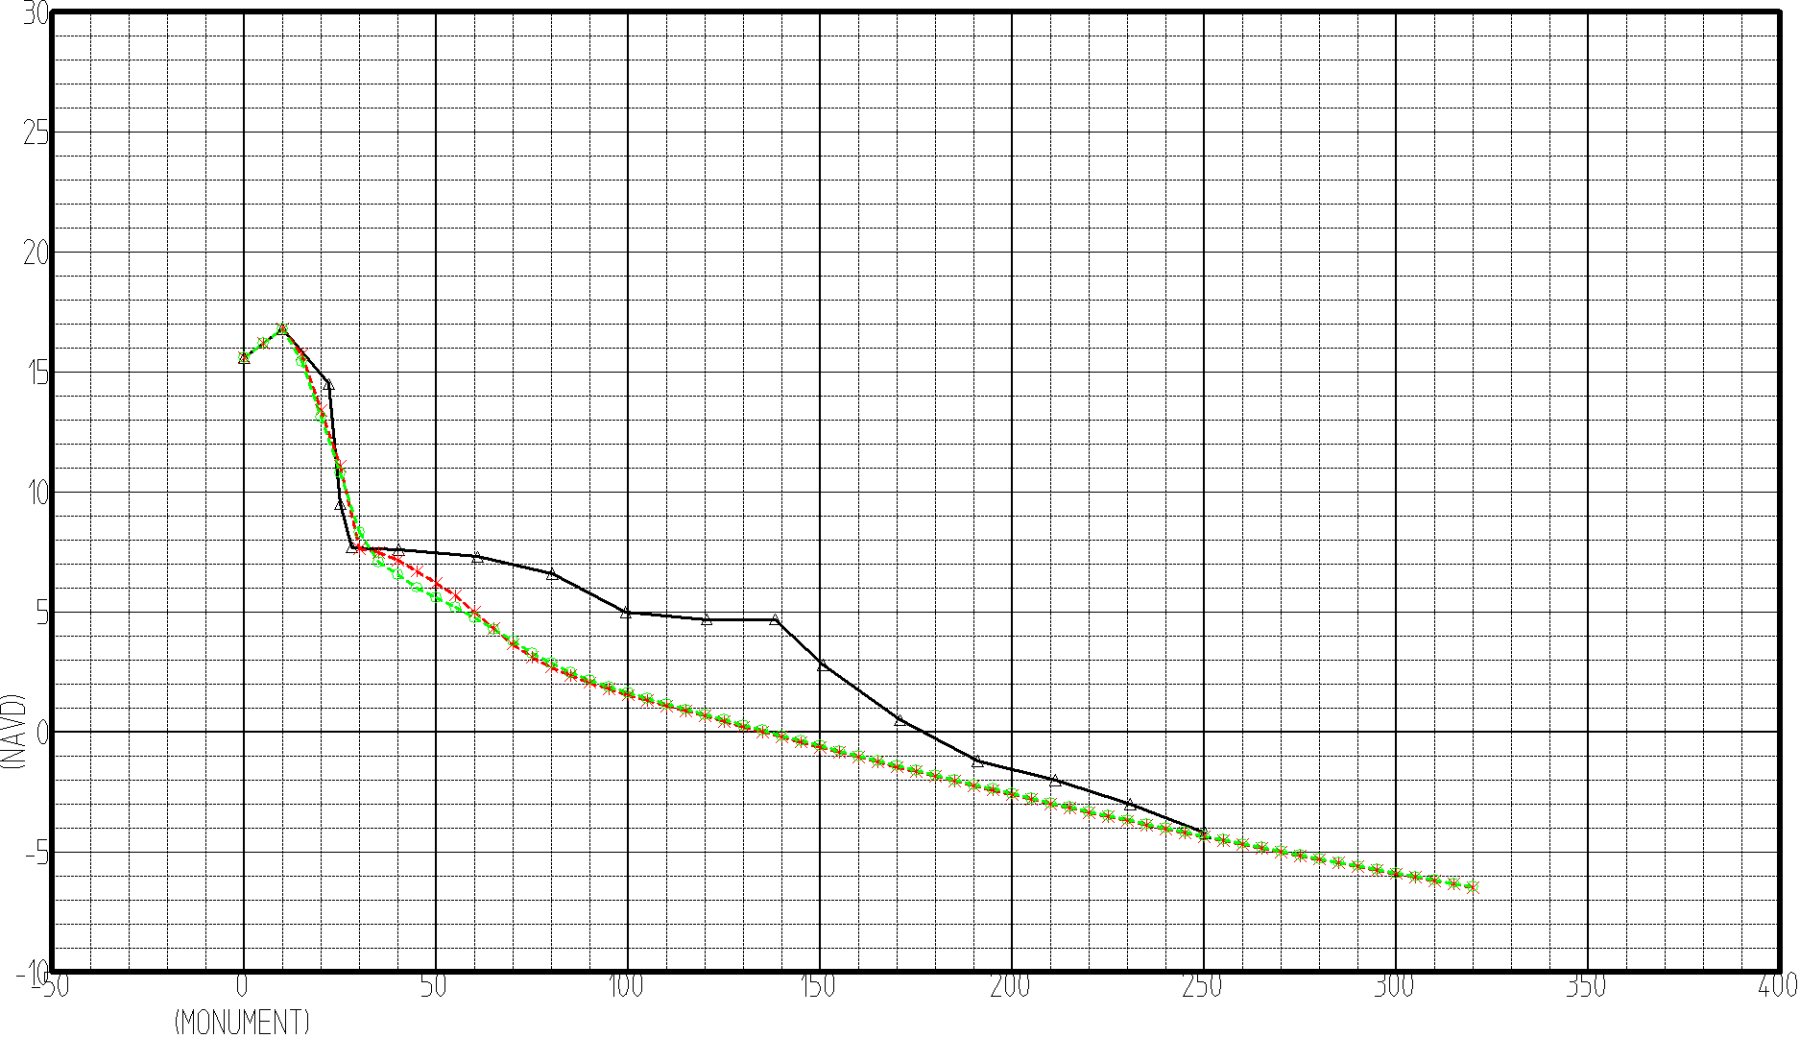
Range: T-71  
 BEARING: 70.00  
 1/1

BEACH PROFILE

- △—△— 2006-07 Indian River
- - - \* - - - 15YR SBEACH ERODED
- - - o - - - 25YR SBEACH ERODED
