## **Appendix X**

SBEACH 15 and 25 yr. Storm Erosion Profiles

Indian River County

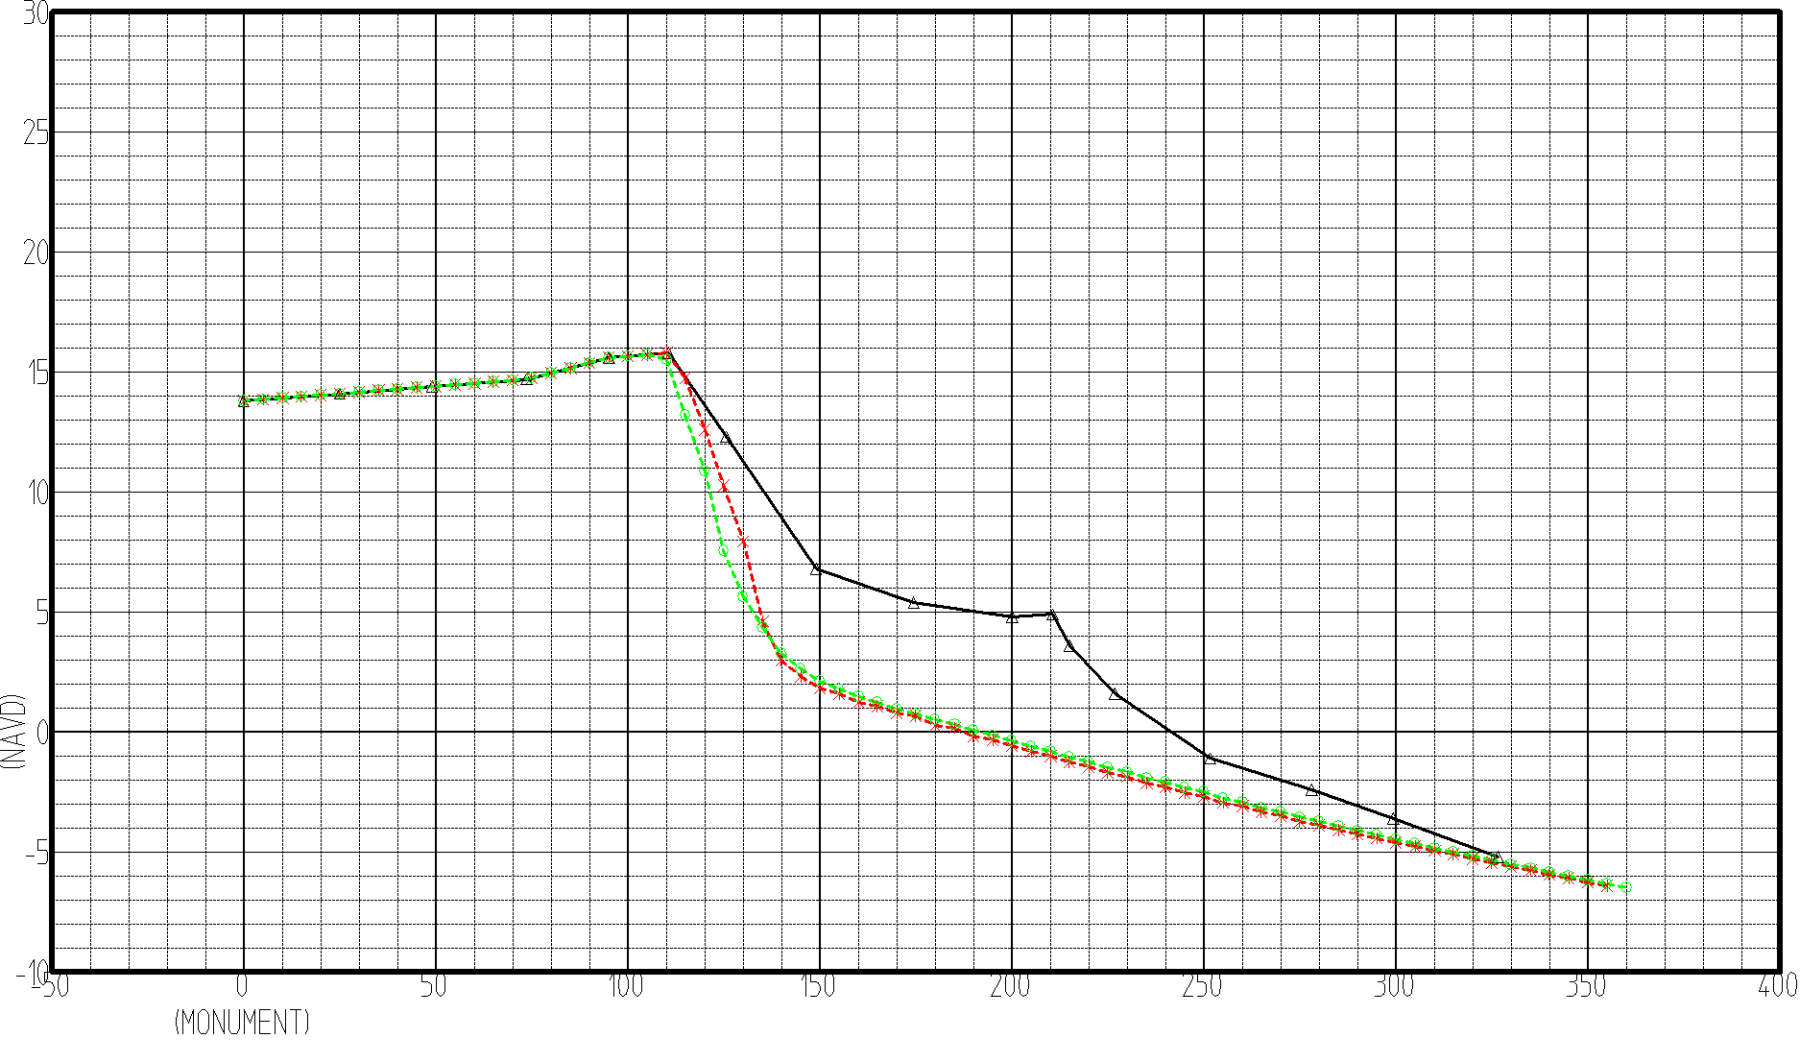
Range: T-71  
 BEARING: 70.00  
 1/1

BEACH PROFILE  
 —△—△— 2006-07 Indian River  
 - - \* - - 15YR SBEACH ERODED  
 - - o - - 25YR SBEACH ERODED

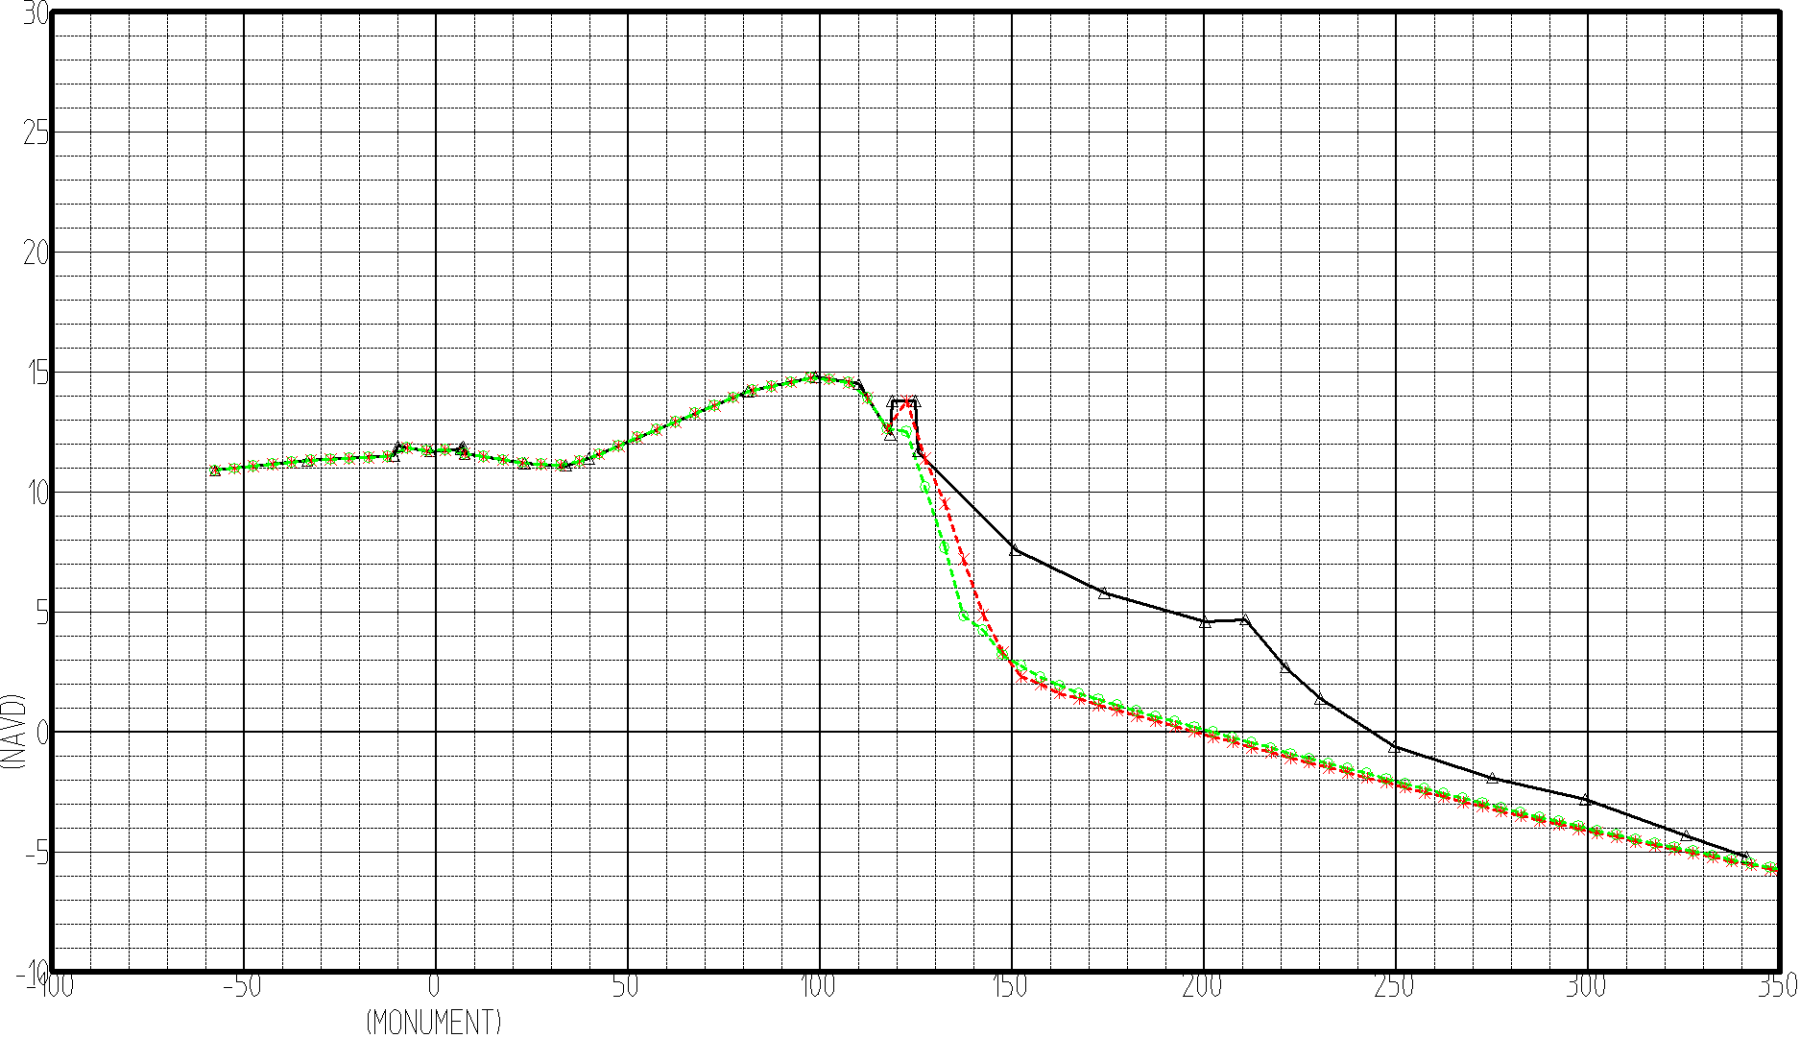
Range: R-73

BEACH PROFILE

—△—△— 2006-07 Indian River

- - \* - - \* - - 15YR SBEACH ERODED

- - o - - o - - 25YR SBEACH ERODED

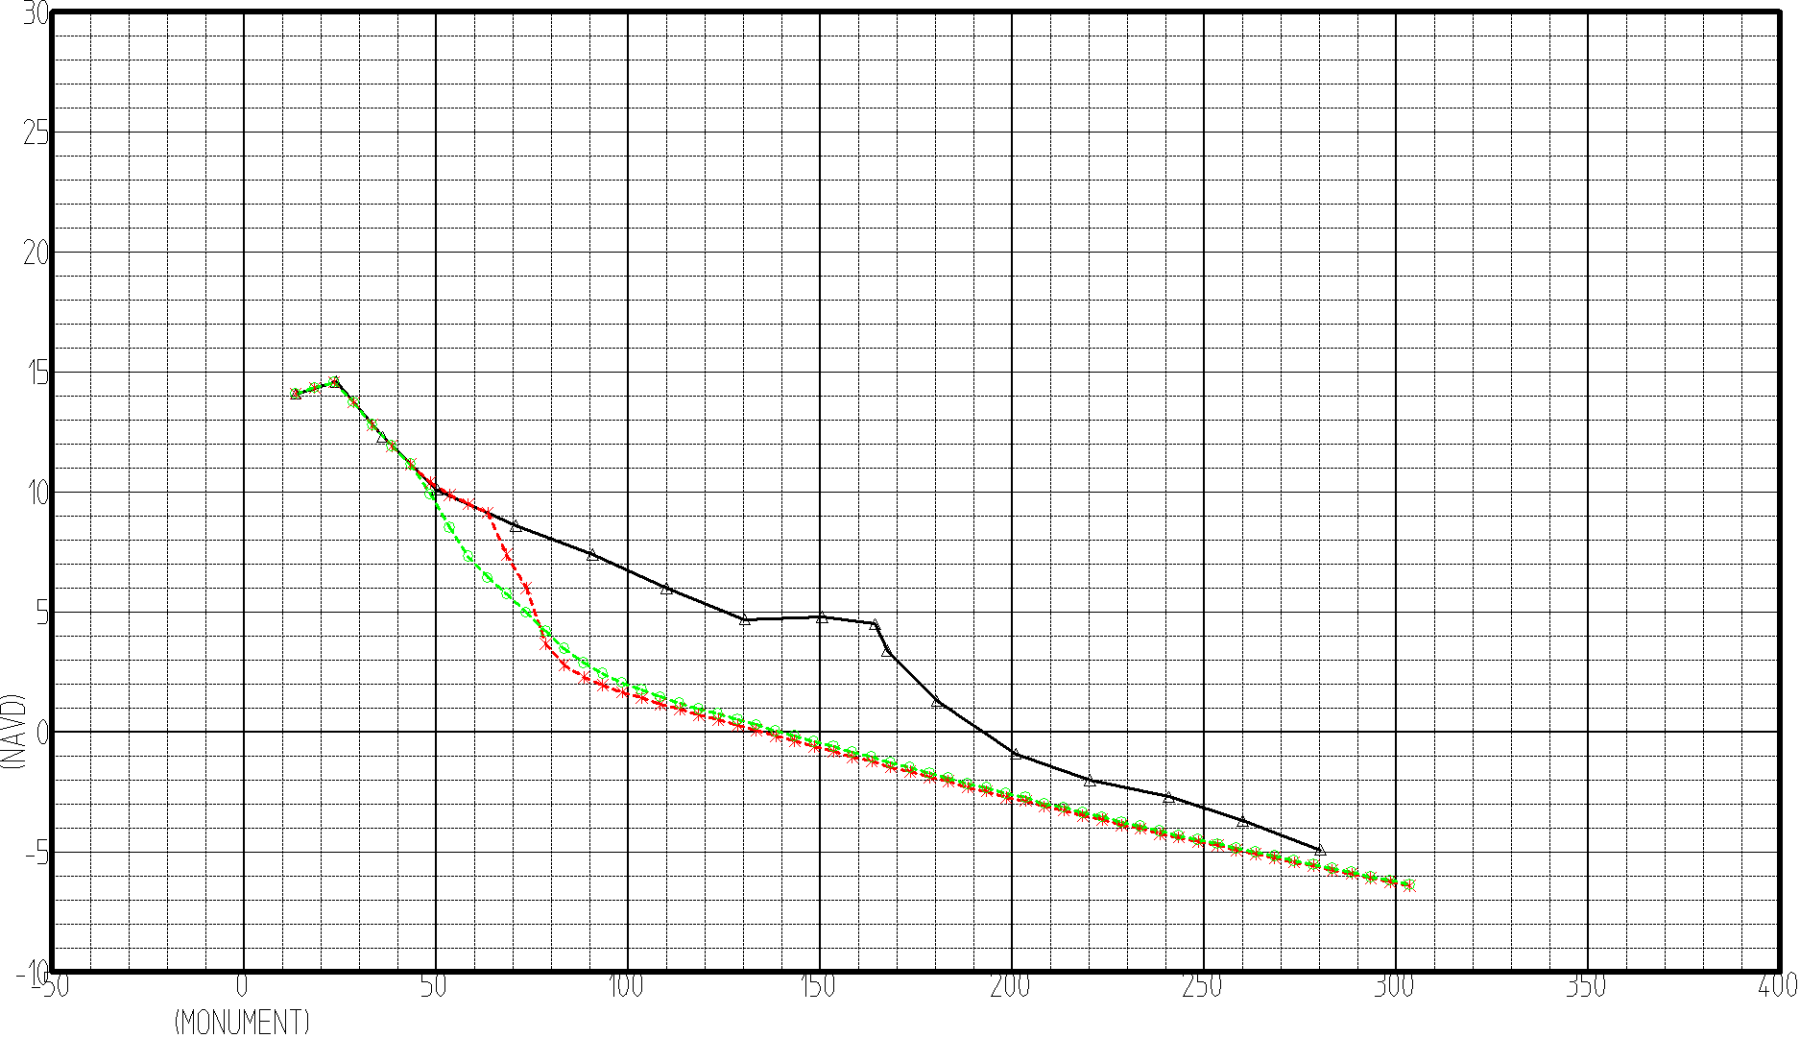
Range: R-74

BEACH PROFILE

- △—△— 2006-07 Indian River
- - - \* - - - 15YR SBEACH ERODED
- - - o - - - 25YR SBEACH ERODED

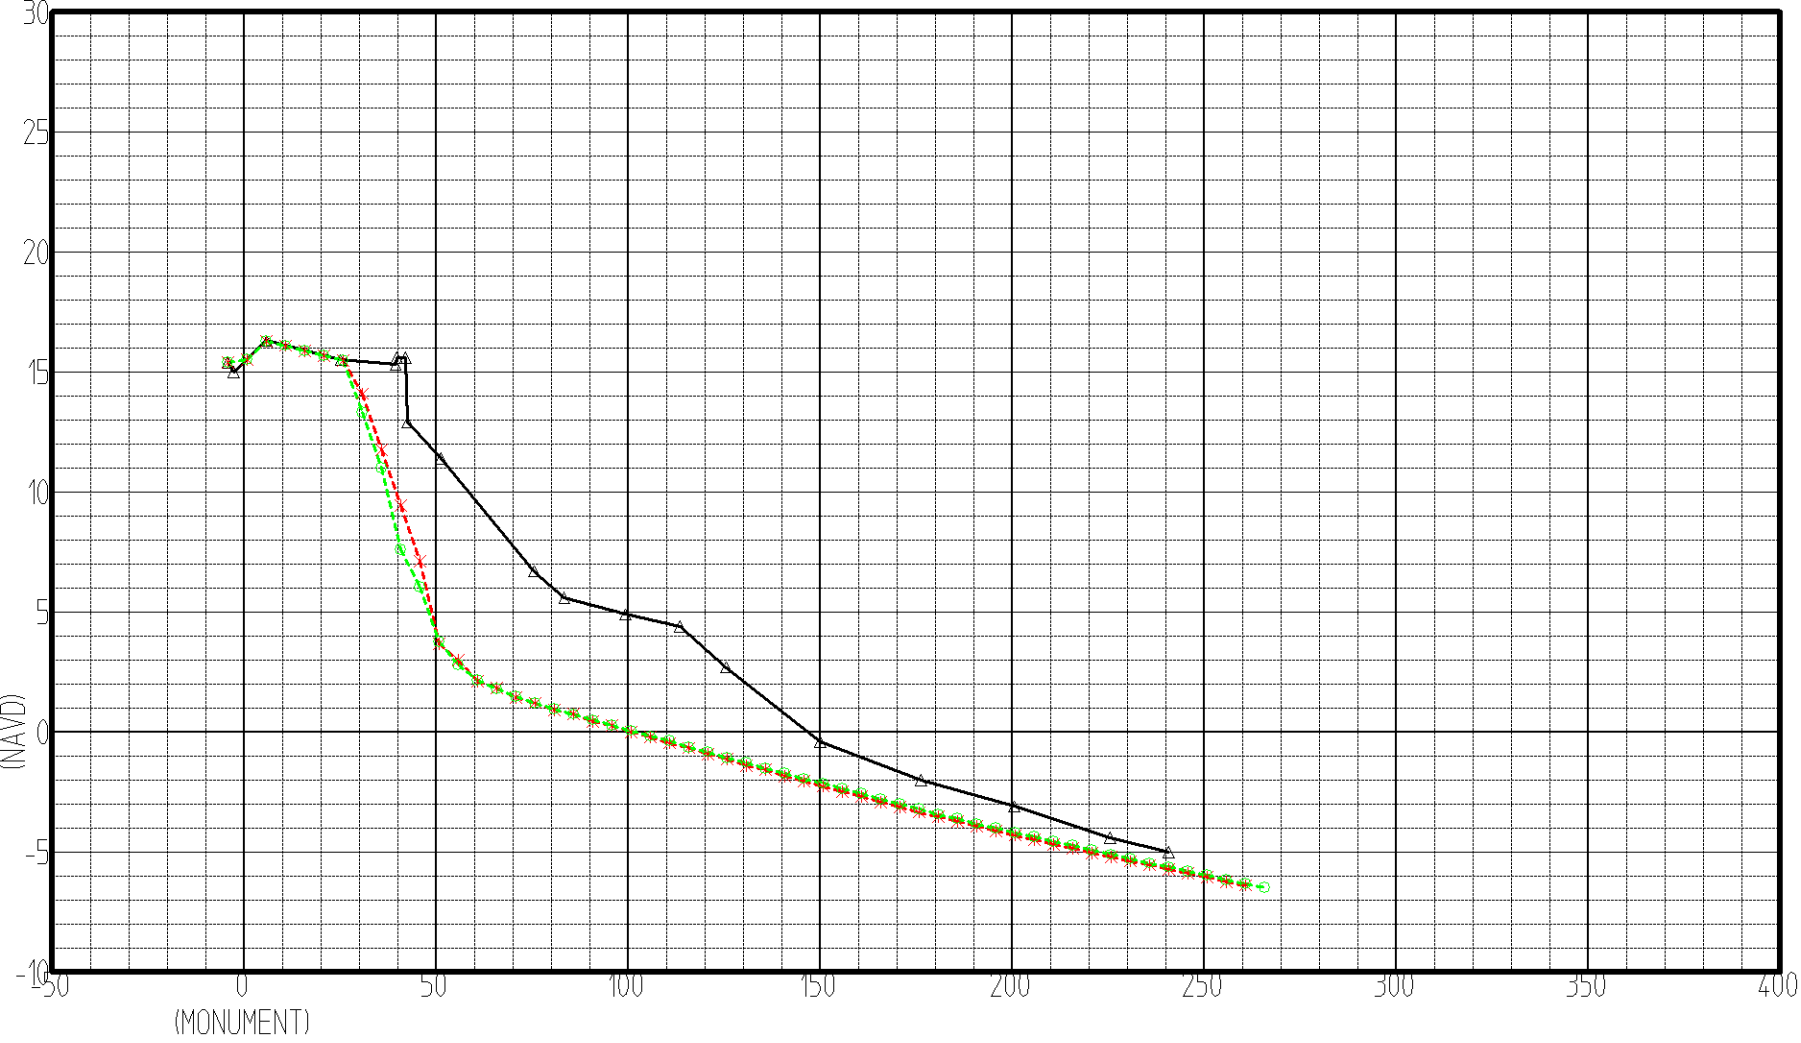
Range: R-75  
 BEARING: 70.00  
 1/1

BEACH PROFILE  
 —△—△— 2006-07 Indian River  
 - - \* - - 15YR SBEACH ERODED  
 - - o - - 25YR SBEACH ERODED

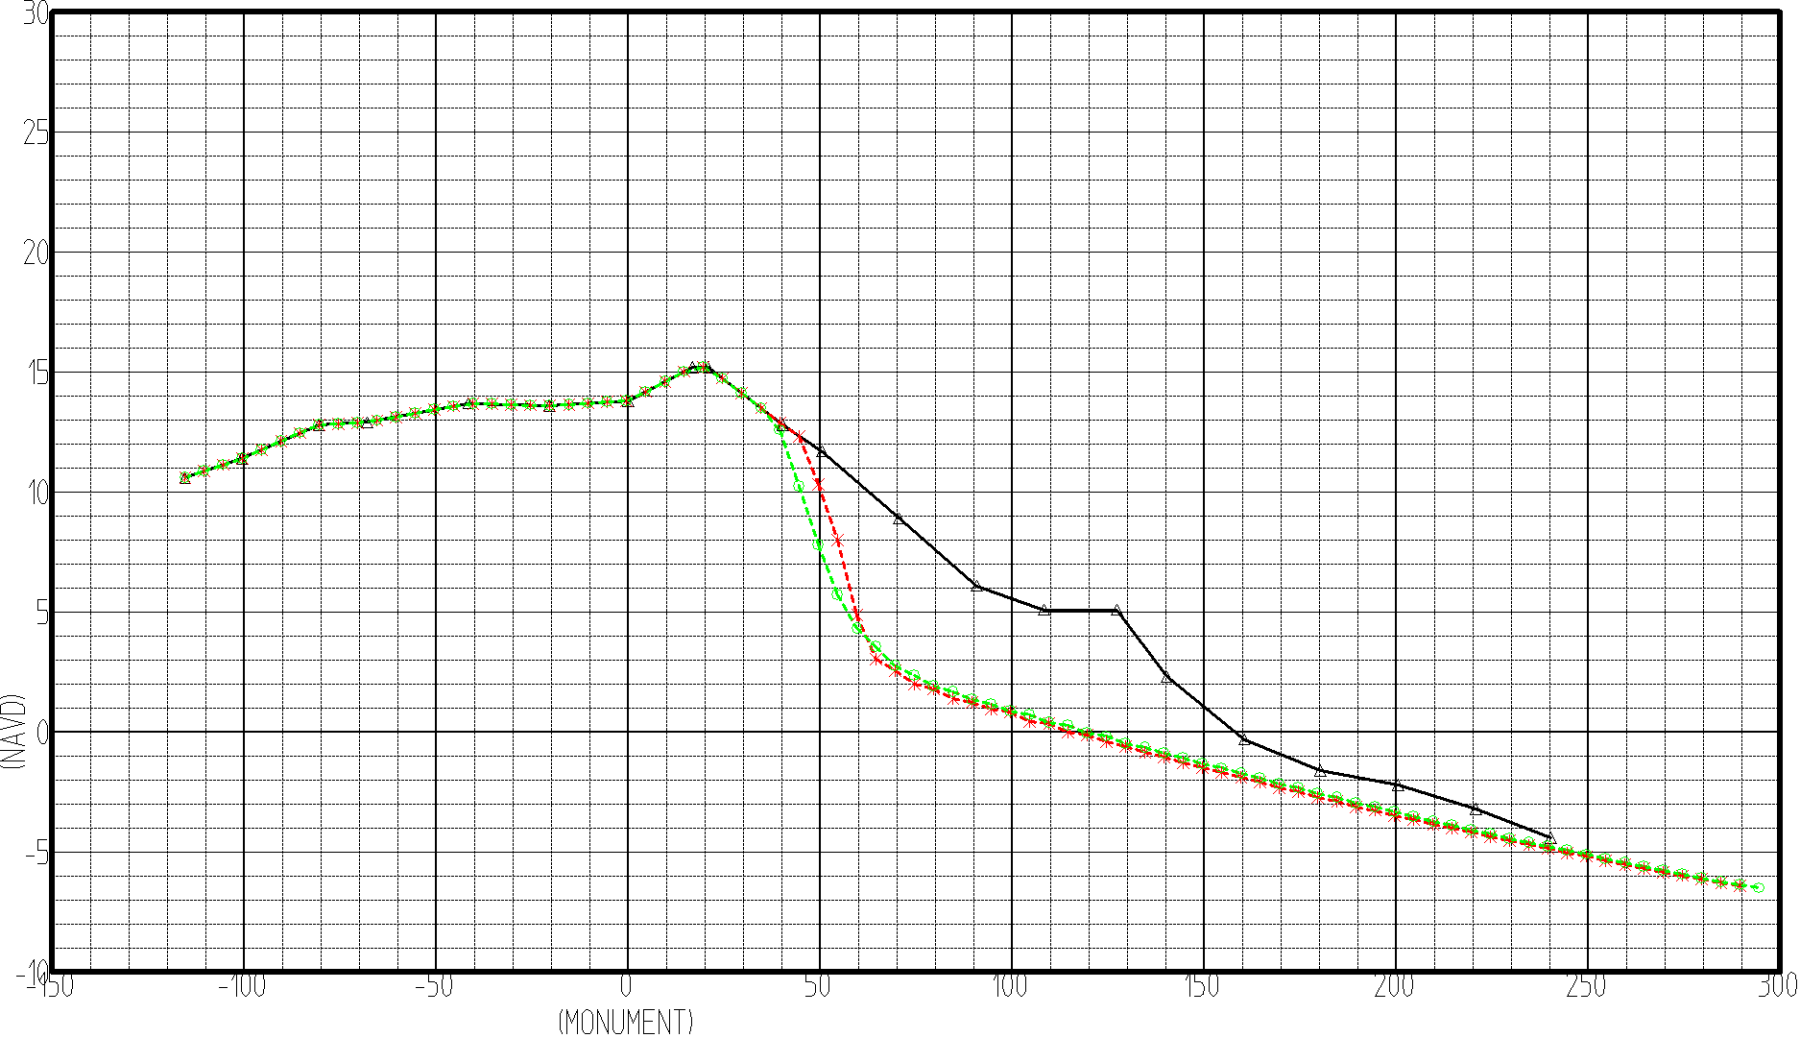
Range: R-76  
 BEARING: 70.00  
 1/1

BEACH PROFILE  
 —△—△— 2006-07 Indian River  
 - - \* - - 15YR SBEACH ERODED  
 - - o - - 25YR SBEACH ERODED

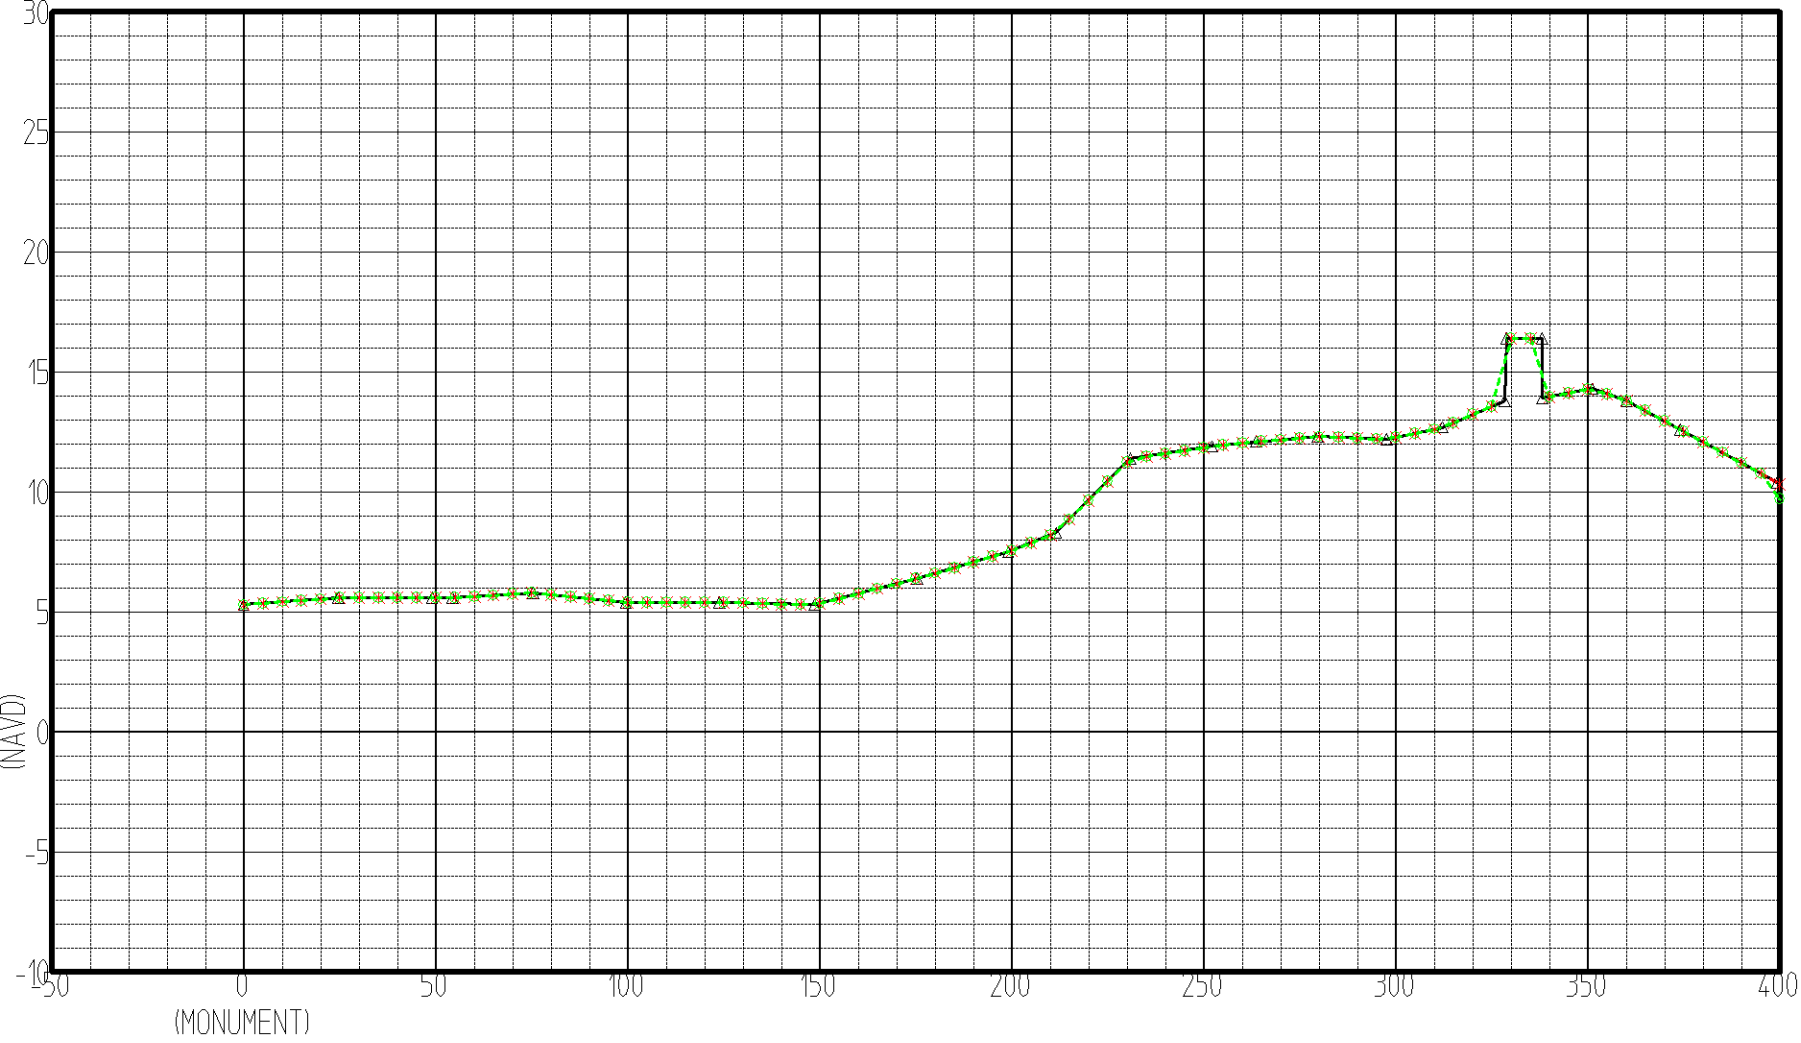
Range: R-77  
 BEARING: 70.00  
 1/2

BEACH PROFILE  
 —△—△— 2006-07 Indian River  
 - - \* - - \* - - 15YR SBEACH ERODED  
 - - o - - o - - 25YR SBEACH ERODED

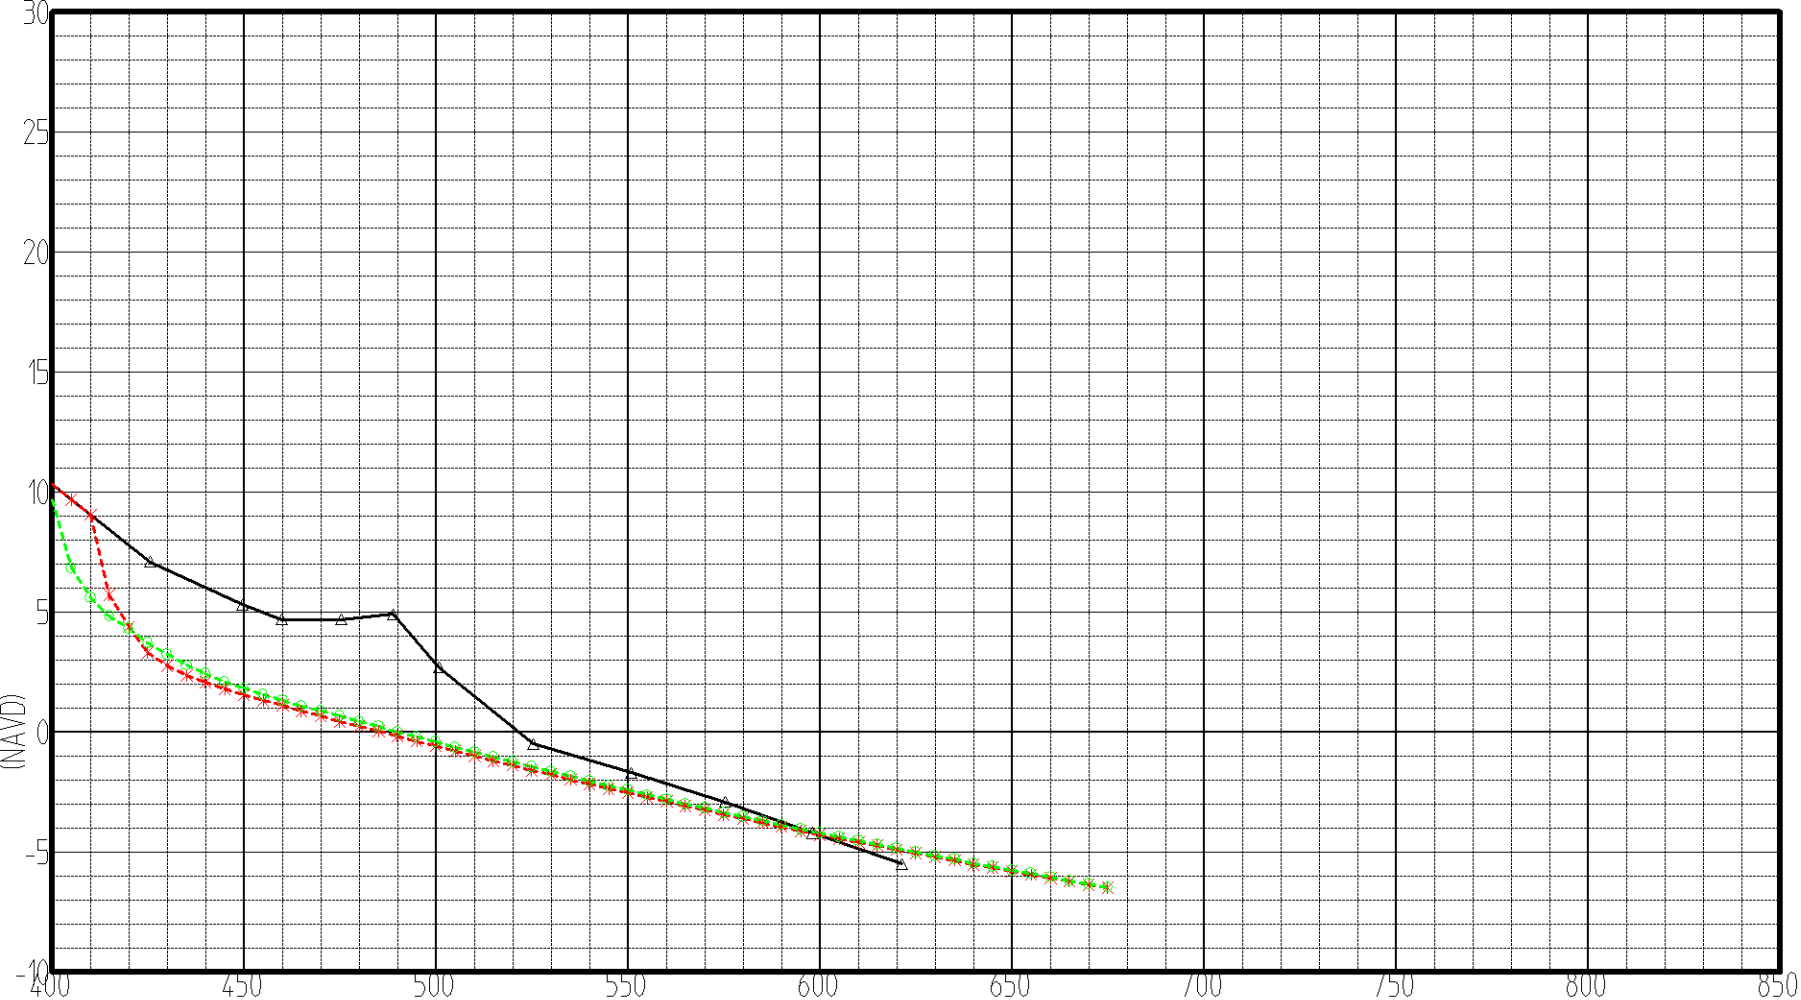
Range: R-77 2/2

BEACH PROFILE

- △—△— 2006-07 Indian River
- - - \* - - - 15YR SBEACH ERODED
- - - o - - - 25YR SBEACH ERODED

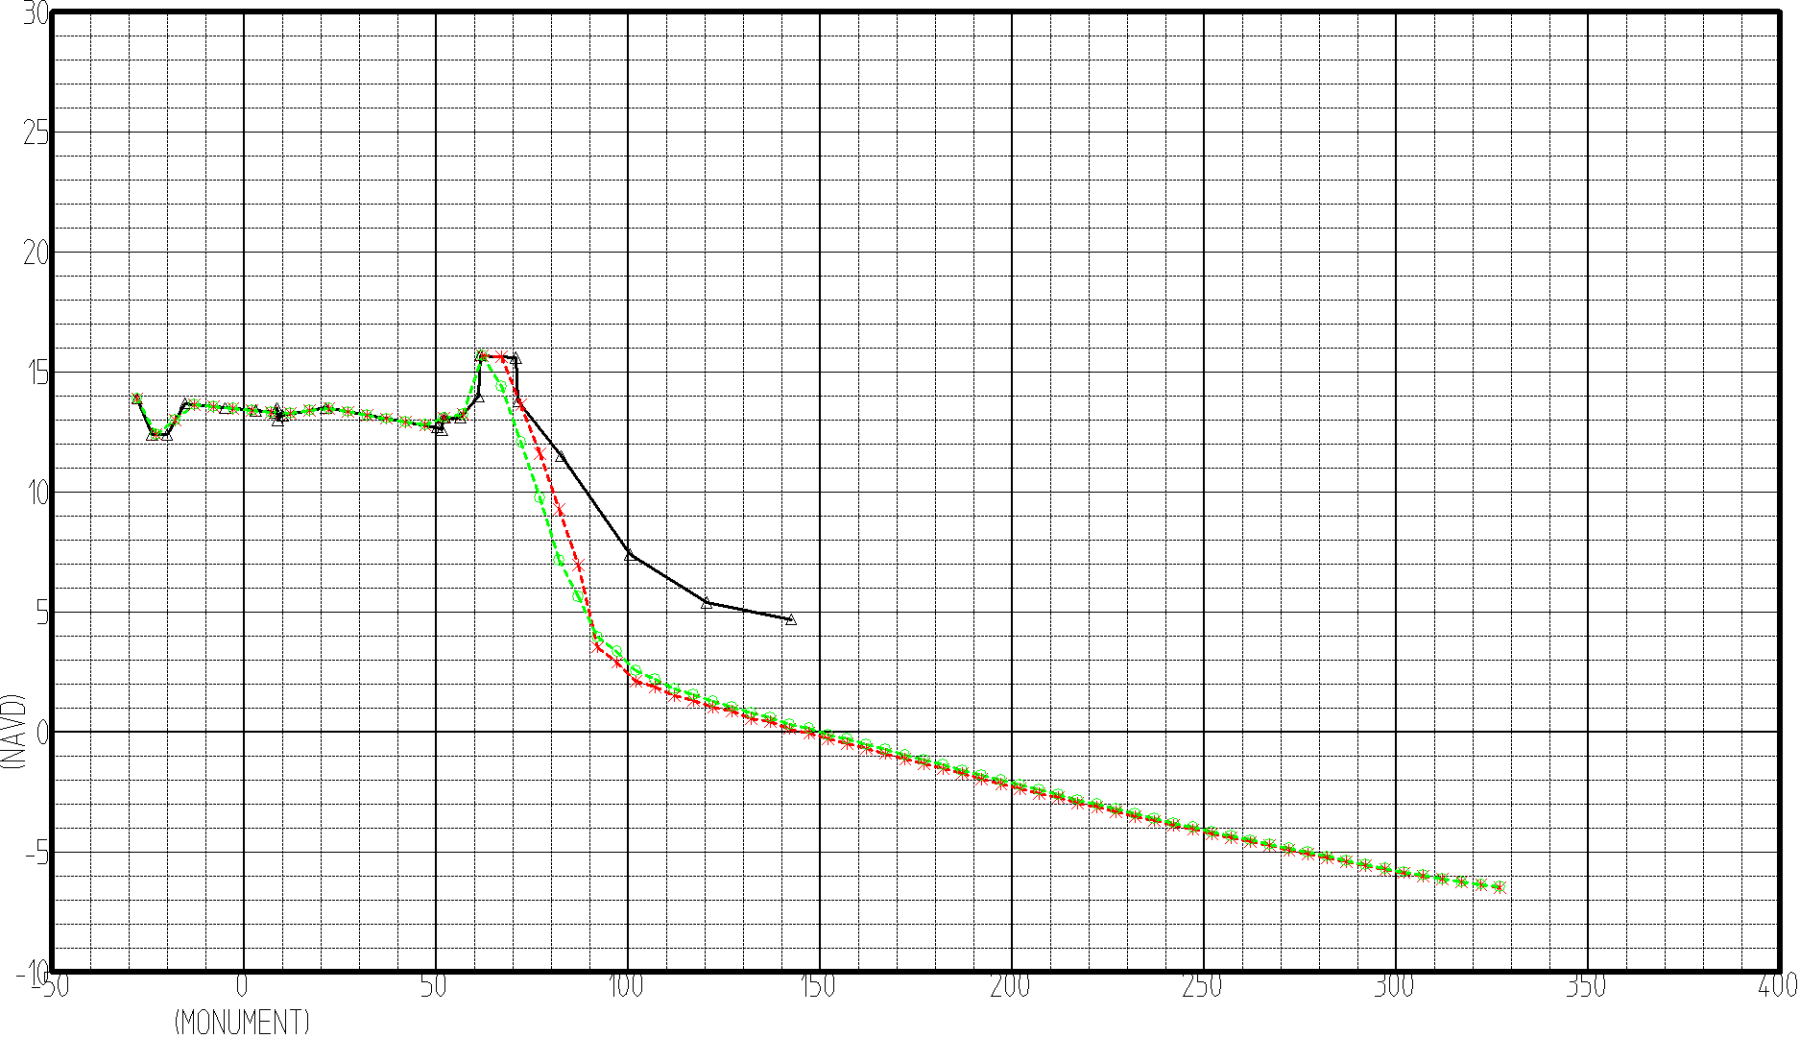
Range: R-78  
 BEARING: 70.00  
 1/1

BEACH PROFILE  
 —△—△— 2006-07 Indian River  
 - - \* - - 15YR SBEACH ERODED  
 - - o - - 25YR SBEACH ERODED

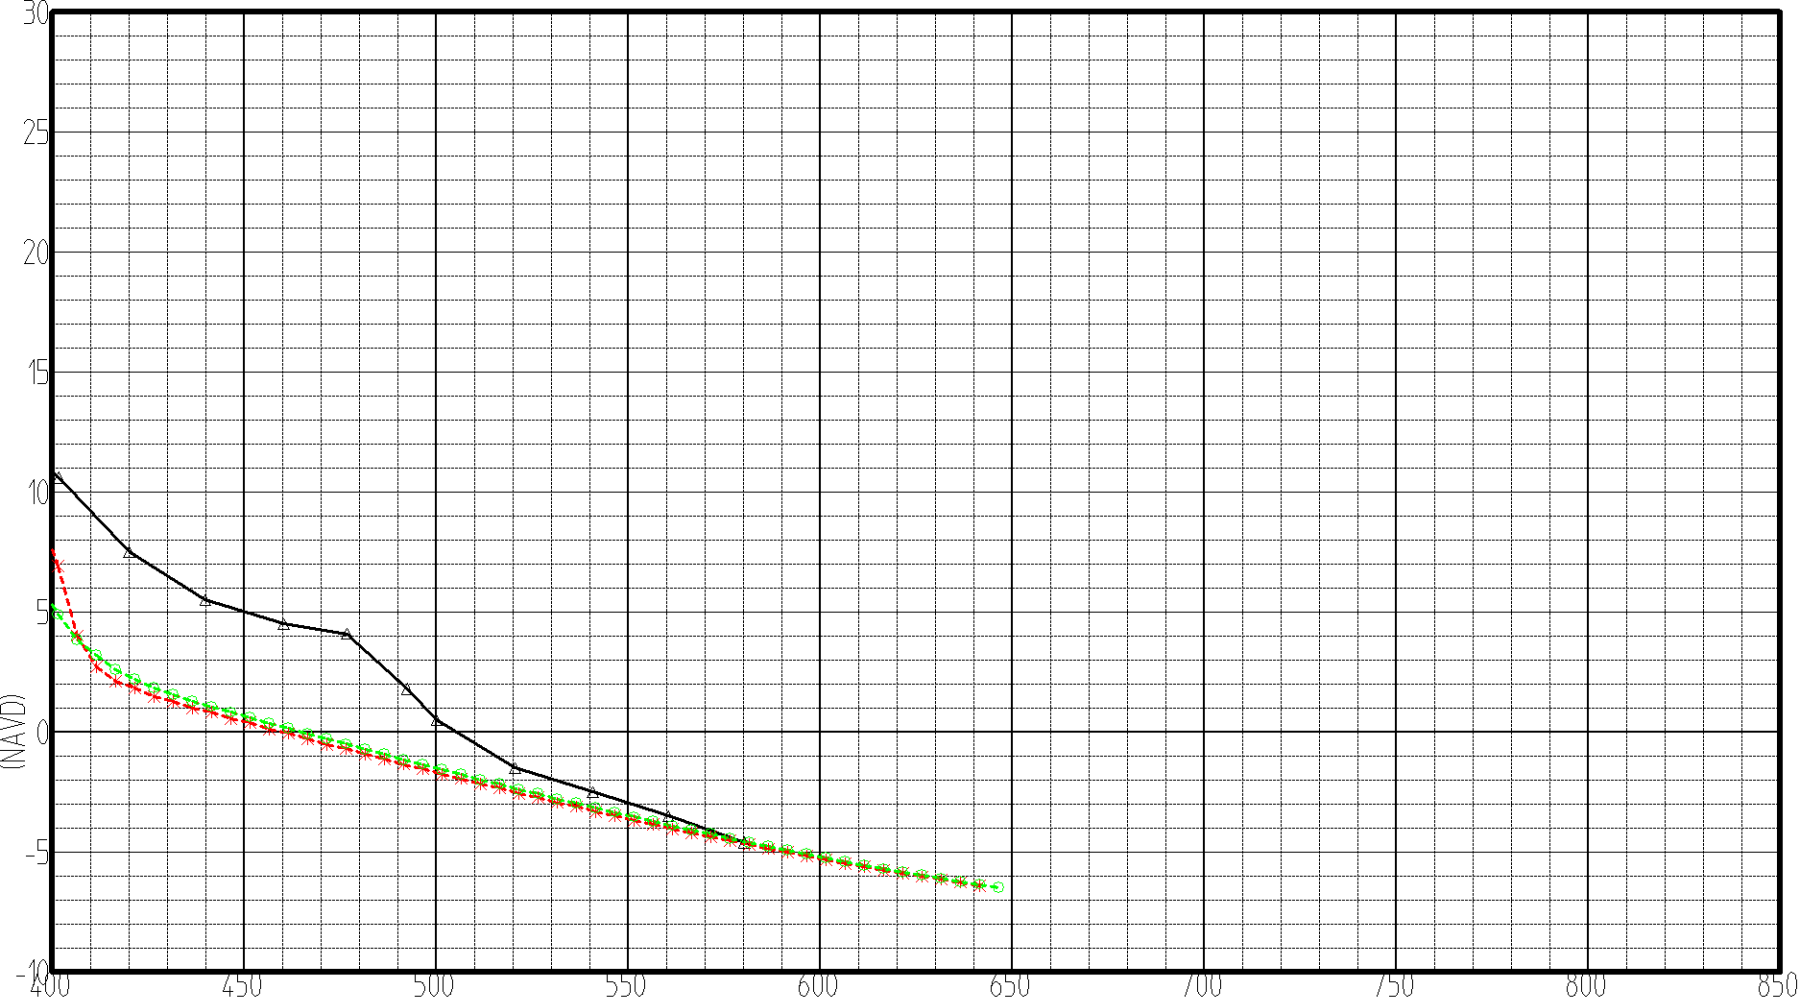
Range: R-81  
 BEARING: 70.00  
 2/2

BEACH PROFILE  
 —△—△— 2006-07 Indian River  
 - - \* - - 15YR SBEACH ERODED  
 - - o - - 25YR SBEACH ERODED

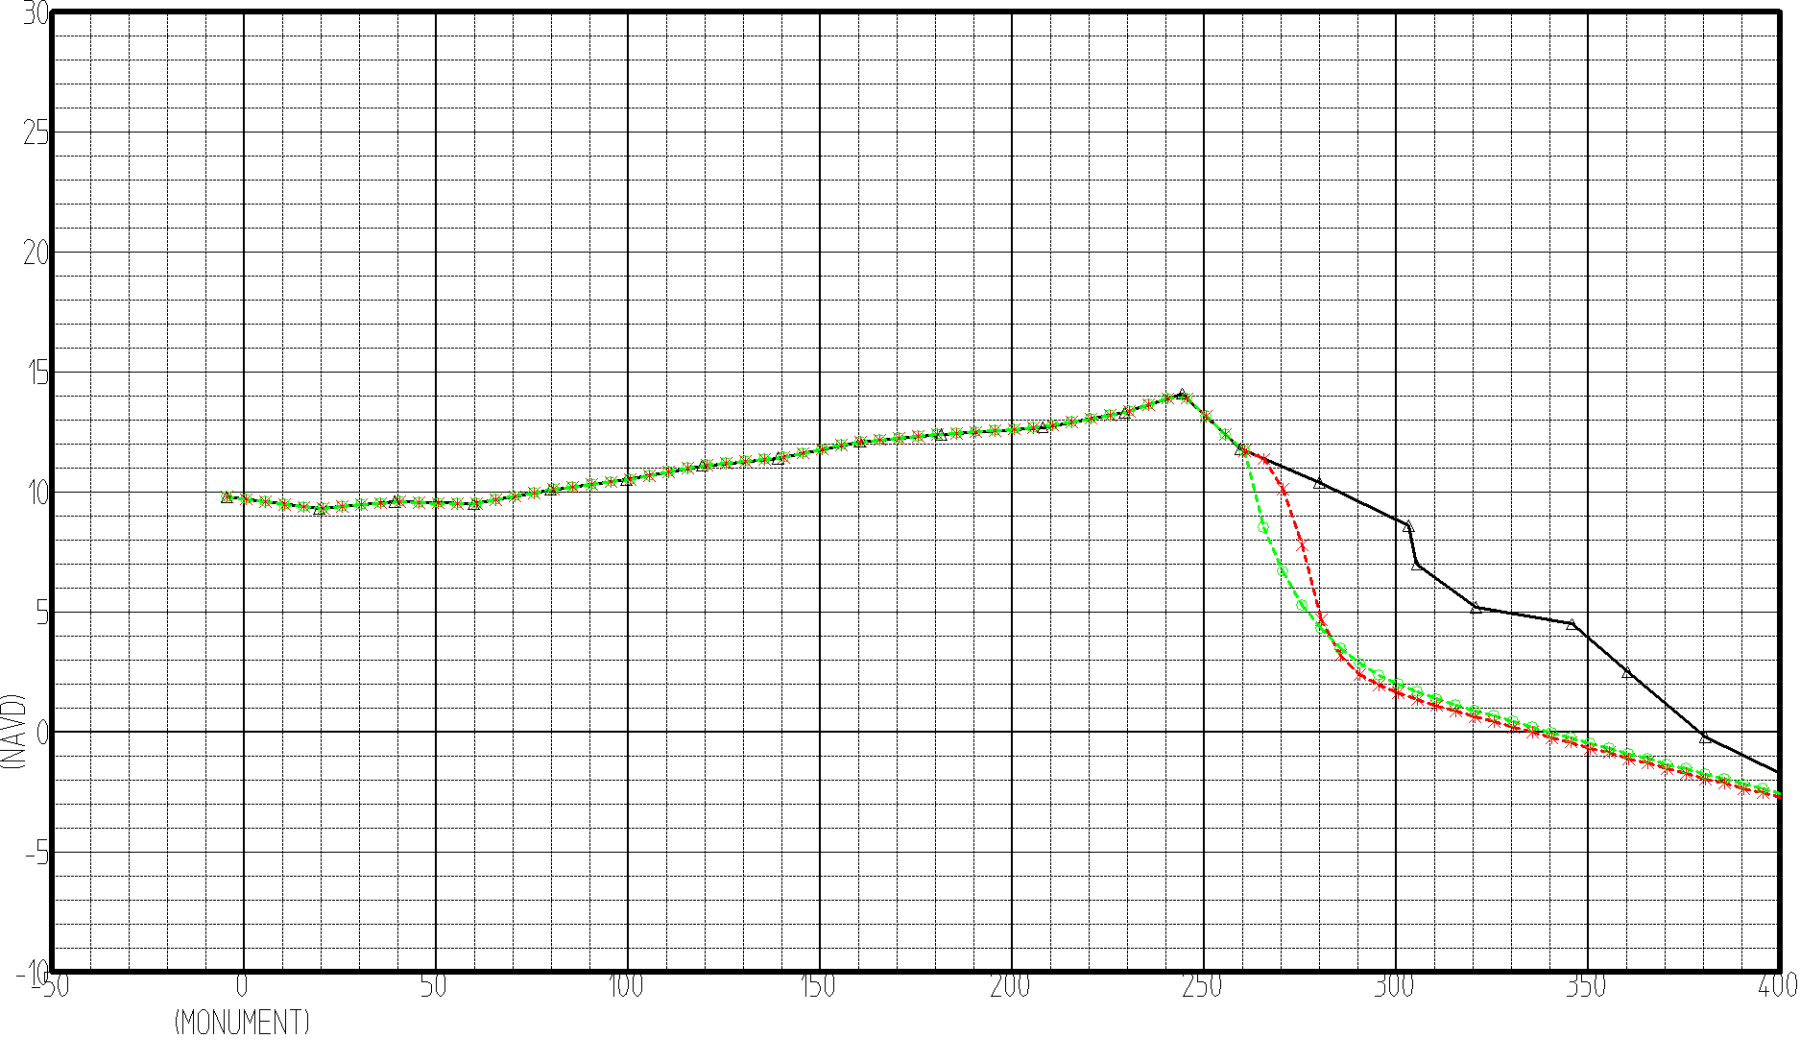
Range: R-82 1/2

BEACH PROFILE

- △—△— 2006-07 Indian River
- - - \* - - - 15YR SBEACH ERODED
- - - o - - - 25YR SBEACH ERODED

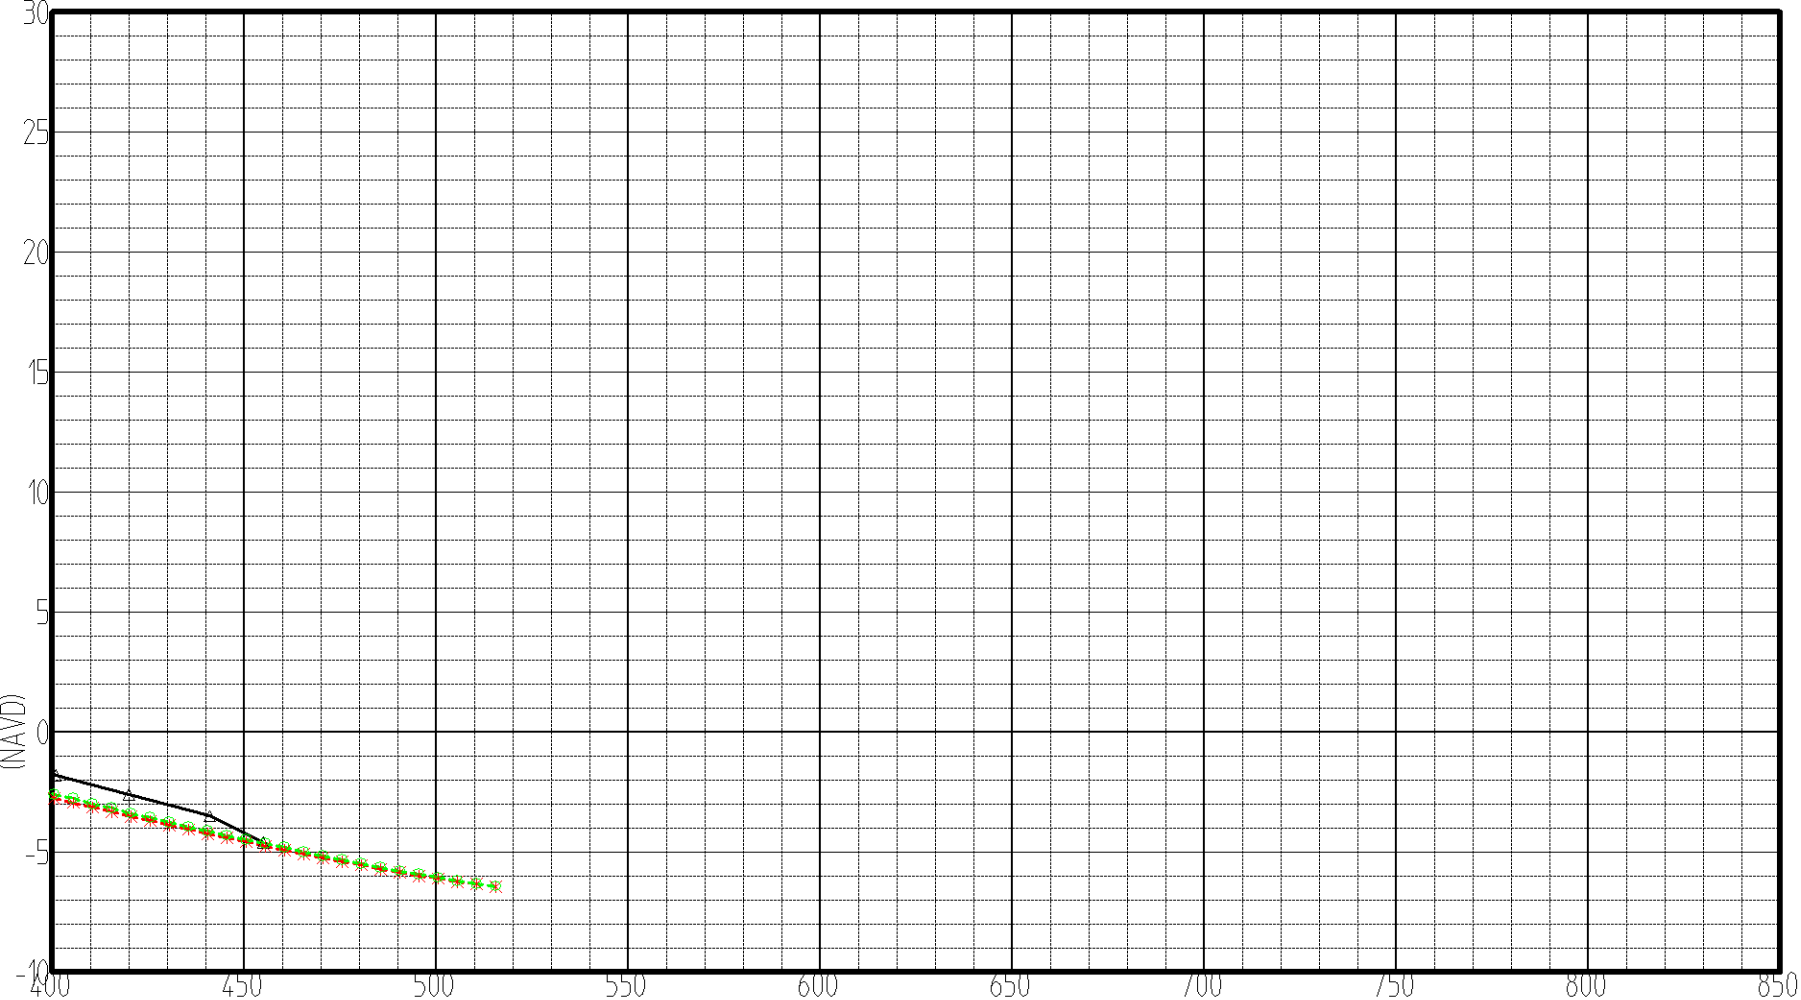
Range: R-82 2/2

BEACH PROFILE

—△—△— 2006-07 Indian River

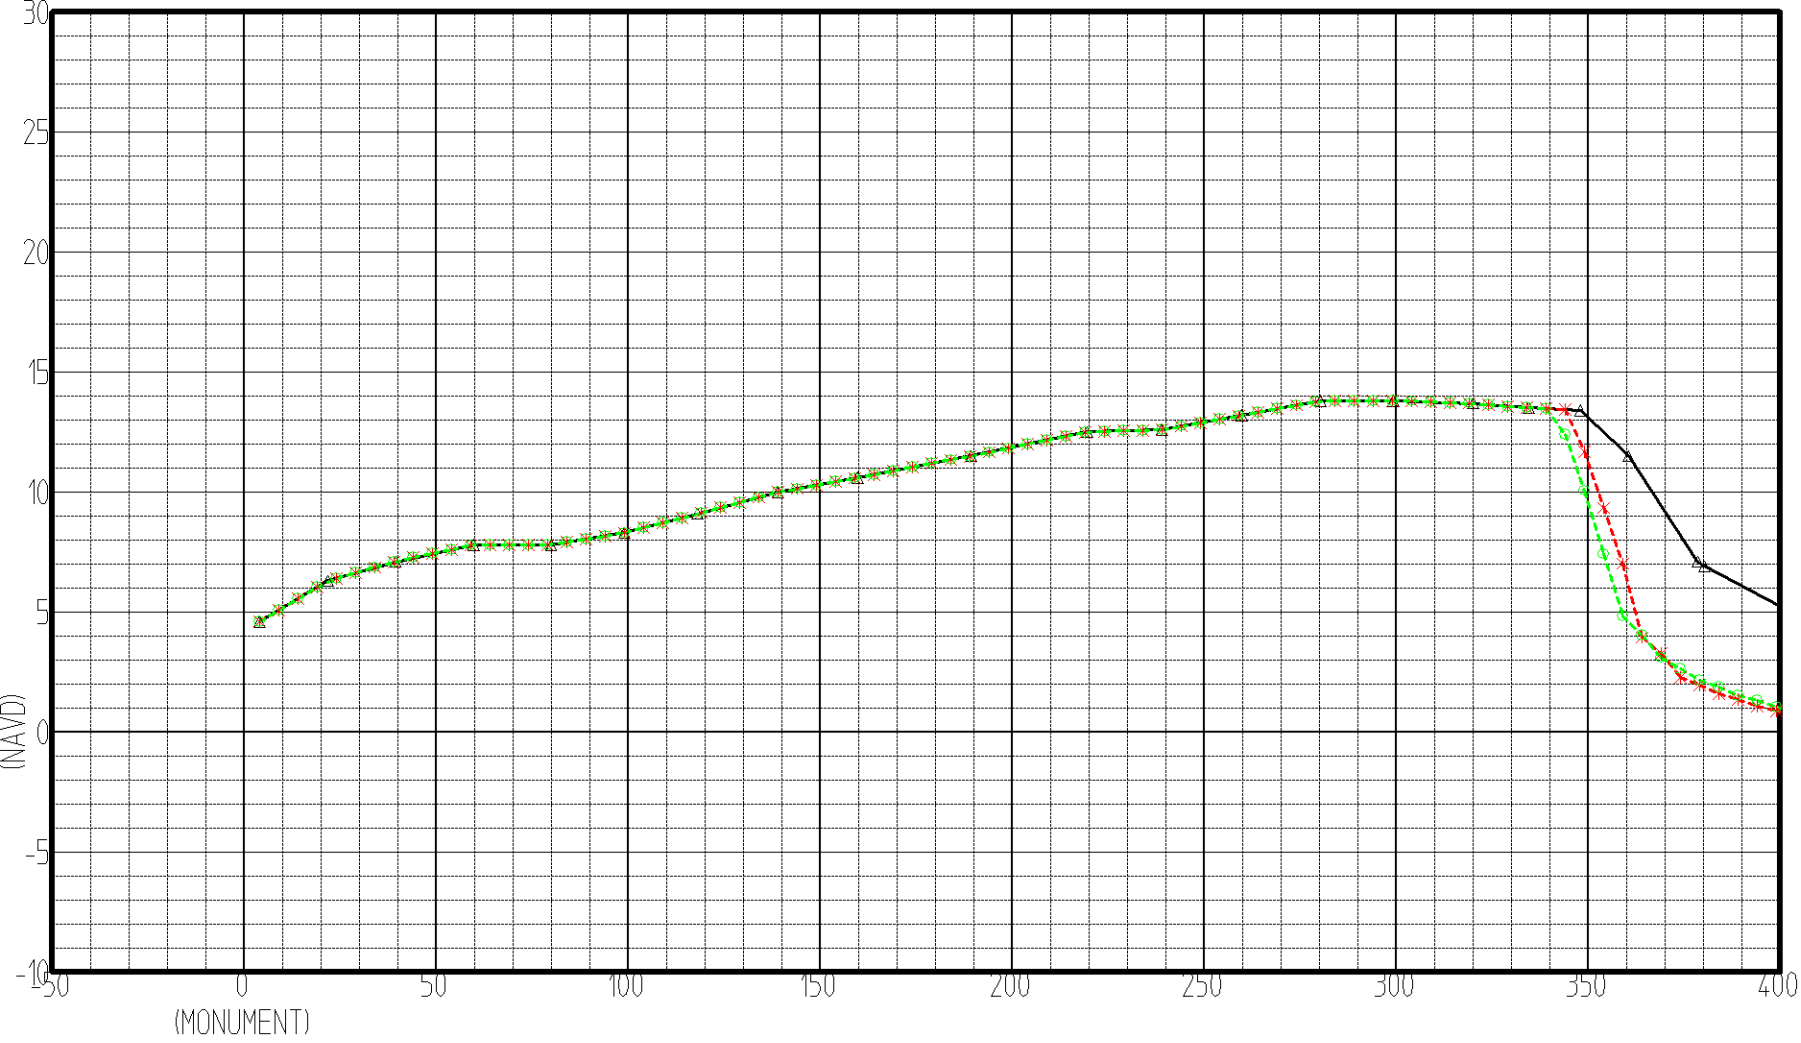
Range: R-83  
 BEARING: 70.00  
 1/2

BEACH PROFILE  
 —△—△— 2006-07 Indian River  
 - - \* - - \* - - 15YR SBEACH ERODED  
 - - o - - o - - 25YR SBEACH ERODED
