## **Appendix X**

SBEACH 15 and 25 yr. Storm Erosion Profiles

Indian River County

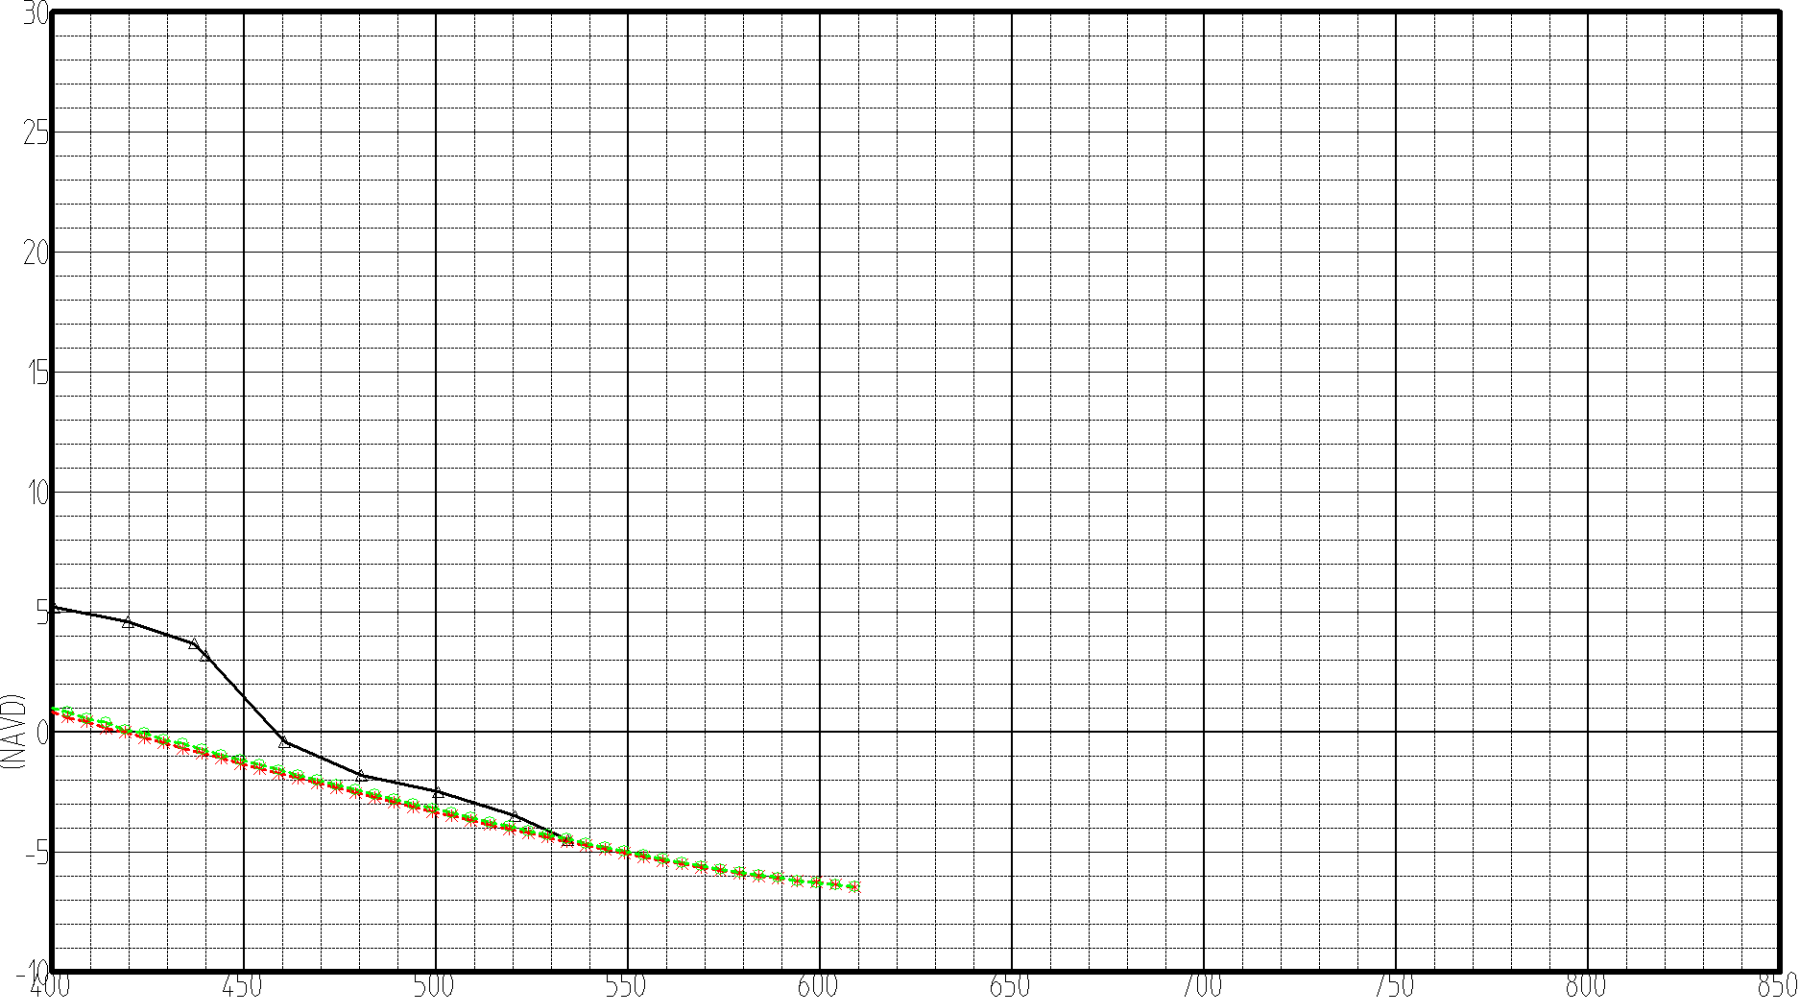
Range: R-83 2/2  
 BEARING: 70.00

BEACH PROFILE  
 —△—△— 2006-07 Indian River  
 - - \* - - 15YR SBEACH ERODED  
 - - o - - 25YR SBEACH ERODED

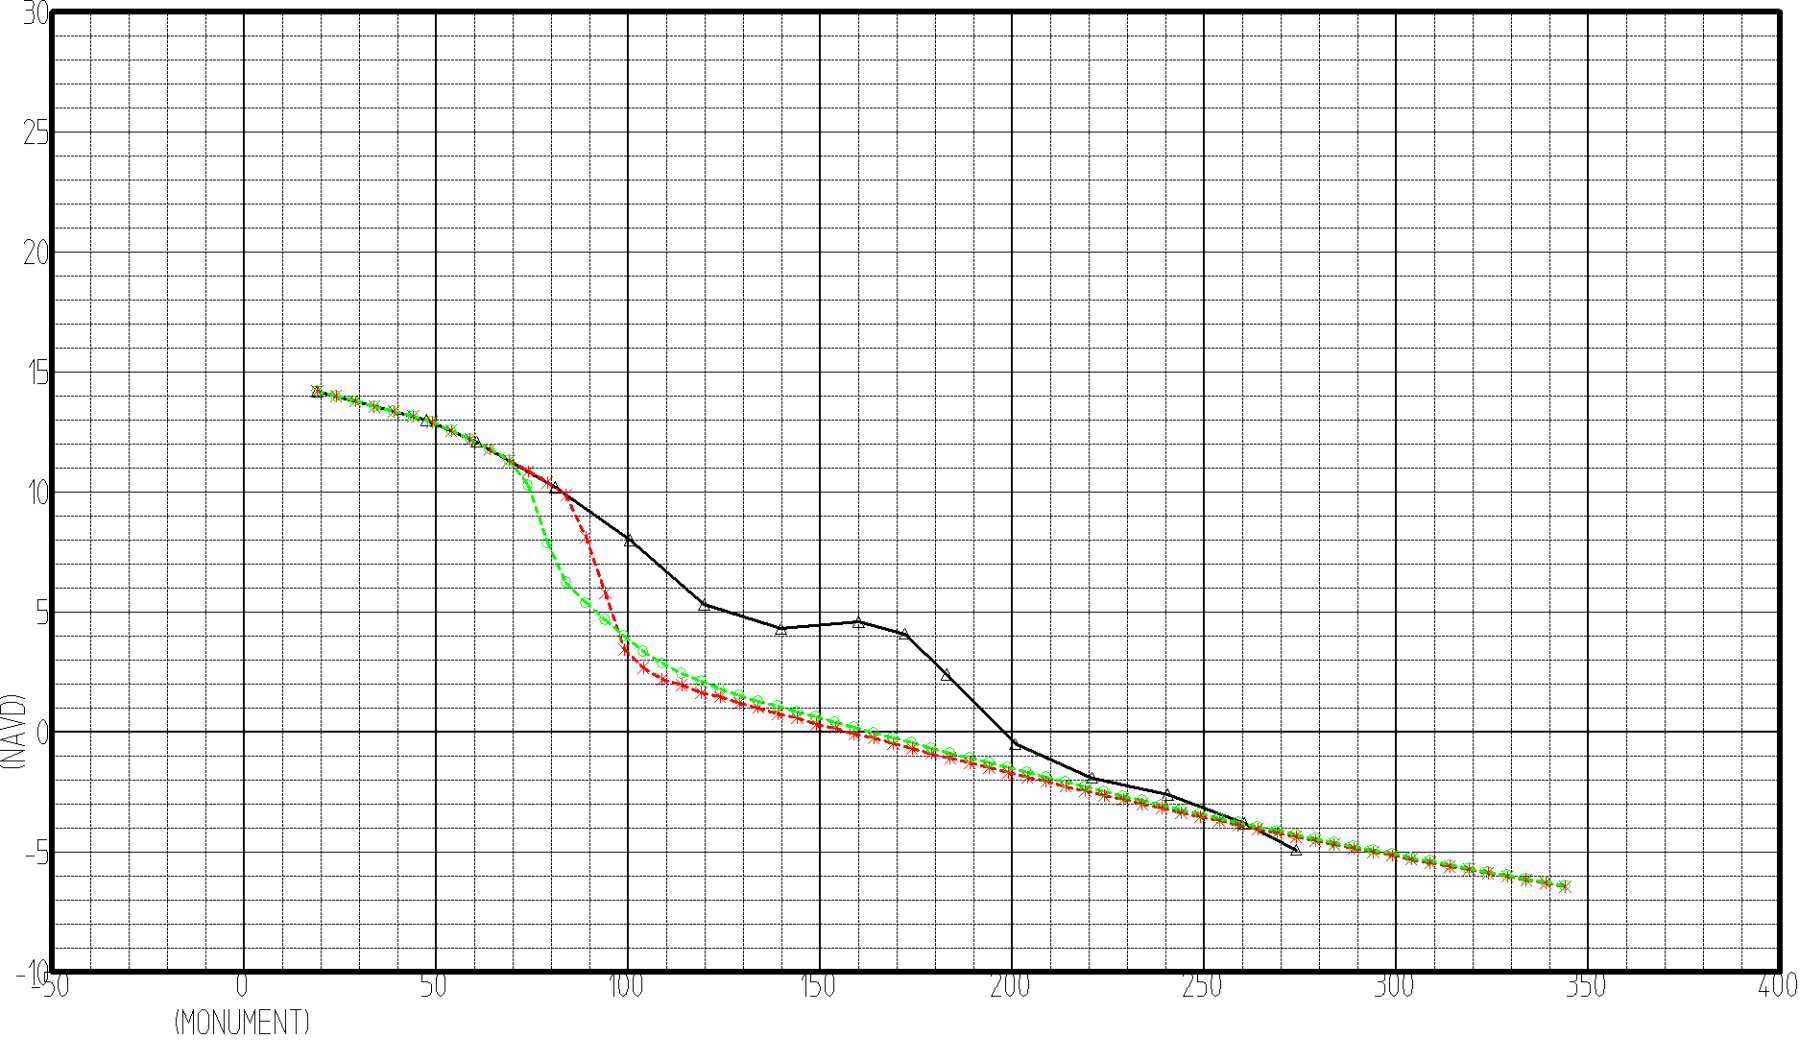
Range: R-84 1/1

BEACH PROFILE

- △—△— 2006-07 Indian River
- - - \* - - - 15YR SBEACH ERODED
- - - o - - - 25YR SBEACH ERODED

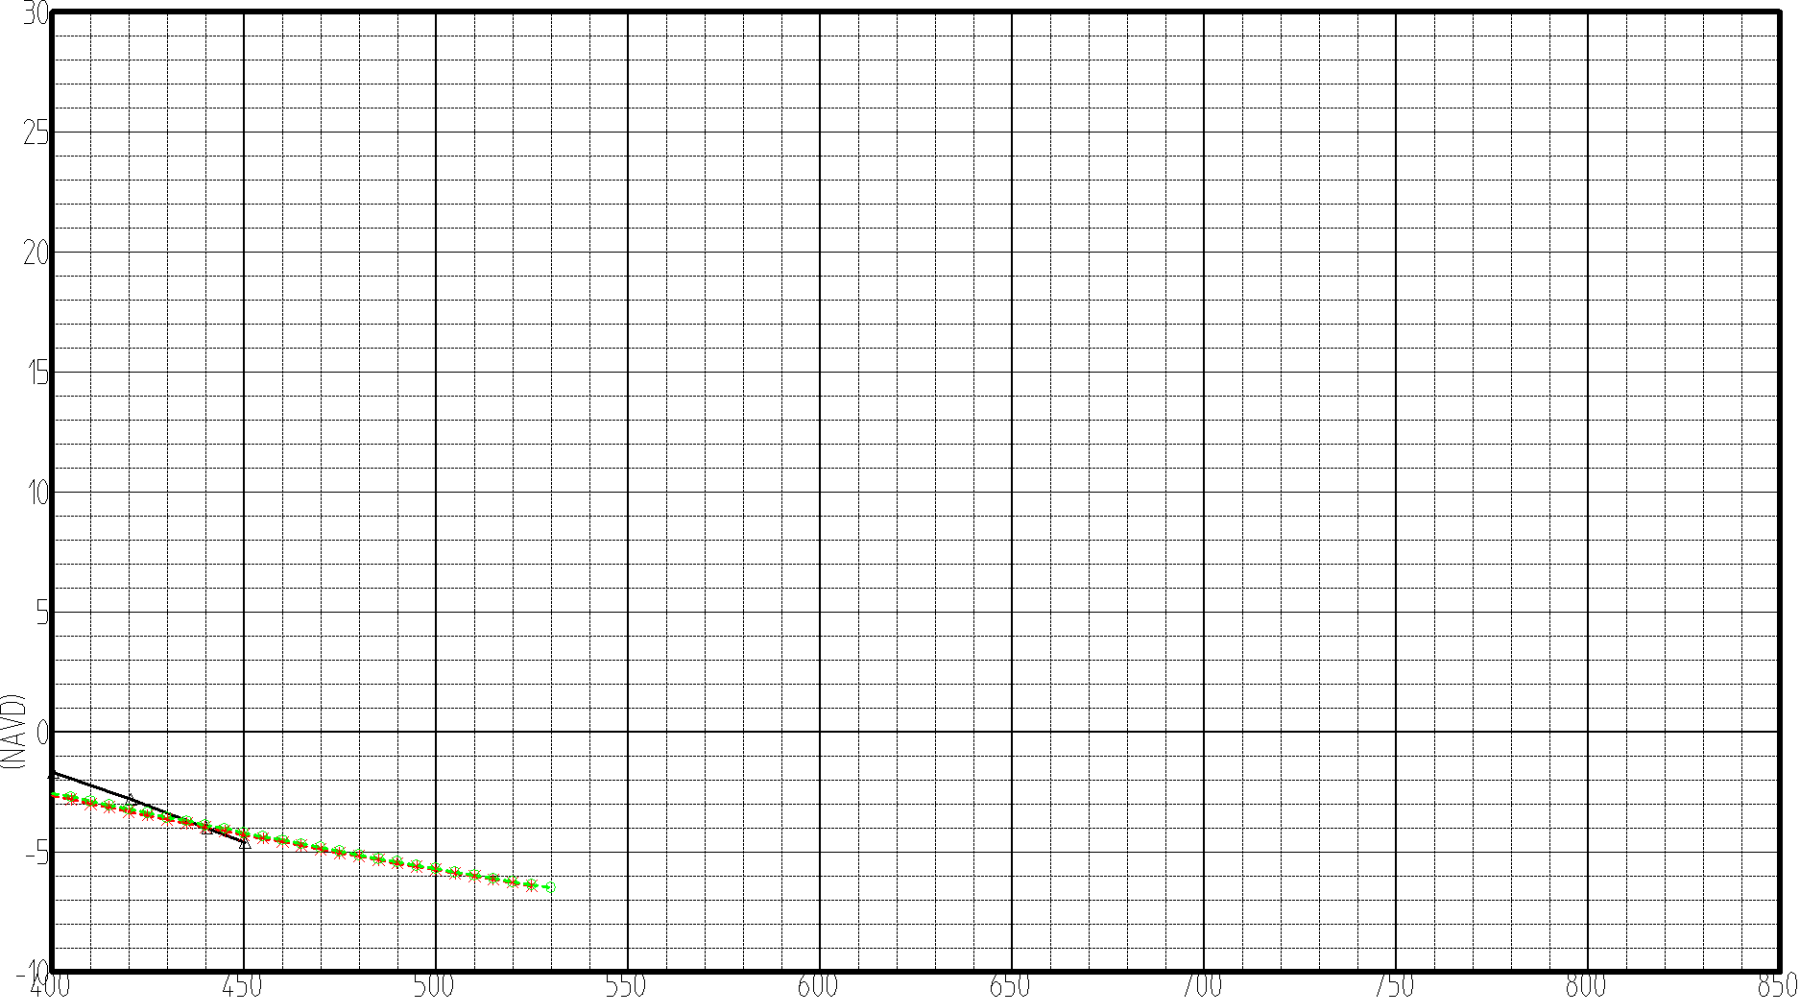
Range: R-85 2/2

BEACH PROFILE

- △—△— 2006-07 Indian River
- - - \* - - - 15YR SBEACH ERODED
- - - o - - - 25YR SBEACH ERODED

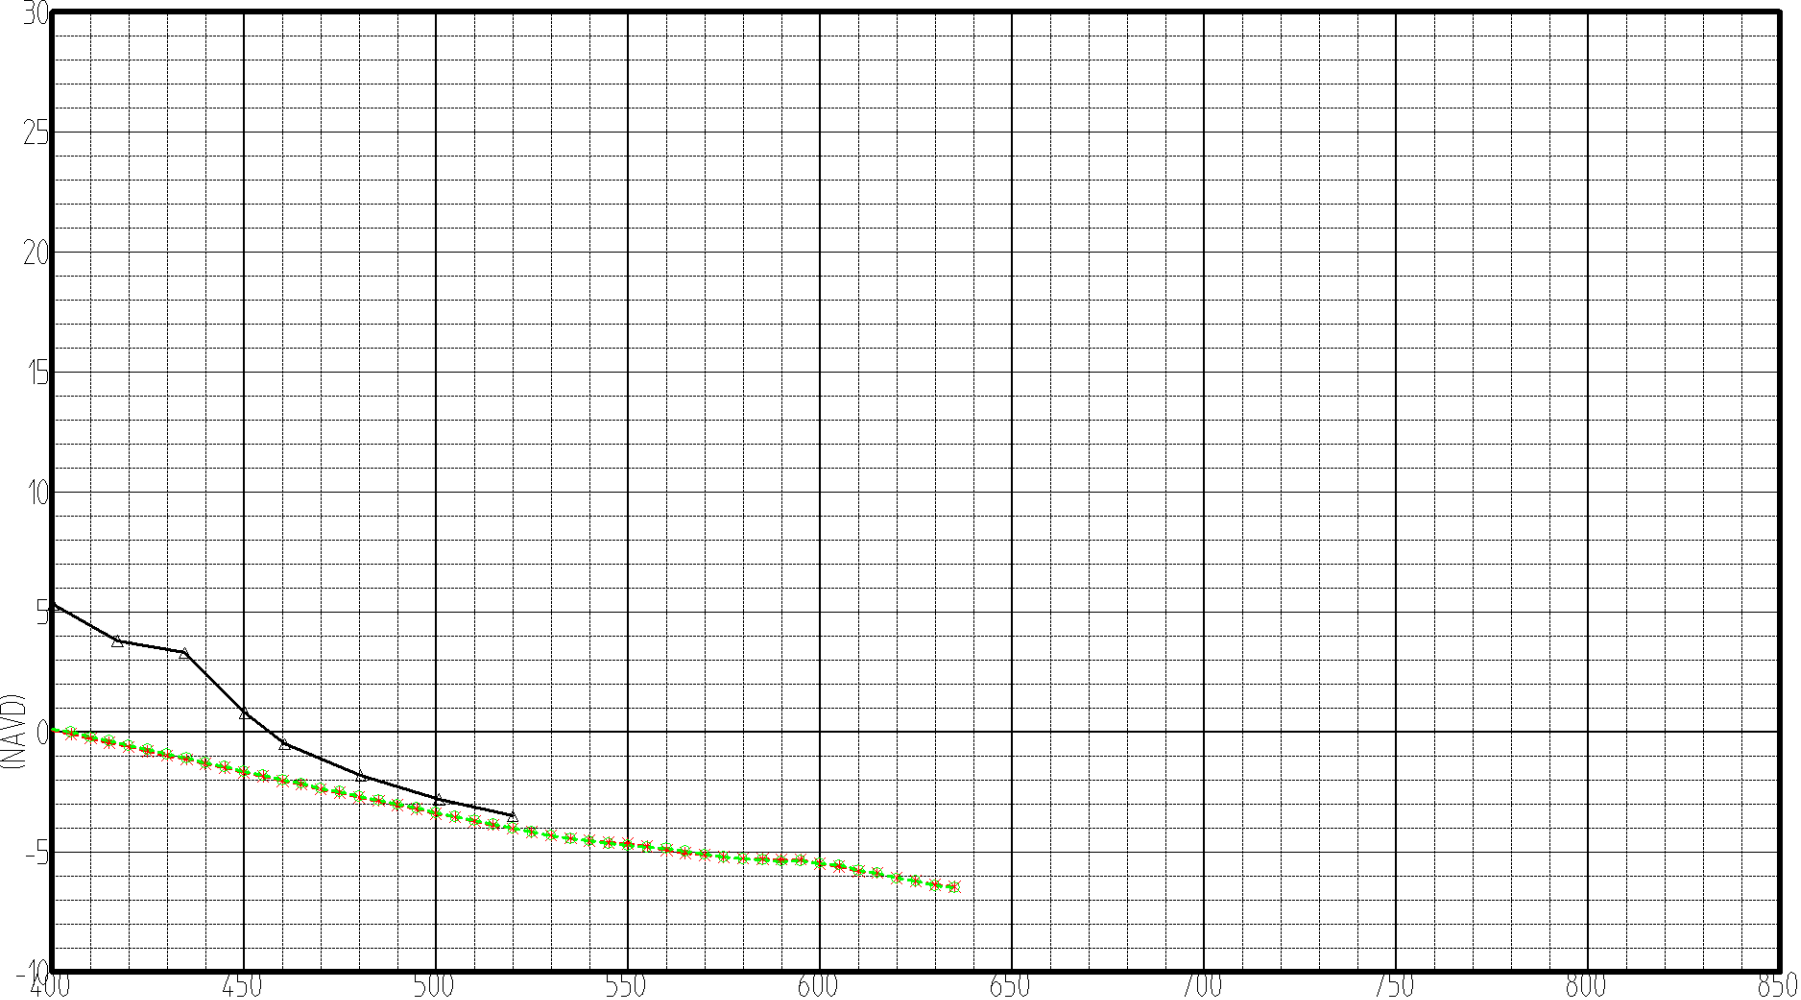
Range: R-88 2/2

BEACH PROFILE

- △—△— 2006-07 Indian River
- - \* - - \* - - 15YR SBEACH ERODED
- - o - - o - - 25YR SBEACH ERODED

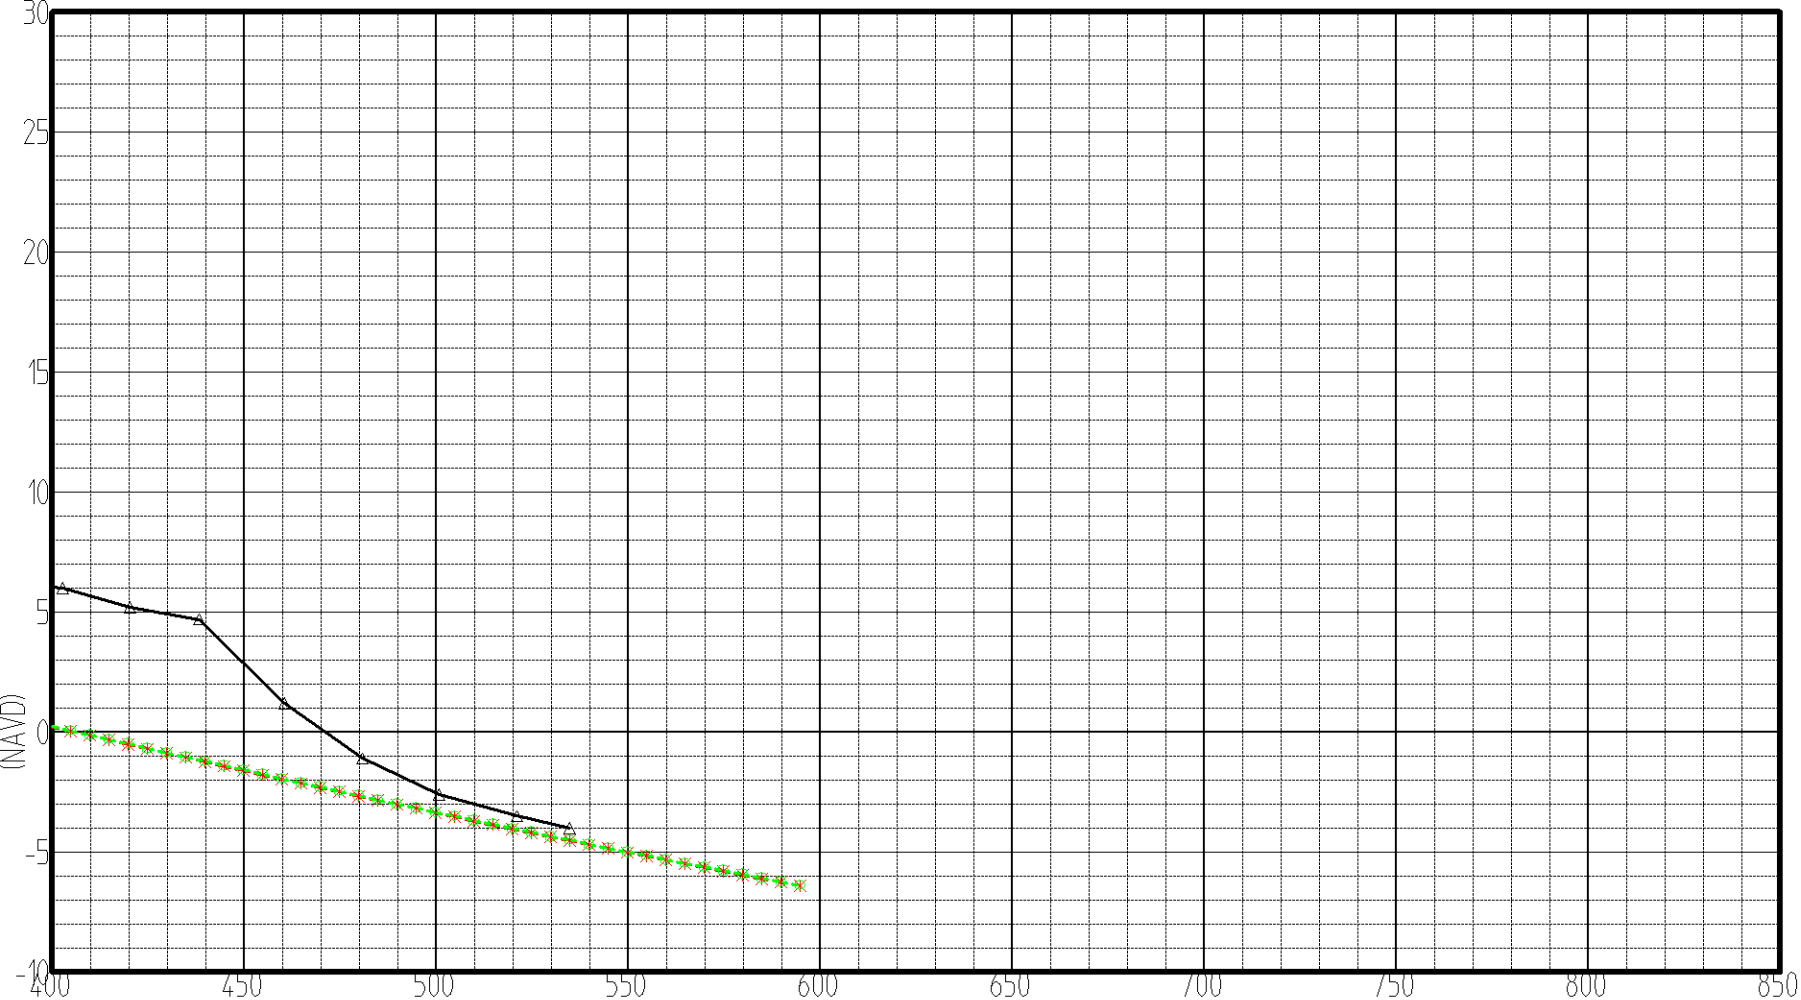
Range: R-89 2/2  
 BEARING: 70.00

BEACH PROFILE  
 —△—△— 2006-07 Indian River  
 - - \* - - \* - - 15YR SBEACH ERODED  
 - - o - - o - - 25YR SBEACH ERODED

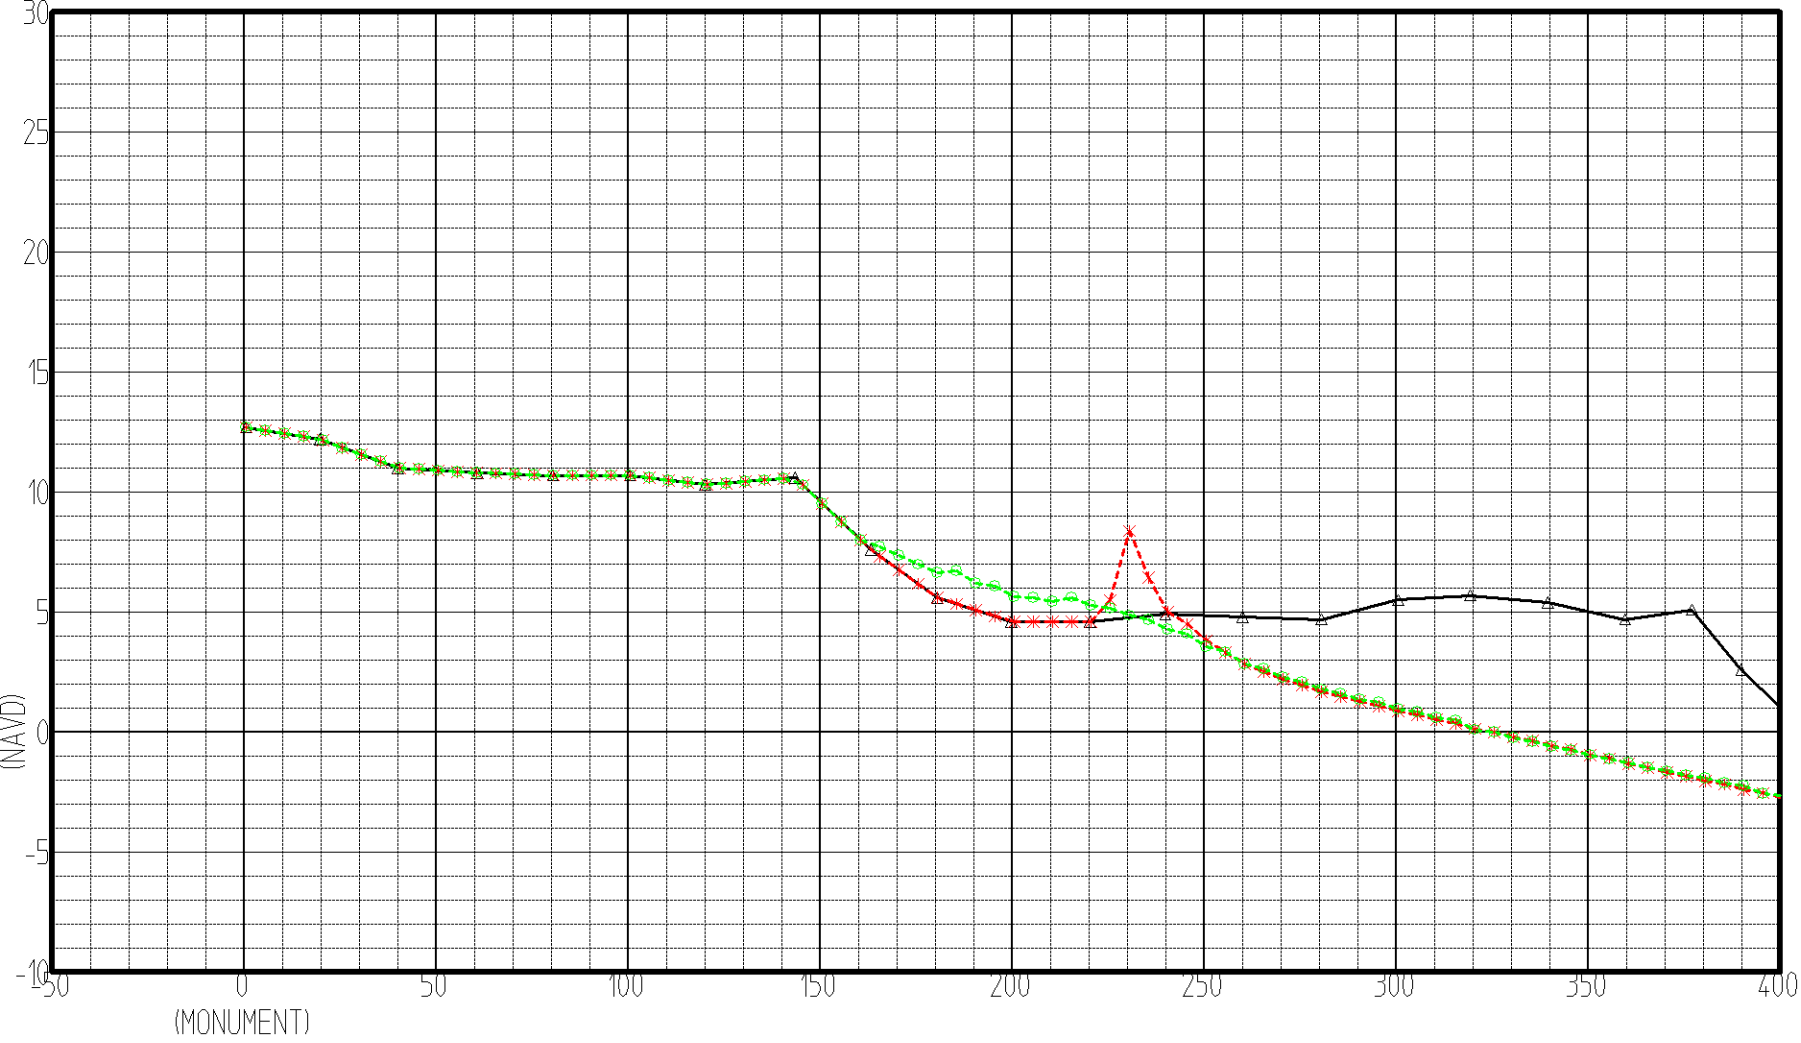
Range: R-91 1/2

BEACH PROFILE

- △—△— 2006-07 Indian River
- - - \* - - - 15YR SBEACH ERODED
- - - o - - - 25YR SBEACH ERODED

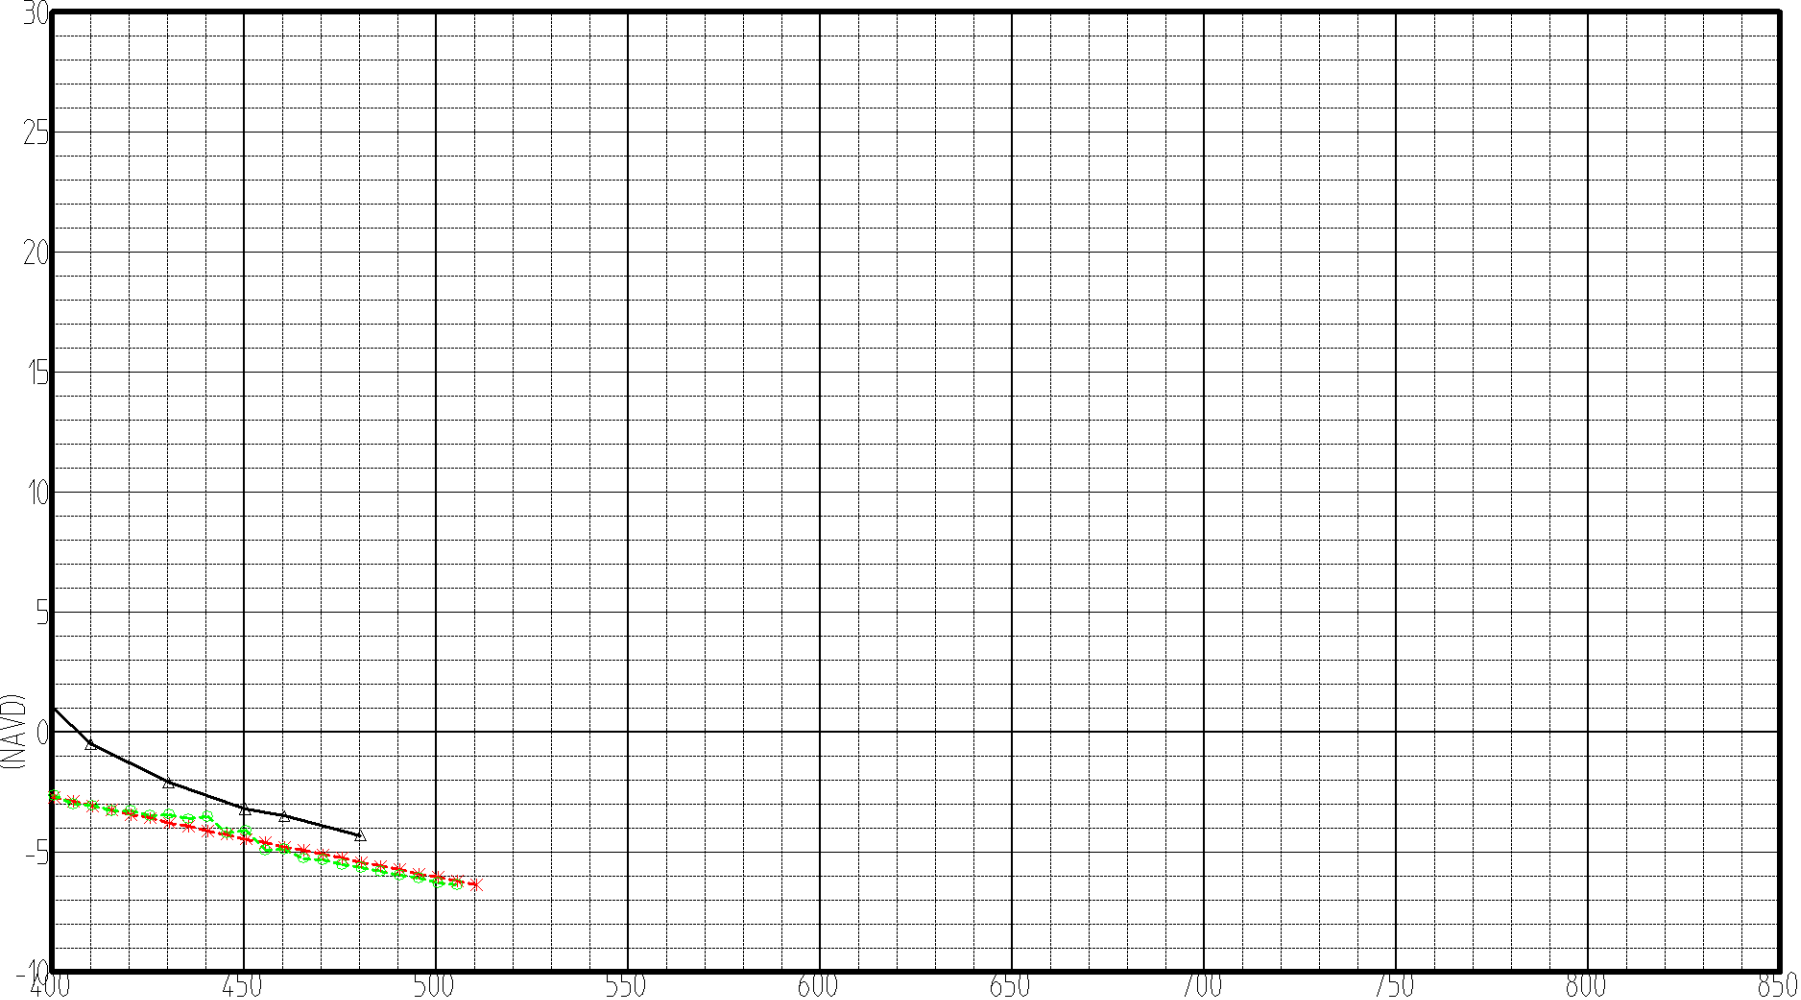
Range: R-91 2/2

BEACH PROFILE

—△—△— 2006-07 Indian River

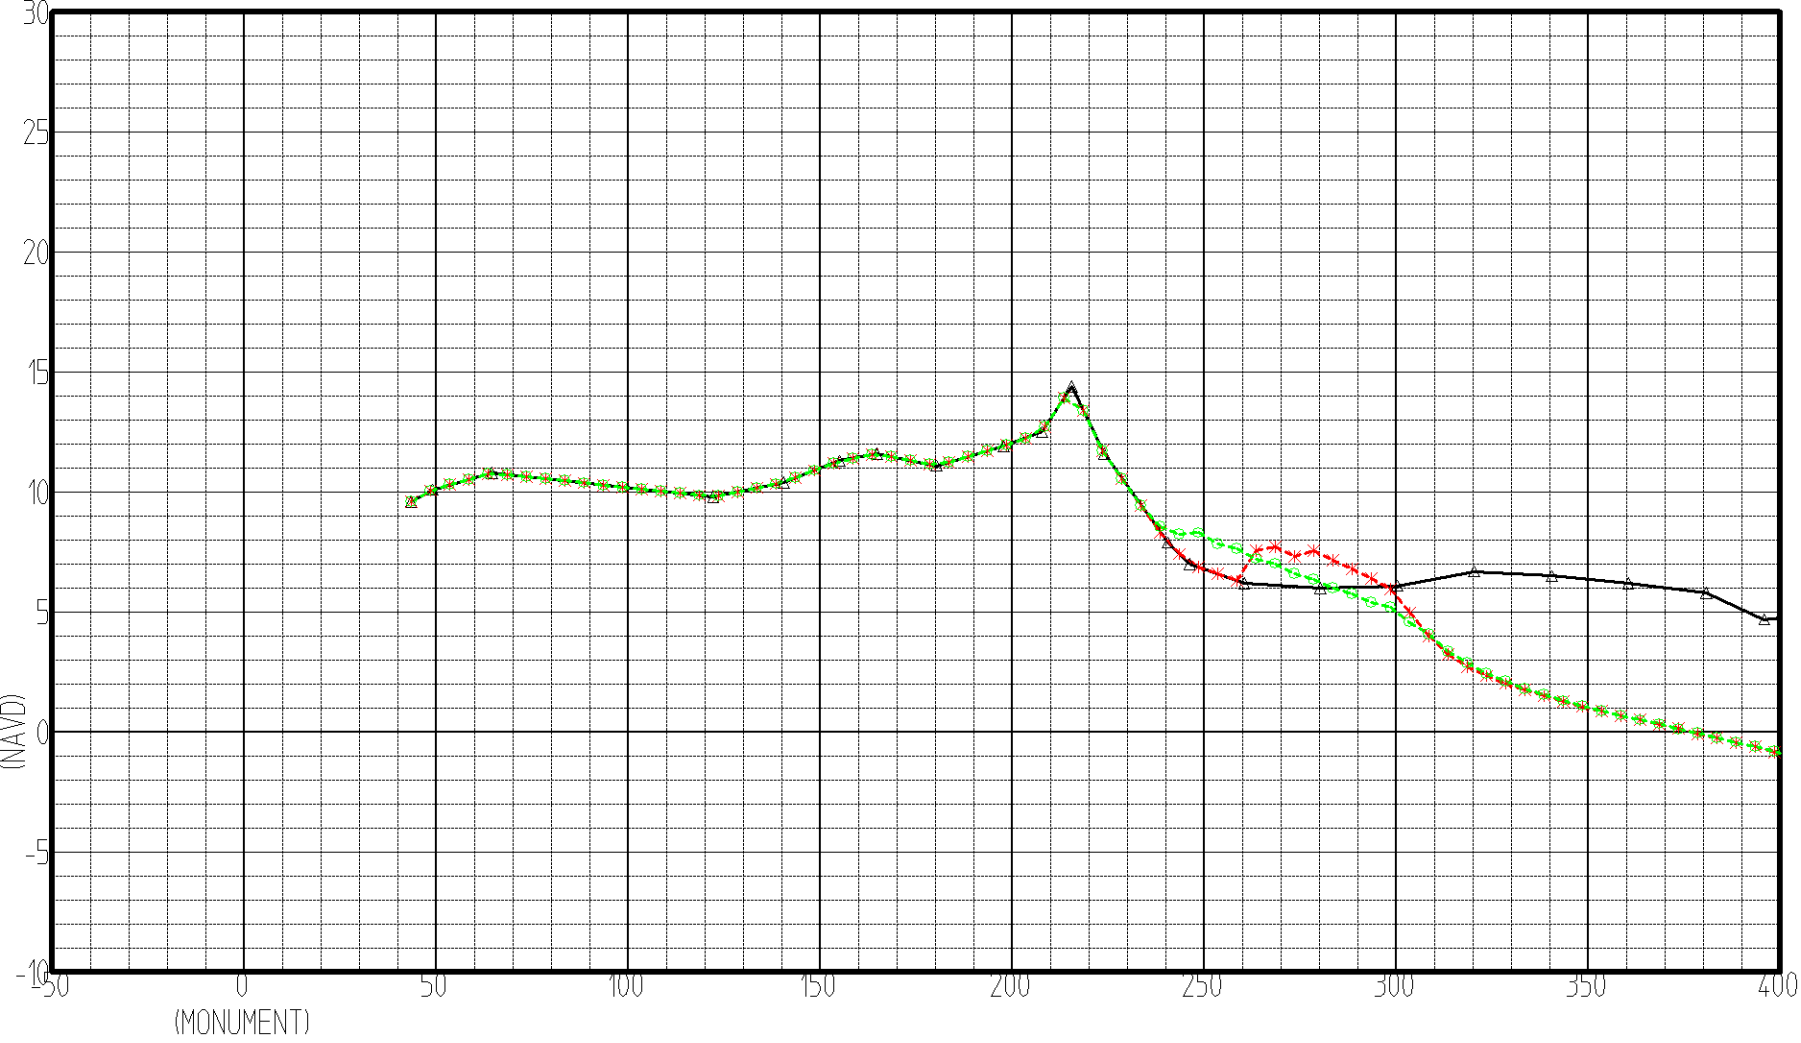
Range: R-92 1/2

BEACH PROFILE

- △—△— 2006-07 Indian River
- - - \* - - - 15YR SBEACH ERODED
- - - o - - - 25YR SBEACH ERODED

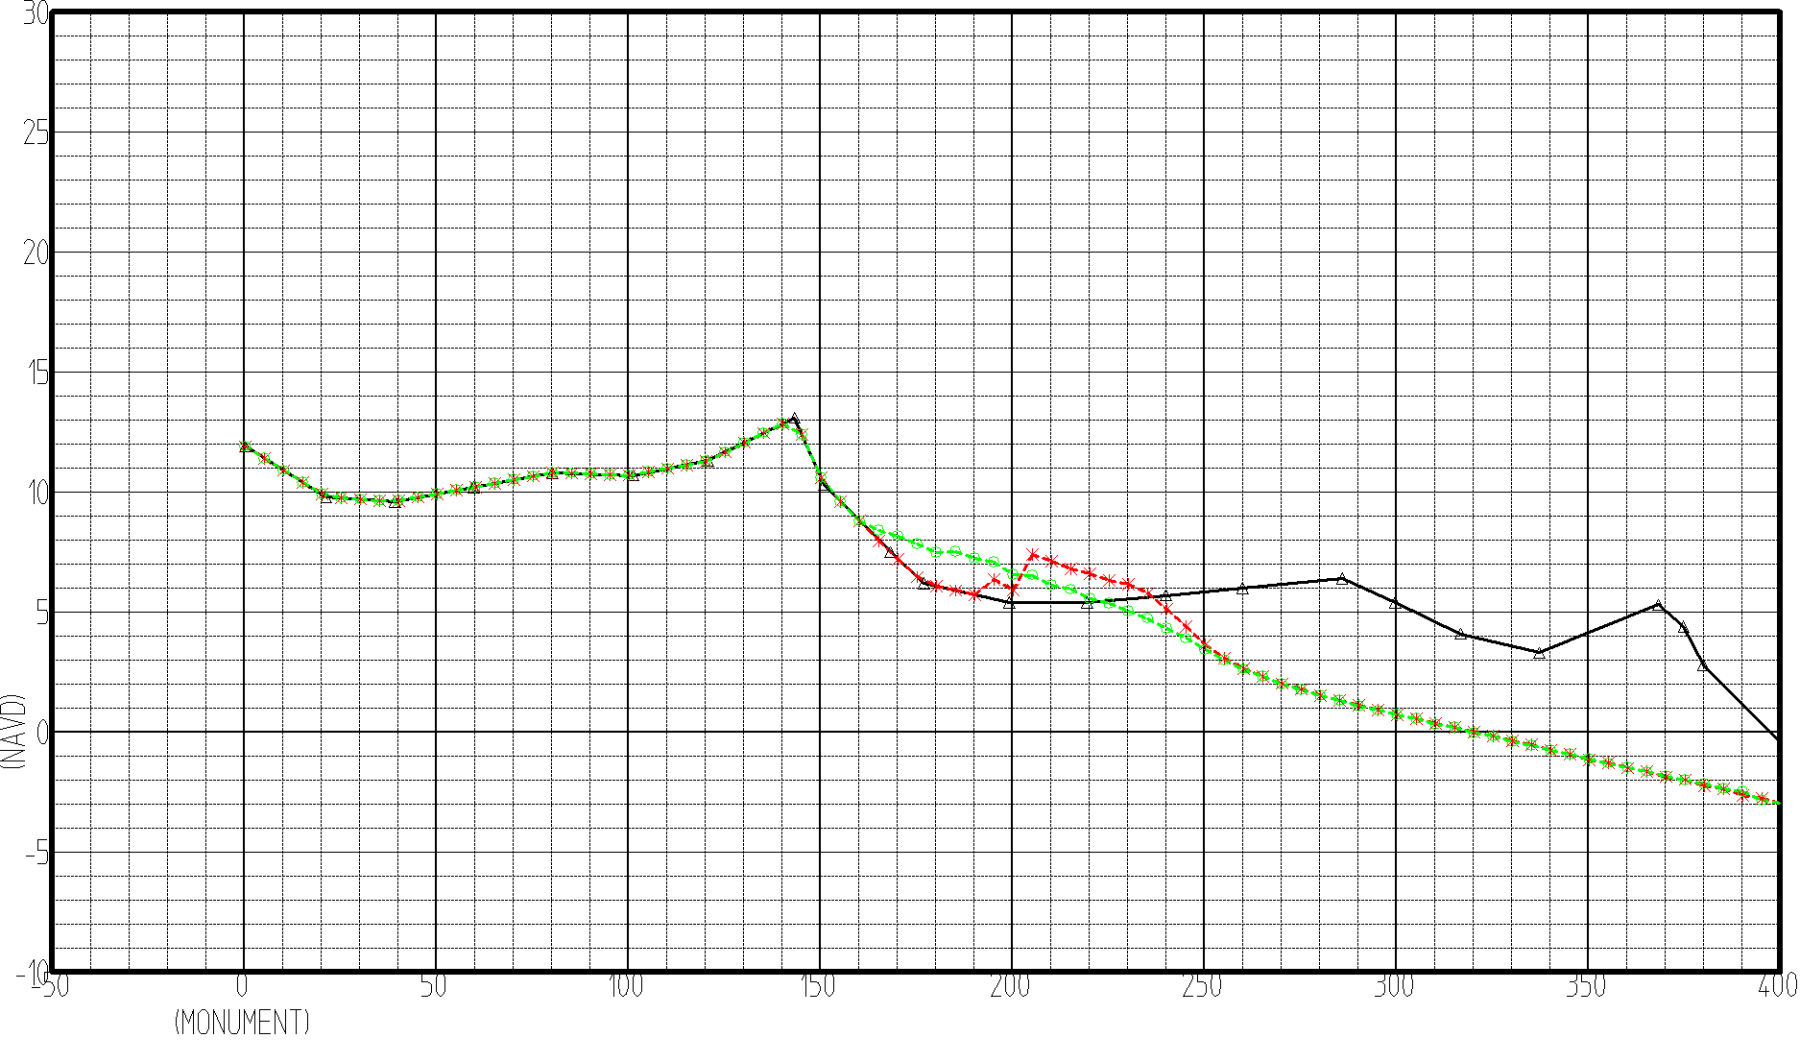
Range: R-93 1/2

BEACH PROFILE

- △—△— 2006-07 Indian River
- - - \* - - - 15YR SBEACH ERODED
- - - o - - - 25YR SBEACH ERODED

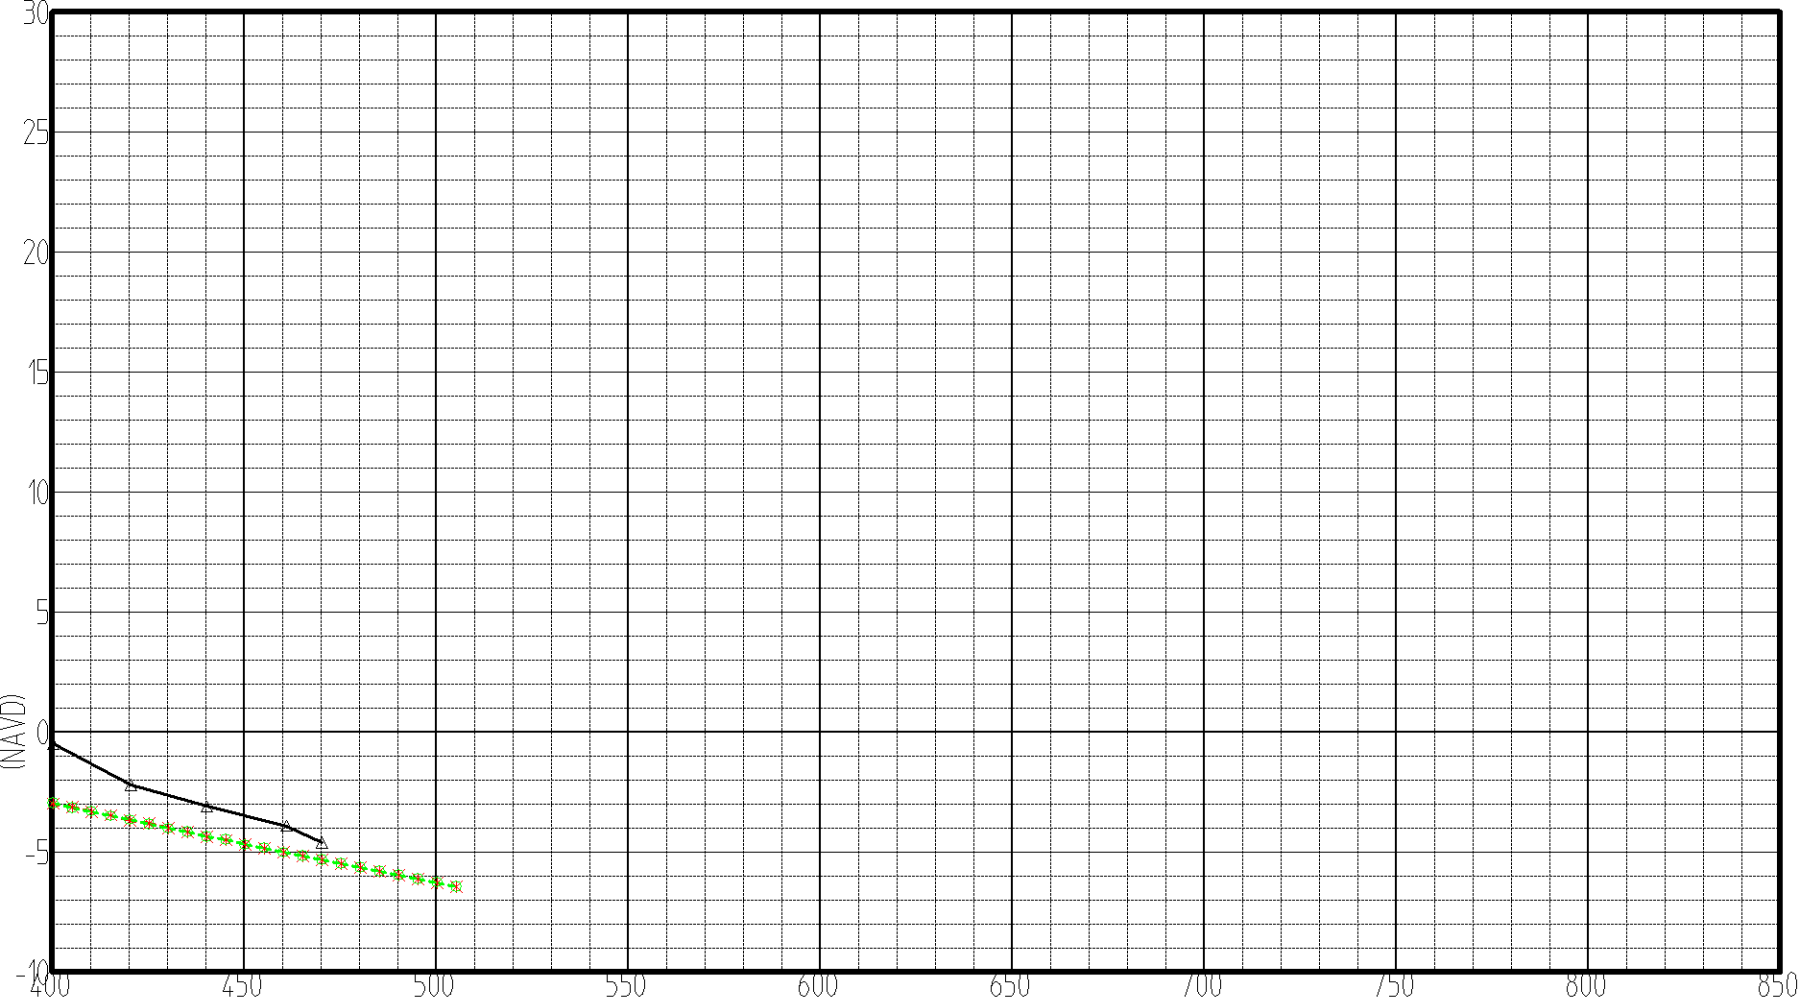
Range: R-93 2/2

BEACH PROFILE

—△—△— 2006-07 Indian River

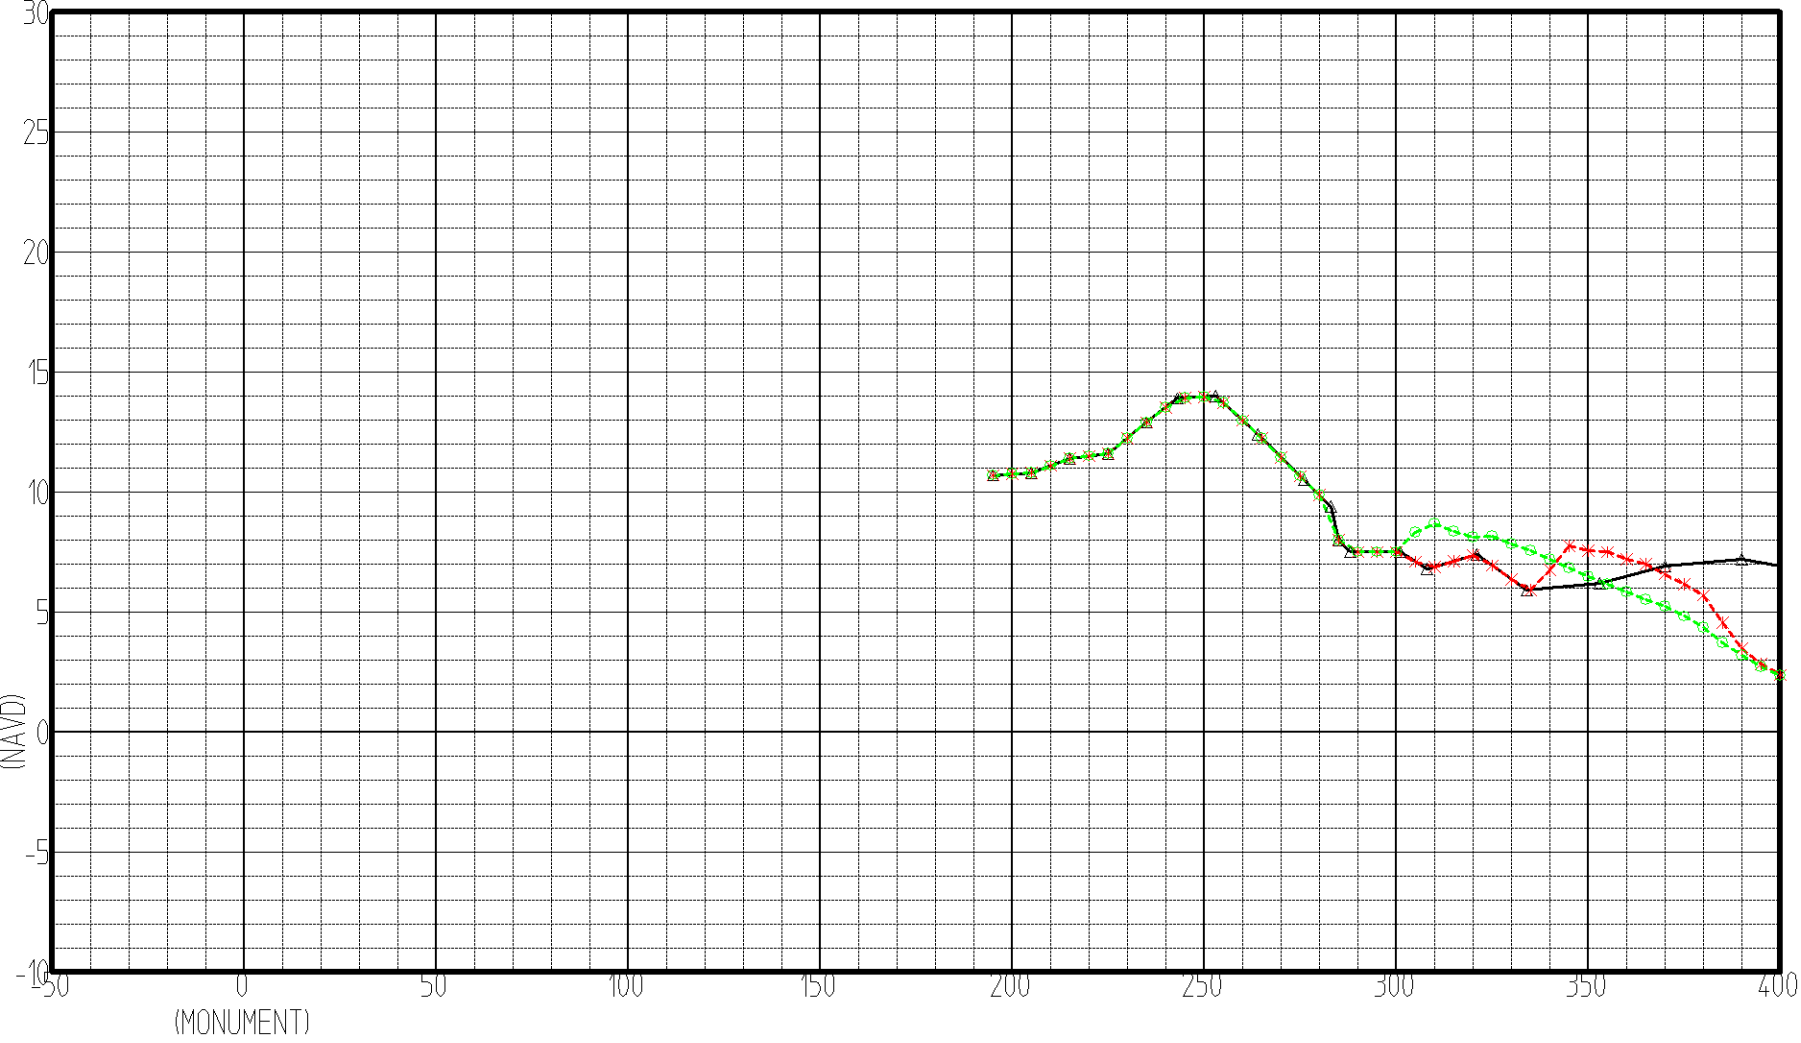
Range: R-94 1/2

BEACH PROFILE

- △—△— 2008-08 Indian River
- - - \* - - - 15YR SBEACH ERODED
- - - ○ - - - 25YR SBEACH ERODED

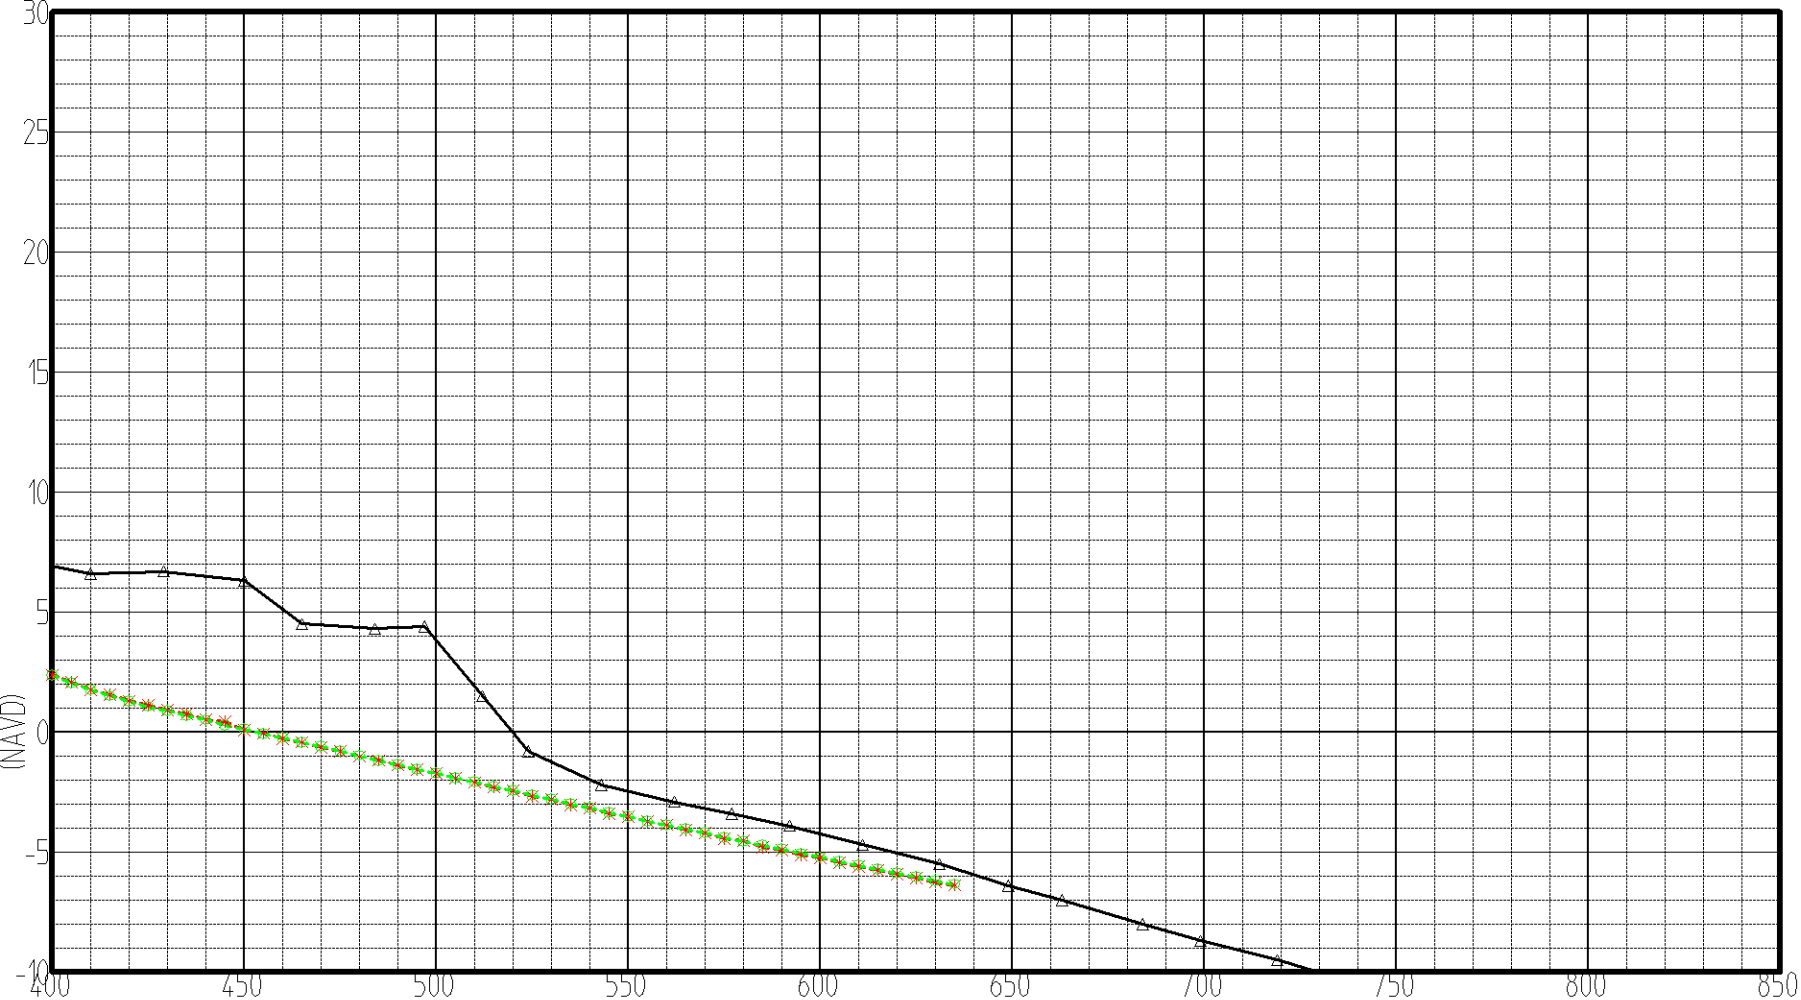
Range: R-94 2/2

BEACH PROFILE

—△—△— 2008-08 Indian River
