## **Appendix X**

SBEACH 15 and 25 yr. Storm Erosion Profiles

Indian River County

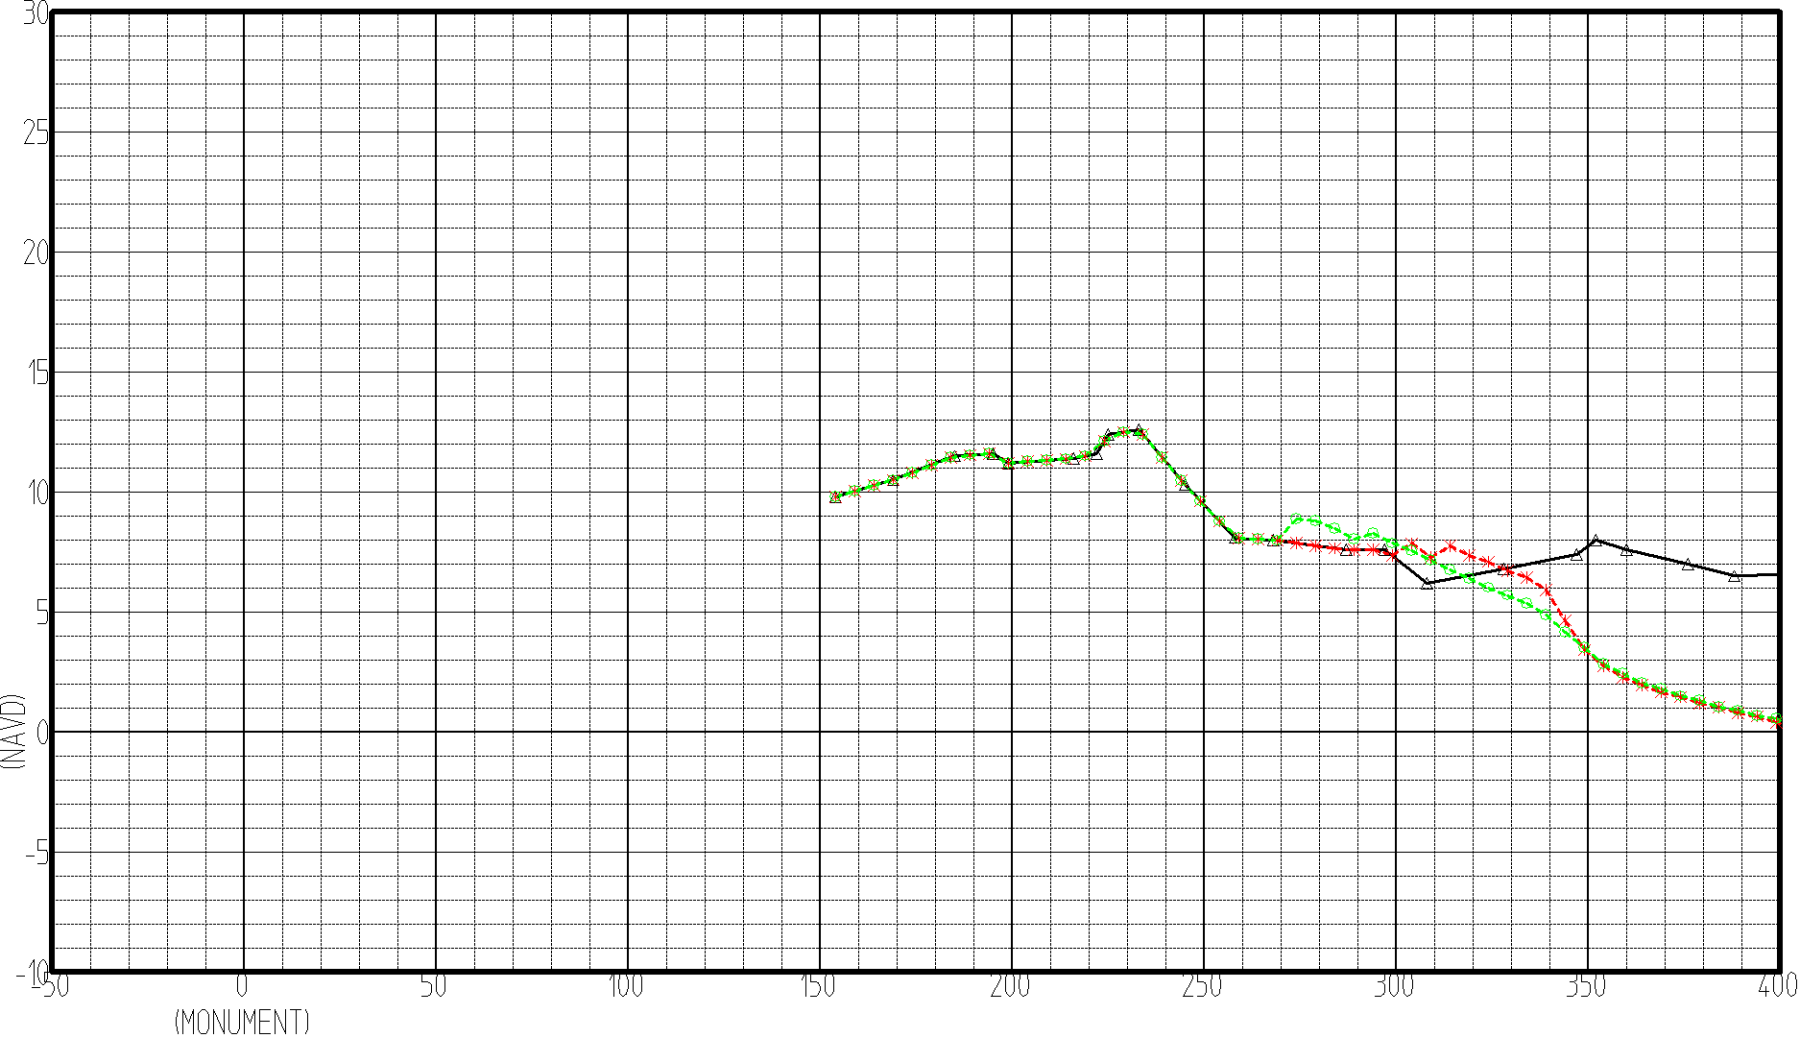
Range: T-96

BEACH PROFILE

—△—△— 2008-08 Indian River

- - - \* - - - 15YR SBEACH ERODED

- - - o - - - 25YR SBEACH ERODED

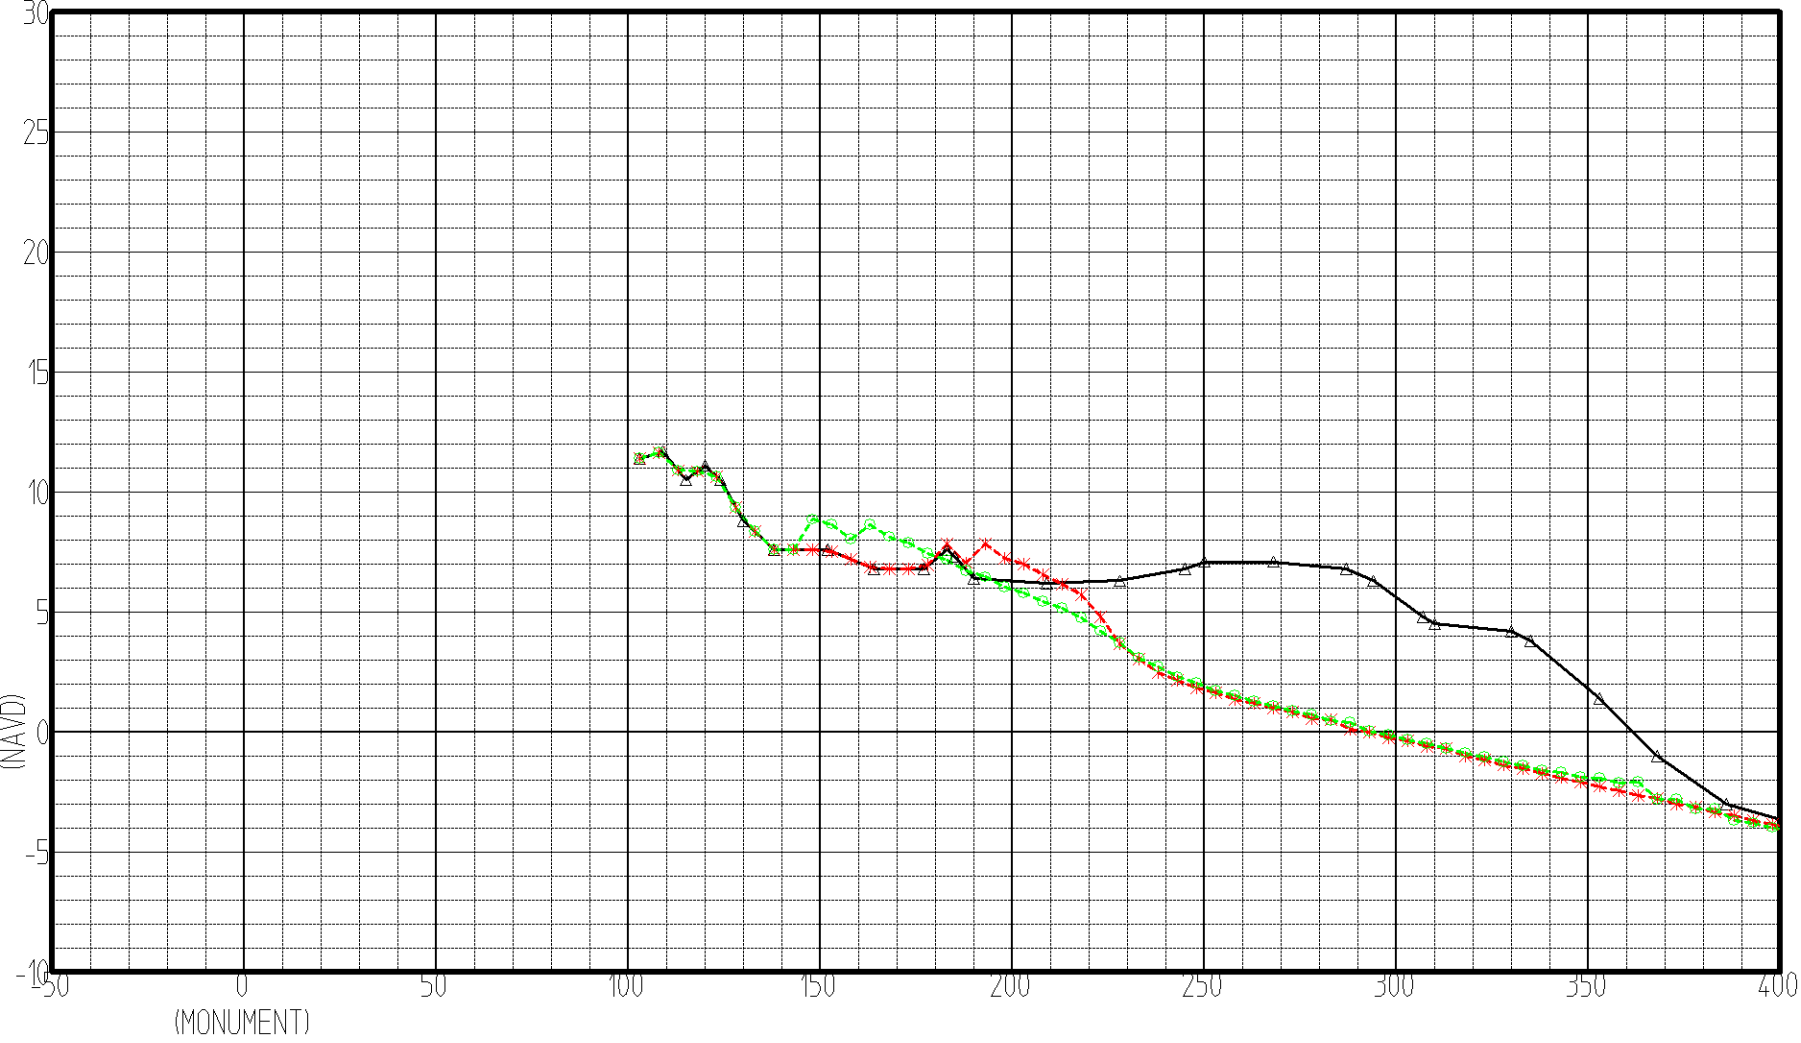
Range: R-97 1/2

BEACH PROFILE

- △—△— 2008-08 Indian River
- - - \* - - - 15YR SBEACH ERODED
- - - o - - - 25YR SBEACH ERODED

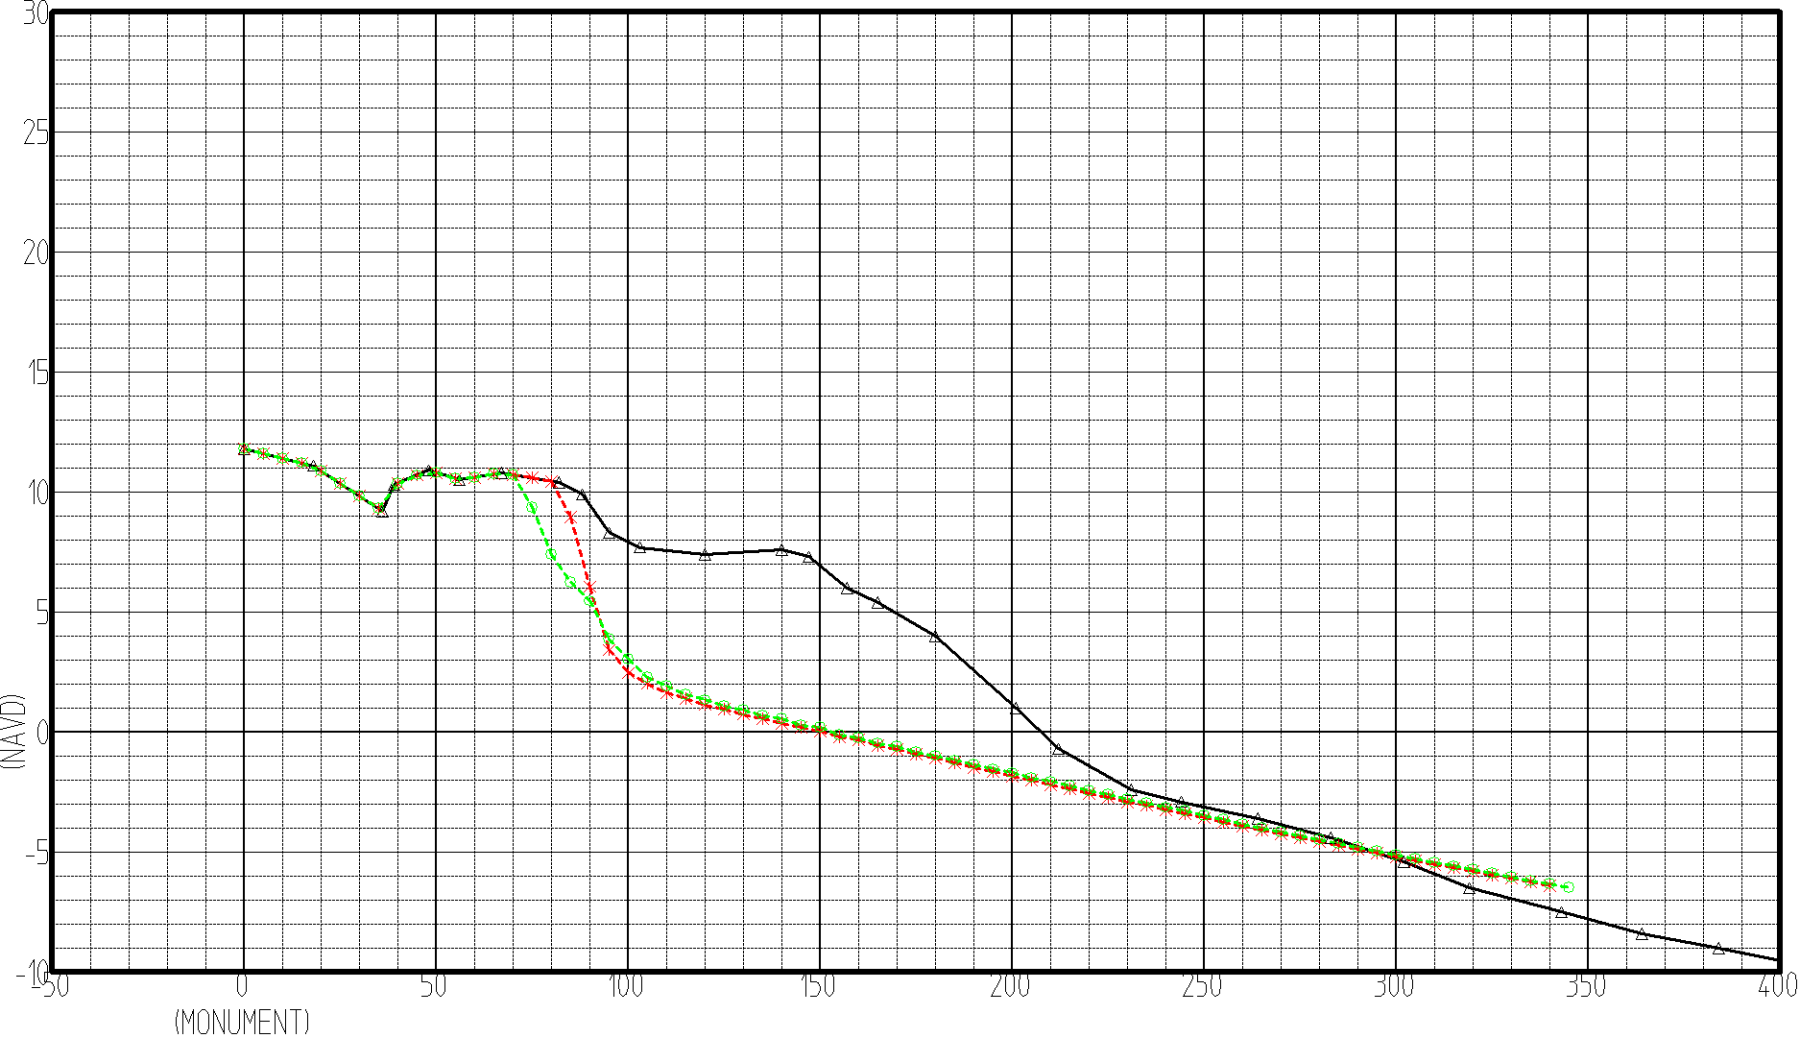
Range: R-99  
 BEARING: 70.00  
 1/2

BEACH PROFILE  
 —△—△— 2008-08 Indian River  
 - - \* - - 15YR SBEACH ERODED  
 - - o - - 25YR SBEACH ERODED

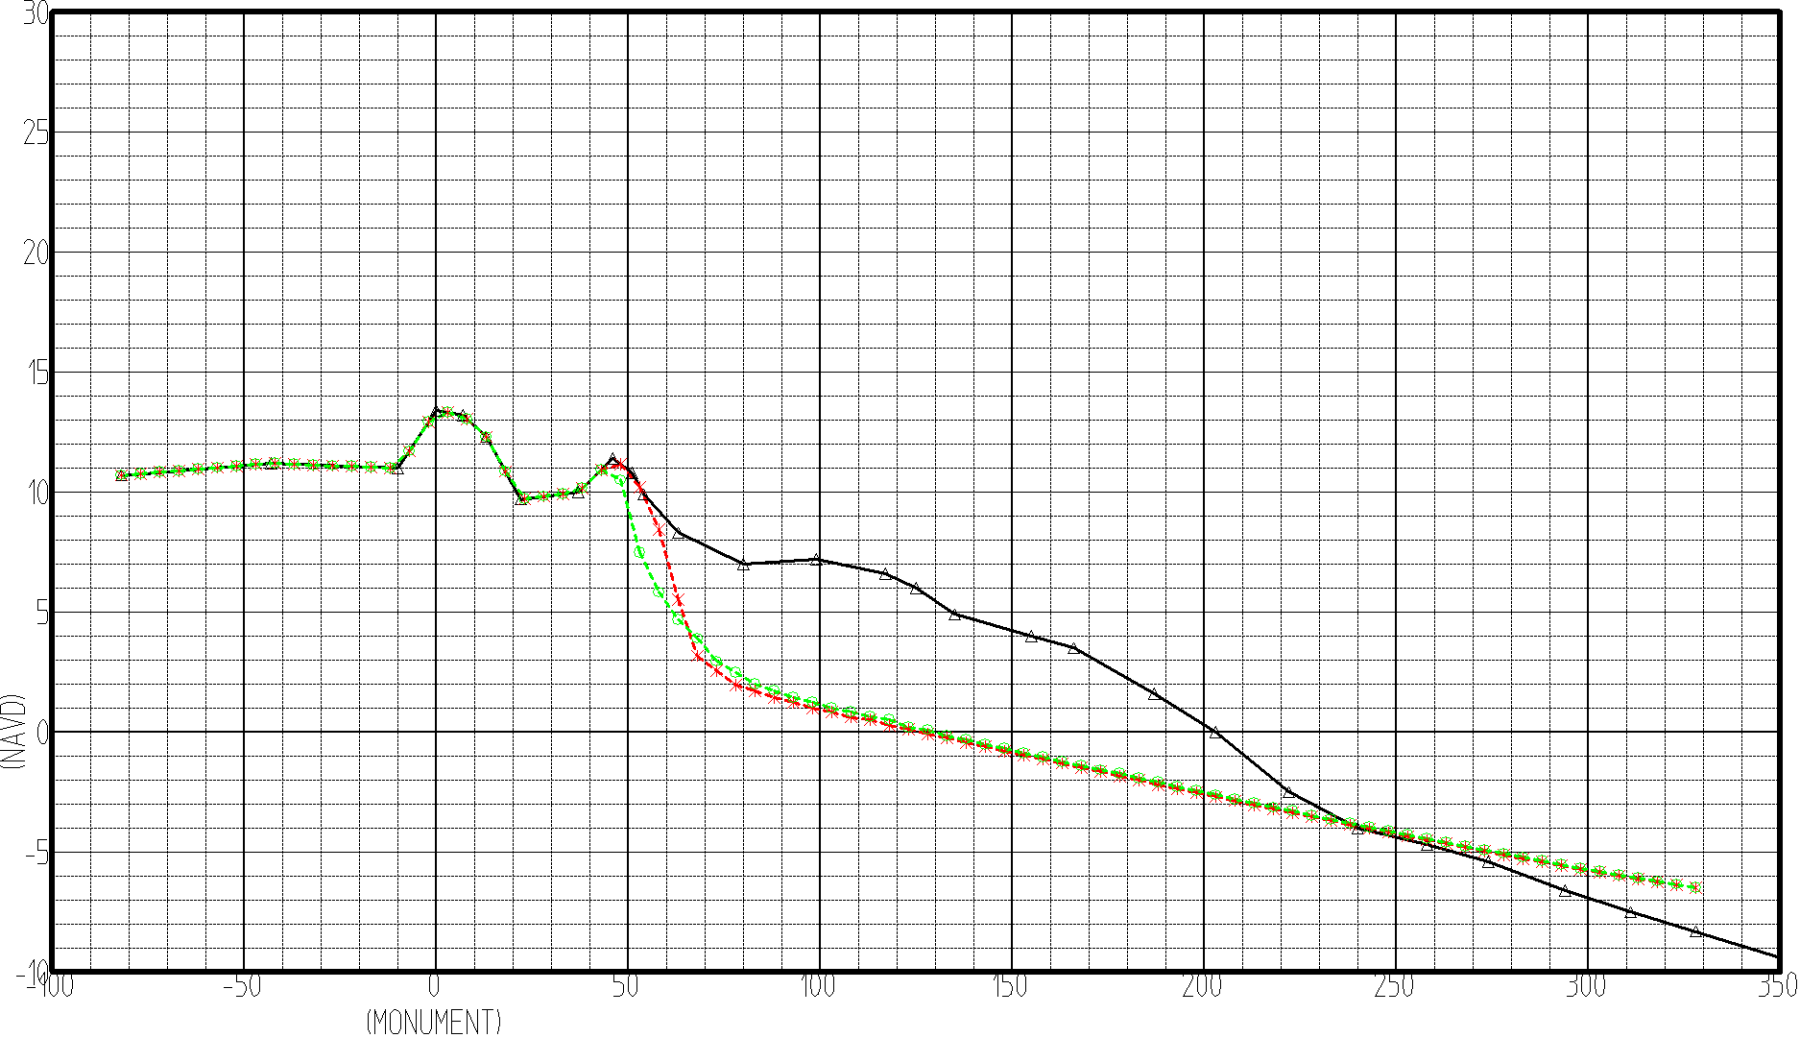
Range: R-101

BEACH PROFILE

—△—△— 2008-08 Indian River

- - - \* - - - 15YR SBEACH ERODED

- - - o - - - 25YR SBEACH ERODED

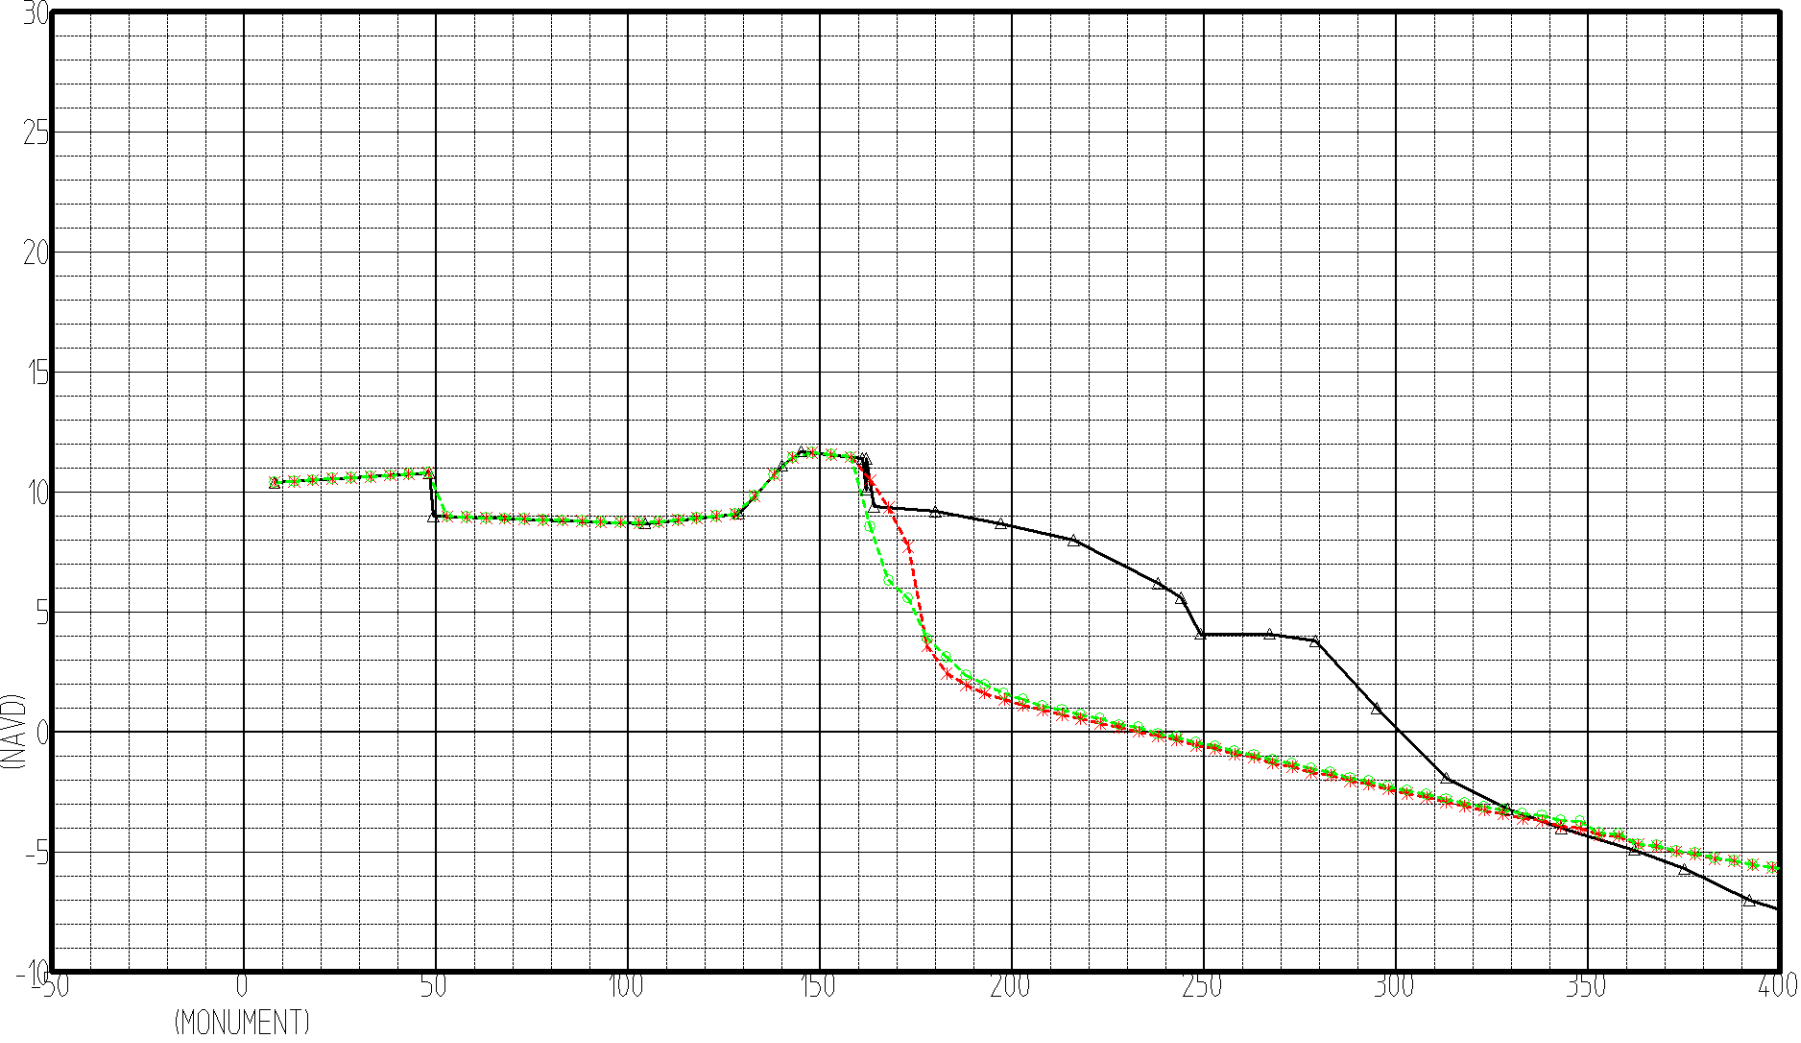
Range: R-103

BEACH PROFILE

—△—△— 2008-08 Indian River

- - - \* - - - 15YR SBEACH ERODED

- - - o - - - 25YR SBEACH ERODED

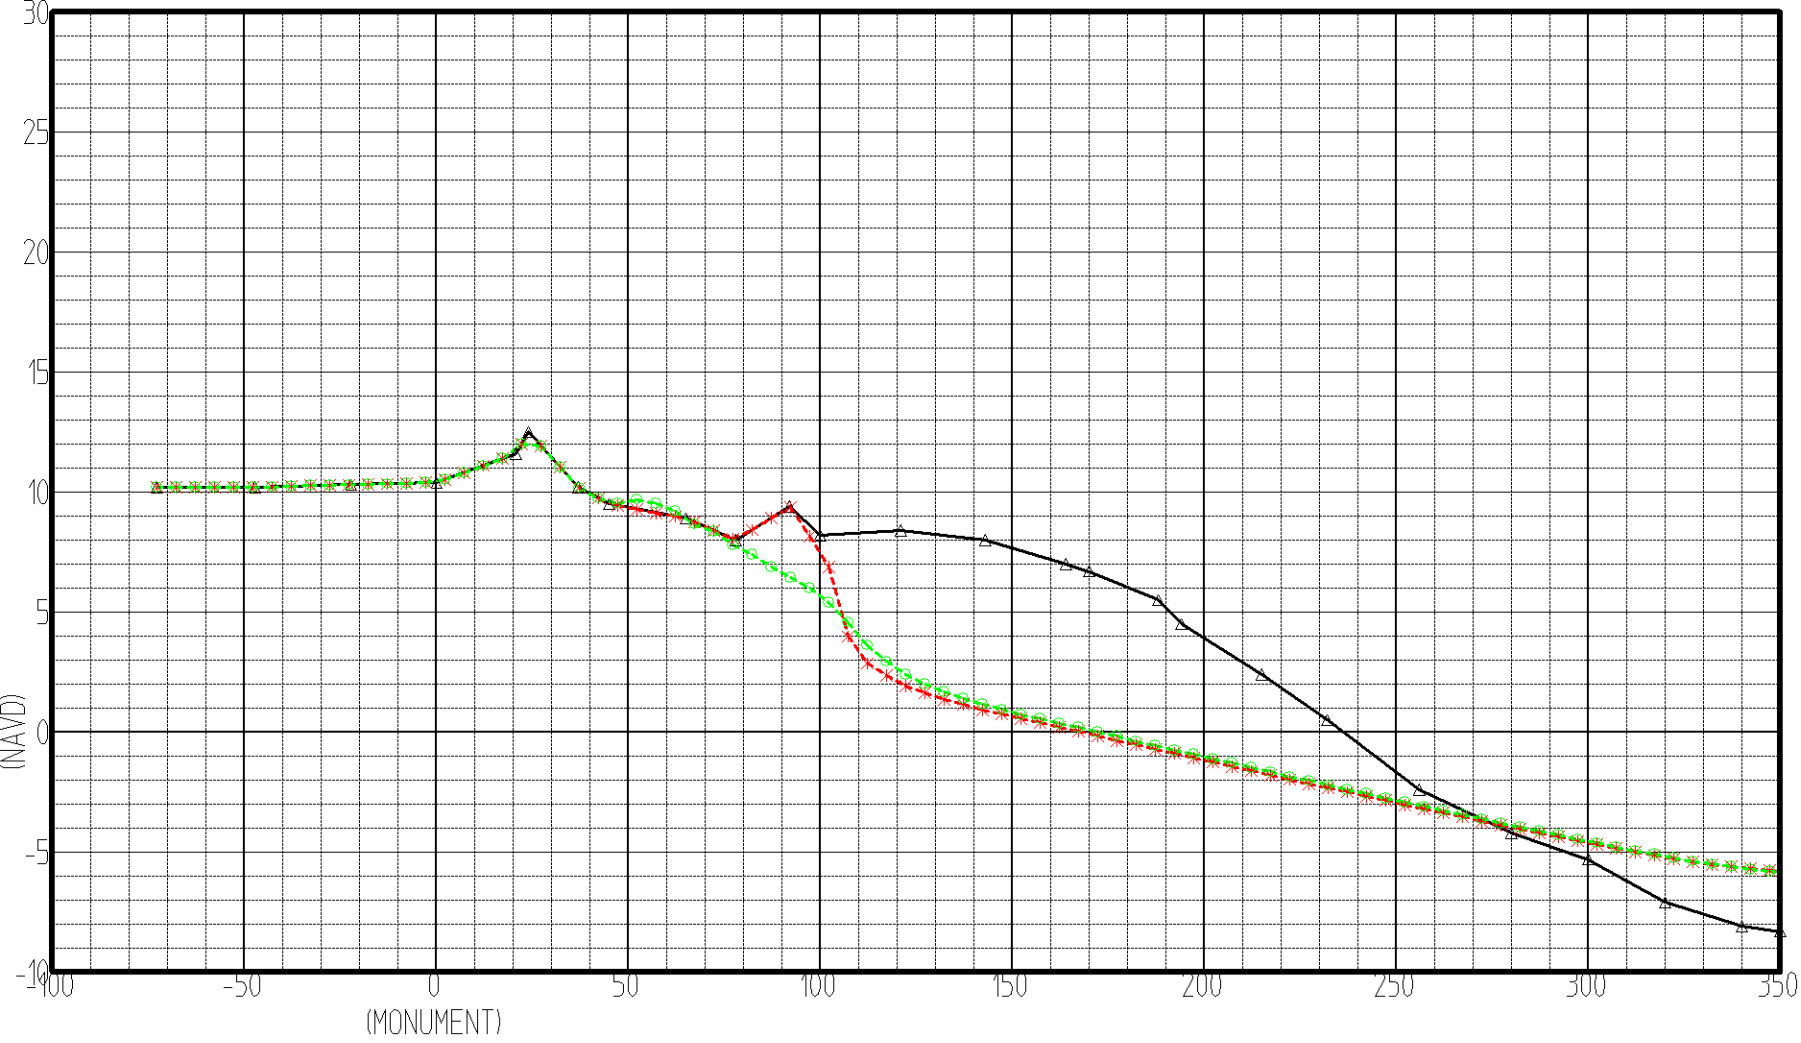
Range: R-104

BEACH PROFILE

—△—△— 2008-08 Indian River

- - - \* - - - 15YR SBEACH ERODED

- - - o - - - 25YR SBEACH ERODED

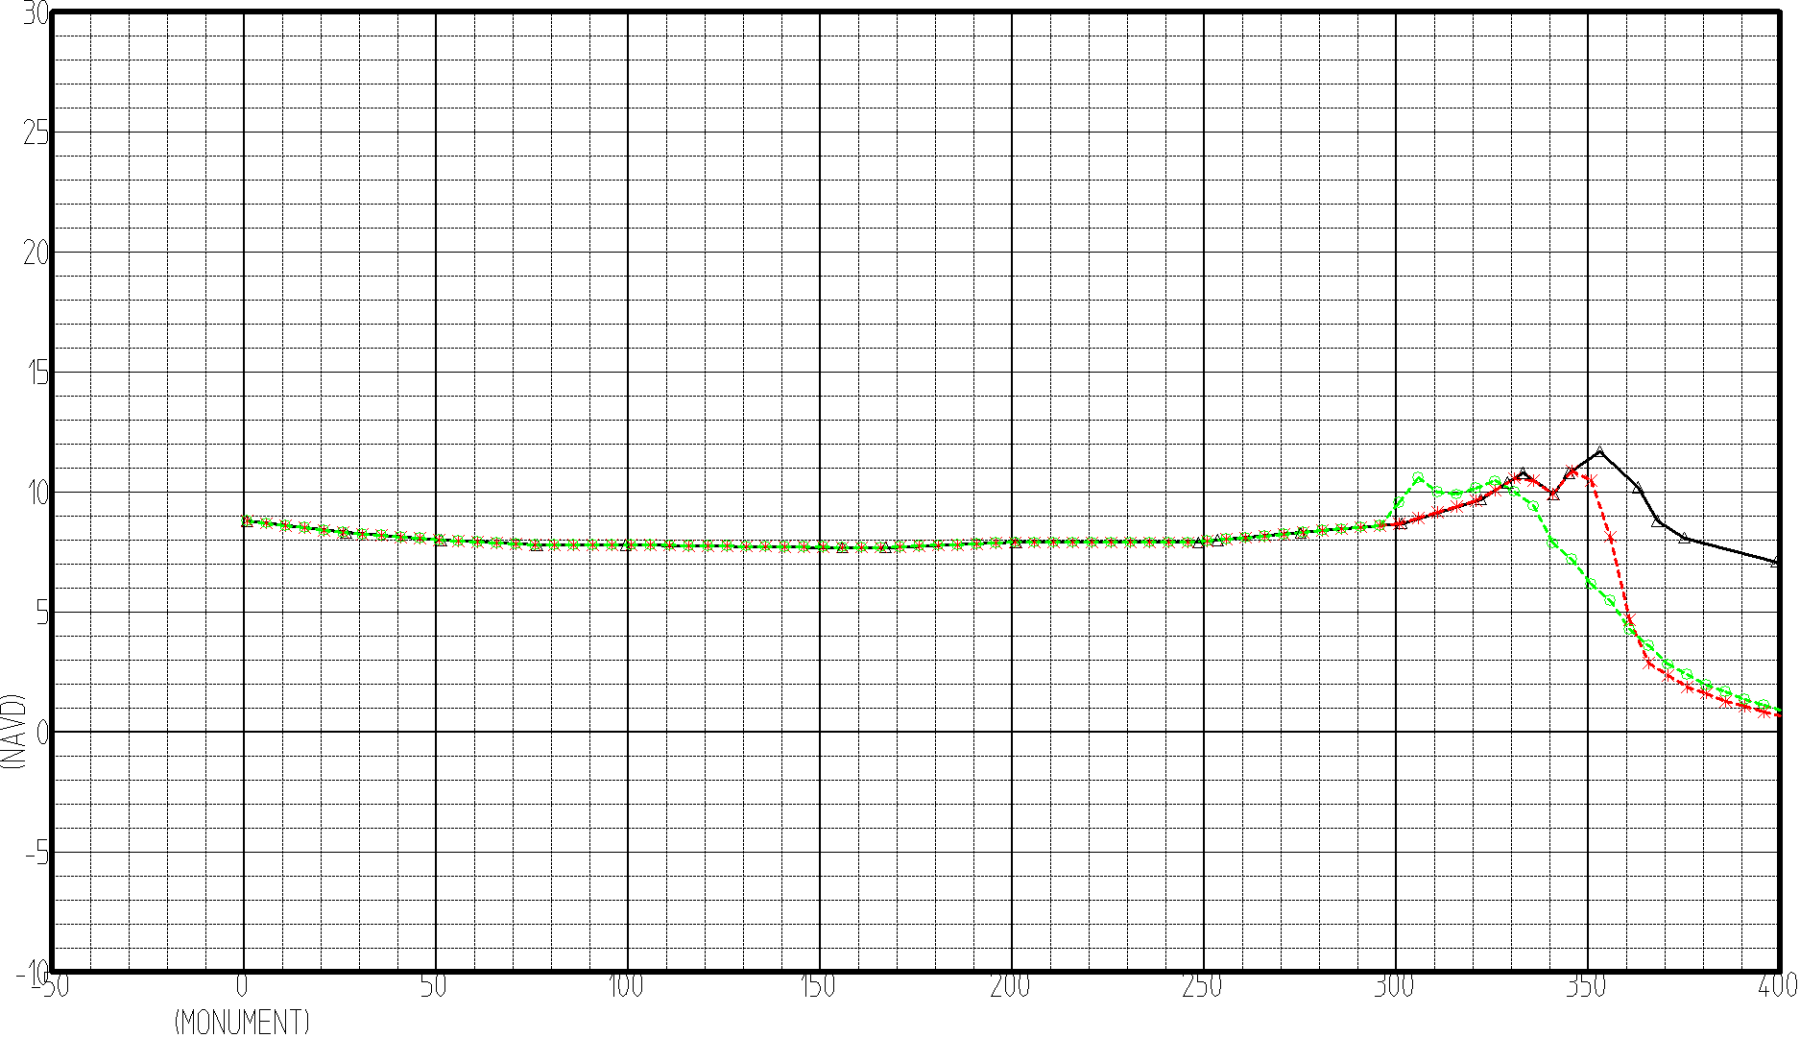
Range: R-108

BEACH PROFILE

—△—△— 2008-08 Indian River

- - \* - - \* - - 15YR SBEACH ERODED

- - o - - o - - 25YR SBEACH ERODED

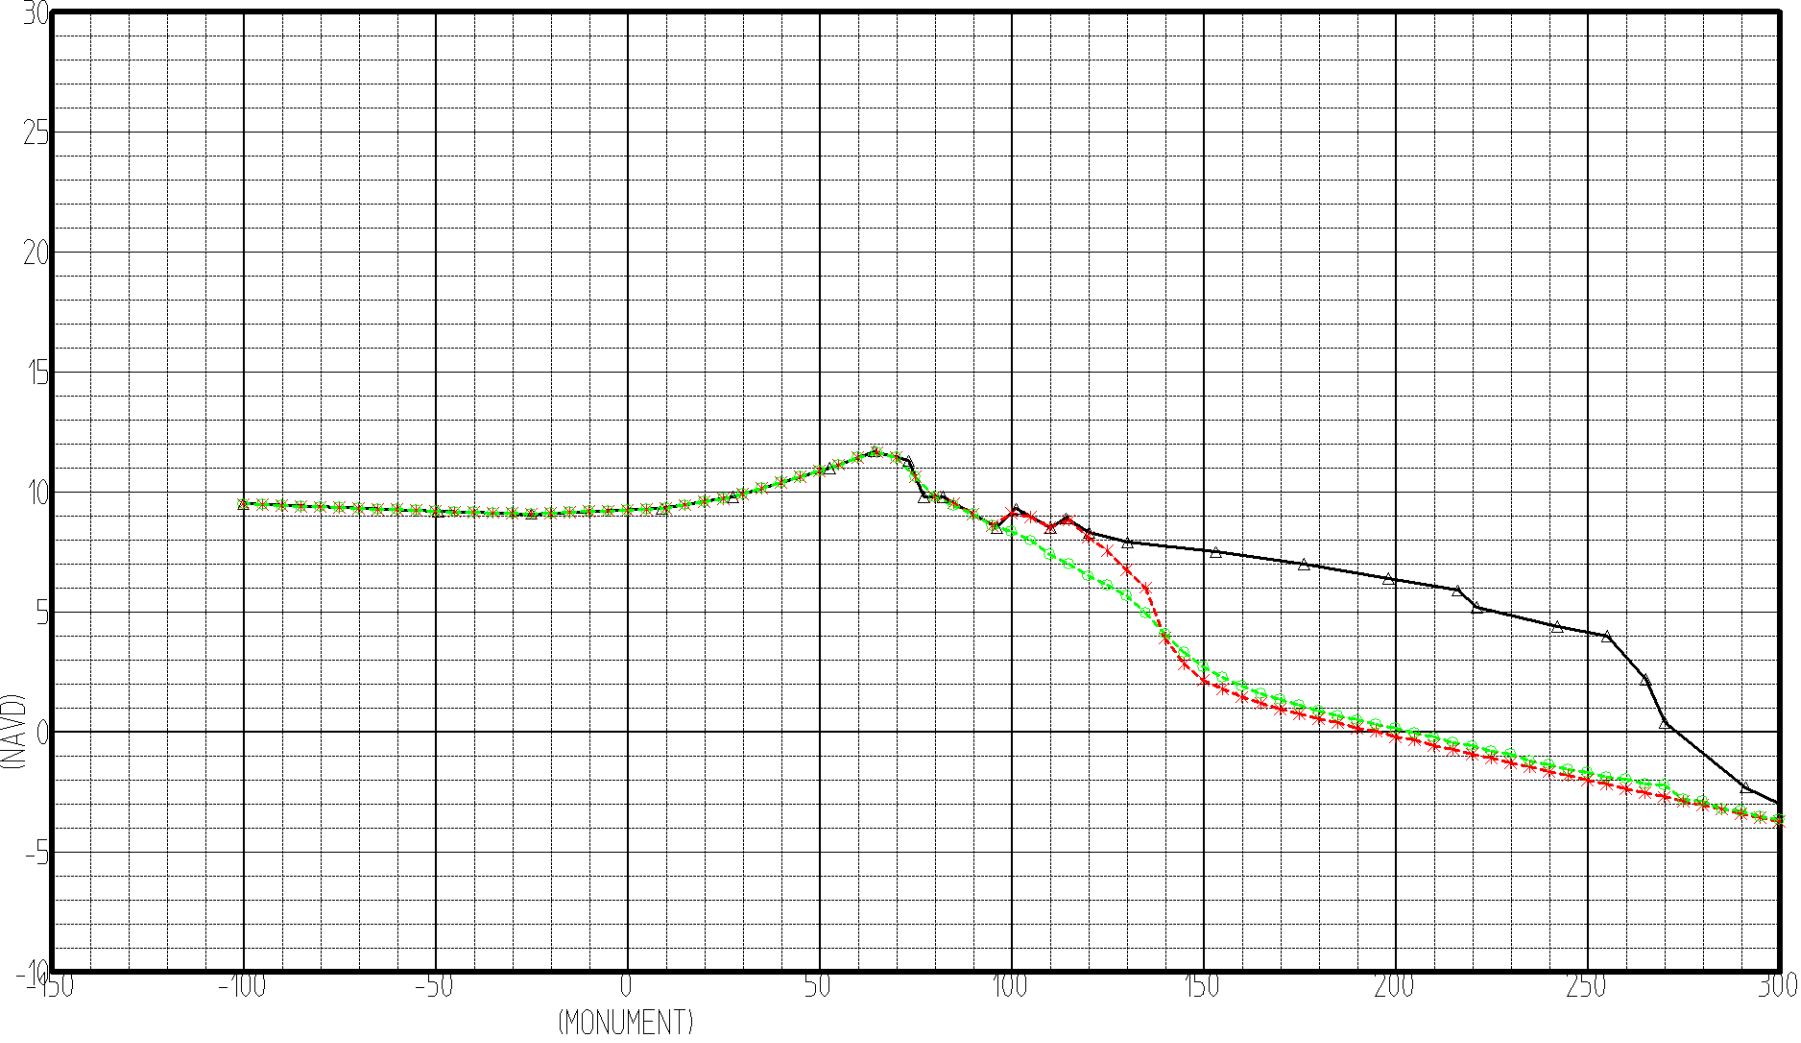
Range: R-110

BEACH PROFILE

—△—△— 2008-08 Indian River

- - - \* - - - 15YR SBEACH ERODED

- - - o - - - 25YR SBEACH ERODED

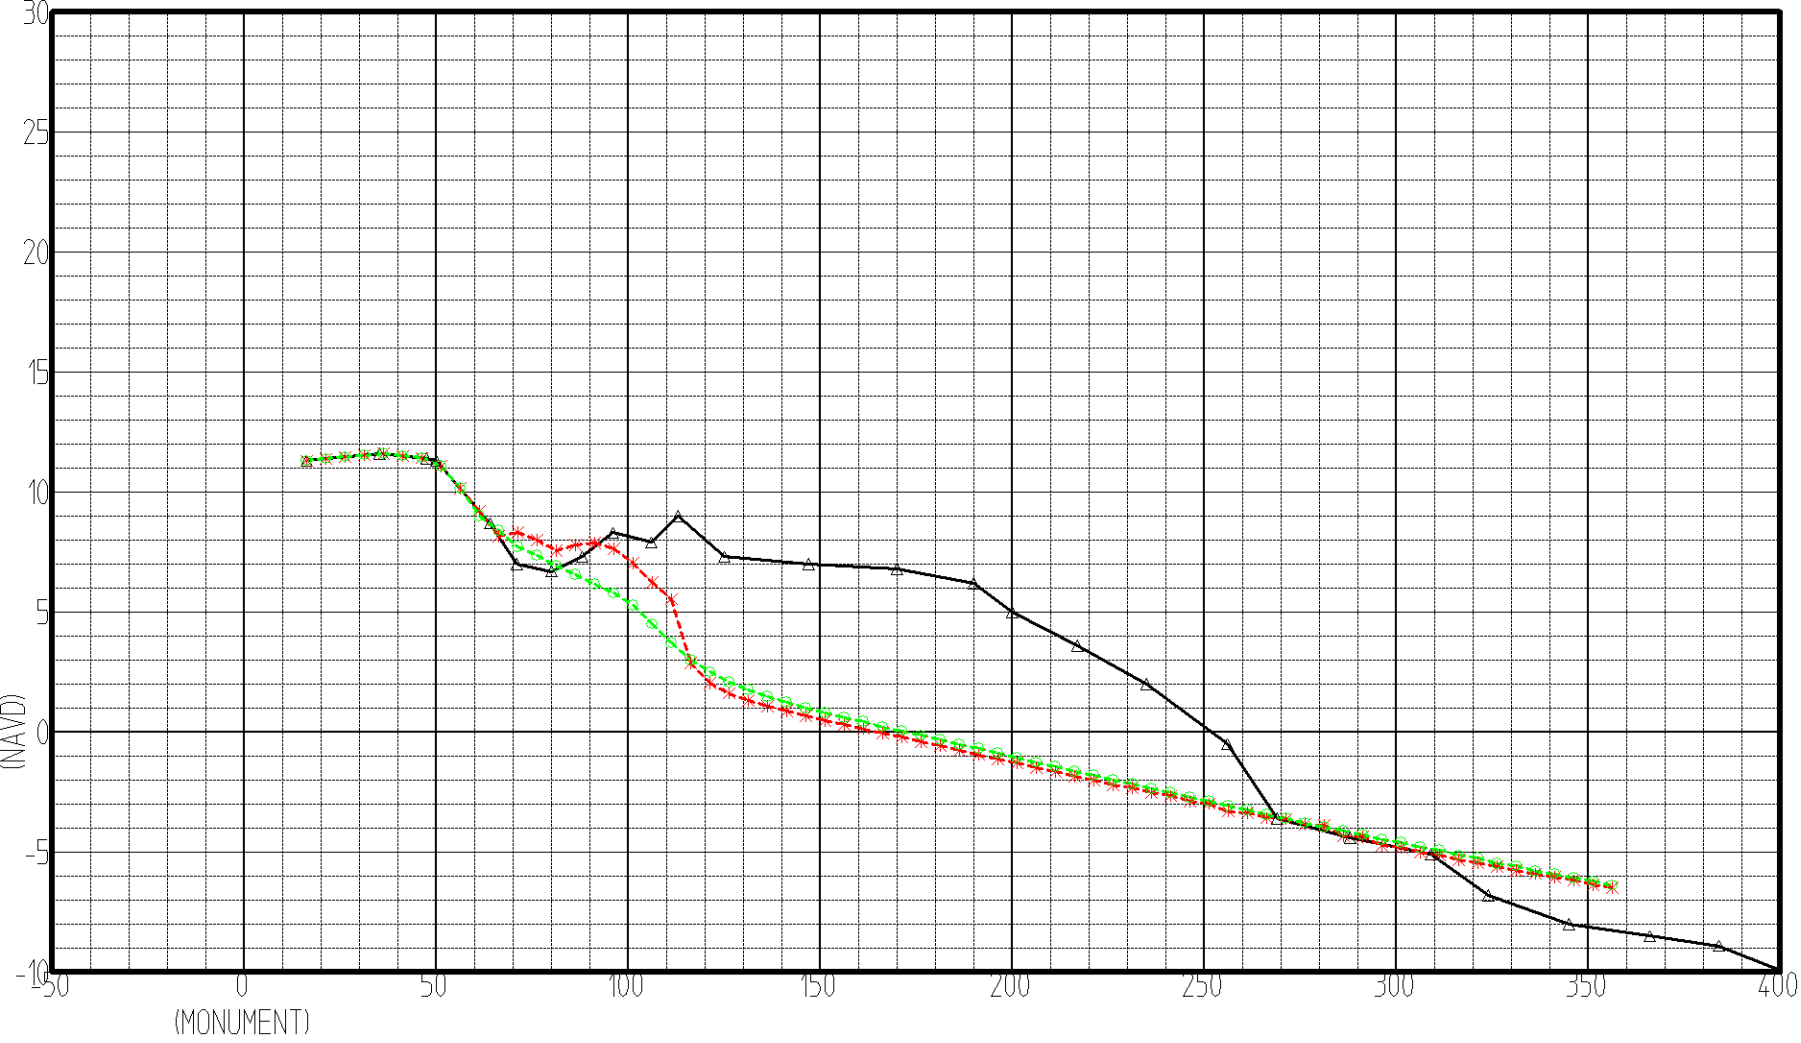
Range: R-111

BEACH PROFILE

- △—△— 2008-08 Indian River
- - - \* - - - 15YR SBEACH ERODED
- - - o - - - 25YR SBEACH ERODED
