Appendix II

SBEACH Model Calibration Profile Plots

St. Johns County

1984 Thanksgiving Storm: Set 1

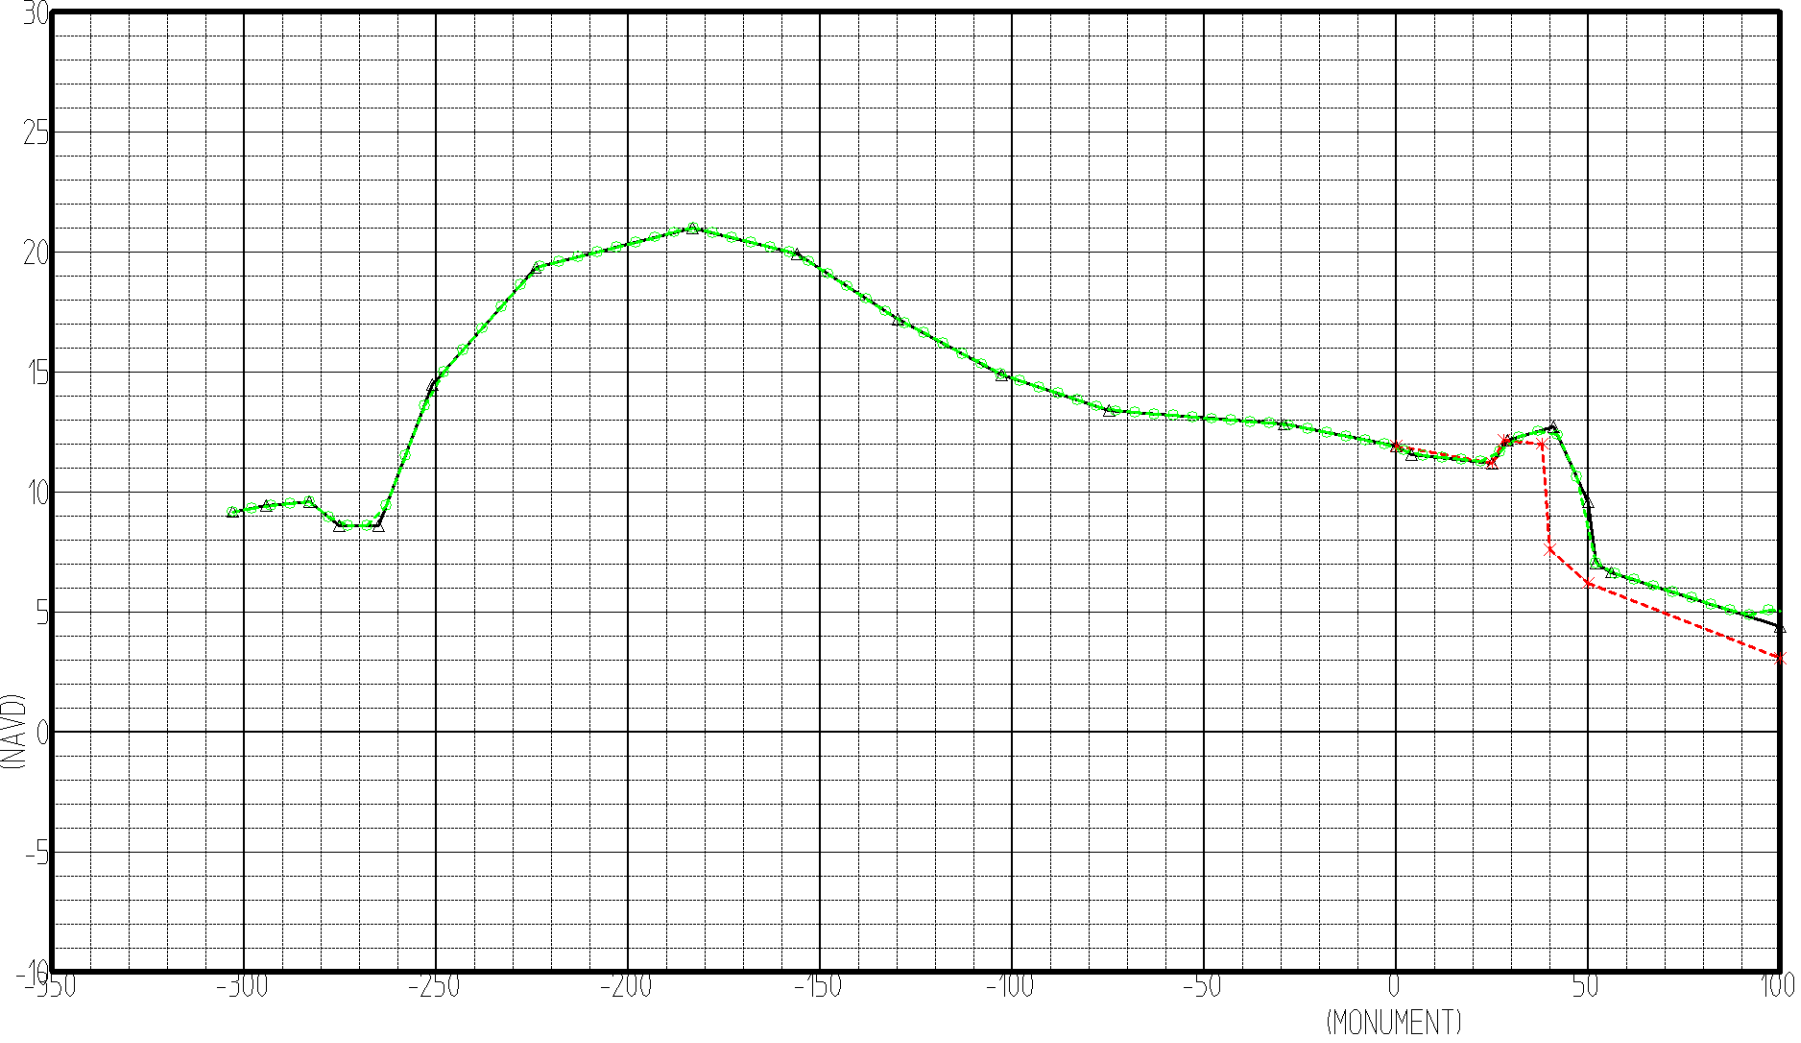
Range: R-1
 BEARING: 75.00
 1/3

BEACH PROFILE
 —△—△— ST JOHN 1984-05
 - - - * - - - POST-STORM 1984-12
 - - - o - - - SJ SBEACH ERODED CND1

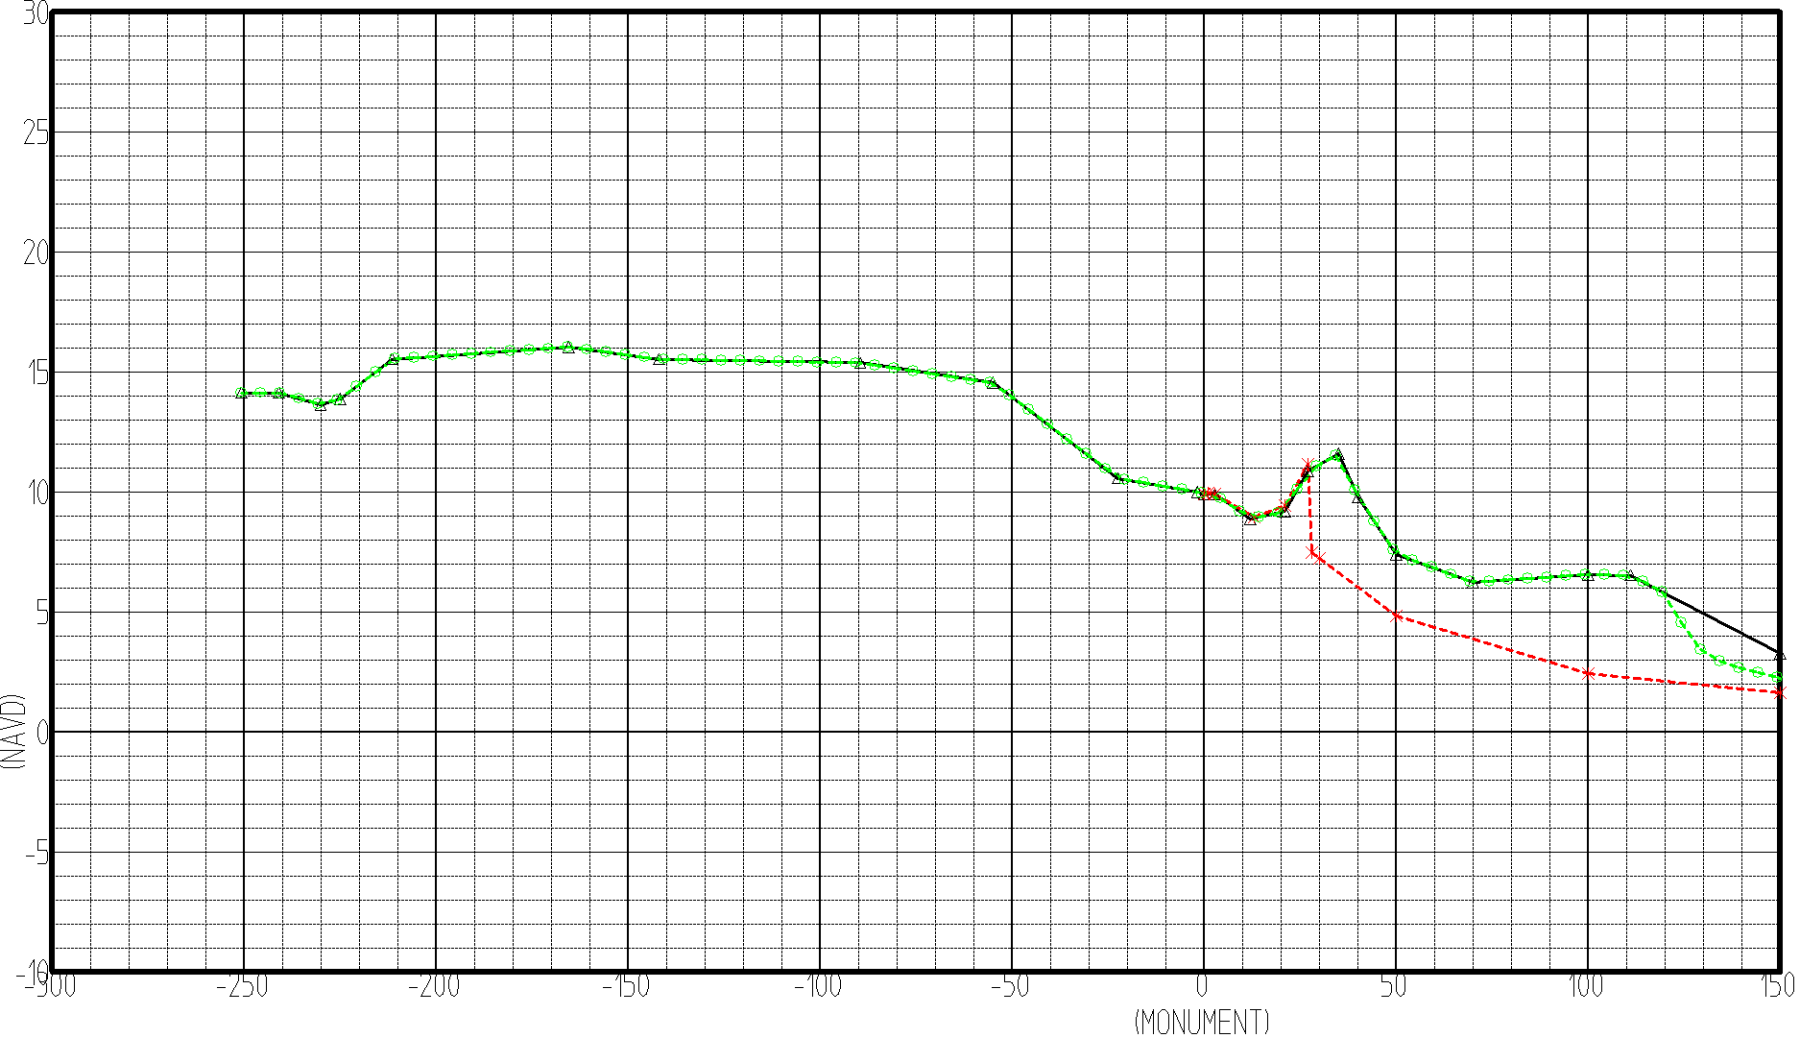
Range: R-3 1/2

- △—△— ST JOHN 1984-05
- - - * - - - POST-STORM 1984-12
- - - ○ - - - SJ SBEACH ERODED CND1

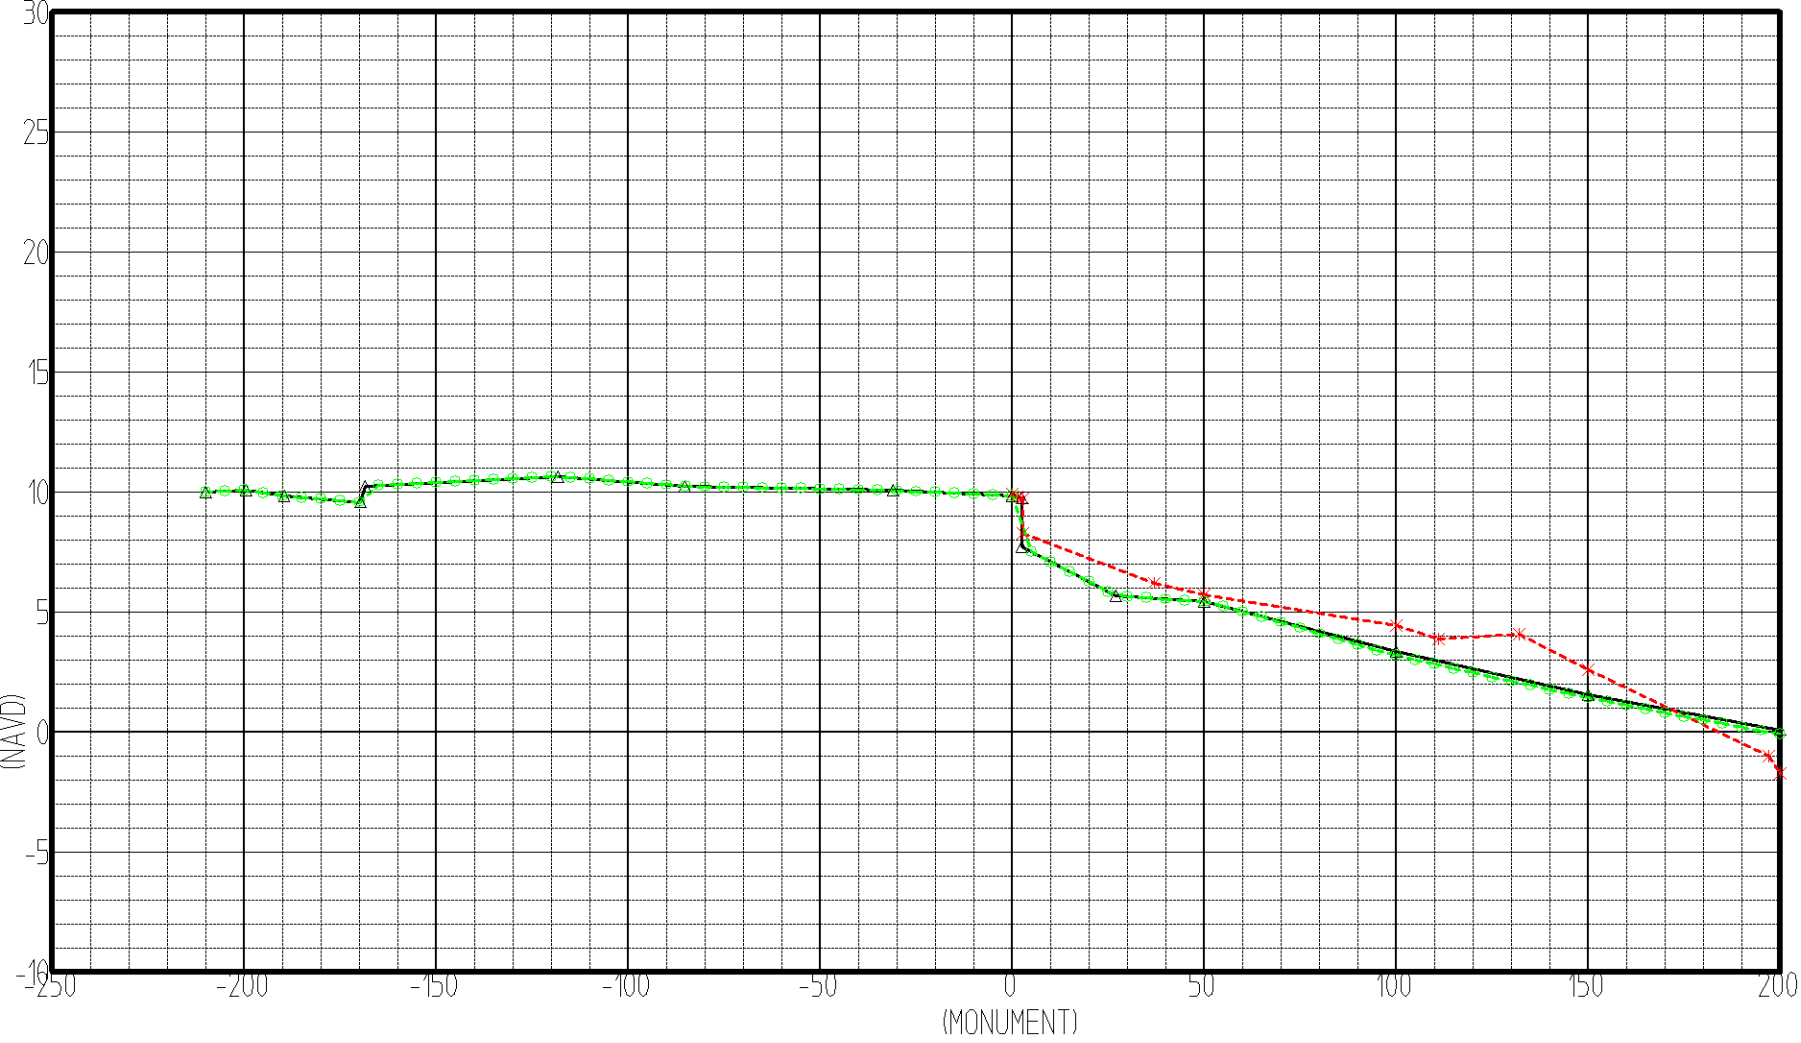
Range: R-6
 BEARING: 75.00
 1/2

BEACH PROFILE
 —△—△— ST JOHN 1984-05
 - - * - - - POST-STORM 1984-12
 - - ○ - - - SJ SBEACH ERODED CND1

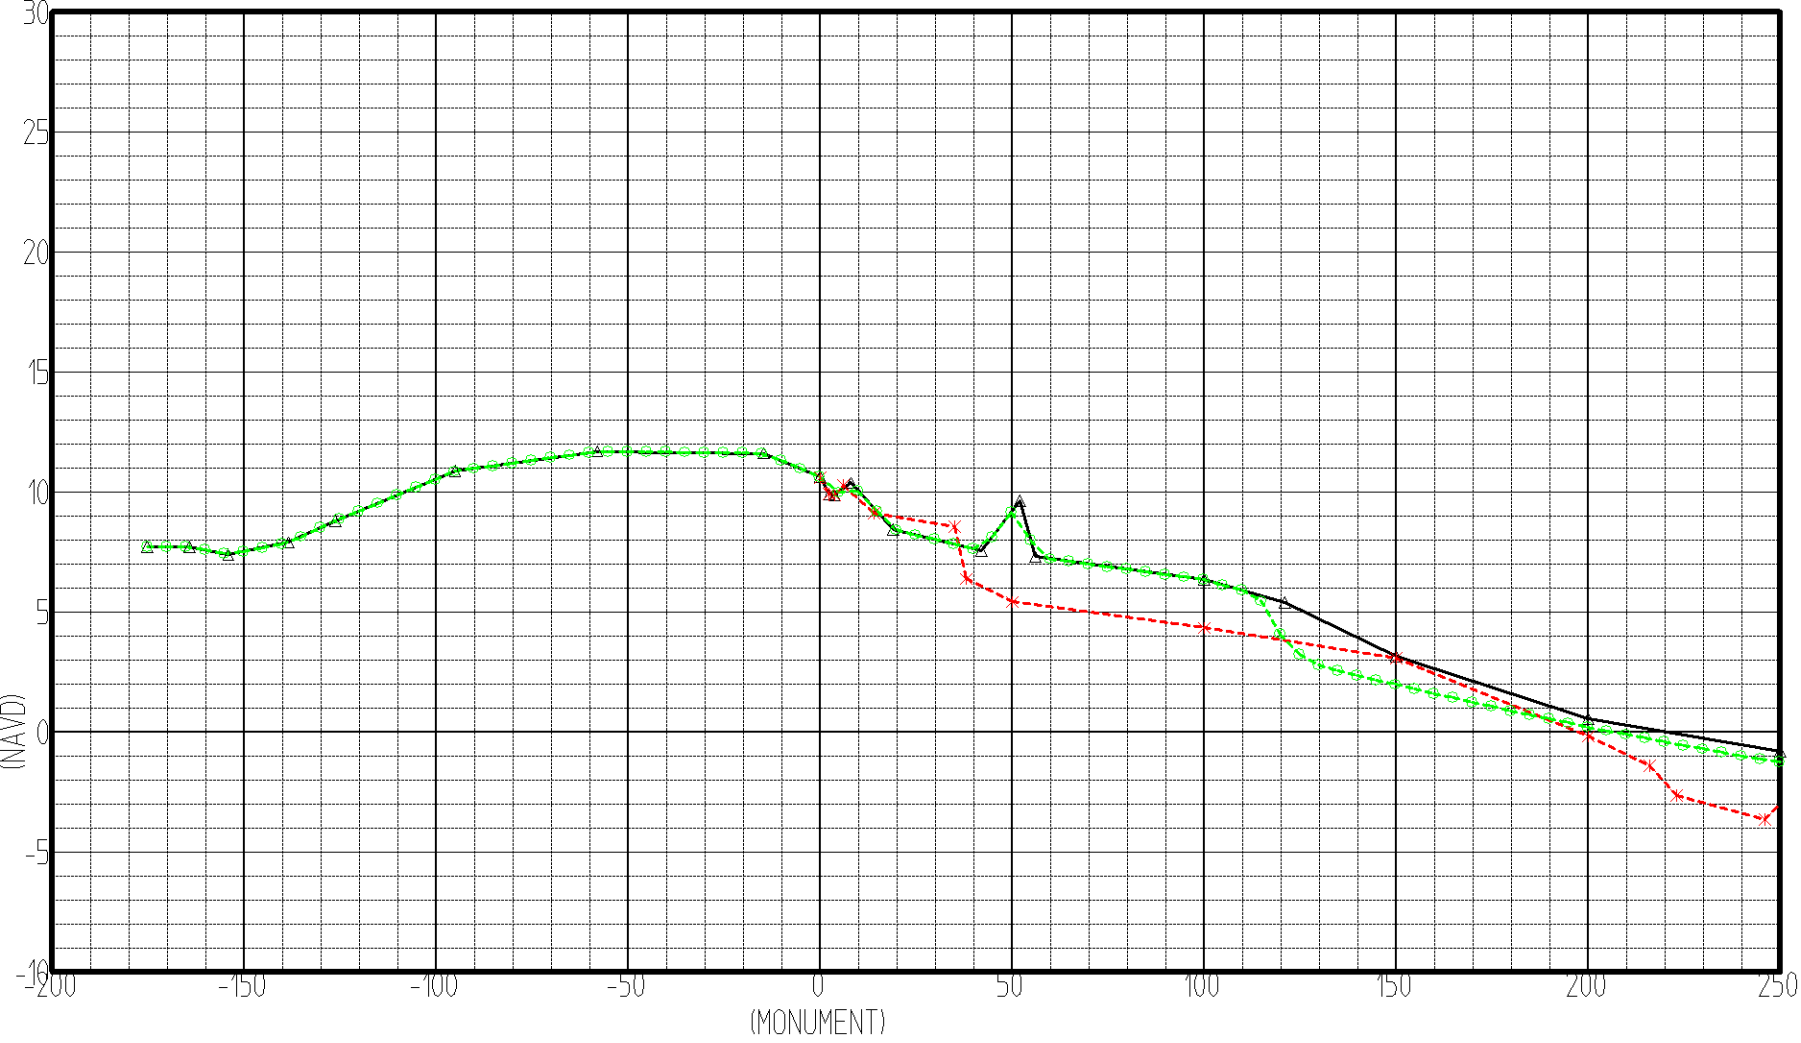
Range: R-9

—△—△— ST JOHN 1984-05

- - - * - - - POST-STORM 1984-12

- - - ○ - - - SJ SBEACH ERODED CND1

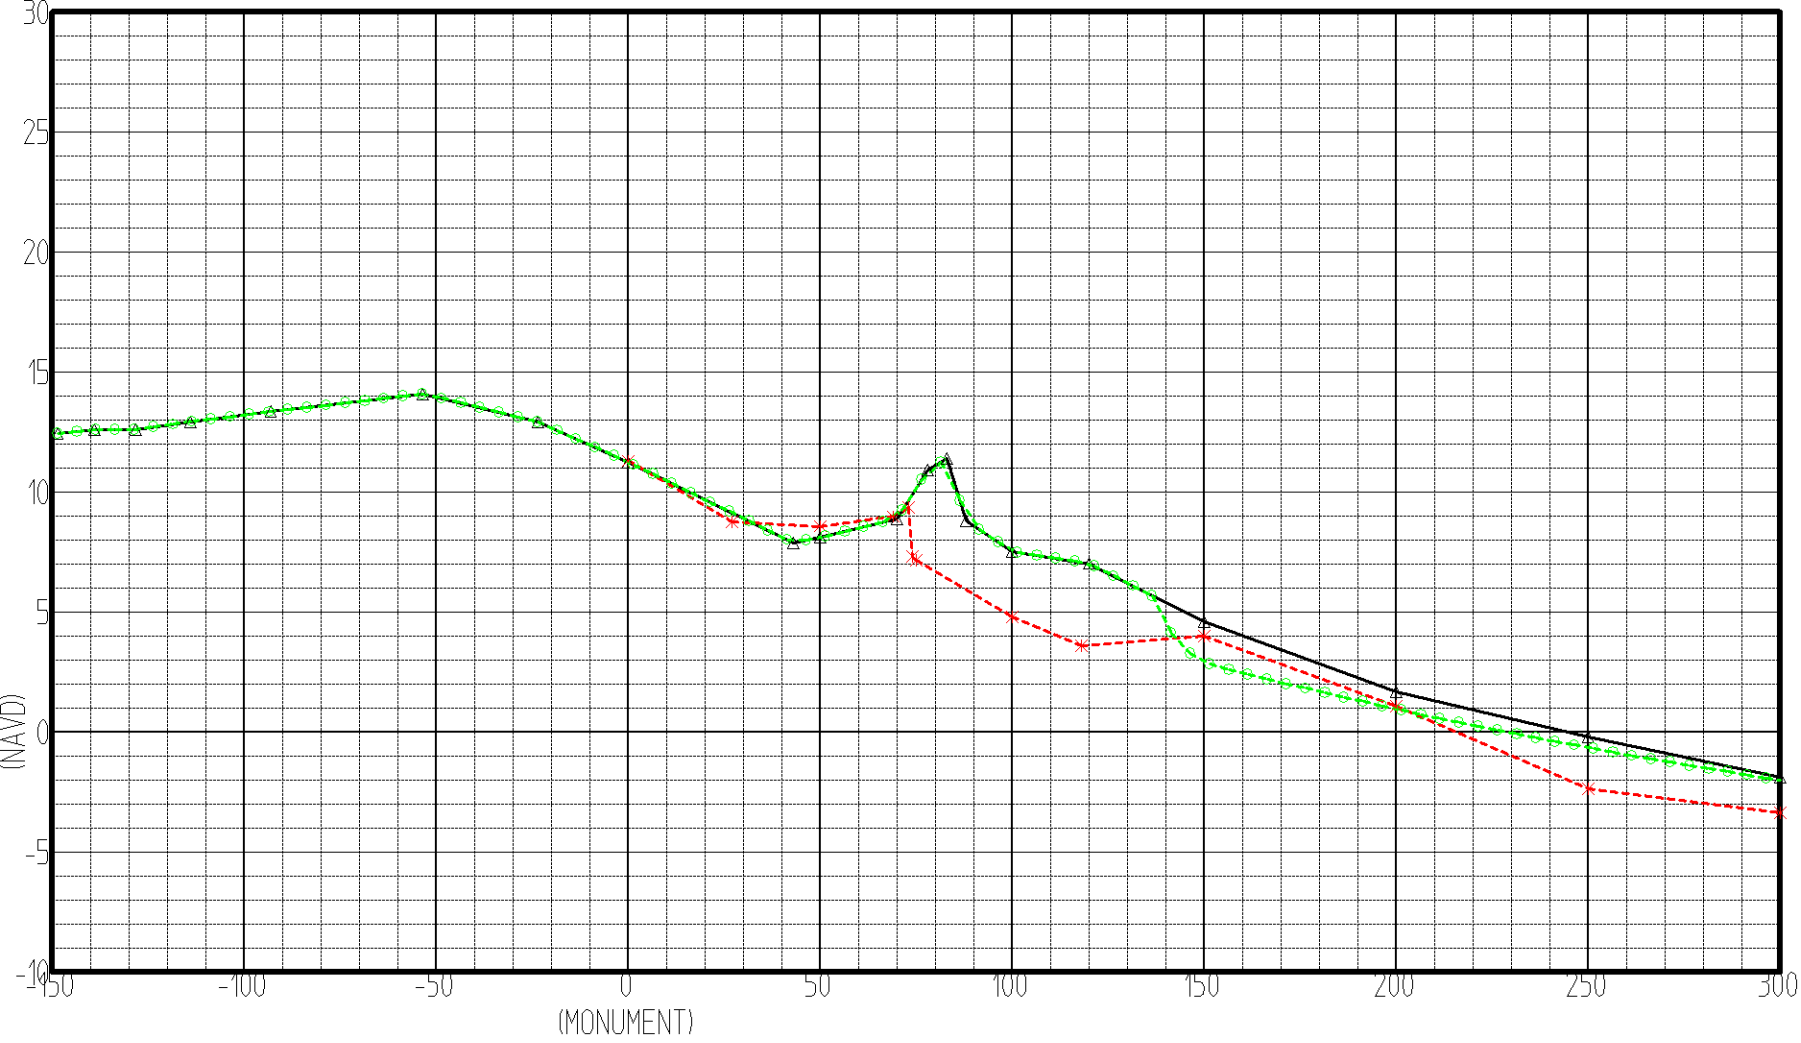
Range: R-12

—△—△— ST JOHN 1984-05

- - - * - - - POST-STORM 1984-12

- - - ○ - - - SJ SBEACH ERODED CND1

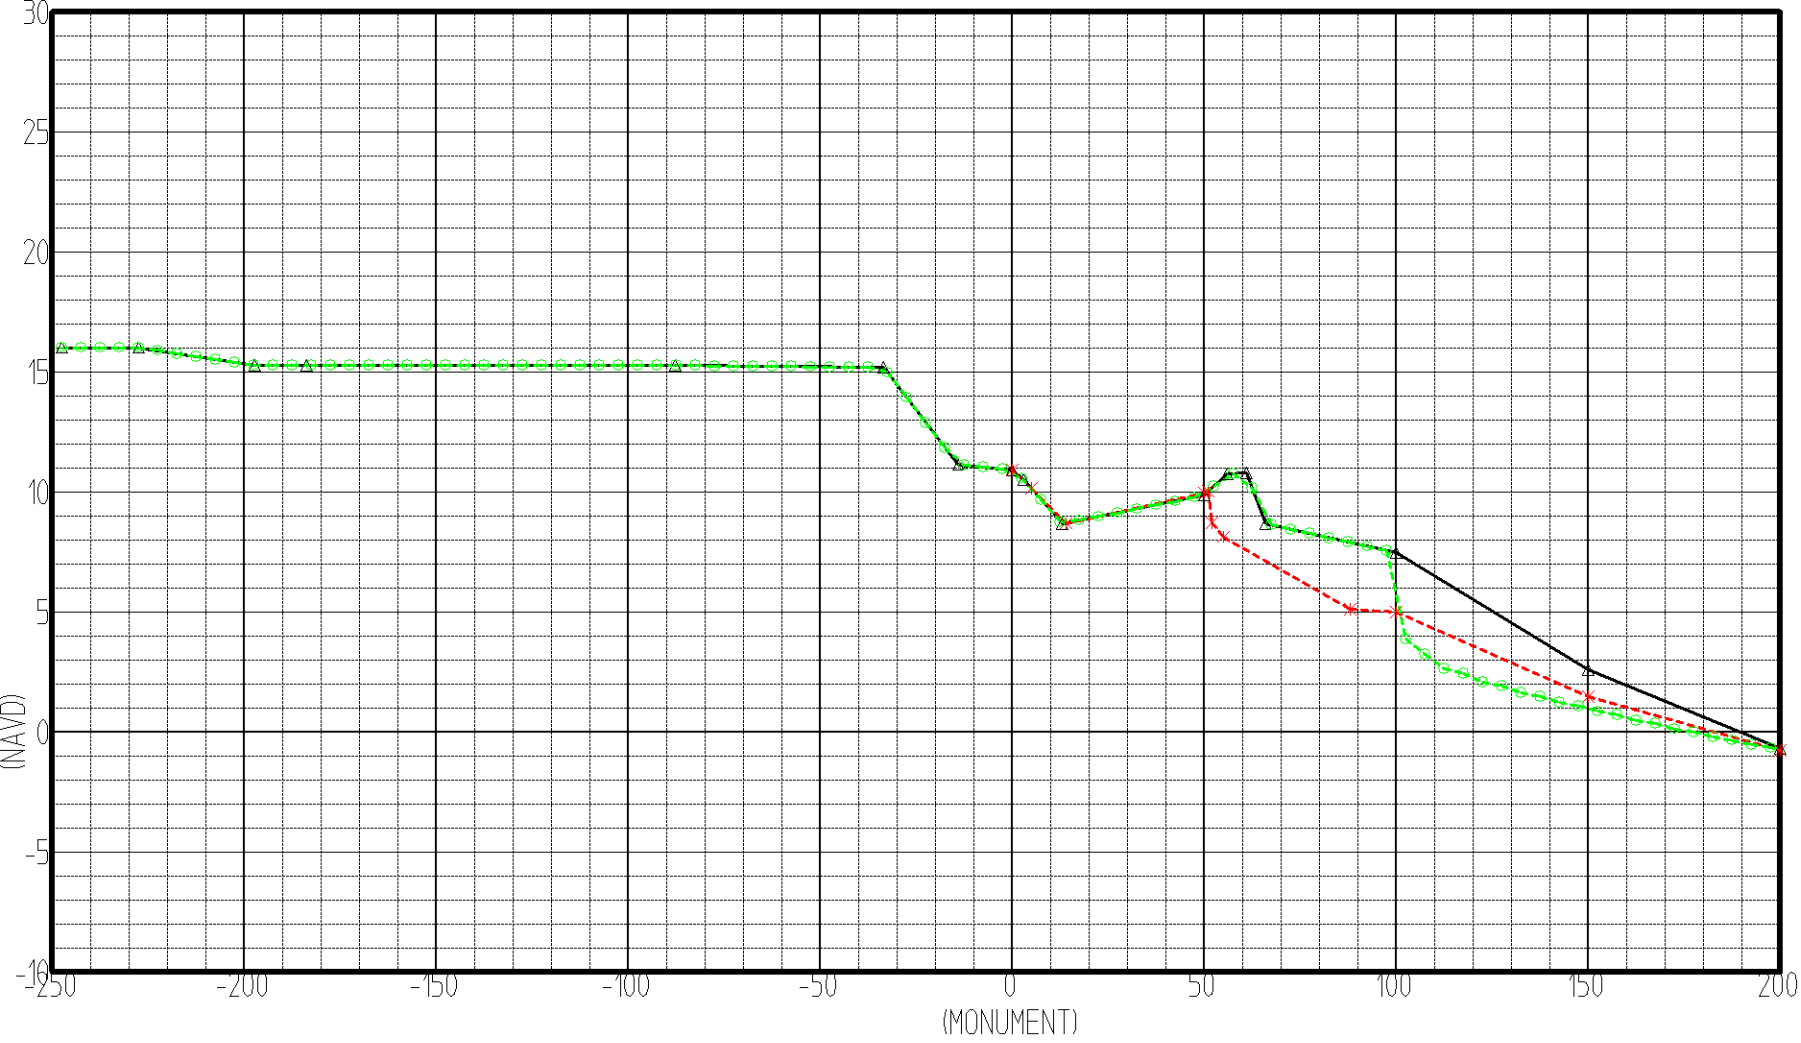
Range: R-18

—△—△— ST JOHN 1984-05

- - - * - - - POST-STORM 1984-12

- - - ○ - - - SJ SBEACH ERODED CND1

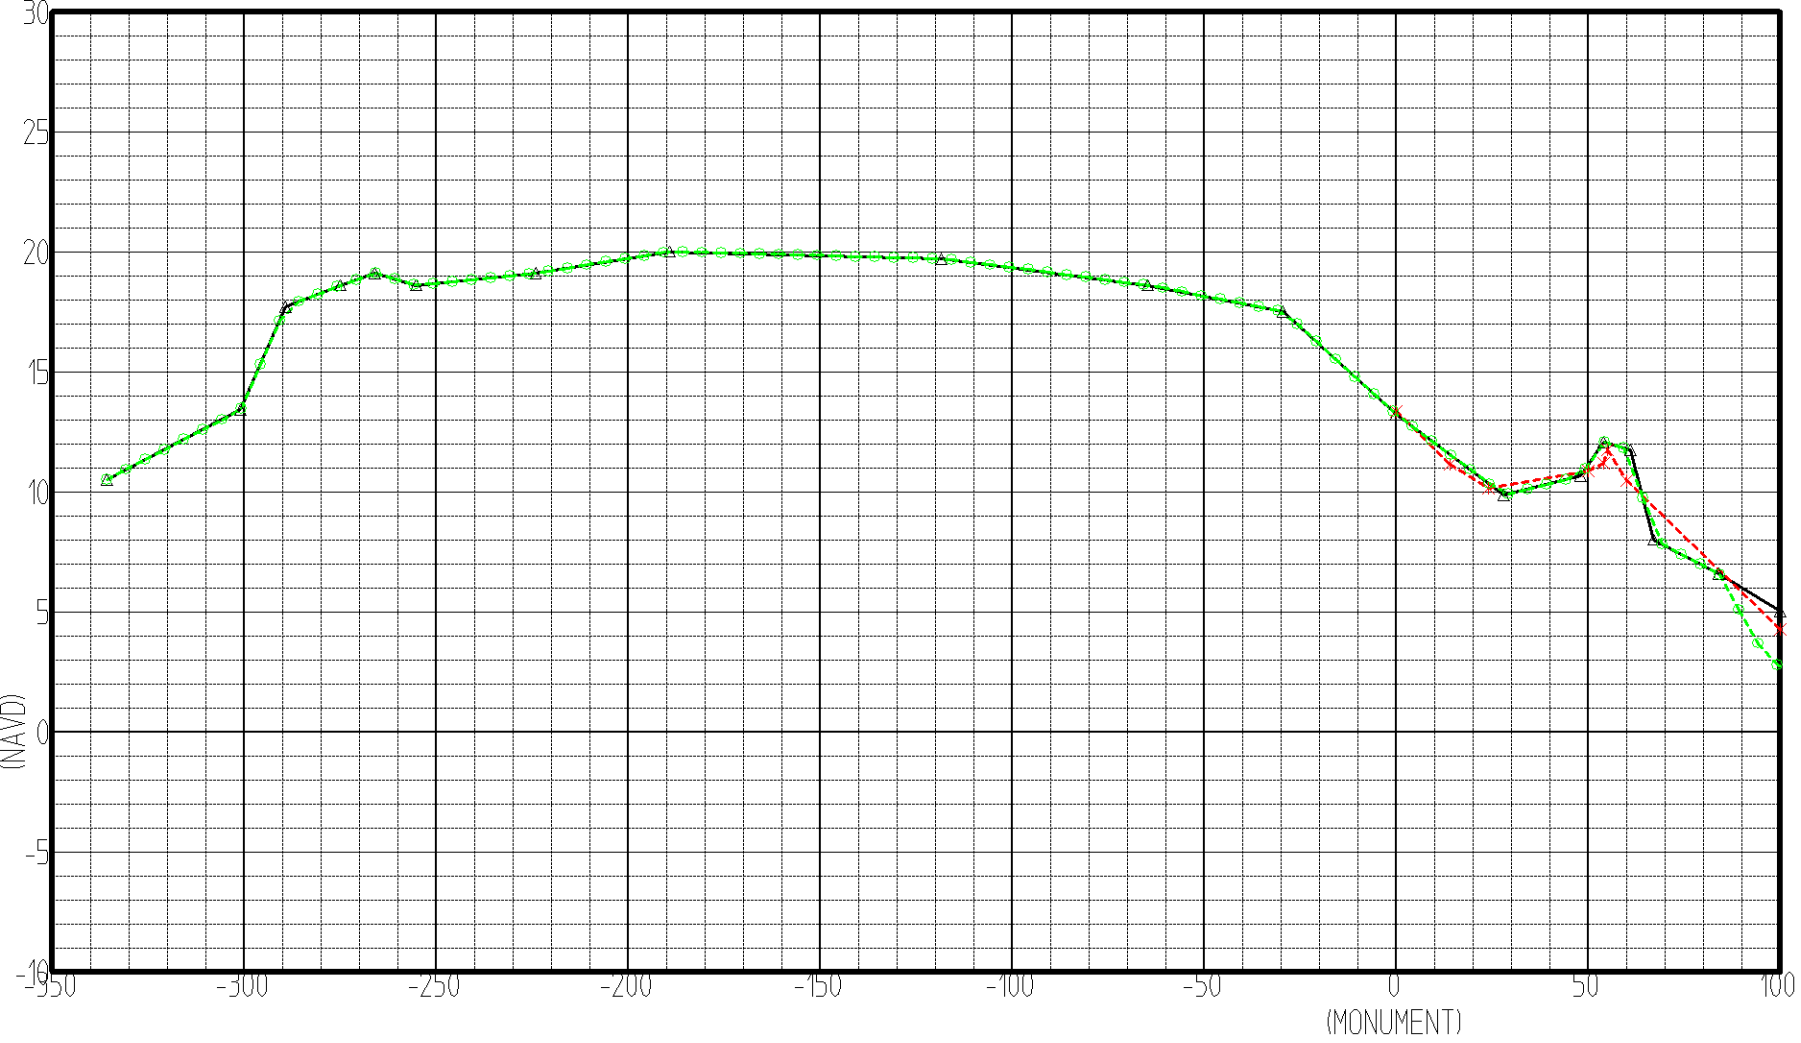
Range: R-21

—△—△— ST JOHN 1984-05

- - - * - - - POST-STORM 1984-12

- - - o - - - SJ SBEACH ERODED CND1

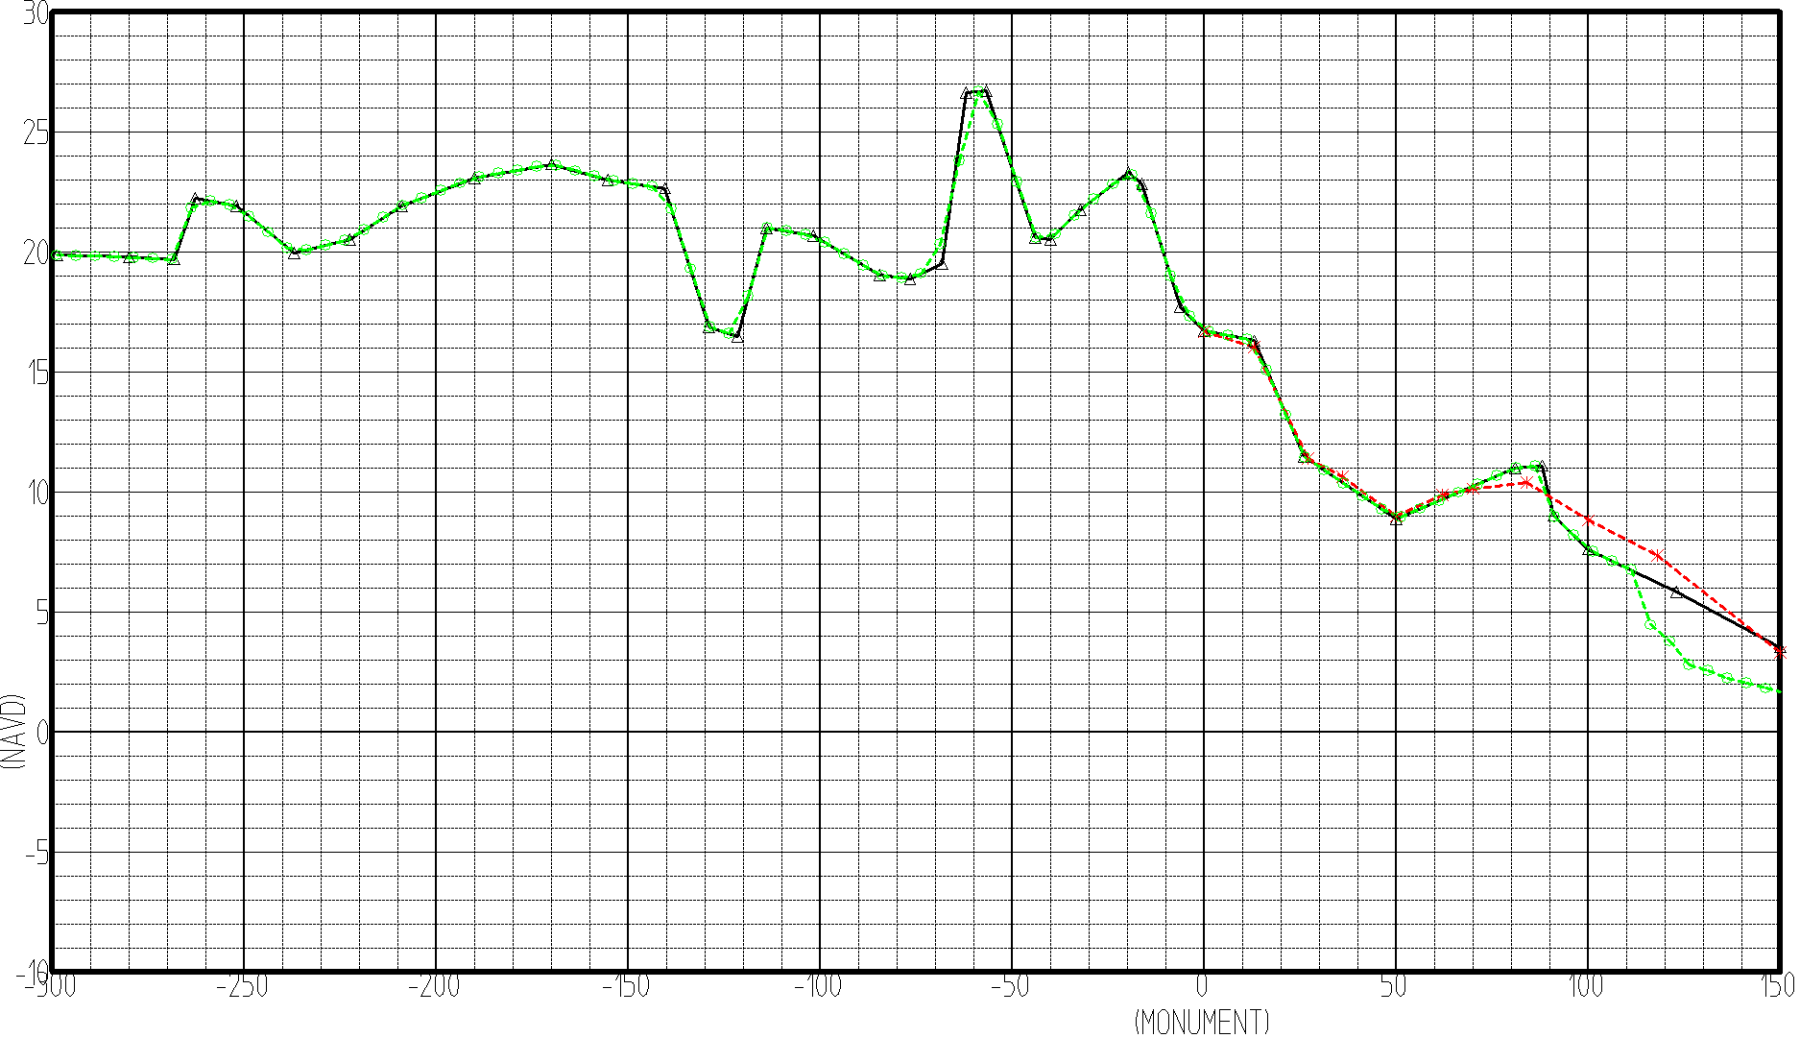
Range: R-24 1/2

—△—△— ST JOHN 1984-05
 - - - * - - - POST-STORM 1984-12
 - - - o - - - SJ SBEACH ERODED CND1

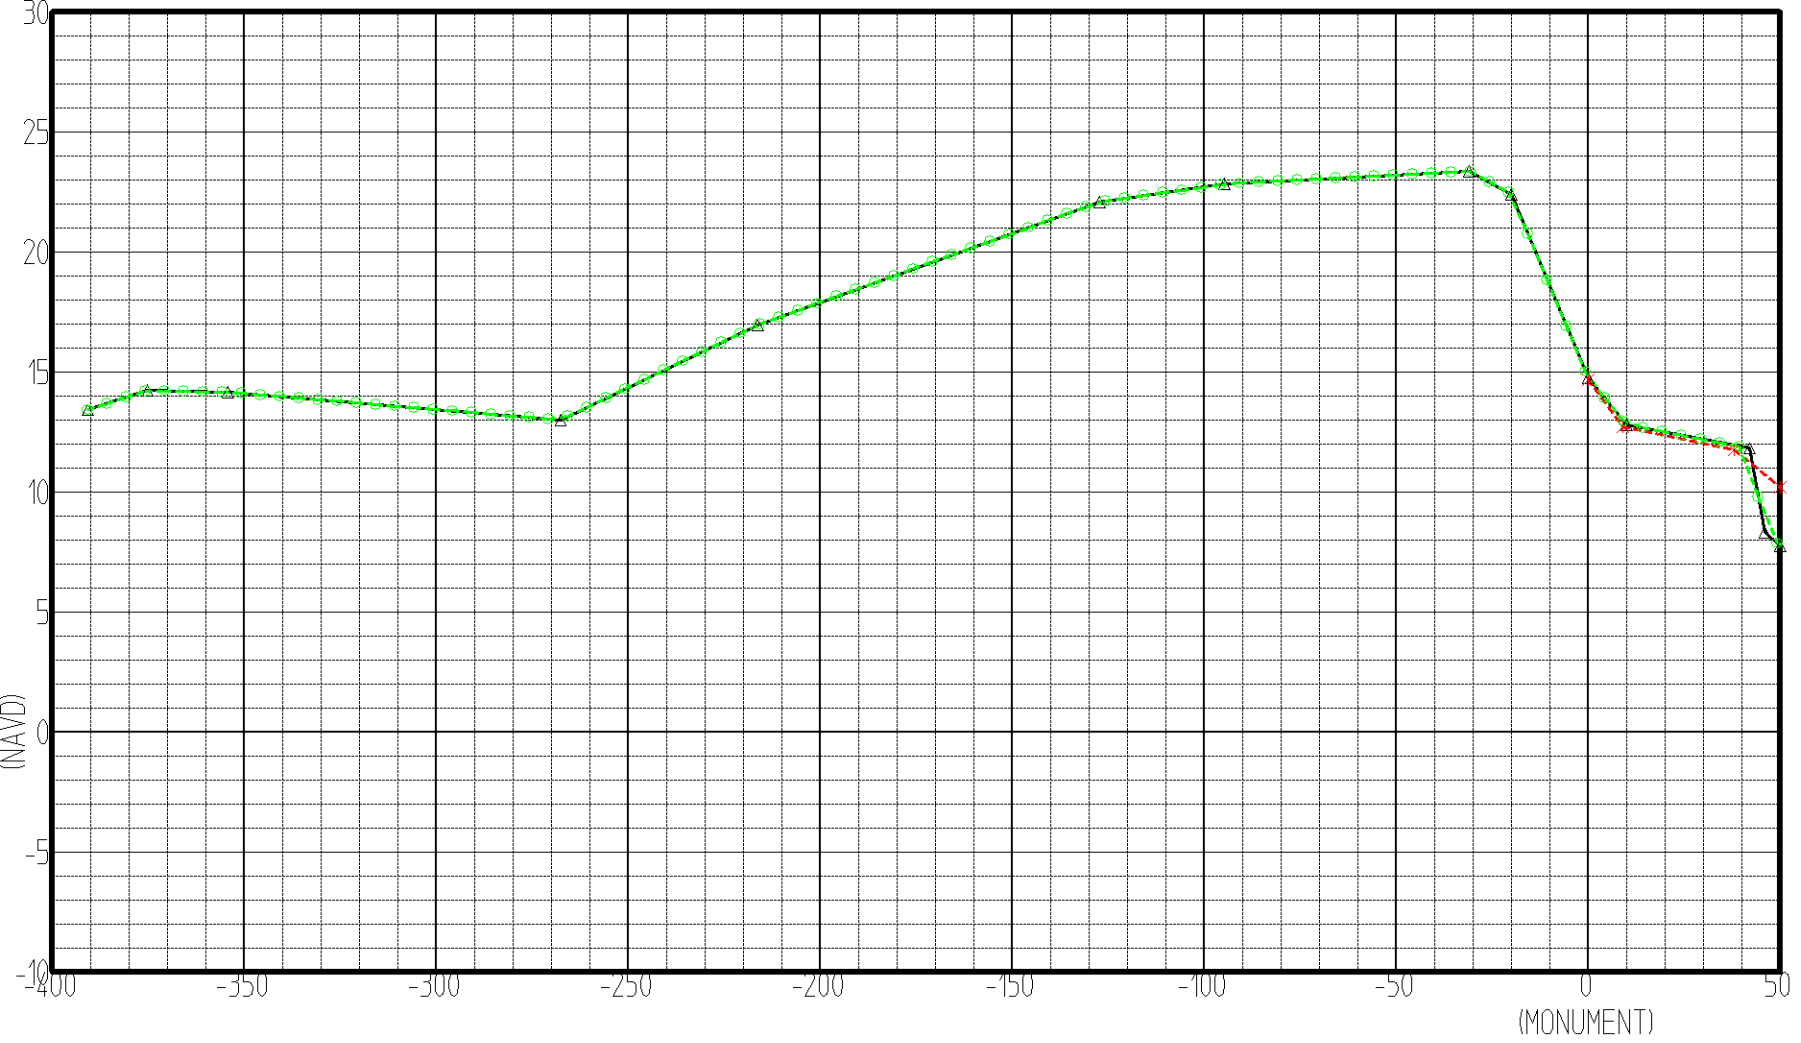
Range: R-27

—△—△— ST JOHN 1984-05

- - * - - * - - POST-STORM 1984-12

- - ○ - - ○ - - SJ SBEACH ERODED CND1
