Hurricane Kate

November 15-23, 1985

Department of Natural Resources
Division of Beaches and Shores
Post Storm Report No. 86-1
September, 1986
By Ralph Clark

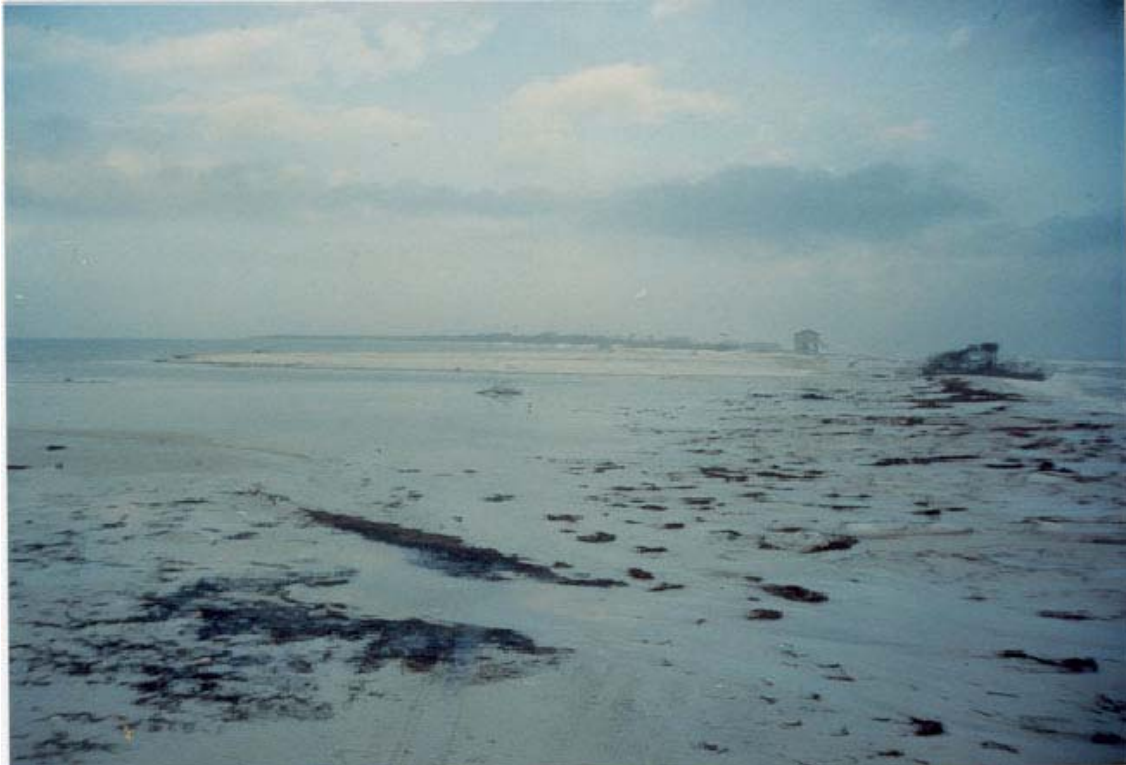
FIGURE 60. Eastern Narrow inundated at high tide three weeks after Kate.
